Karuah East Quarry Biodiversity Offset Area Monitoring Report

Karuah East Quarry Biodiversity Offset Area and Lot 12

**Report prepared for:
Hunter Quarries**

Rev 2
23 March 2023

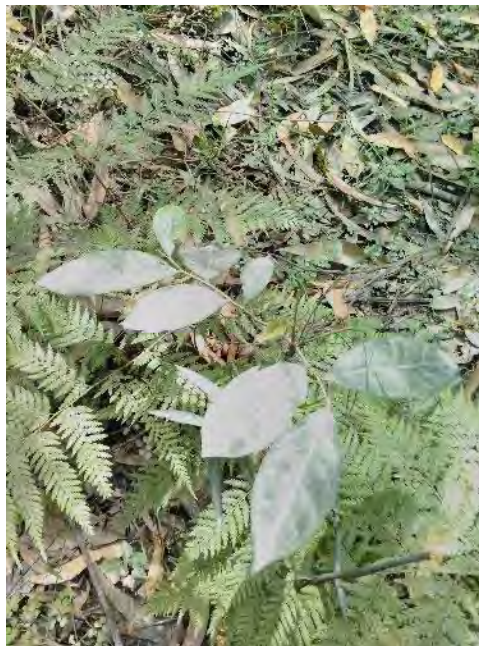
- Moderate levels of dust were observed on foliage (see **Photo 1**) and on the ground at several monitoring sites along the boundaries of quarry operations. Dust levels remain relatively similar to the previous survey period, as such monitoring of this disturbance should be continued in future years to assess any potential influence on remnant vegetation.

Photo 1: Dust Cover on Foliage recorded at MP 4 in 2020

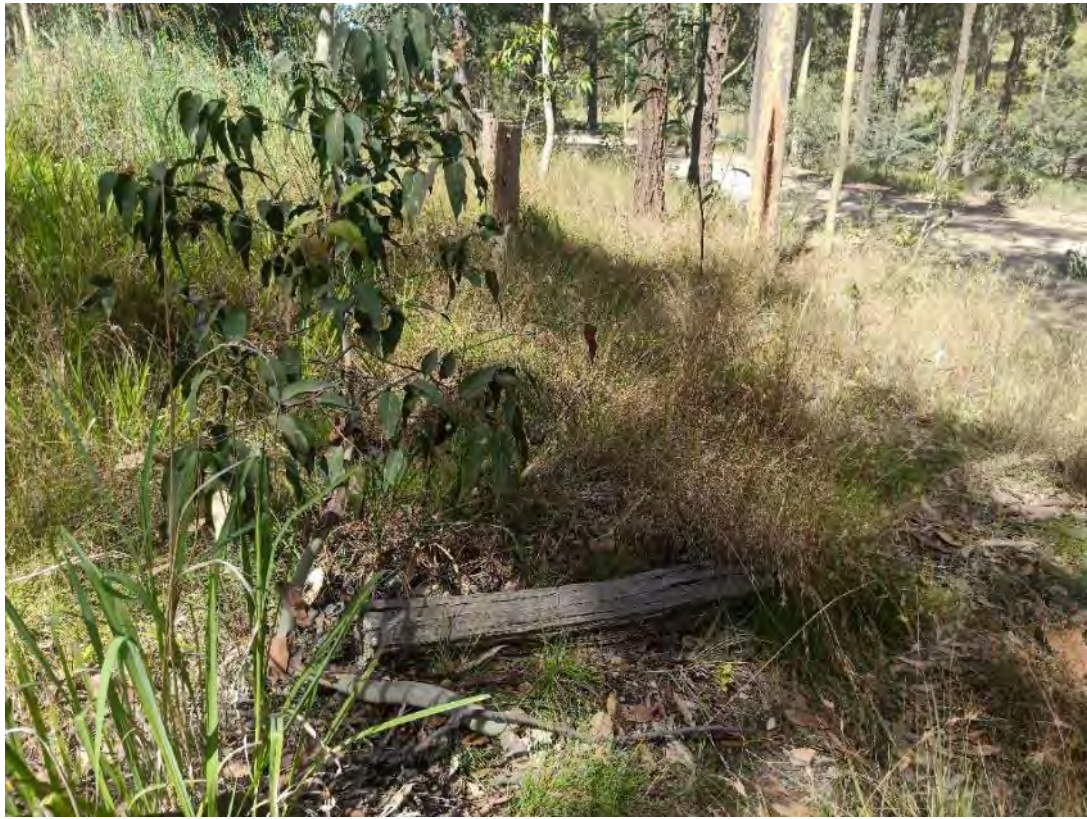
- Internal fencing is also required around the existing dwellings on Lot 5 and Lot 14.
- The barbed-wire fence alongside the far northern boundary of Lot 5 requires repair throughout due to the fence having either fallen, lost tension or damage from fallen trees (**Photo 3** and **Figure 6**).
- Fencing alongside the north-eastern boundary of Lot 5 has been removed with the intention of replacing it.
- Fencing is absent along the western boundary of Lot 5 and will need installation
- Fencing along the western boundary of Lot 13 and haul road has been repaired from prior damage (see **Photo 4**).
- Fencing (Koala Fence) has been removed from the large dam to the south-east of the rock crushing area due to dam wall repairs. Repairs have now been completed and the fence needs to be re-installed.
- All fencing works are required to be undertaken in accordance with Section 3.2 of the BOAMP.

Photo 3: Fallen fence along far northern boundary of Lot 5.

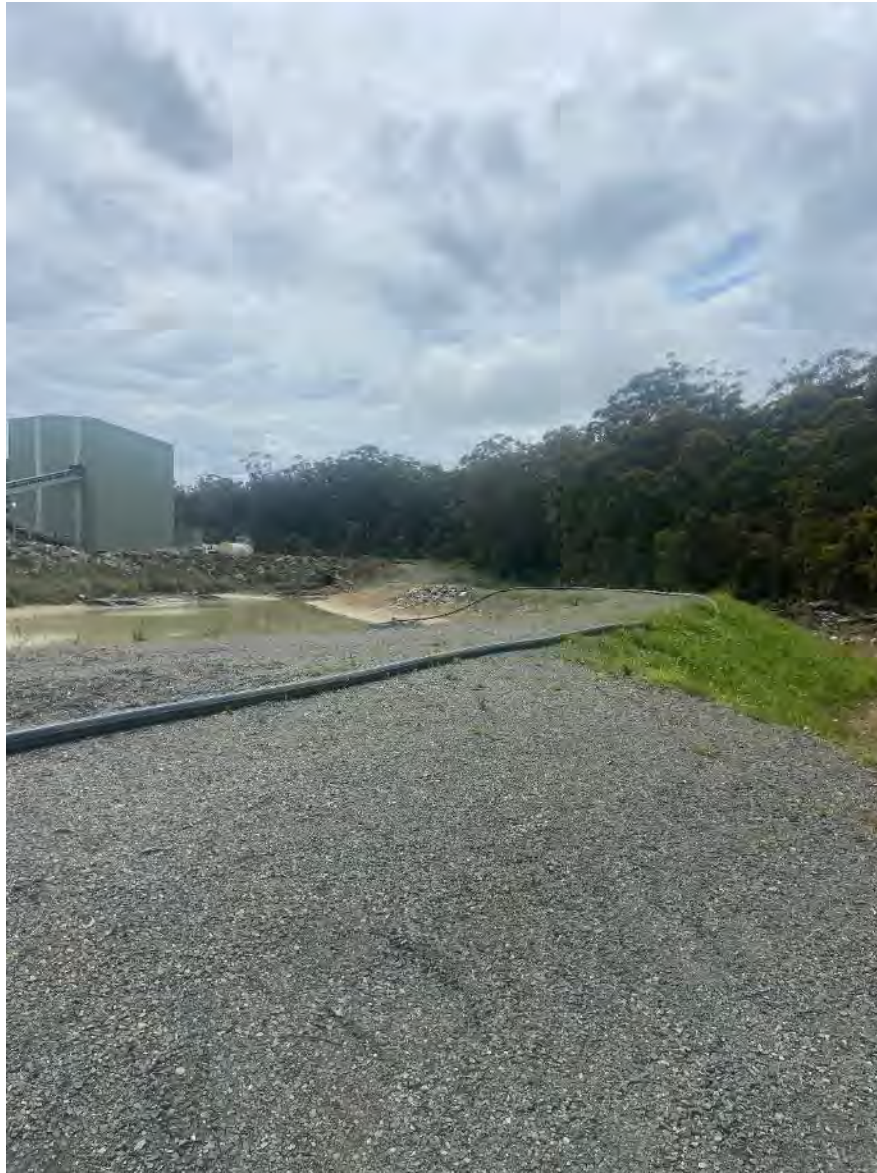
Photo 5: No fence along south eastern side of dam. Needs to be re-installed after dam wall repairs.

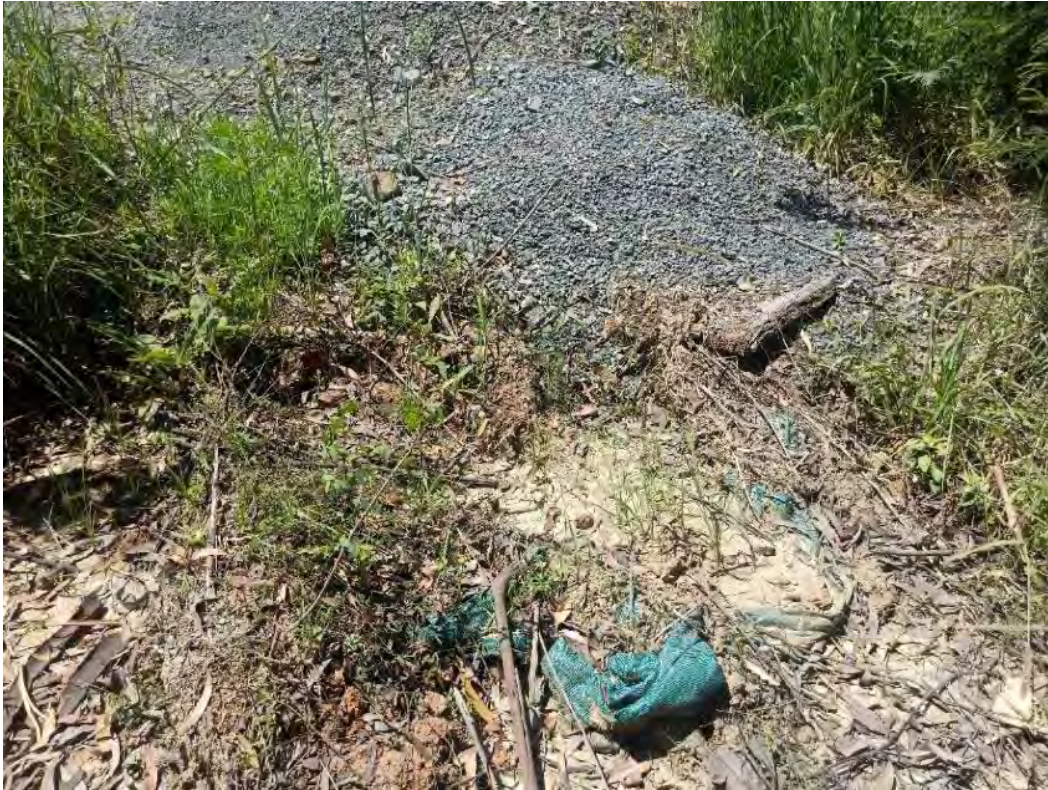
- In three locations, the installed sediment fencing was overtopping (observed in 2018, 2019, 2020, 2021 and 2022) and, therefore, no longer provided active sediment control (**Figure 6**). It was observed in these locations that some sediment had been deposited within the surrounding environment. The overtopping sediment fencing along the western boundary of the quarry, within Lot 12, and adjacent to monitoring site MP 15 has fallen and is no longer adequately collecting sediment (see **Photo**).

Photo 6: Sediment fencing down and overtopping within Lot 12.
