# **Karuah East Quarry Biodiversity Offset Area Monitoring Report**

Karuah East Quarry Biodiversity Offset Area and Lot 12

**Report prepared for:  
Hunter Quarries**

Rev 1  
22 December 2023

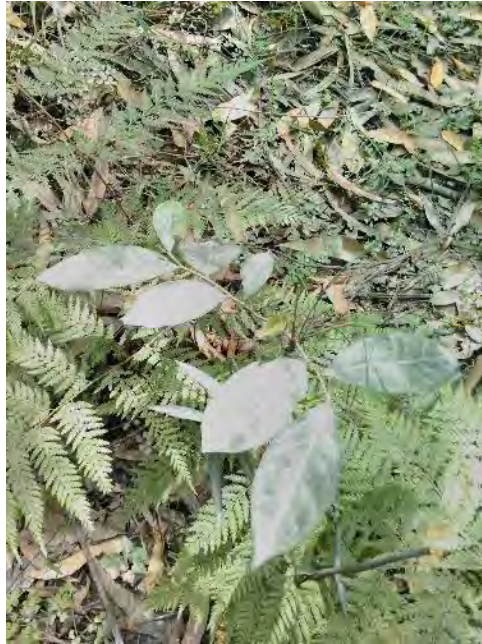
- High levels of dust were observed on foliage (see **Photo 1**) and on the ground at several monitoring sites along the boundaries of quarry operations. Dust levels have increased compared to previous years and remnant vegetation is deteriorating. Monitoring of this disturbance should be continued to assess further impact on remnant vegetation.

**Photo 1: Dust Cover on Foliage recorded at MP 4 in 2020**

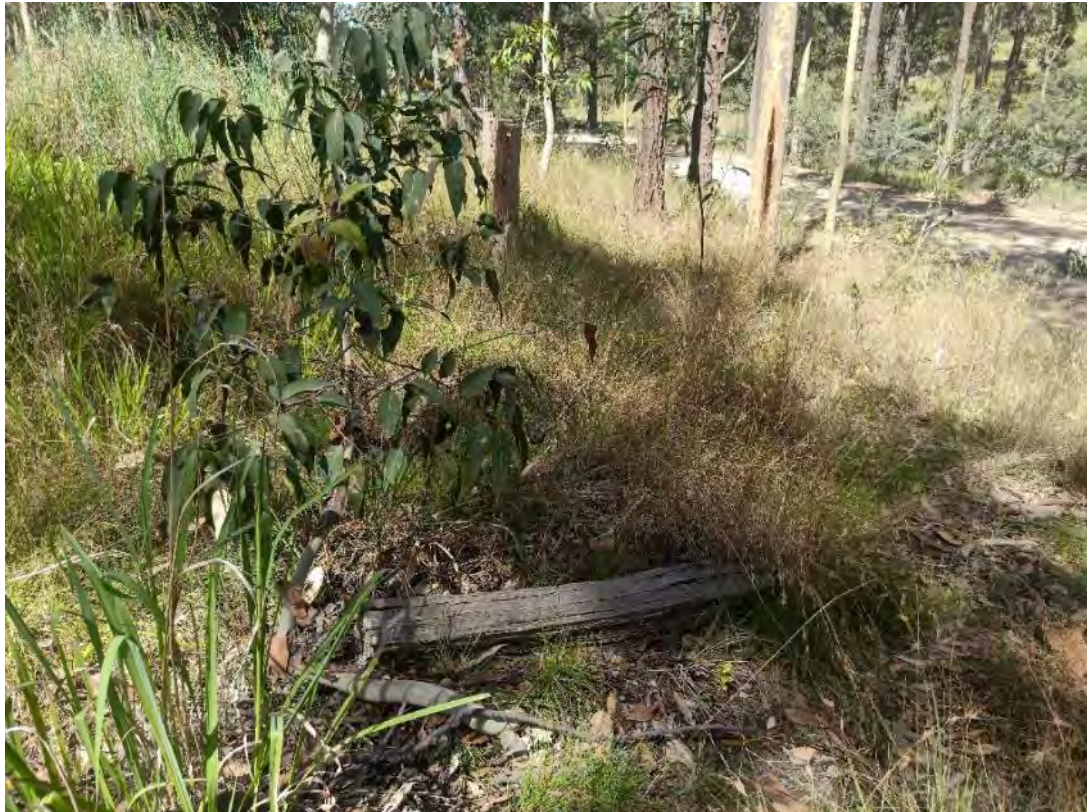
- Internal fencing is also required around the existing dwellings on Lot 5 and Lot 14.
- The barbed-wire fence alongside the far northern boundary of Lot 5 requires repair throughout due to the fence having either fallen, lost tension or damage from fallen trees (**Photo 5** and **Figure 6**).

**Photo 5: Fallen fence along far northern boundary of Lot 5.**

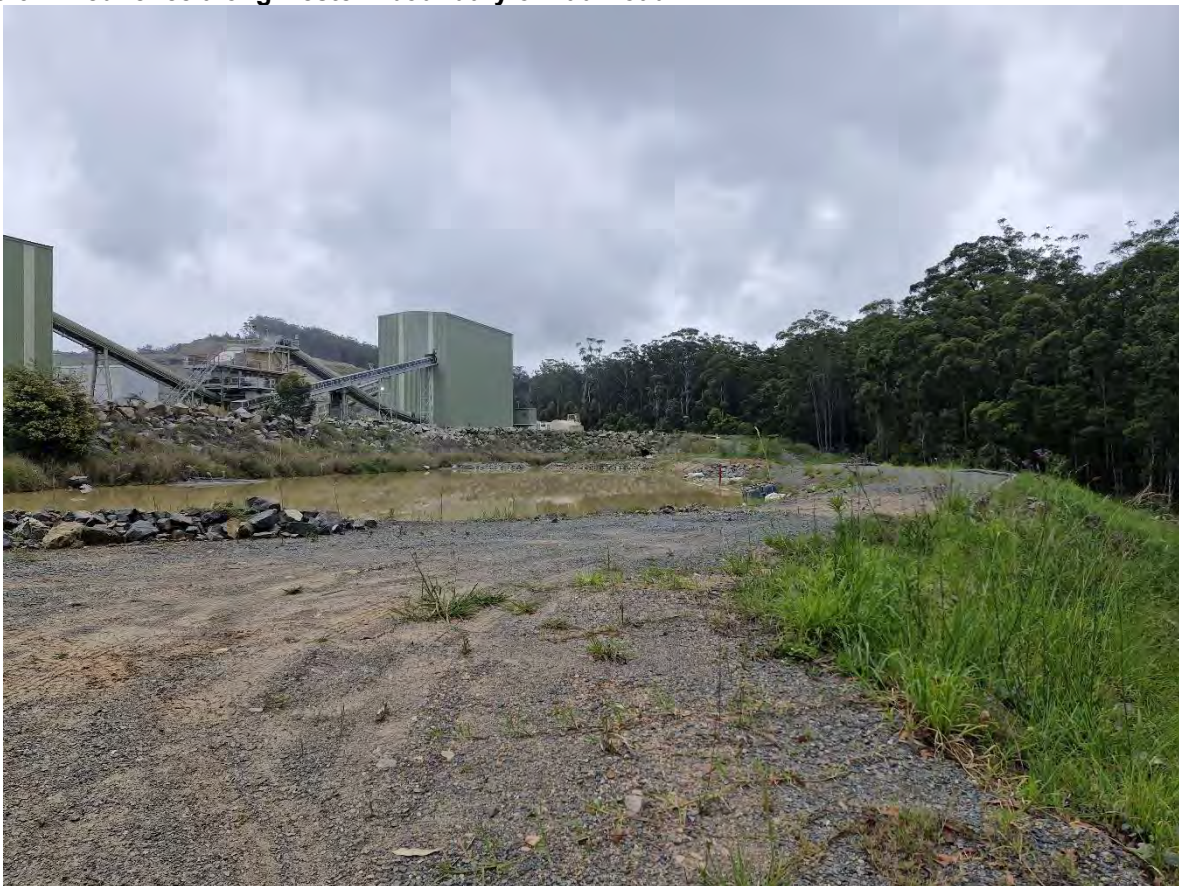
- Fencing along the western boundary of Lot 13 and haul road has been repaired from prior damage (see **Photo 6**).
- Fencing (Koala Fence) has been removed from the large dam to the south-east of the rock crushing area due to dam wall repairs. Repairs have now been completed and the fence needs to be re-installed. (**Photo 7**)

**Photo 7: No fence along southeastern side of dam. Needs to be re-installed after dam wall repairs.**

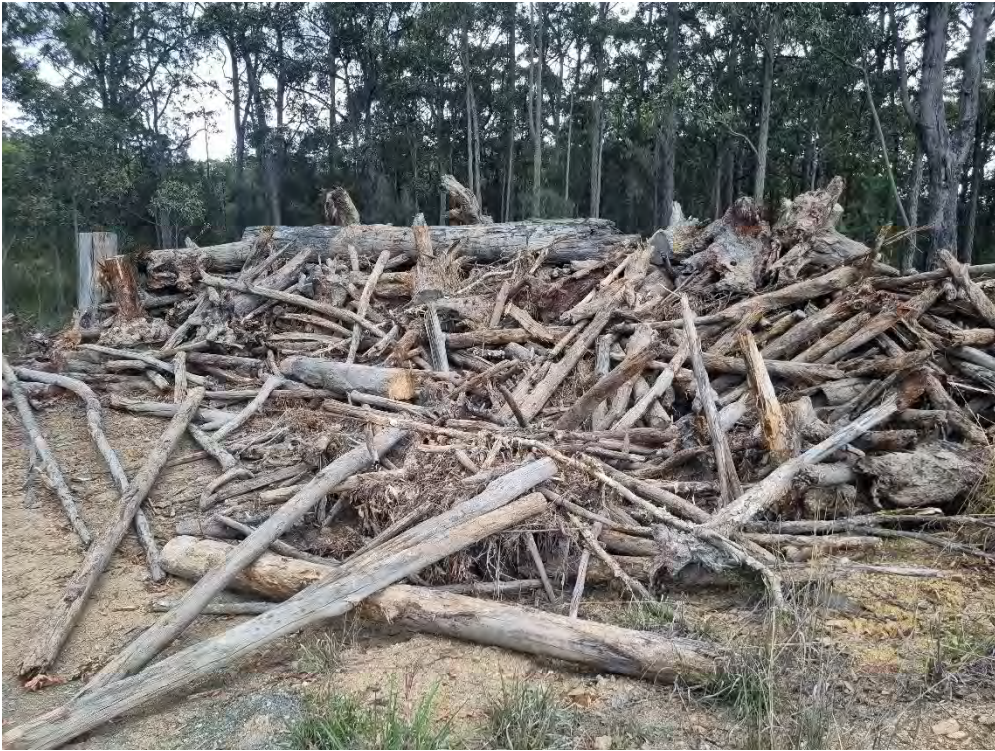
- Fencing along the eastern boundary of the disturbance area in Lot 13 is non-existent (**Figure 6**).
- Many timber stockpiles were observed outside of the disturbance area along fence lines and at the end of the access track southeast of the rock quarry (**Photo 8**).

**Photo 8: Large timber stockpile outside of the disturbance area towards the southeastern access track from the rock quarry.**

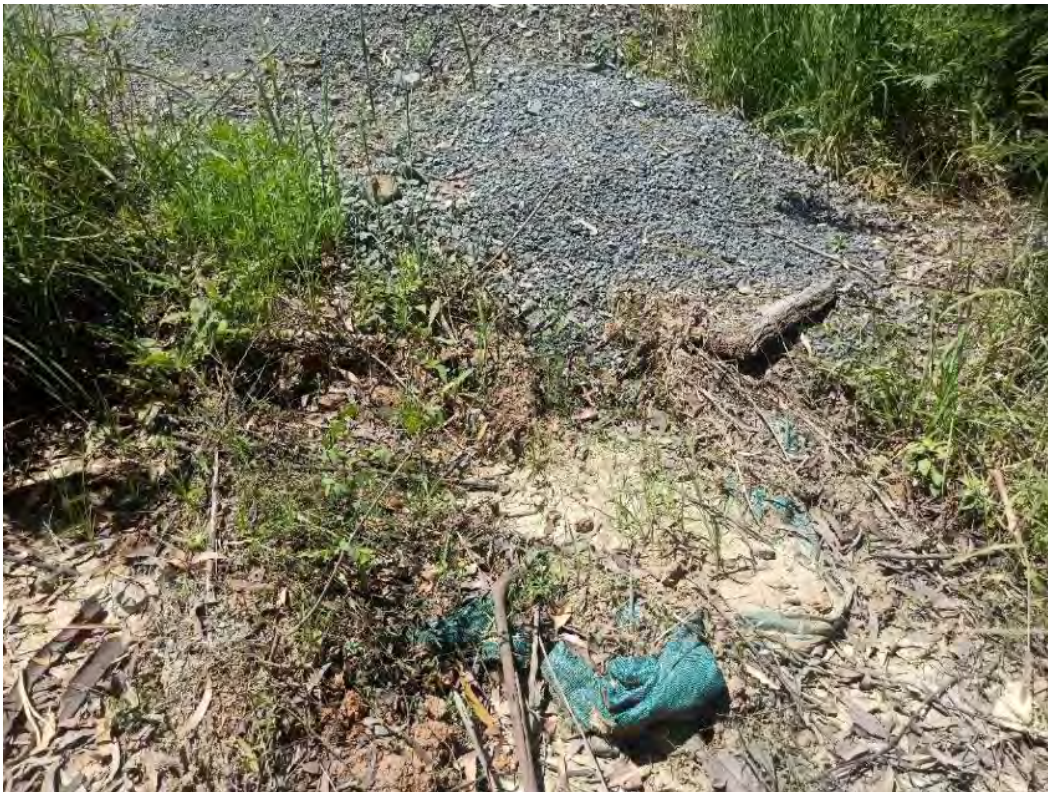
- It was observed in the 2021 monitoring event that excavated rock and sediment produced by the quarry operations has runoff the eastern boundary of the quarry into the BOA (**Photo 9**). This material forms a layer across this area where it is mixed in with organic material. It is recommended that silt fencing or bunding be installed to prevent the further introduction of this material into the BOA. Further excavated rock has been noted to the west of the haul road which

**Photo 9: Sediment fencing down and overtopping within Lot 12.**
