Appendix 5 – Biodiversity Offset Area Monitoring Report

Karuah East Quarry Biodiversity Offset Area Monitoring Report

**Report prepared for:
Karuah East Quarry Pty Limited**

Report Prepared by Wedgetail Project Consulting

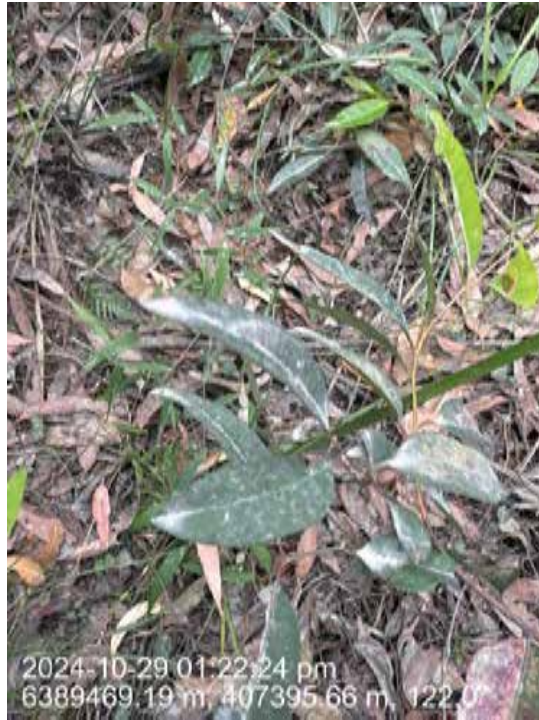
- High levels of dust were observed on foliage (see **Photo 1**) and on the ground at several monitoring sites along the boundaries of quarry operations. Dust levels have increased compared to previous years and remnant vegetation is deteriorating. Monitoring of this disturbance should be continued to assess further impact on remnant vegetation.

Photo 1: Dust Cover on Foliage recorded near MP6 in 2024

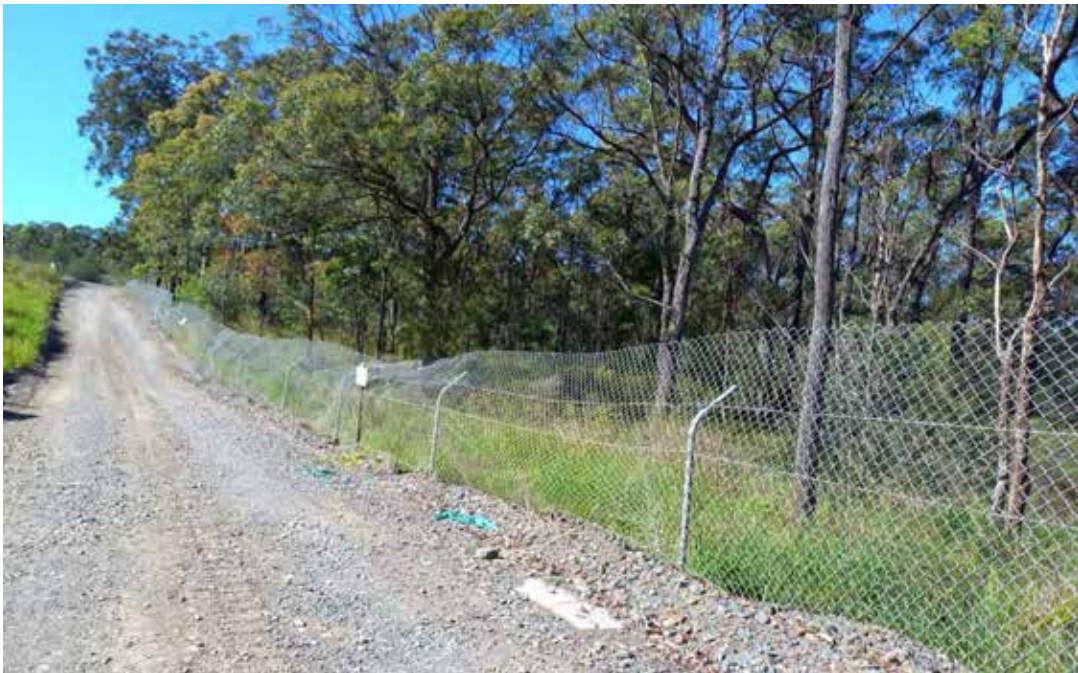
Photo 5: Fixed fence along western boundary of haul road

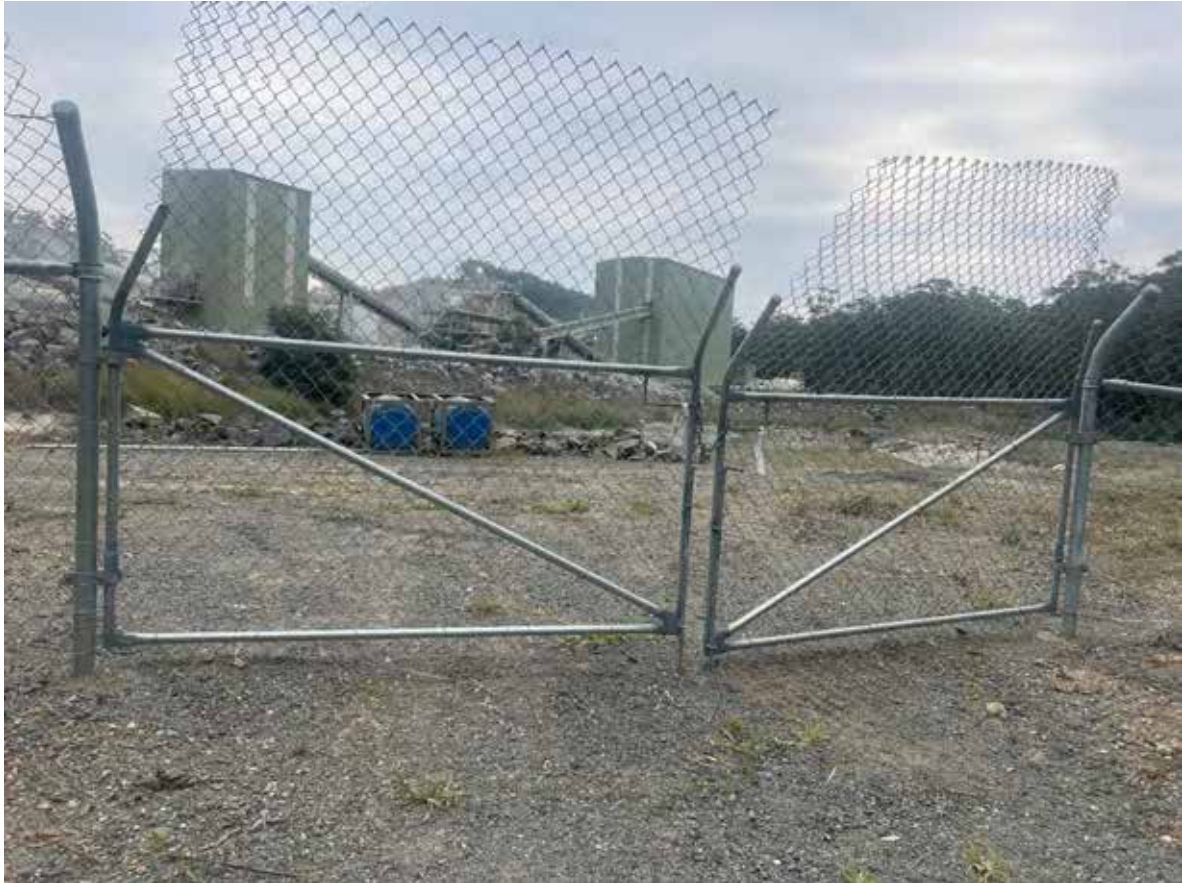
- Internal fencing is also required around the existing dwellings on Lot 5 and Lot 14.
- The barbed-wire fence alongside the far northern boundary of Lot 5 requires repair throughout due to the fence having either fallen, lost tension or damage from fallen trees (**Figure 6**).
- Fencing alongside the north-eastern boundary of Lot 5 has been removed with the intention of replacing it.
- Fencing is absent along the western boundary of Lot 5 and will need installation
- Fencing along the western boundary of Lot 13 and haul road has been repaired from prior damage (see **Photo 5**).
- Fencing (Koala Fence) has been removed from the large dam to the south-east of the rock crushing area due to dam wall repairs. Repairs have now been completed and the fence was re-installed in 2024 (**Photo 6**).

Photo 6: New gate and fencing installed in 2024 along a section of the eastern border of the quarry within Lot 13.

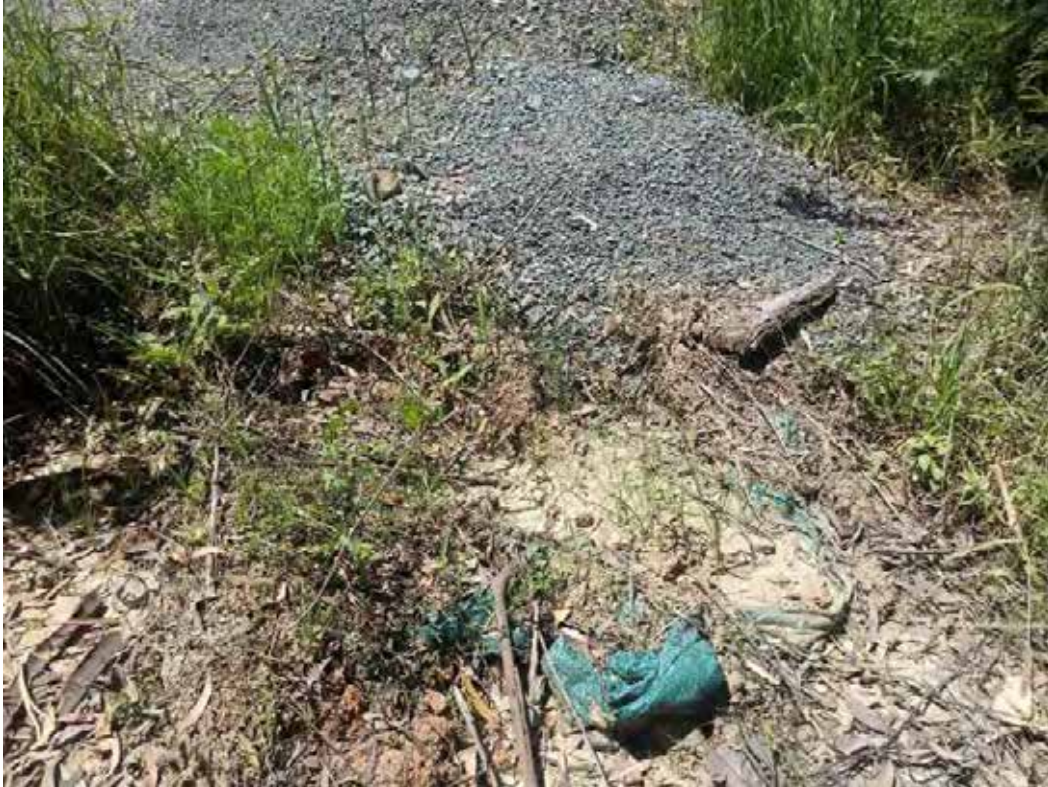
Photo 9: Sediment fencing down and overtopping within Lot 12.

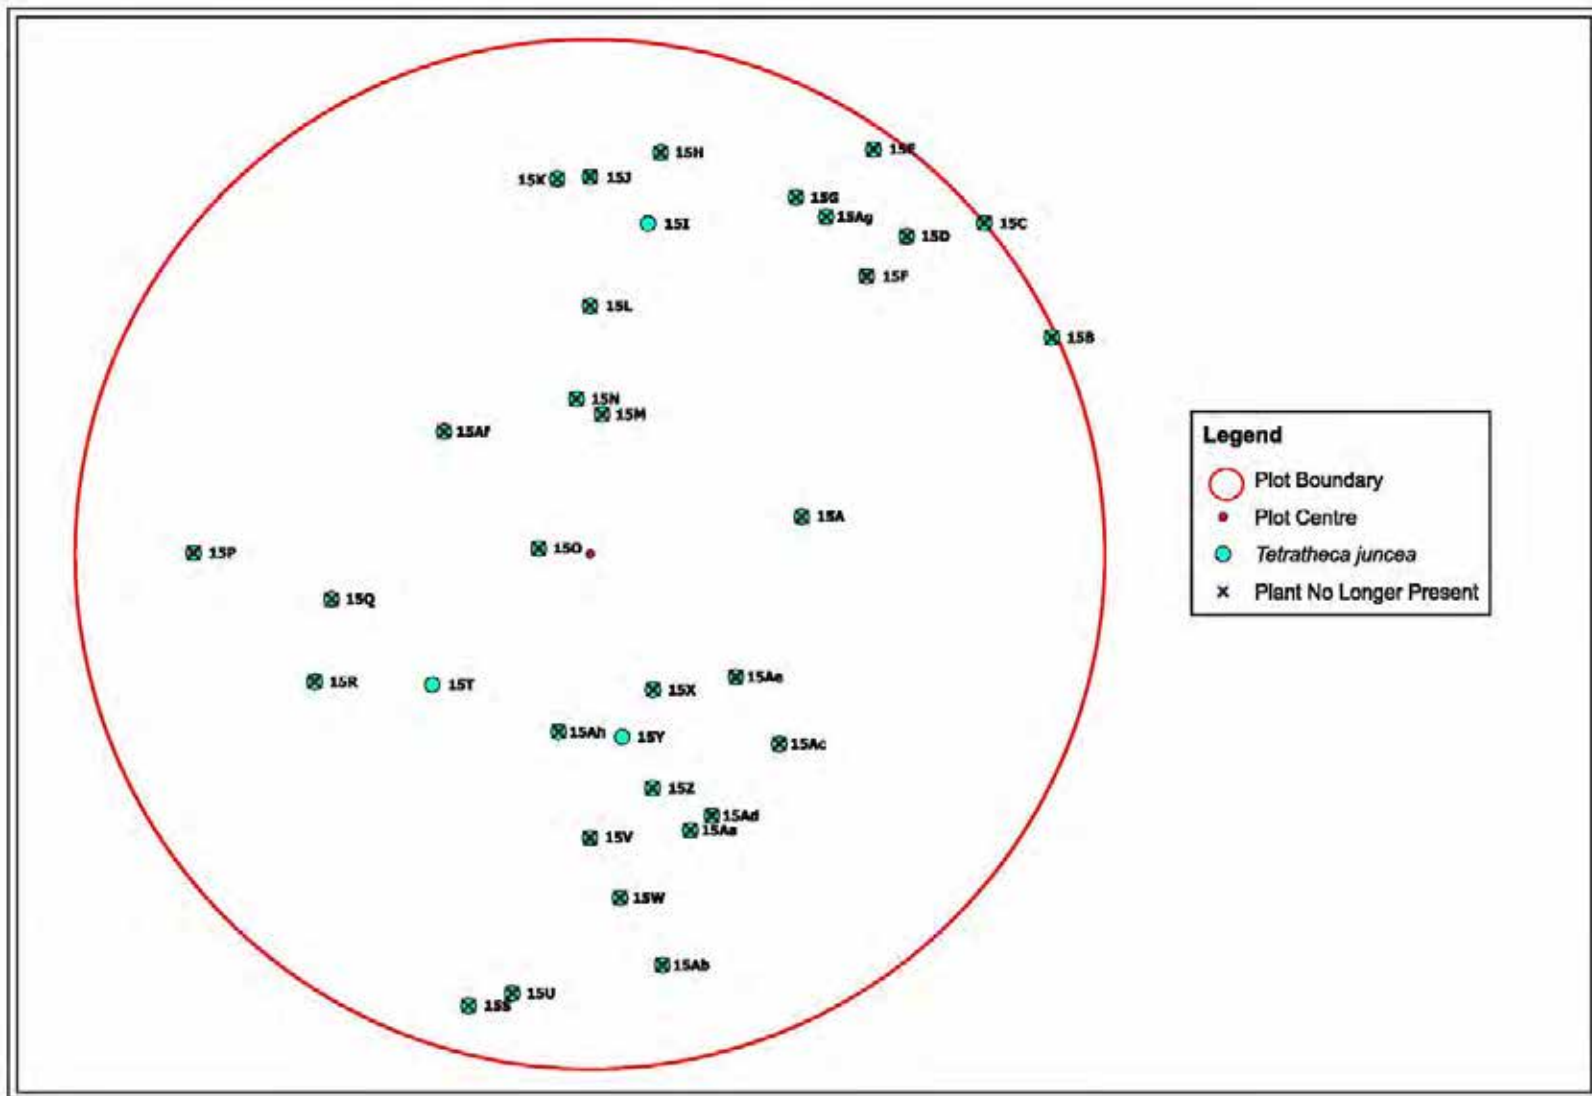
Monitoring Point 15 - *Tetratheca juncea* monitoring results 2024

Unfortunately, a major reduction in population numbers was observed at MP15, in which roughly 13% of the original plants remain. A thick layer of dust was observed on the foliage which has seemingly increased over the years. It is likely that the reduction in plant numbers could be linked to edge effects from quarry operations, i.e. increasing dust pollution. No other major disturbances were noted during monitoring (**Plate 9**).
