Karuah East Quarry Biodiversity Offset Area Monitoring Report

Karuah East Quarry Biodiversity Offset Area and Lot 12

Rev 1
22 December 2023

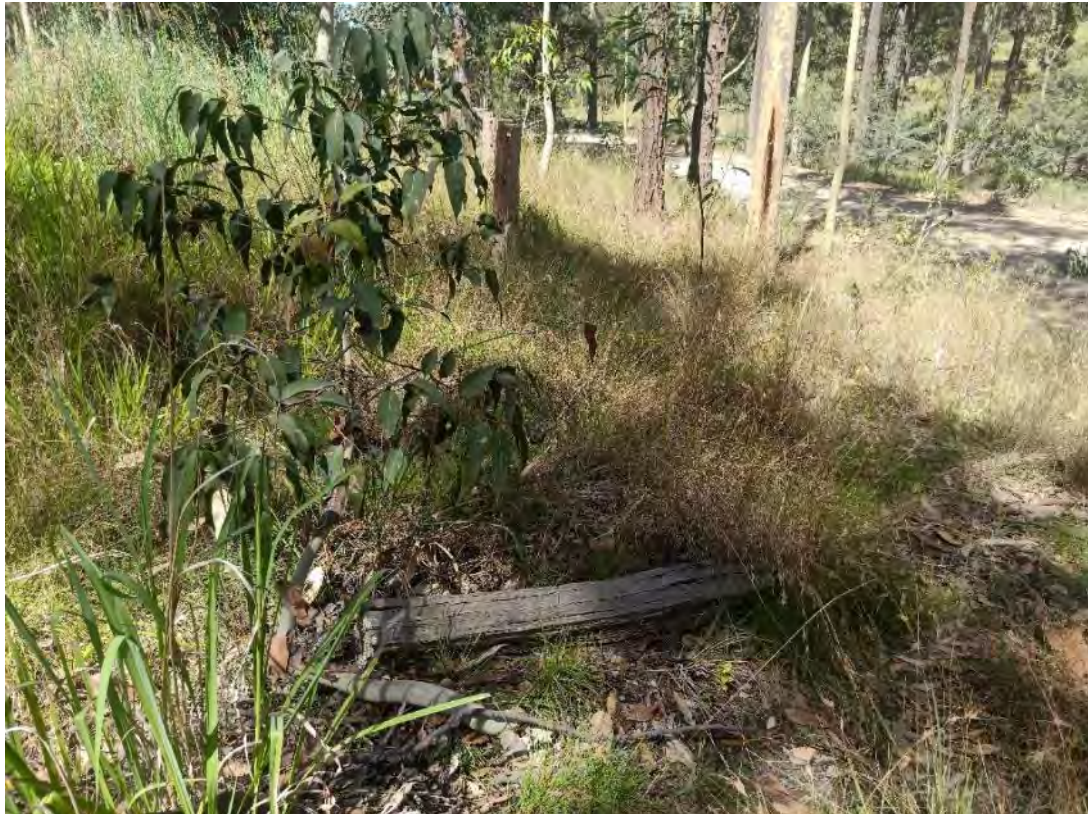
- Internal fencing is also required around the existing dwellings on Lot 5 and Lot 14.
- The barbed-wire fence alongside the far northern boundary of Lot 5 requires repair throughout due to the fence having either fallen, lost tension or damage from fallen trees (**Photo 5** and **Figure 6**).

Photo 5: Fallen fence along far northern boundary of Lot 5.

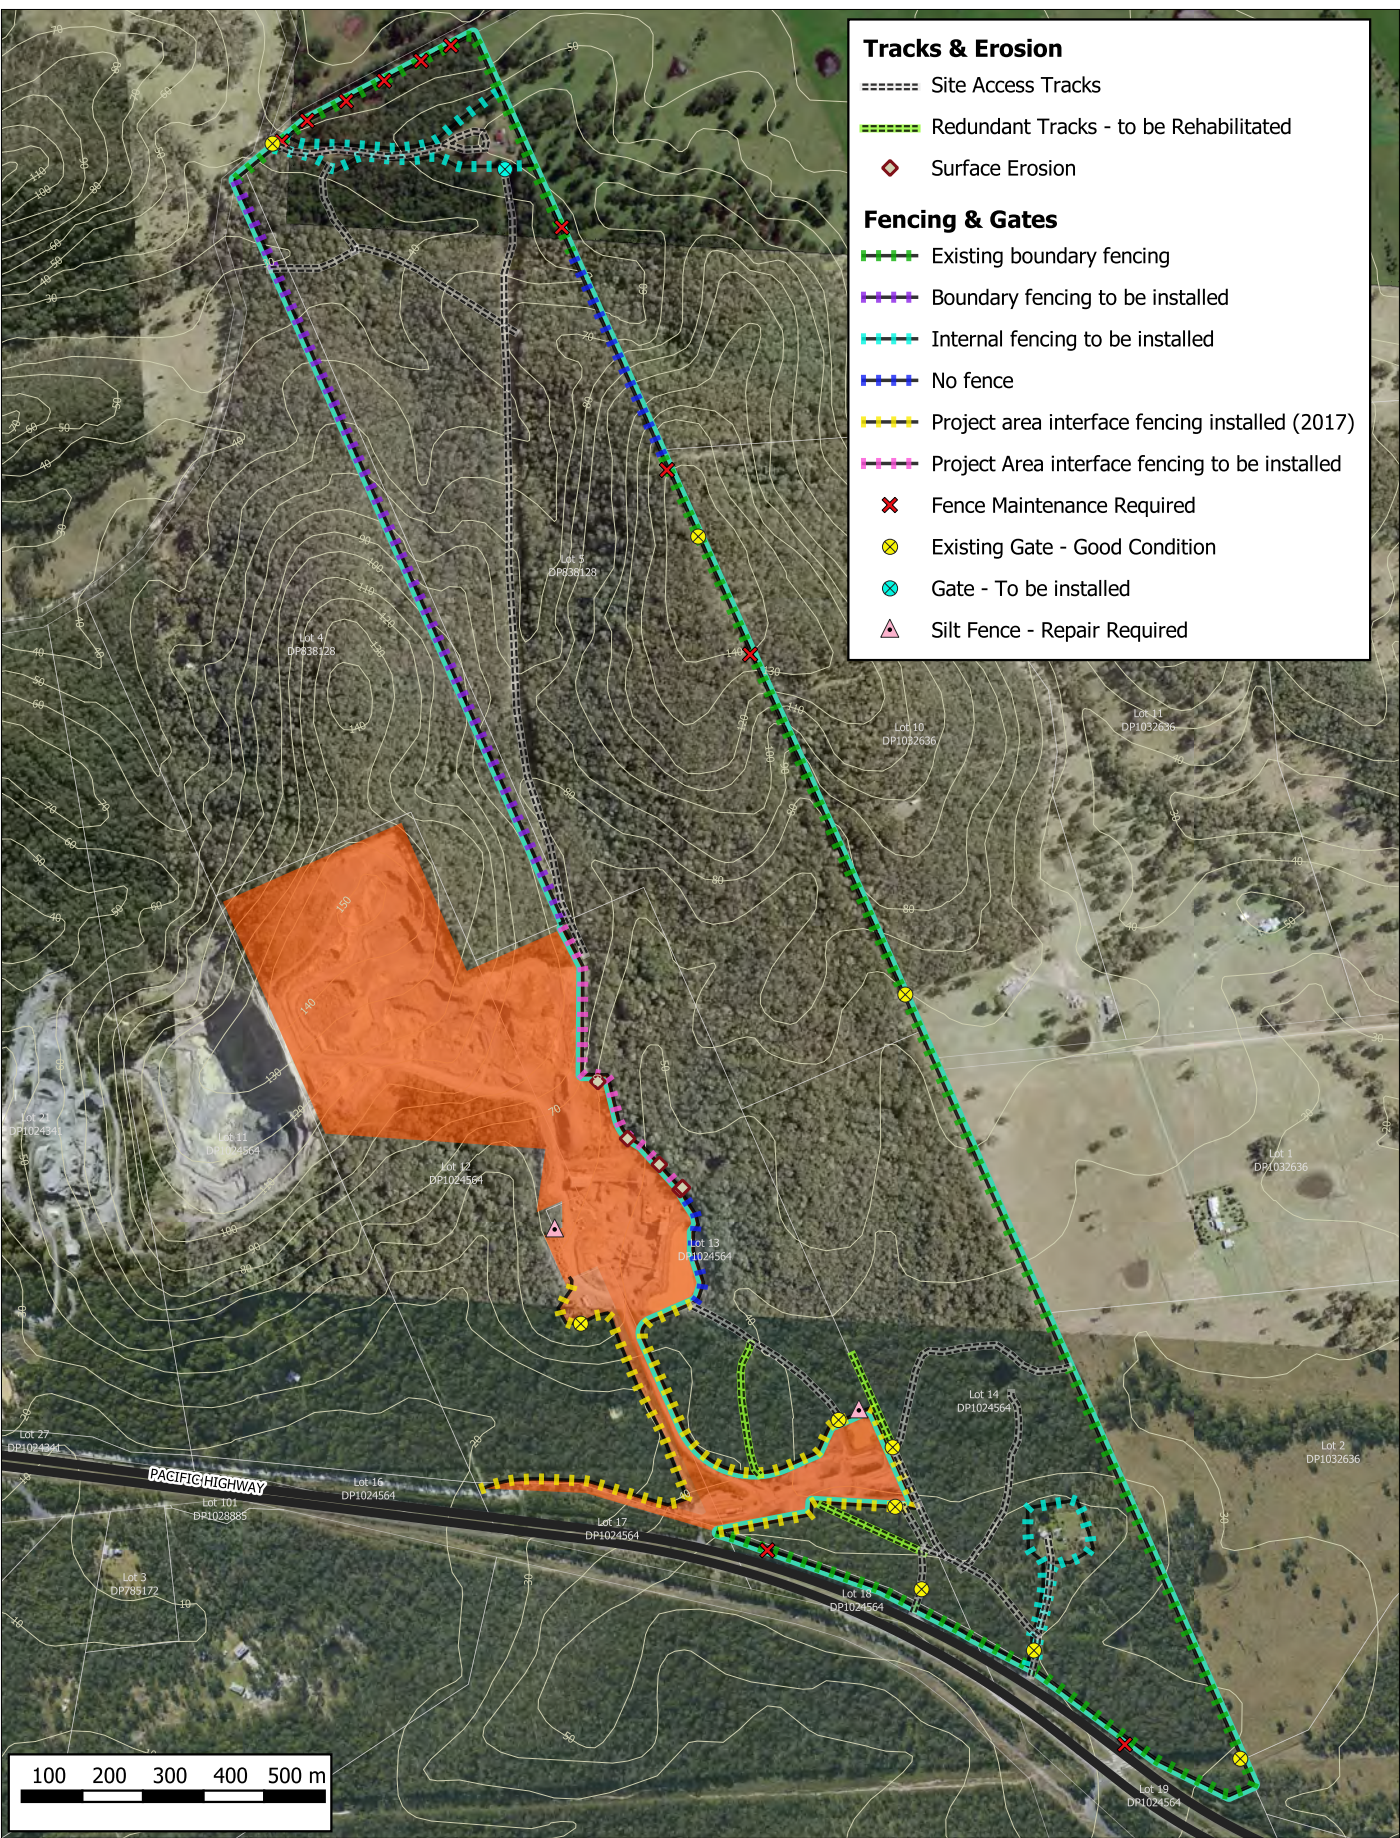
- In three locations, the installed sediment fencing was overtopping (observed in 2018, 2019, 2020, 2021, 2022 and 2023) and, therefore, no longer provided active sediment control (**Figure 6**). It was observed in these locations that some sediment had been deposited within the surrounding environment. The overtopping sediment fencing along the western boundary of the quarry, within Lot 12, and adjacent to monitoring site MP 15 has fallen and is no longer adequately collecting sediment (see **Photo 8**).
