Appendix 4 – Biodiversity Offset Area Monitoring Report

Karuah East Quarry Biodiversity Offset Area Monitoring Report

Rev 1

Rev. No.	Revision Date	Author/s	Reviewer	Details
Rev 1	10 February 2026	Rachel Neal	Mark Dean	Draft

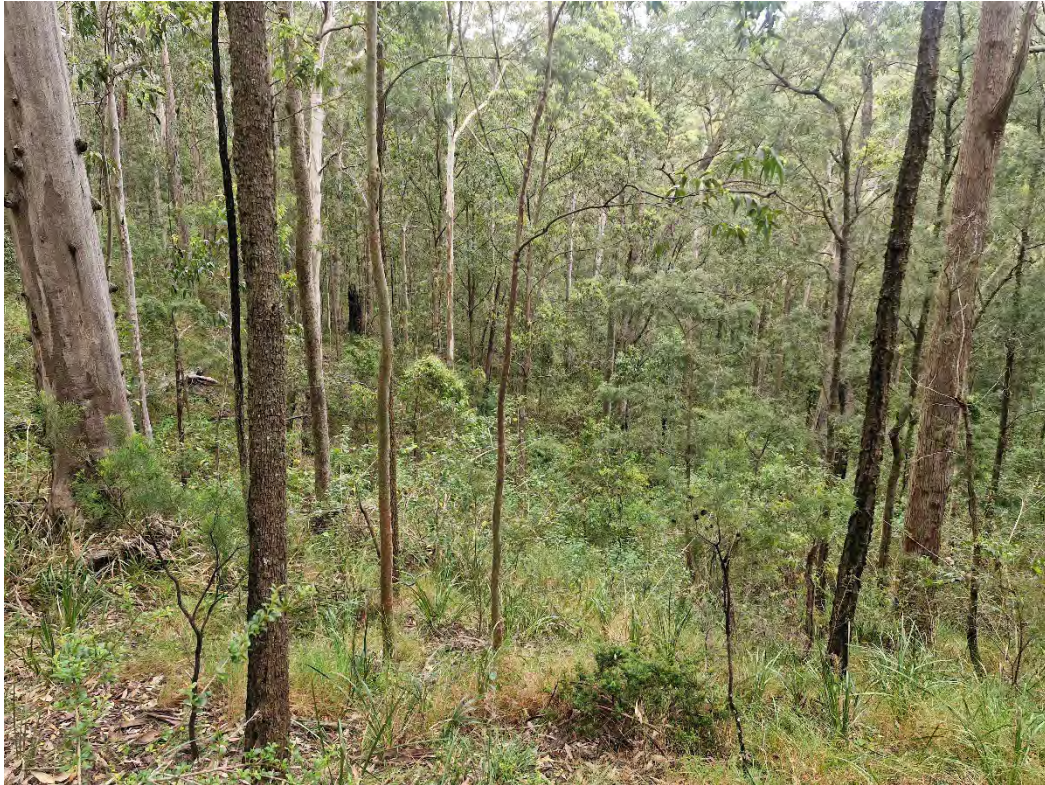
Photo 1: Heavy Lantana infestation occurring in the gully, east of MP2.

It is strongly recommended that weed control works for the next 12 months should focus on the Lantana infestations in Lot 5, northern section of Lot 12 and north-east part of Lot 13, especially within the vicinity of MP 3 and MP 4, to protect *Asperula asthenes* individuals. *Asperula asthenes* within MP3 is particularly suffering and requires immediate attention. Evidence of weed management was observed in the vicinity of MP 1, almost totally diminishing the burden within this monitoring point. Priority should also be given to controlling infestations alongside waterways where Lantana has become most abundant. These weed control activities must be undertaken in spring in accordance with the procedures detailed in Section 3.10 of the BOAMP due to the presence of threatened flora (*Asperula asthenes*) in these areas.

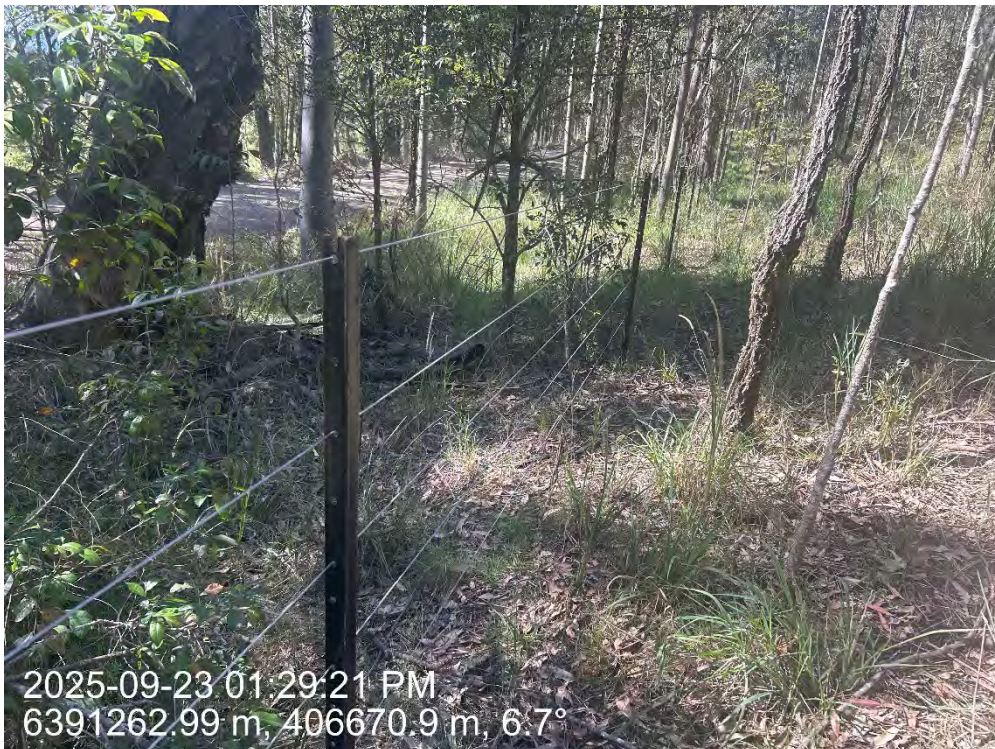
Photo 5: Fence repair works observed along far northern boundary in 2025

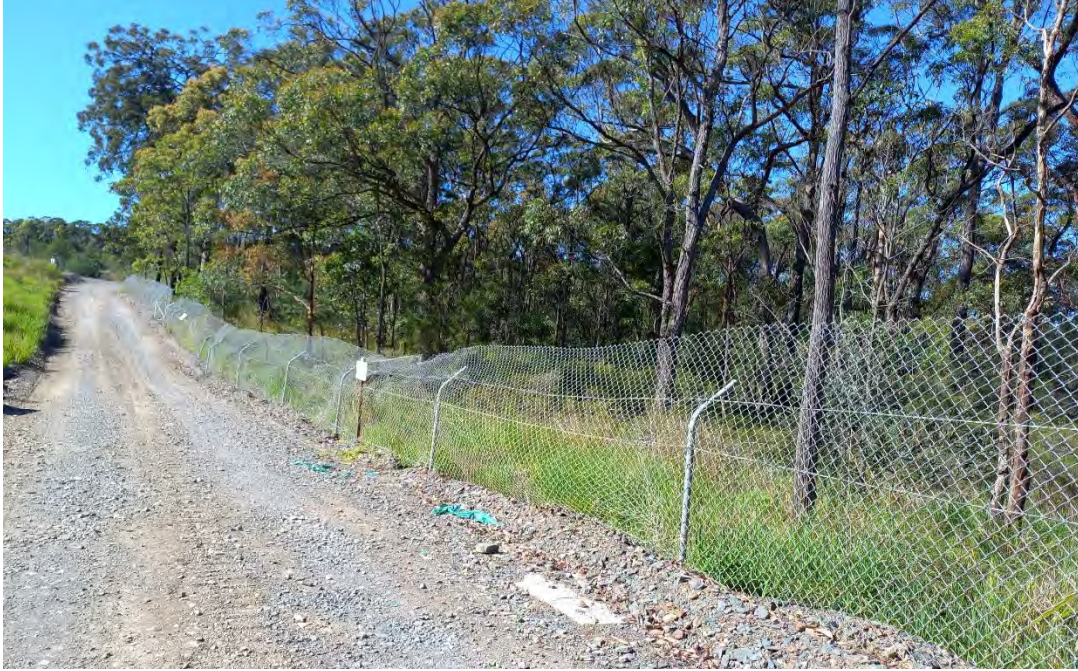
Photo 6: Fixed fence along western boundary of haul road

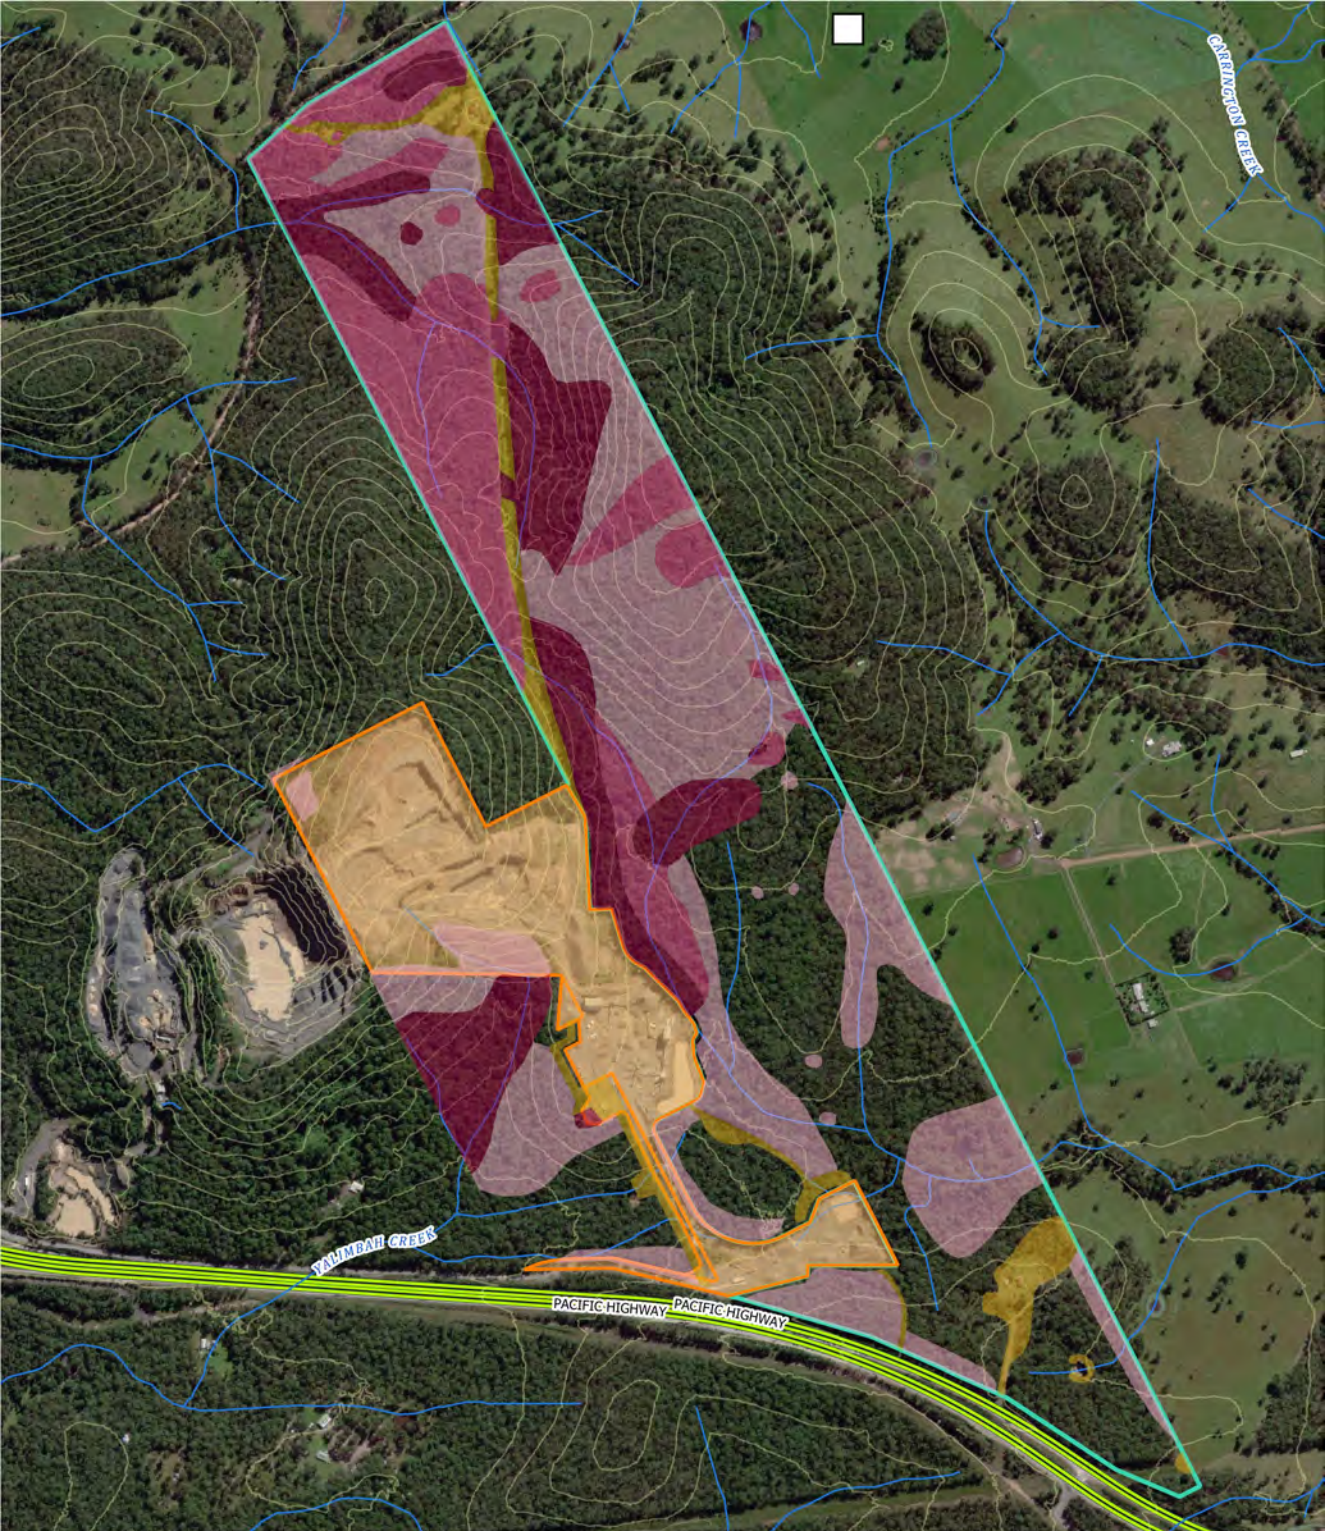
- Weed Densities**
- Lantana - High
 - Lantana - Moderate
 - Lantana - Scattered
 - Exotic Grasses

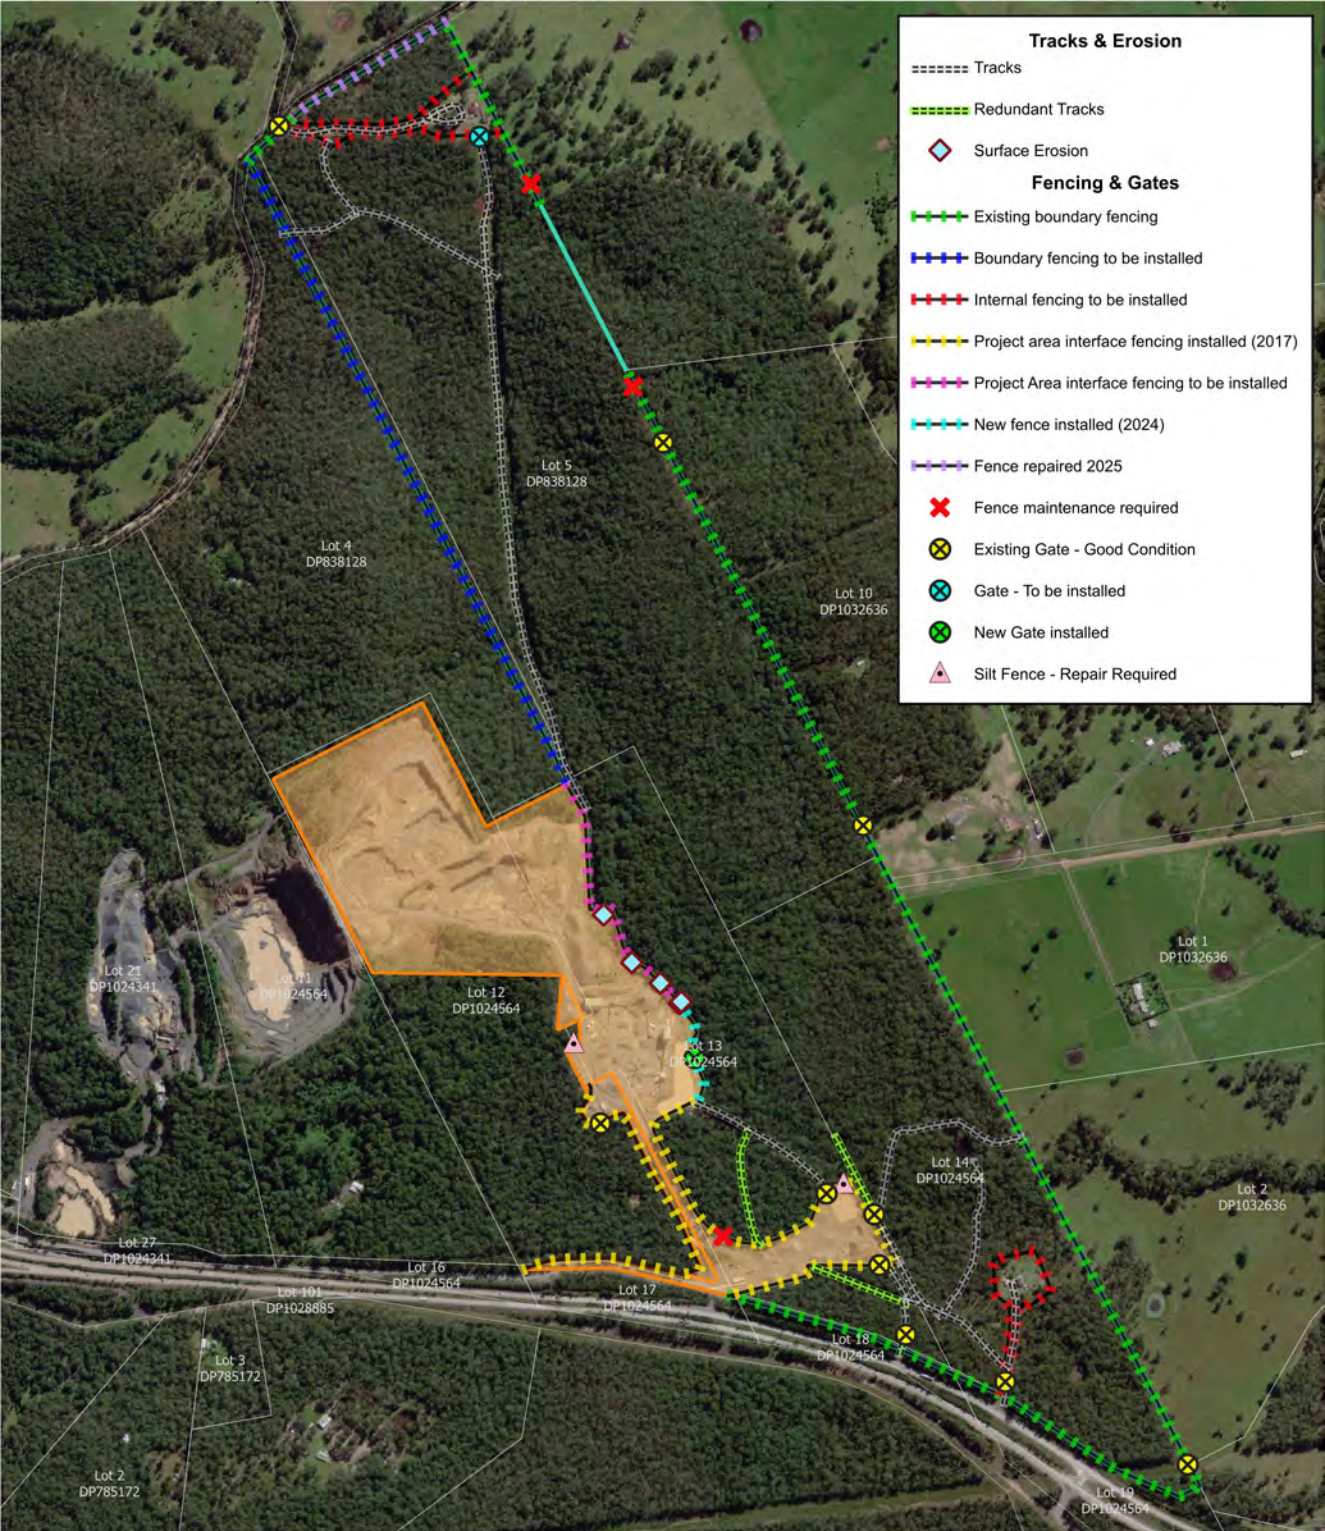
Figure 6:
Tracks, Erosion and
Fencing

- Erosion had formed a trough and sediment produced from the quarry had run off the eastern boundary into Lot 12 and into a dam. There is evidence of major sedimentation (**Photo 3** and **Photo 4**). Sediment fencing has since been installed and continued monitoring will determine if this is adequately collecting sediment (**Photo 10**).

Additional maintenance is recommended at the access tracks along the north-western boundary of Lot 5, that have become overgrown and are no longer accessible by vehicle.

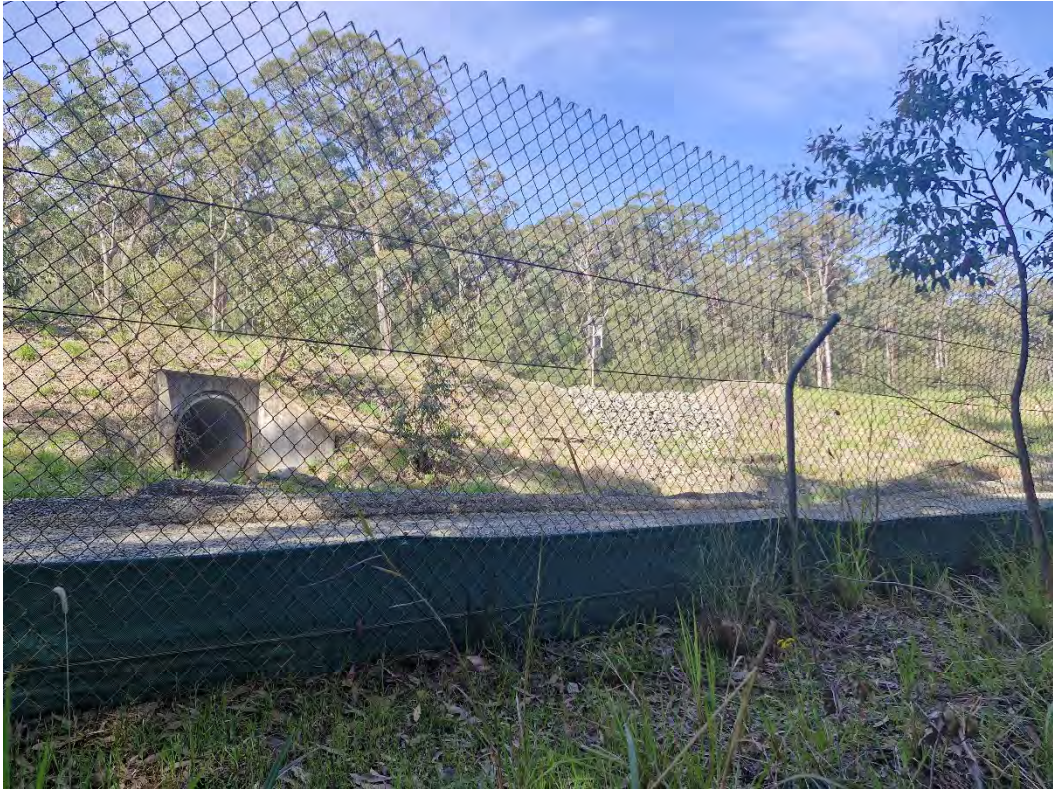
Photo 10: Sediment fencing repaired since previously damaged.

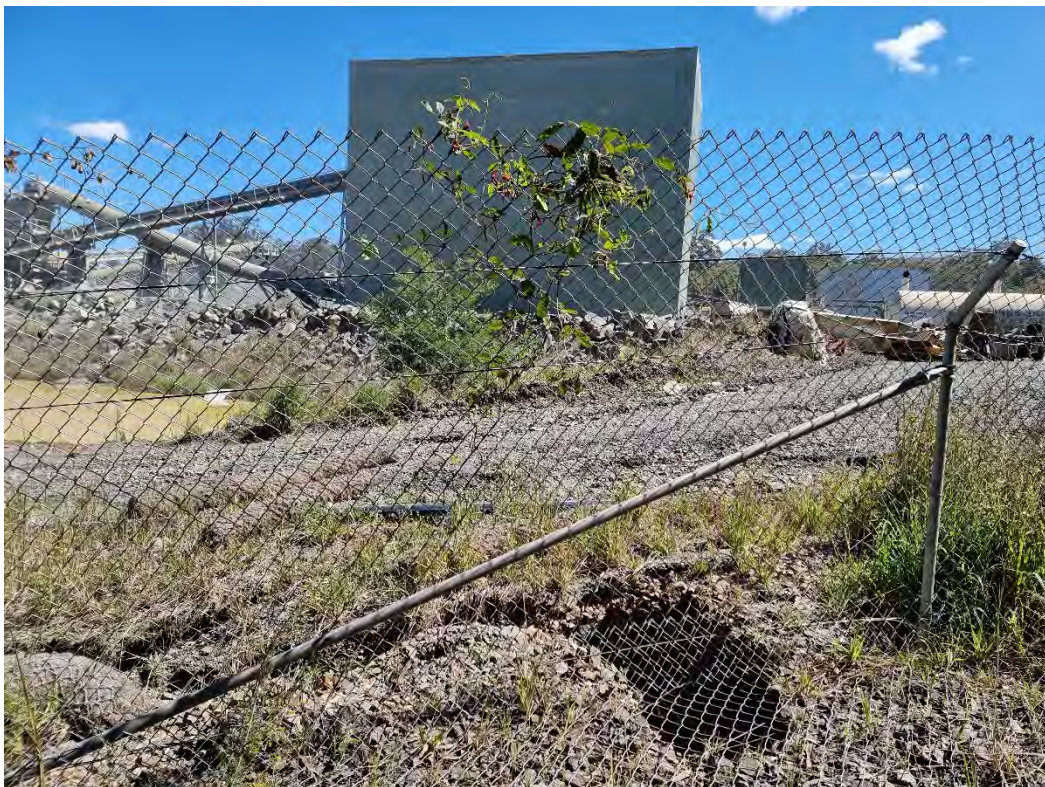
Photo 11: No sediment fencing installed at the time of fence repair (2024) resulting in further erosion (2025).
