Karuah Hard Rock Quarry

Summary of Environmental Monitoring Data

For the Period: December 2013

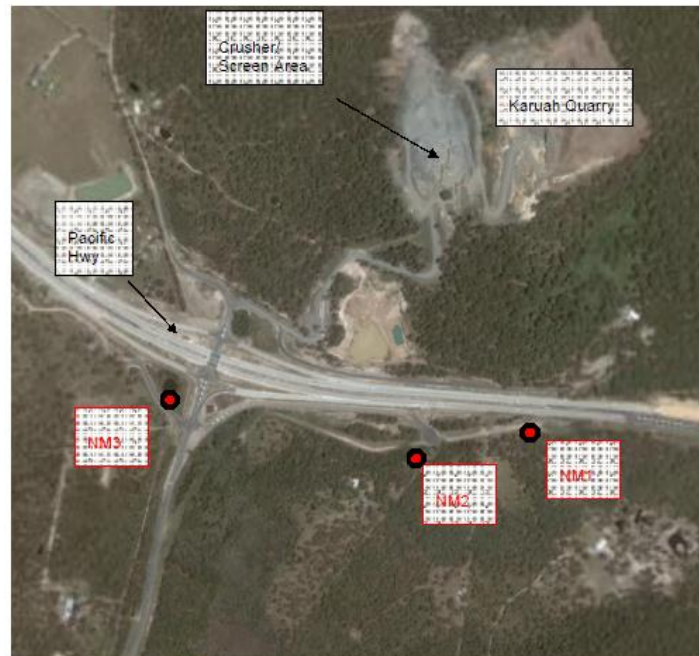
Figure 2 - Noise Monitoring Locations

Figure 2 below illustrates the noise monitoring locations at Karuah Quarry.
