Karuah Hard Rock Quarry

Summary of Environmental Monitoring Data

For the Period: March 2014

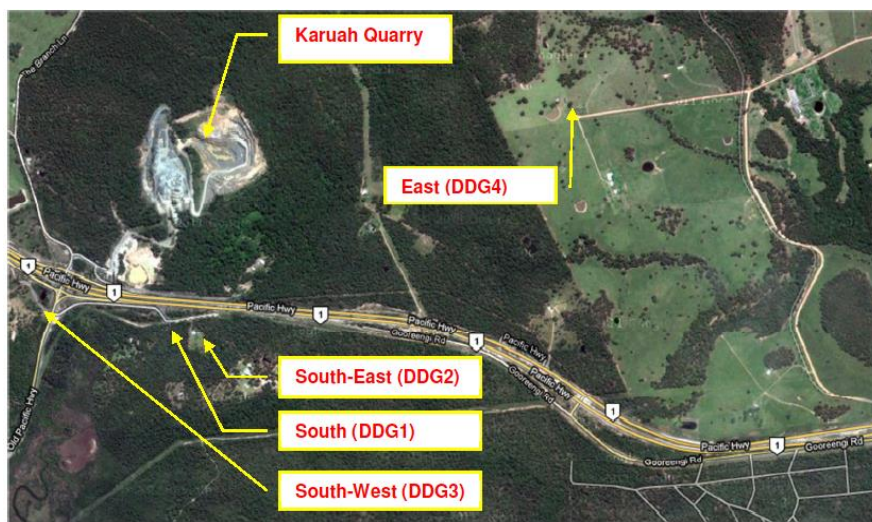
Figure 1 - Air Quality Monitoring Locations

Figure 1 Illustrates the air quality monitoring locations at Karuah Quarry.

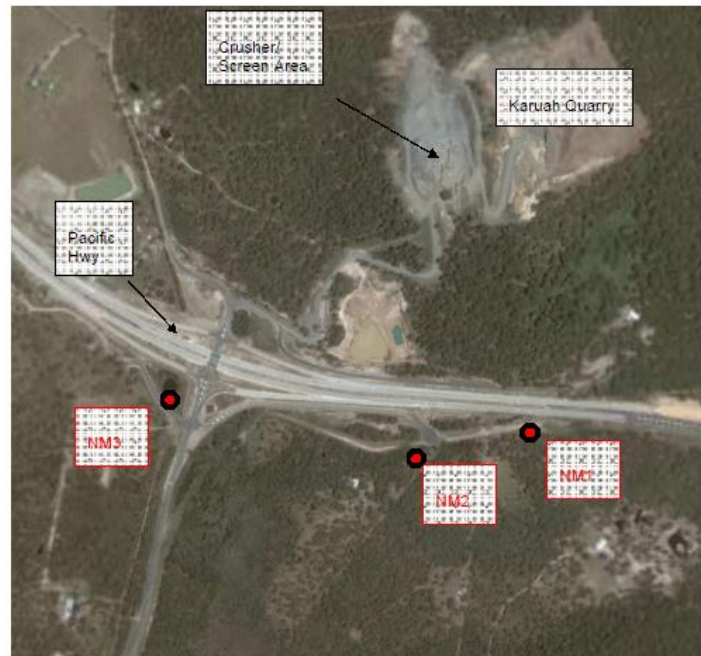
Figure 2 - Noise Monitoring Locations

Figure 2 below illustrates the noise monitoring locations at Karuah Quarry.
