**ANNUAL REVIEW FOR THE KARUAH EAST
HARD ROCK QUARRY, KARUAH, NSW**

***Review Period: 1 January, 2018 – 31 December
2018***

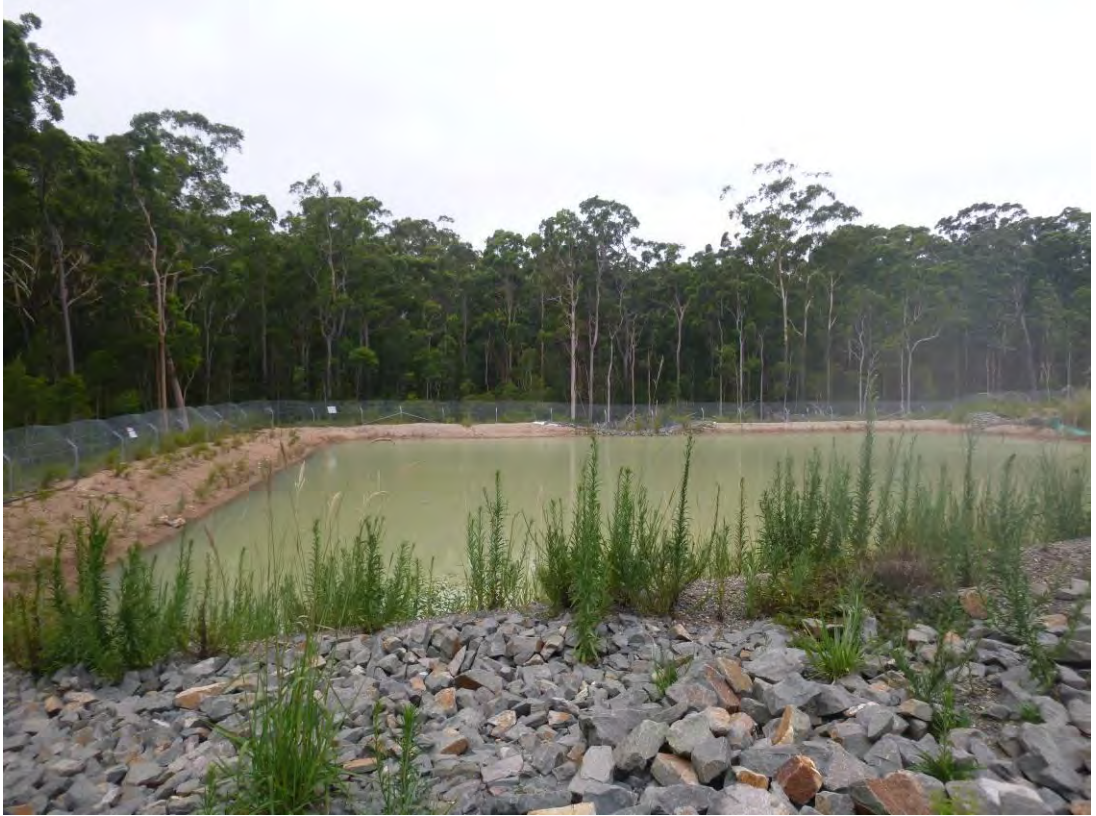
Photo 1 –Dam 3 (November 2018)

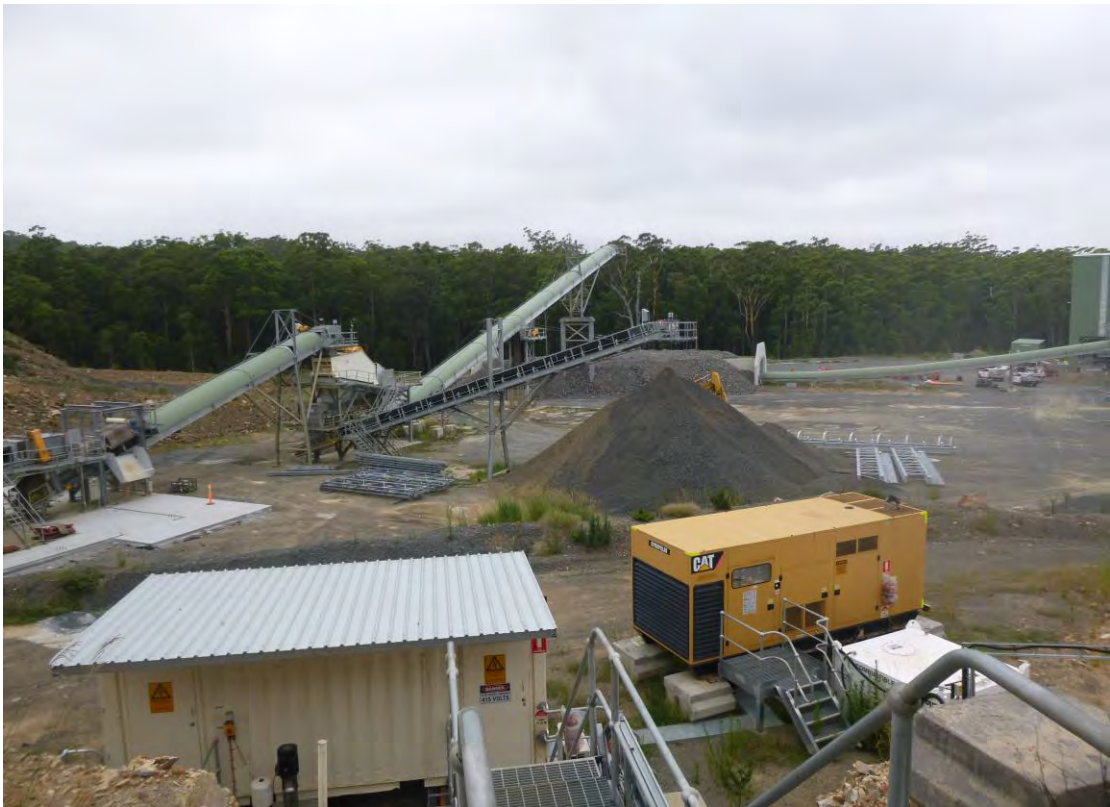
Photo 2 – Stage 1 of the crushing plant. Stage 2 of the crushing plant under construction and can be seen to the far right. (December 2018).

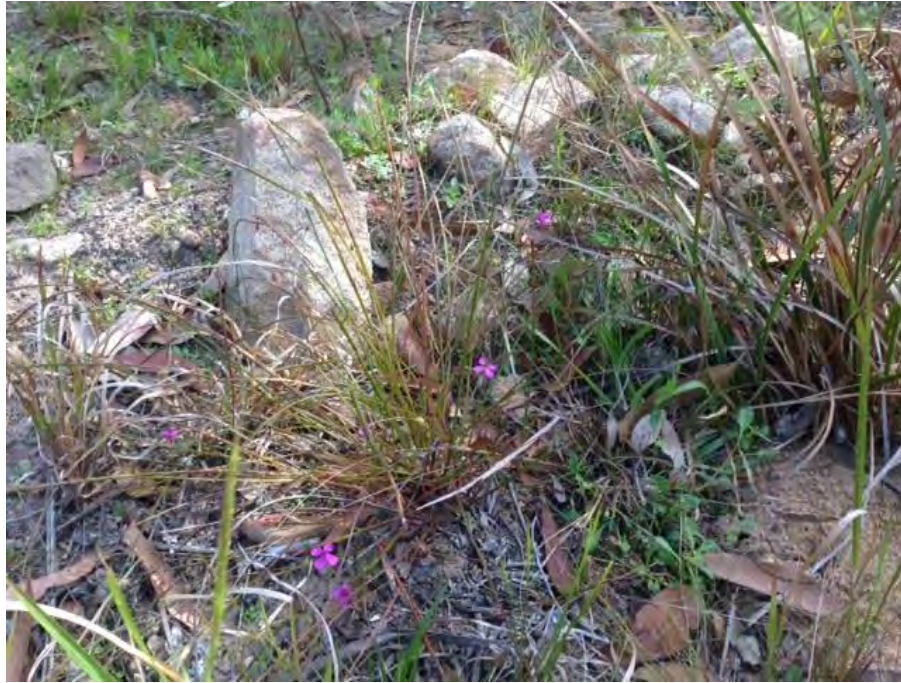
Photo 6 - *T. juncea* in flower in September 2018

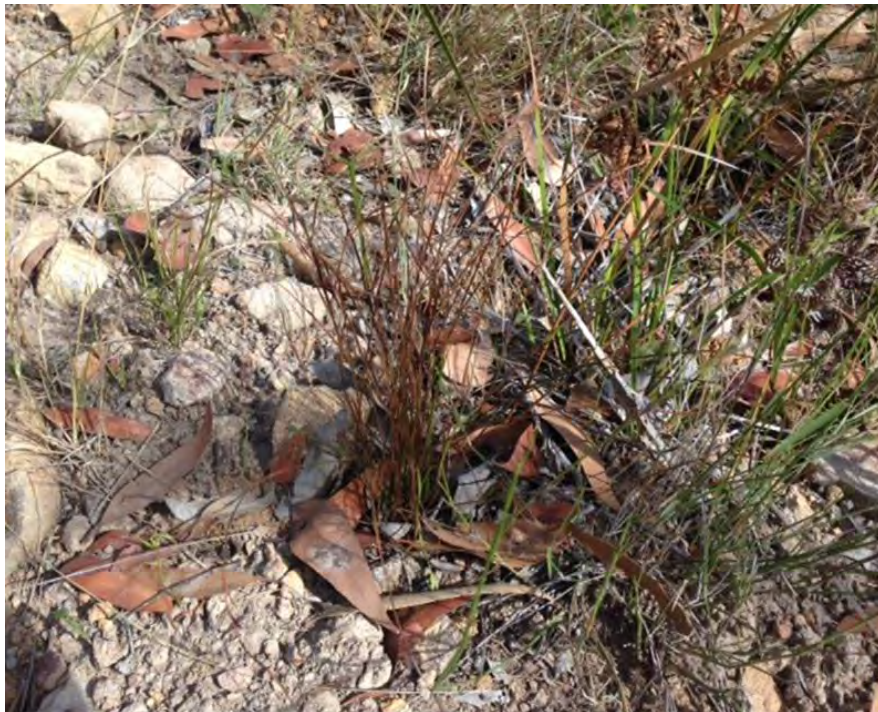
Photo 7 - Unhealthy/browning of *T. juncea* in September 2018

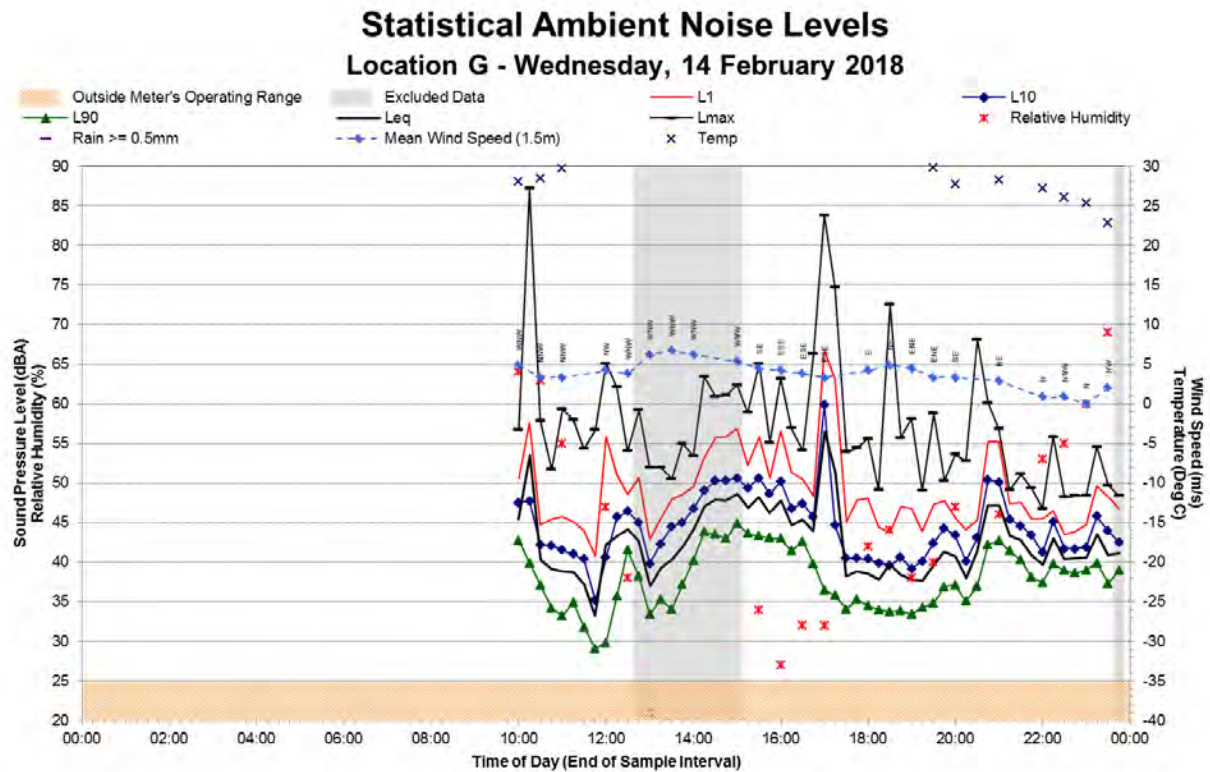
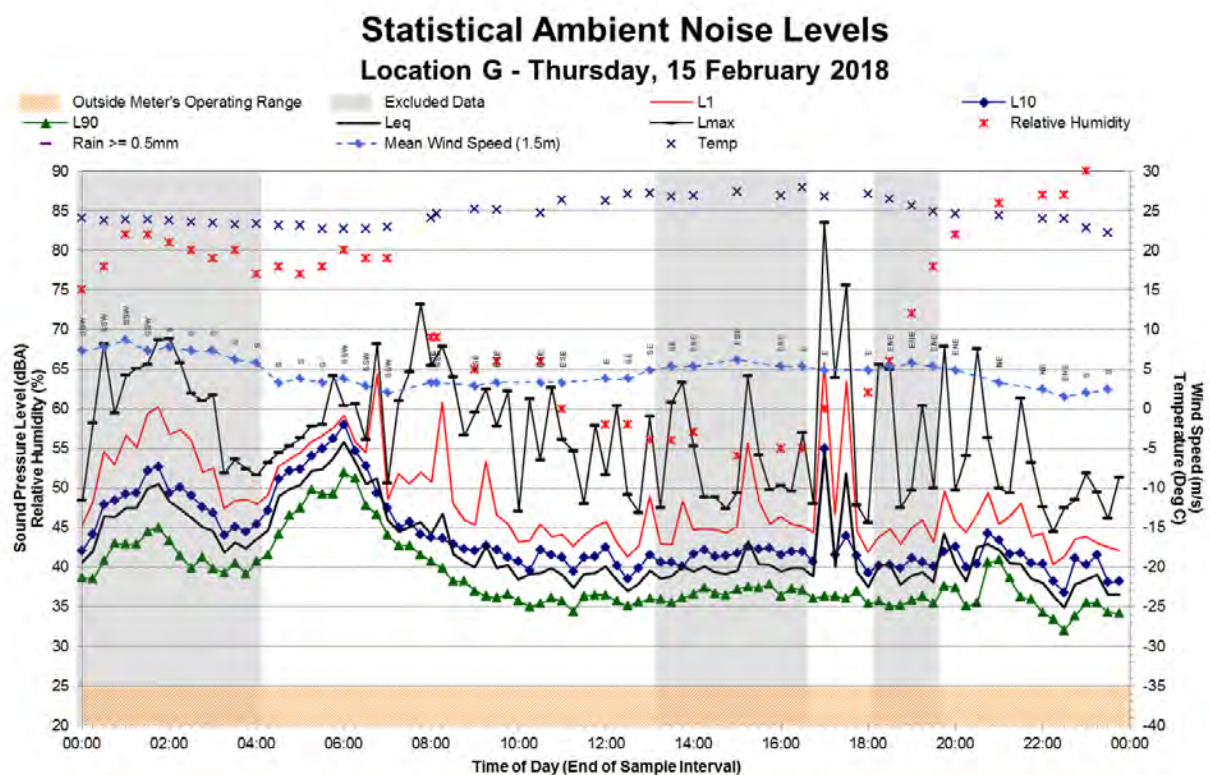
Location G Continuous Statistical Ambient Noise Monitoring Results

It is unlikely Karuah East Quarry consistently exceeded the criteria at Location G. **Appendix 4** shows that the overall LA_{eq} at Location G was typically around 40 dBA during operational hours (7 am to 6 pm) and compliant weather conditions. The presence of other ambient noise sources such as birds, insects and road traffic on the Pacific Highway indicate that Karuah East noise contributions were likely to have been below this overall level and therefore in the region of compliance (no more than 38 dBA) at Location G during the monitoring period (i.e. the 5 dBA exceedance observed during the operator-attended survey was atypical).

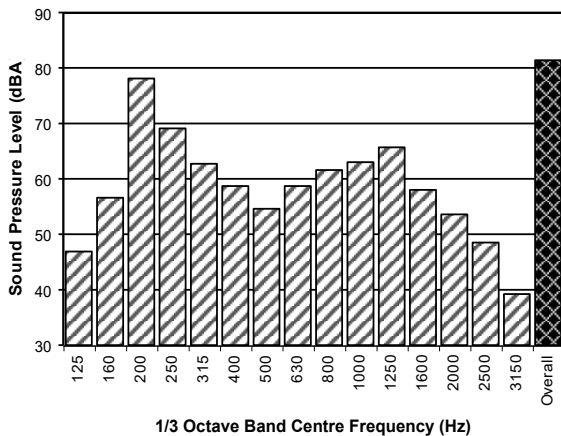
The following figure shows a 1/3 octave band frequency analysis where the noise is dominated by the 200 Hz band. Note that the indicated level of each individual band is less than the overall level, which is the logarithmic sum of the bands.

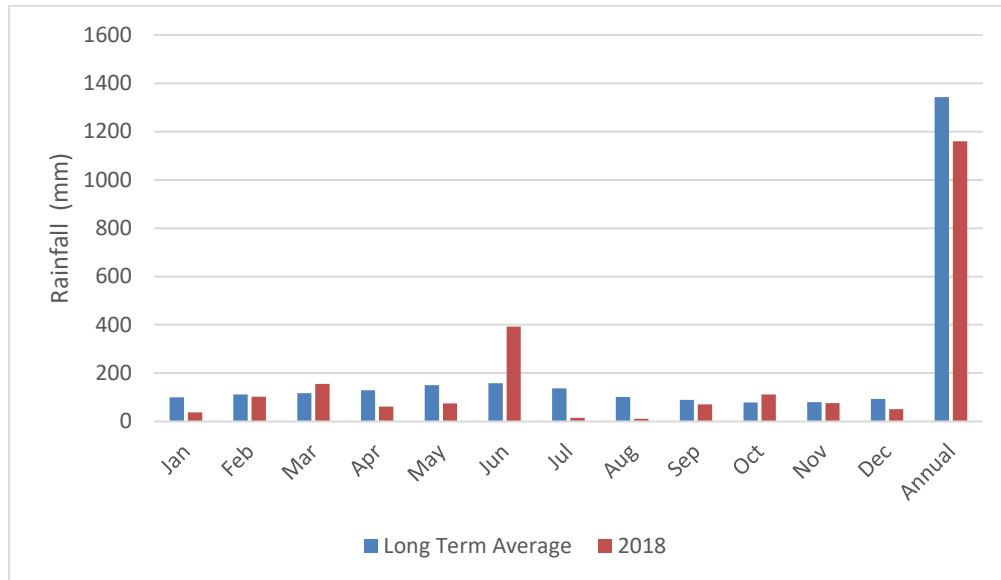
Chart 1: 2018 monthly rainfall compared to average rainfall at Nelson Bay weather station (source BOM)

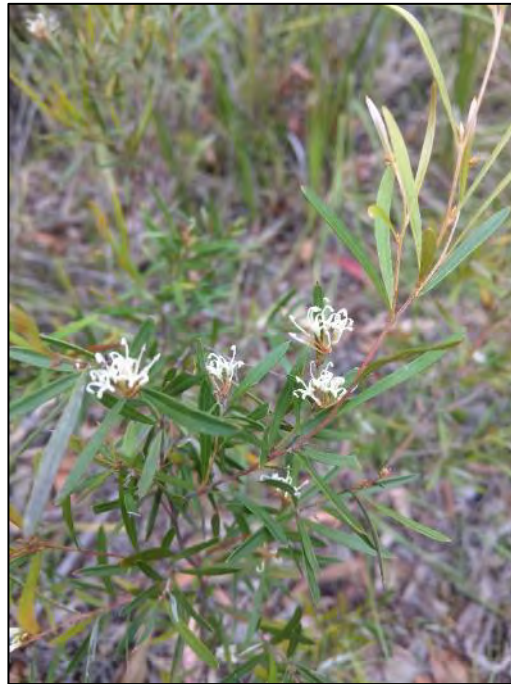
pH and TSS exceedances for each licenced discharge point is summarised below:

While there was a decline in the populations of threatened species across the BOA at half of the monitoring locations, some sites did exhibit growth and had healthy plants. Typically, these sites were more protected, occurring lower areas and along protected creek lines. Increases in threatened species was observed at MP 4, 7 and 12. Flowering and fruiting was generally higher than the previous survey events for both *Tetradlea juncea* and *Asperula asthenes*. *Grevillea parviflora* subsp. *parviflora* was not observed to be flowering or fruiting at any of the Monitoring Points. However, both fruit and flowers were observed on individuals within the vicinity of MP8. (**Plate 1**).

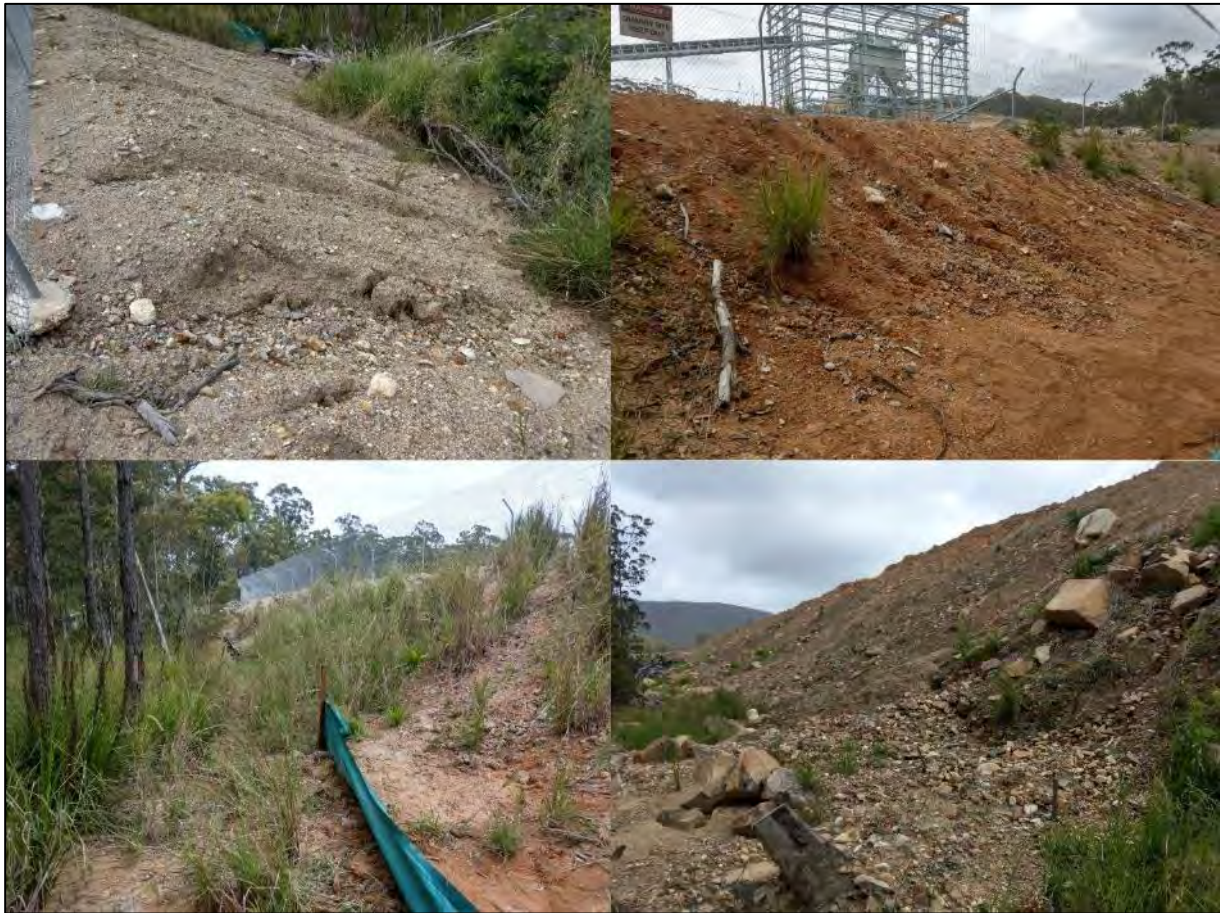
- It was observed during the 2018 monitoring event that the wall of Dam 3 was being colonized by native species of plants actively protecting it from further erosion. However, the wall of Dam 1 as well as the overburden stockpile wall were only sparsely colonized by plants and were still actively eroding in some areas.

Plate 2: Erosion along the south-eastern bank of Dam 1 (top and bottom left) and the overburden stockpile (bottom right)

Certain areas of the BOA (primarily the steep slopes on Lot 5) have the potential to develop erosion following Lantana control works. The need for erosion or soil stabilisation measures following initial treatment of moderate and high density Lantana areas on steep slopes will be assessed at each maintenance / monitoring event.

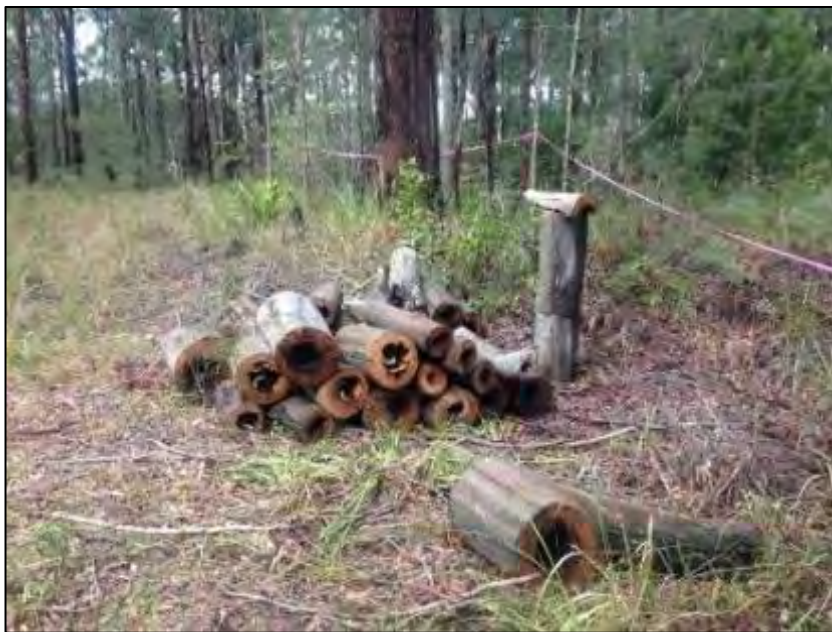
In addition to this, a number of hollows and hollow log sections (total of 77) have been salvaged and are in the process of being prepared for redistribution into the BOA (**Plate 3**). The location of the hollow logs to be redistributed throughout the BOA is shown on **Figure 7**. The quantity and locations of hollows and other salvaged organic materials that are redistributed in the BOA will be recorded as part of future monitoring. As clearing for the first stage of the KEQ project has been completed as of November 2016, the salvaged hollows will need to be installed to offset loss of hollows at a 1:1 ratio as per Section 3.8 of the BOAMP

Plate 3: Hollow sections salvaged for redistribution into the BOA

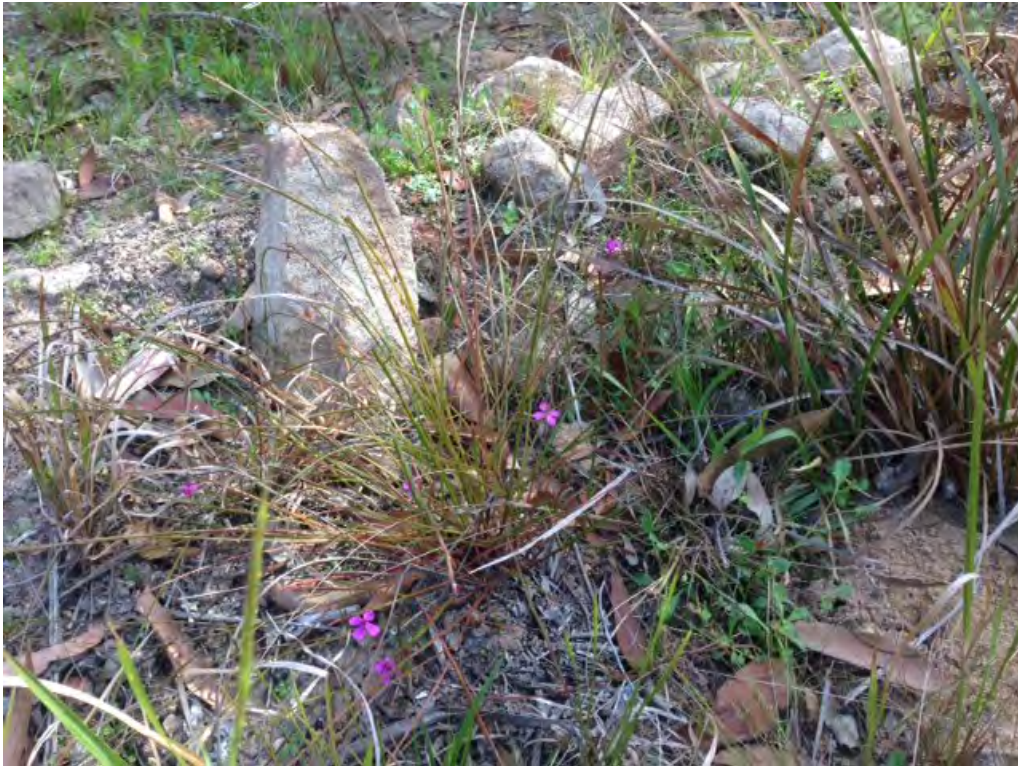
Photo 2: Unhealthy/browning *T.juncea*

The monitoring of the *T. juncea* translocation, as of September 2018, has shown a survival rate of 37% for the third year of monitoring. Kleinfelder (2018) have also observed a decline in the *T. juncea* numbers within the Biodiversity Offset for the past three years. It is noted that the yearly rainfall totals as recorded by the Bureau of Meteorology's official weather station at Nelson Bay has been below the long-term average in 2016, 2017 and 2018. This suggests that the natural decline in *T. juncea* population is potentially related to the drier than normal conditions.

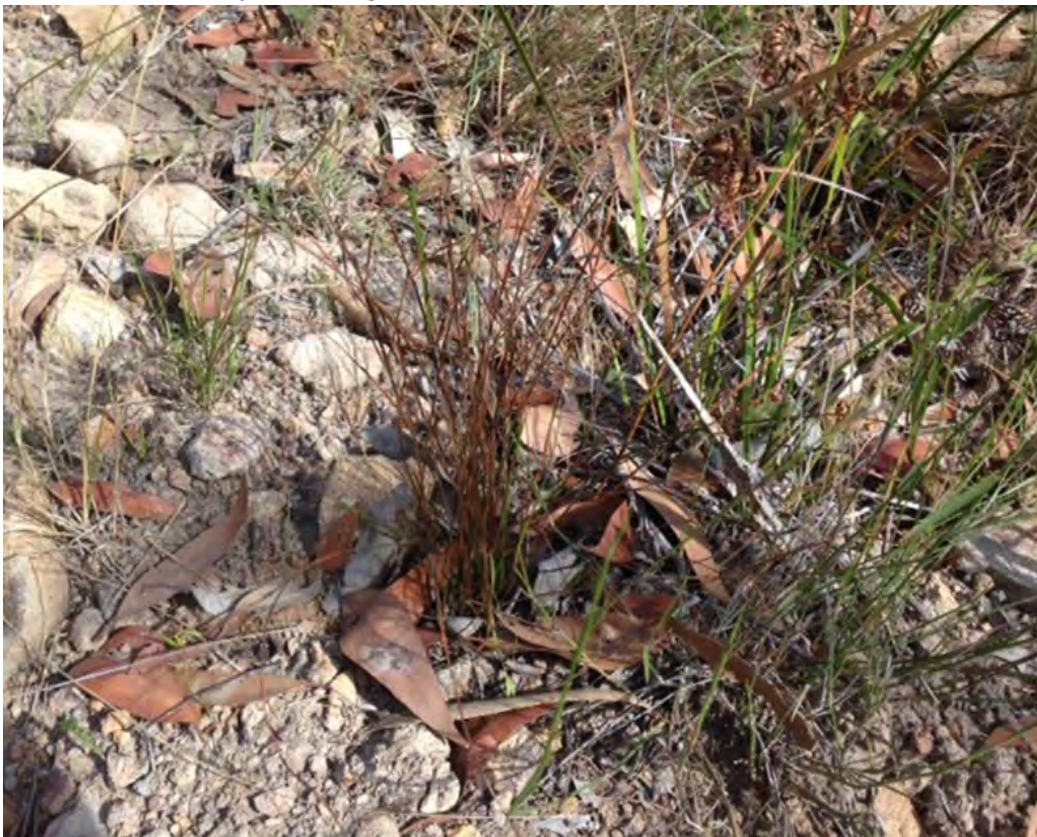
Photo 3: Considerable regrowth of native vegetation in translocation rows

However, it should also be noted that the translocation site is considerably more overgrown with native vegetation than the previous years. *T. juncea* are quite difficult to find when they are not in flower, particularly in heavily vegetated areas. Thus, it is considered that there was a chance of potentially missing individual *T. juncea* during the survey effort which would result in a lower predicted rate of survival.
