# **ANNUAL REVIEW**

## **KARUAH EAST HARD ROCK QUARRY**

### **KARUAH, NSW**

***Review Period: 1 January, 2020 – 31 December 2020***

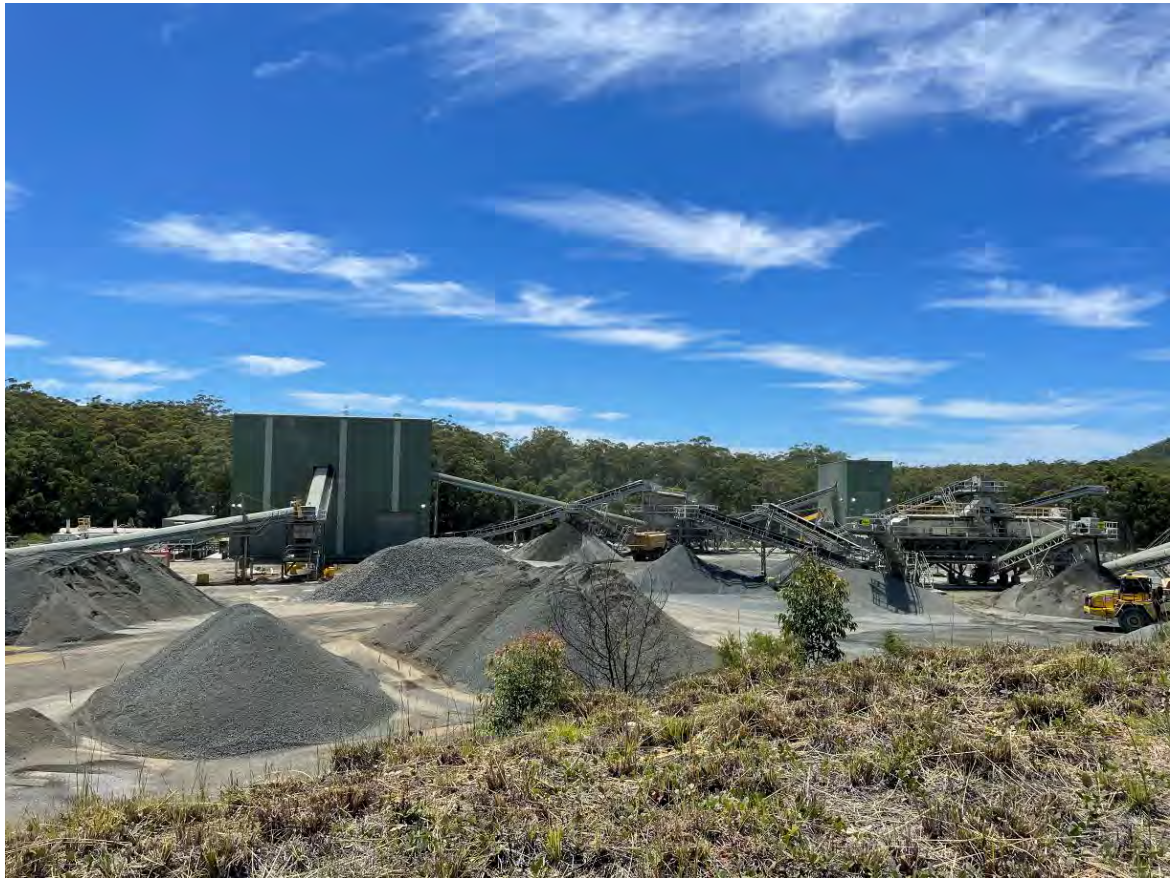
**Photo 1 –Crushing Plant (January 2021)**

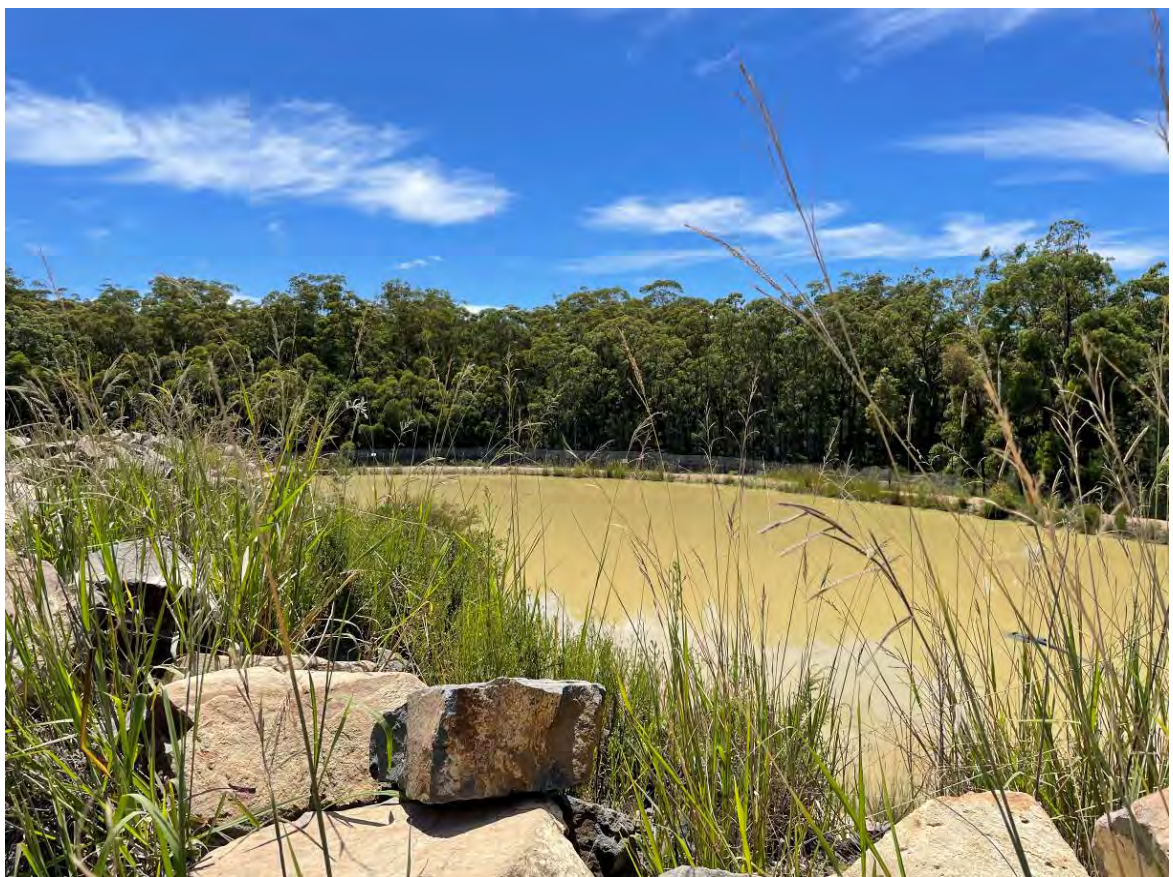
**Photo 2 –Dam 1 (January 2021)**

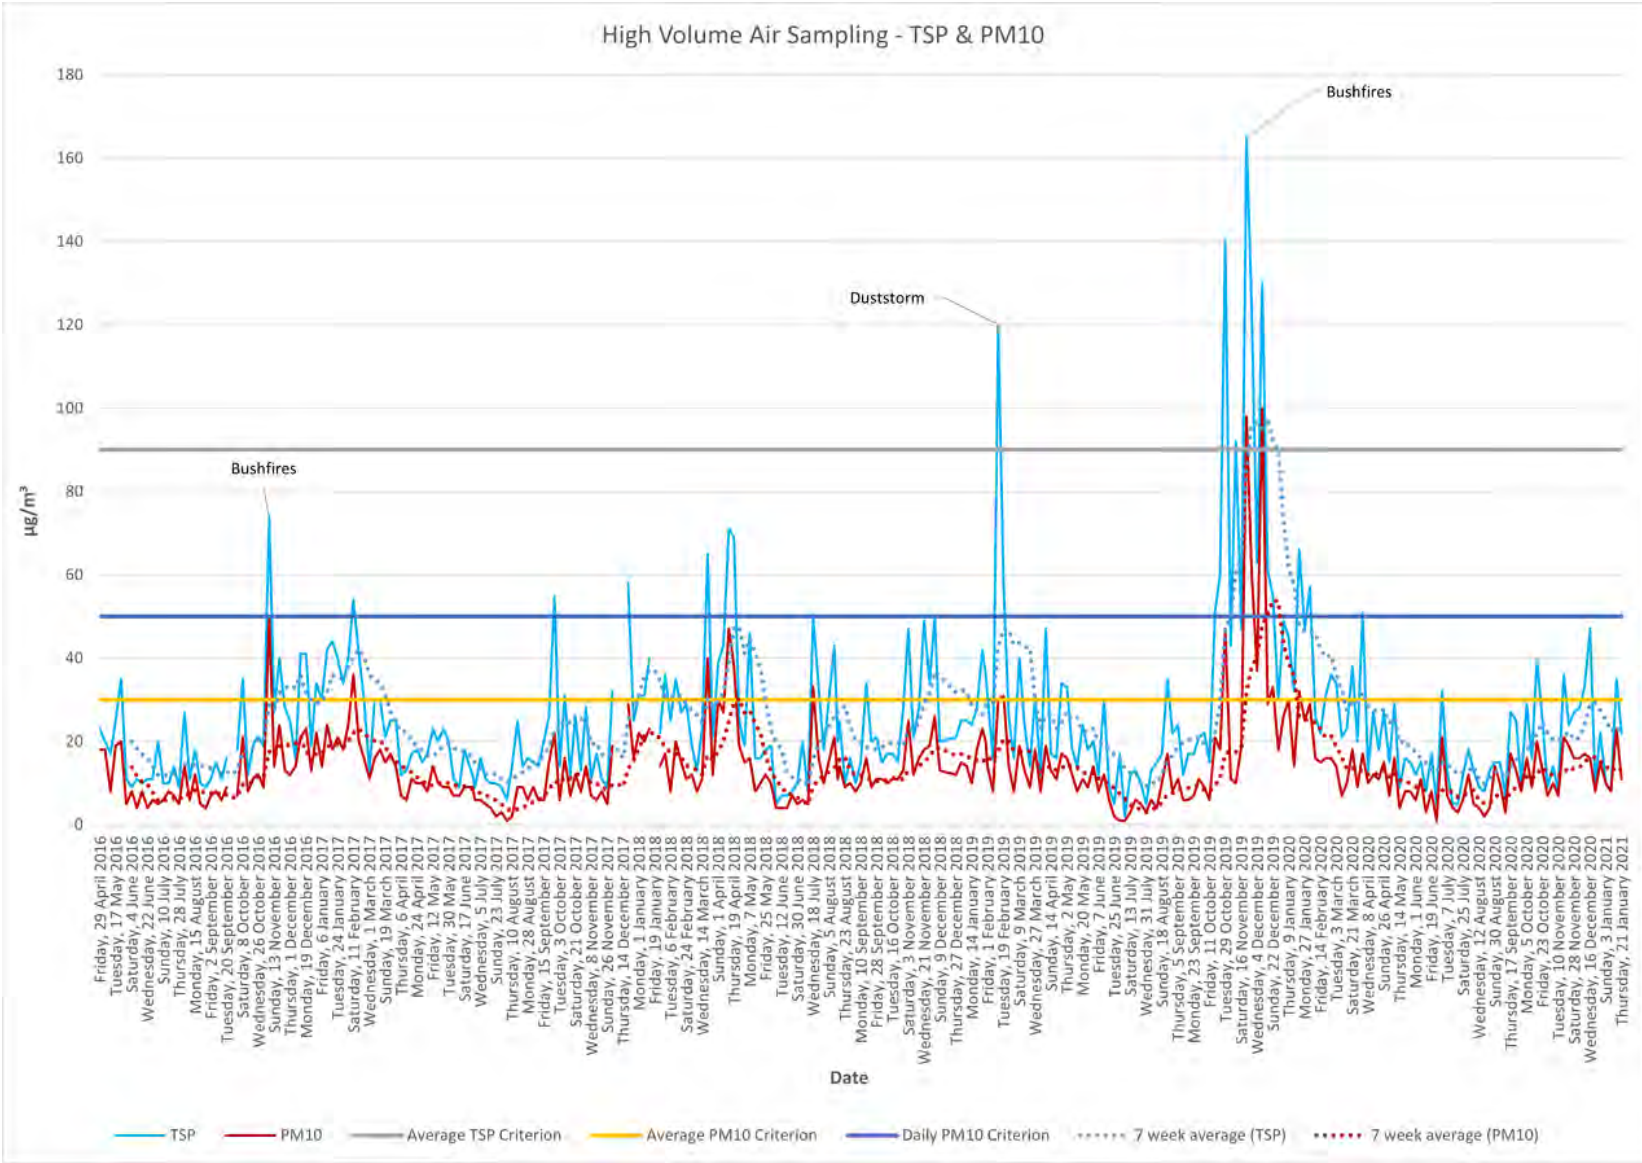
Figure 2 High Volume Air Sampling – Long-term Trends

The short-term impact assessment criteria of 50  $\mu\text{g}/\text{m}^3$  was not exceeded during 2020. Long term trends are shown on **Figure 2**.

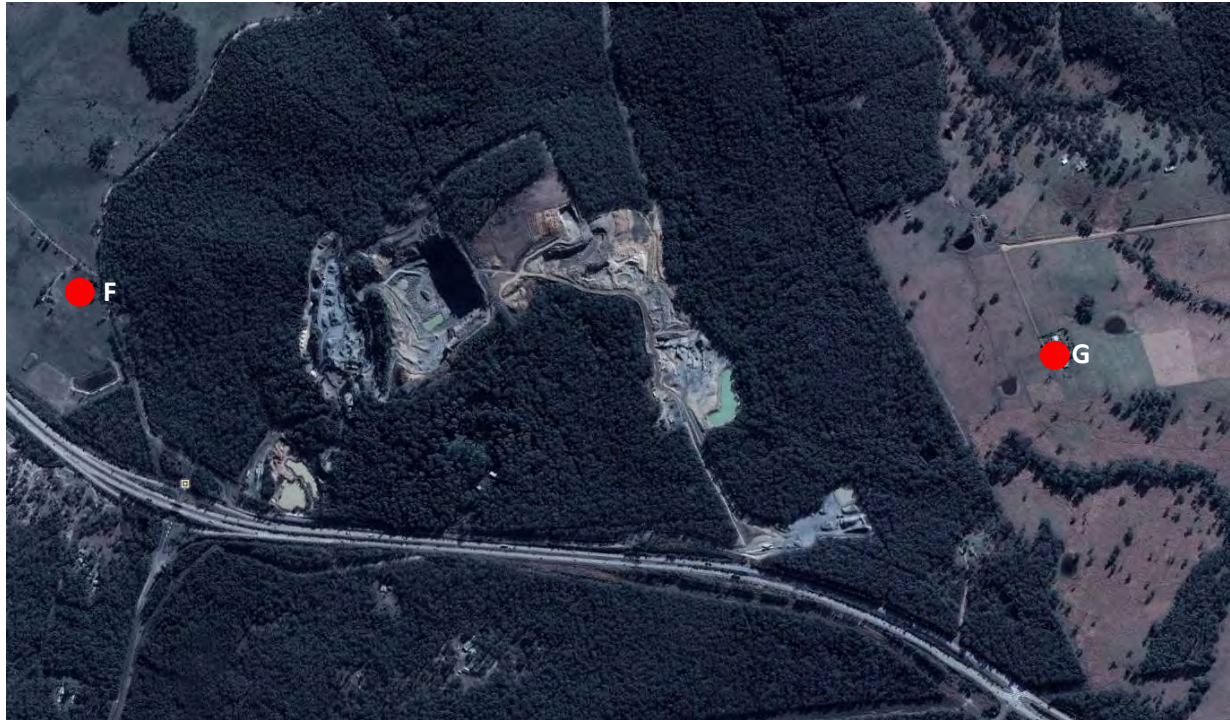
**Figure 1 - Noise Monitoring Locations**

MONITORING METHOD	LOCATION	FREQUENCY	CRITERIA
Attended Noise Monitoring	F,G	Quarterly	As Per Table 10,12,13 of the Noise Management Plan (SLR, 2015)
Unattended Noise Monitoring	G	Quarterly	As Per Table 10,12,13 of the Noise Management Plan (SLR, 2015)

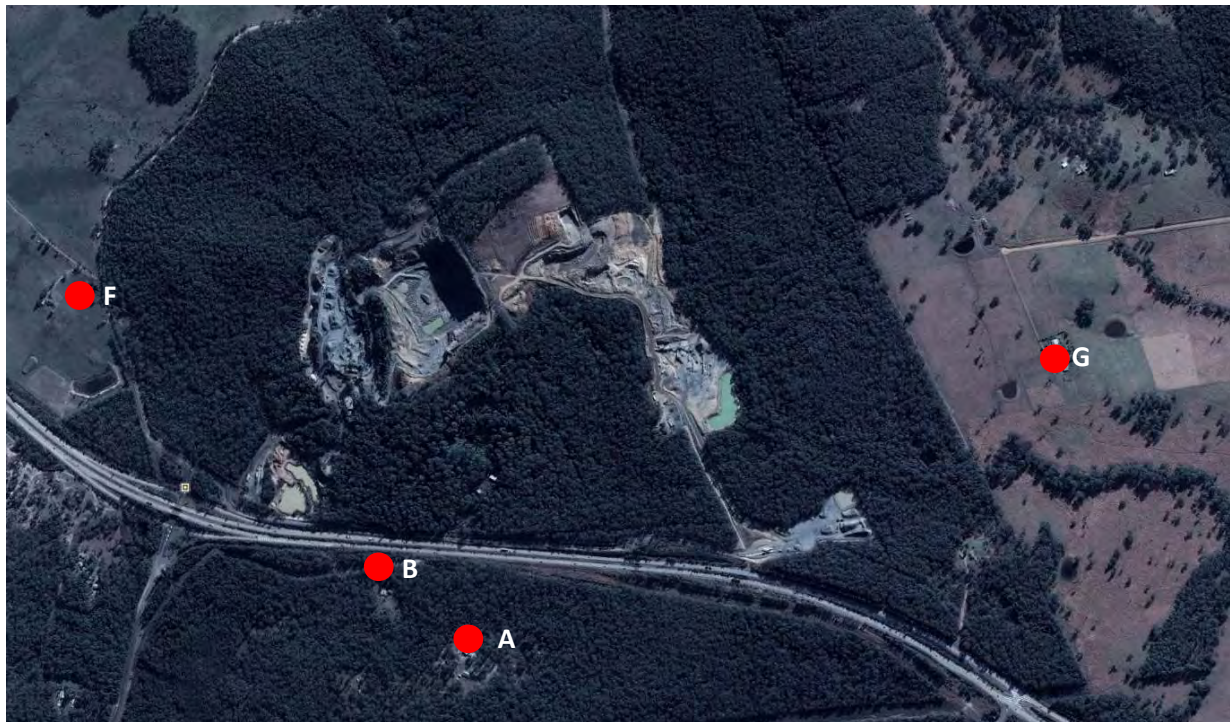
**Figure 1 - Noise Monitoring Locations**

MONITORING METHOD	LOCATION	FREQUENCY	CRITERIA
Unattended Noise Monitoring	G	Quarterly	As Per Table 10,12,13 of the Noise Management Plan (SLR, 2015) As Per EPL 20611
Attended Noise Monitoring	A		
Attended Noise Monitoring	B		As Per EPL 20611
Attended Noise Monitoring	F		As Per Table 10,12,13 of the Noise Management Plan (SLR, 2015)
Attended Noise Monitoring	G		As Per Table 10,12,13 of the Noise Management Plan (SLR, 2015) and EPL 20611

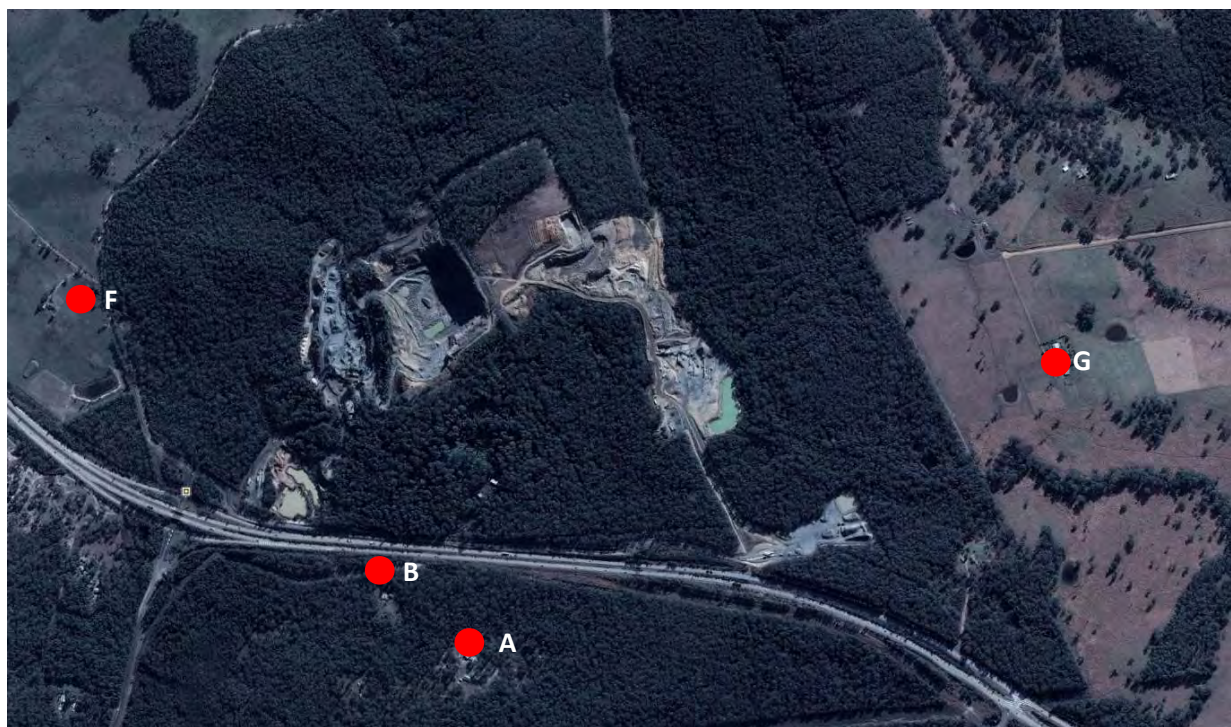
**Figure 1 – Noise Monitoring Locations**

<b>MONITORING METHOD</b>	<b>LOCATION</b>	<b>FREQUENCY</b>	<b>CRITERIA</b>
Unattended Noise Monitoring	G	Quarterly	As Per Table 10,12,13 of the Noise Management Plan (SLR, 2015)
Attended Noise Monitoring	A		As Per EPL 20611
Attended Noise Monitoring	B		As Per EPL 20611
Attended Noise Monitoring	F		As Per Table 10,12,13 of the Noise Management Plan (SLR, 2015)
Attended Noise Monitoring	G		As Per Table 10,12,13 of the Noise Management Plan (SLR, 2015) and EPL 20611

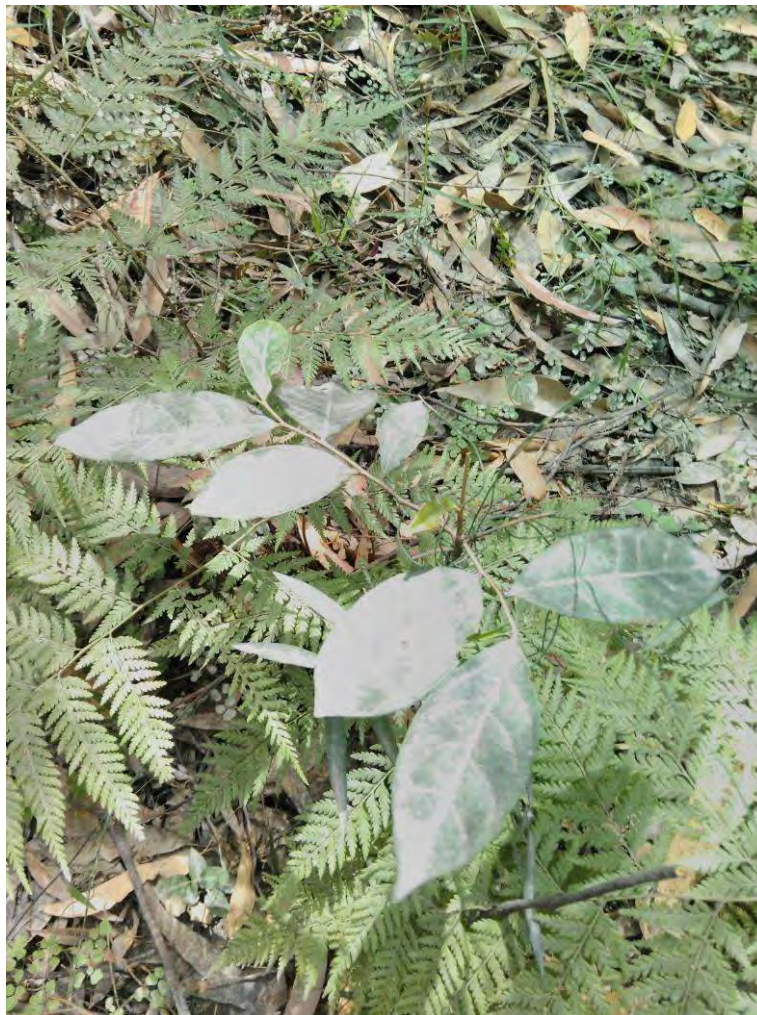
- Past clearing at MP 12 is beginning to show signs of regeneration.
- High levels of dust were observed on foliage (see **Photo 1**) and on the ground at monitoring sites MP 6 and MP 7 along the eastern boundary of quarry operations. Minor dust cover was recorded at MP 18 and MP 15 along the quarry's western boundary. Whilst rainfall events following the 2020 monitoring event have likely reduced dust levels, monitoring of this disturbance should be continued in future years to assess any potential impacts to remnant vegetation.

**Photo 1**      **Dust cover on foliage recorded at MP 4**

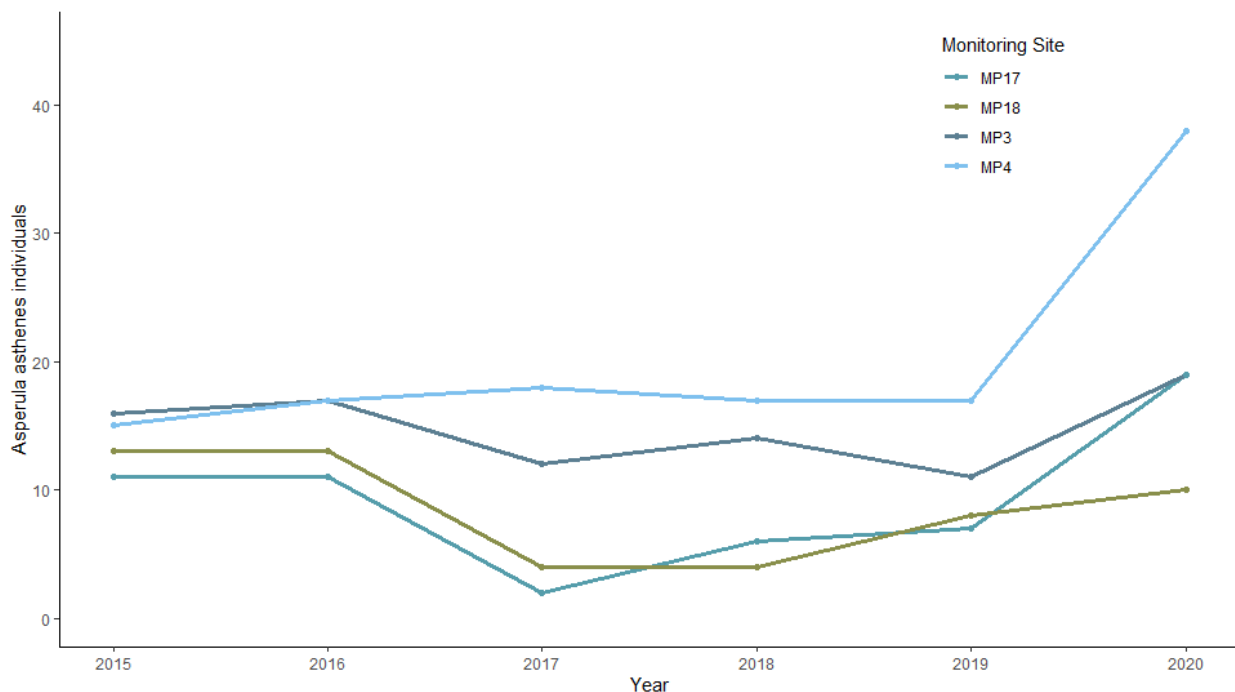
The increase in abundance for the species across the monitoring sites continues a pattern of fluctuating abundance results for the species since 2015 and is likely due to improved conditions over winter, including higher rainfall (see **Plate 1**). There is no discernible pattern indicating impacts from quarry operations with *A.asthenes* abundance approximately 55% greater than the 2015 baseline.

**Plate 8** *Asperula asthenes* abundance at monitoring sites (2015-2020)

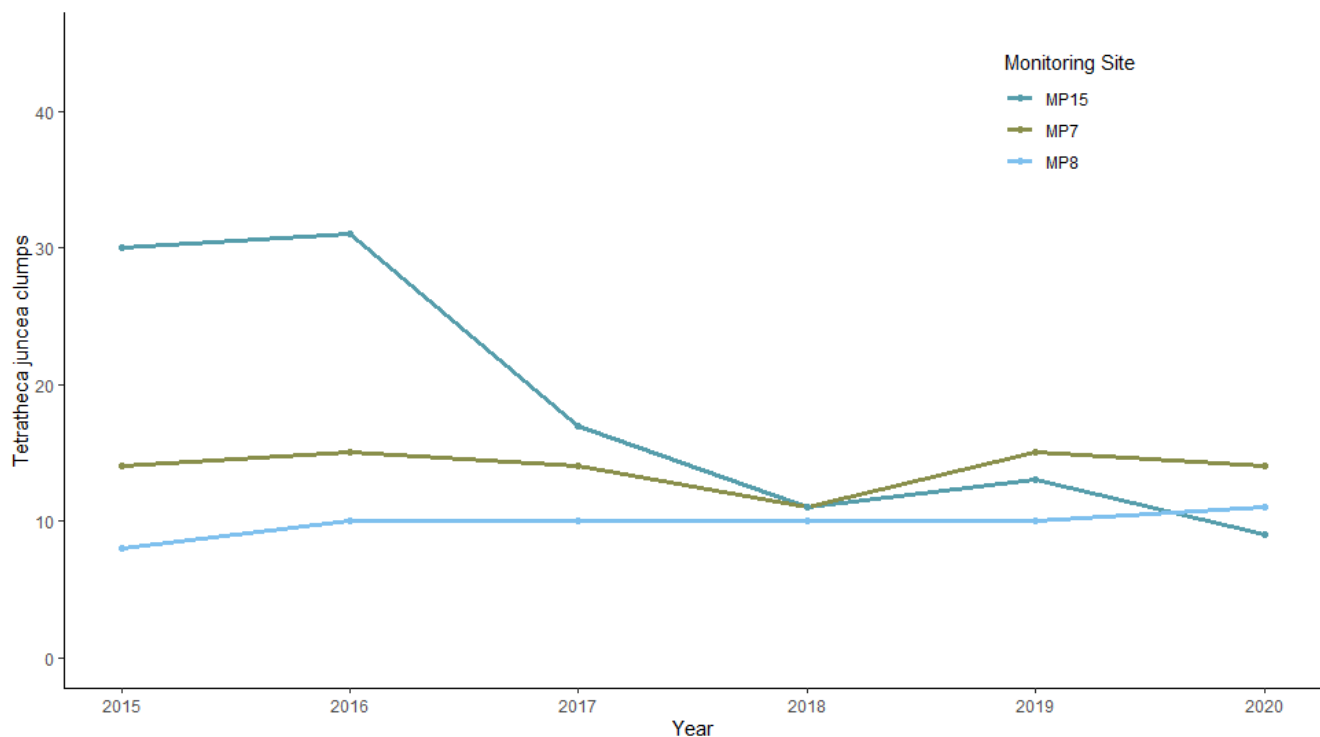
Flowering was recorded for the species across all three monitoring plots (MP 7, MP 8, and MP 15) during the 2020 monitoring event. Of the 15 plants recorded at MP 7, nine were in flower (60%) with a mean of 5.8 flowers, compared to 67% flowering and 5.2 flowers in 2019. MP 8 saw an increase from 60% flowering and 2.6 flowers to 92% flowering and 6.27 flowers. MP 15 also increased from only 54% flowering and 2.4 flowers in 2019 to 100% and 2.3 flowers in 2020. These results indicate the species is in good reproductive condition, likely due to favourable conditions (i.e. rainfall) over winter and into spring.

**Plate 9** *Tetratheca juncea* abundance at monitoring sites (2015-2020)

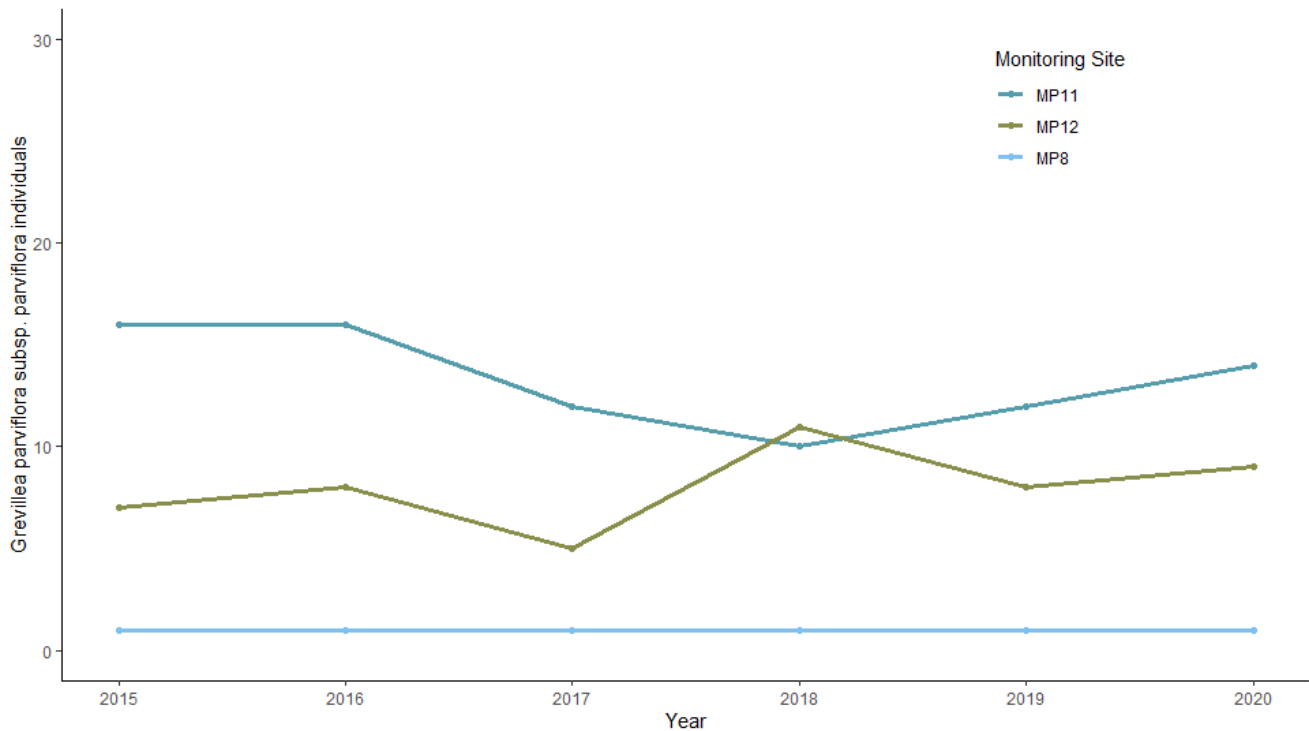
Monitoring for *G. parviflora* subsp. *parviflora* was completed at three monitoring sites; MP 8, MP 11 and MP 12. The population remains stable with a small increase in abundance recorded between 2019 and 2020 at MP 11 (12 to 14 plants) and at MP 12 (8 to 9 plants) (see **Plate 10**). However, despite the increase in abundance at MP 11 four plants were found to have died since 2019 with minor dieback recorded on three others. Overall, there is little change in abundance for the species since the 2015 baseline indicating minimal impact from quarry operations.

**Plate 10** *Grevillea parviflora subsp. parviflora* abundance at monitoring sites (2015-2020)

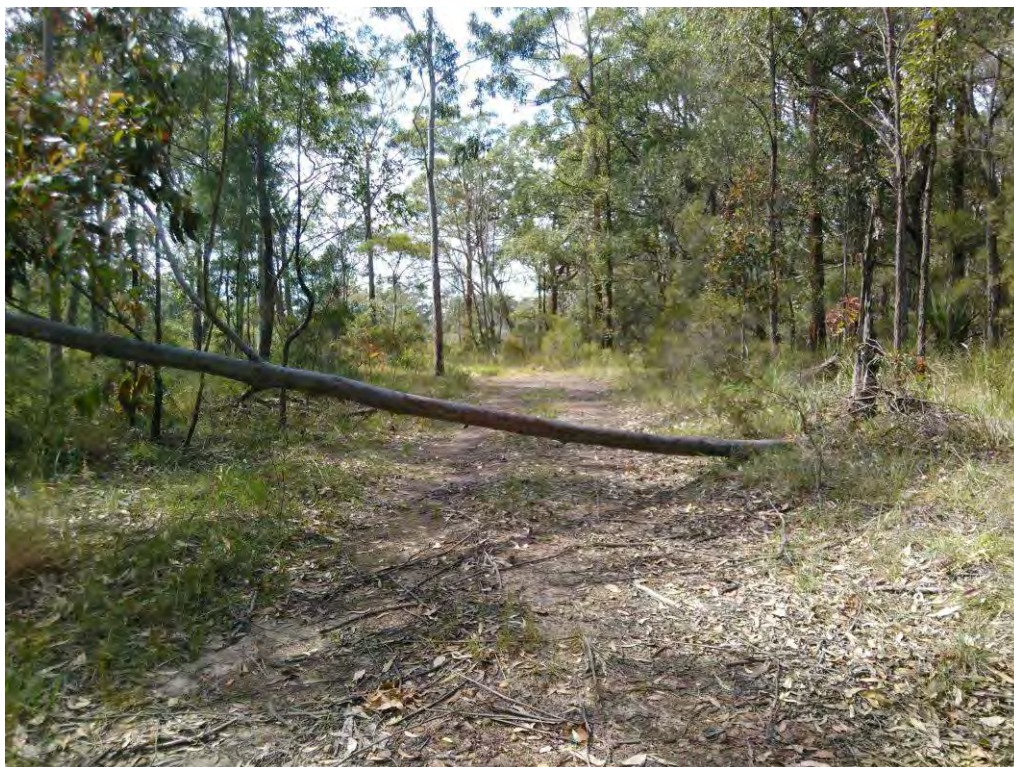
**Photo 2**      **Fallen Tree along access track in Lot 14**

Maintenance is recommended at the access track along the south-western boundary of Lot 14 to remove a small tree that has recently fallen over (see **Photo 2** and **Figure 6**). Works along the powerline easement track have improved accessibility and should continue to be maintained.

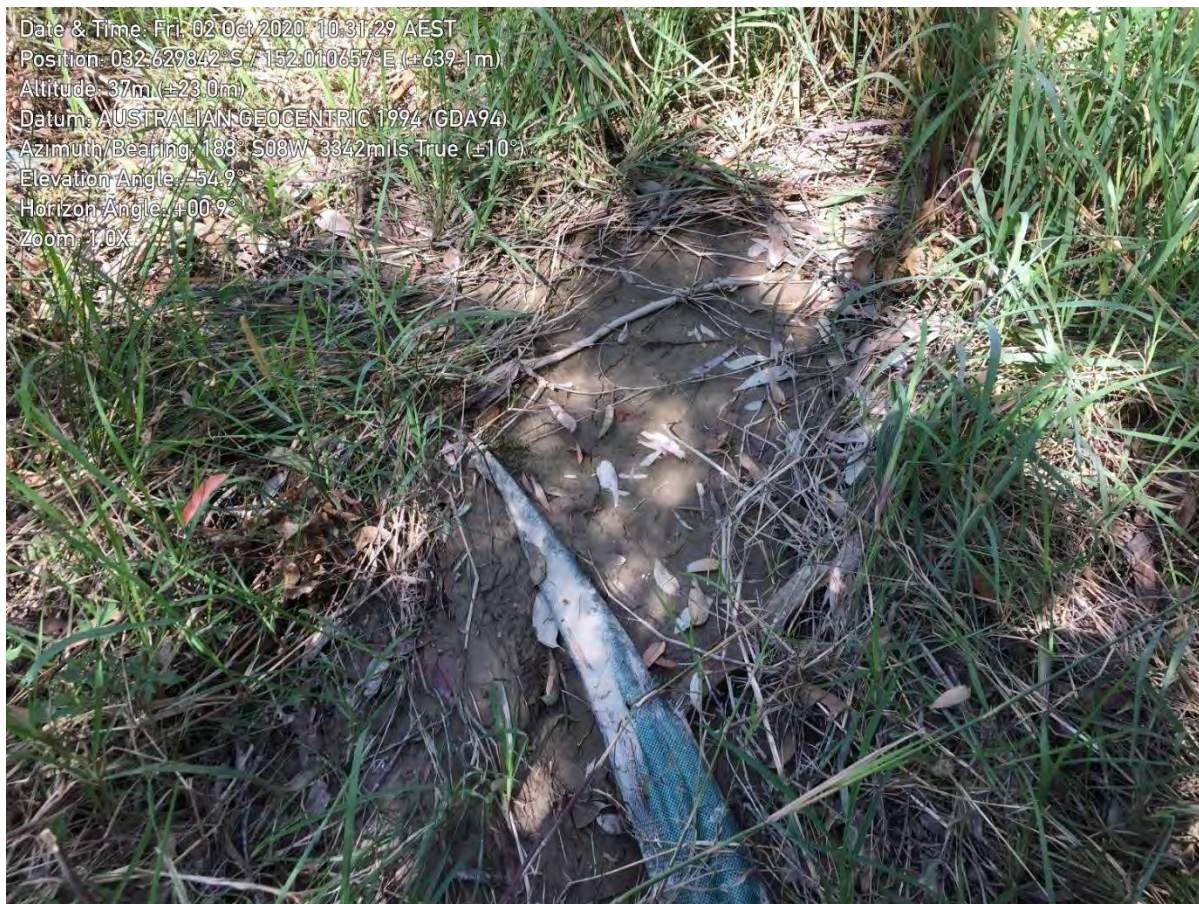
- It was noted during the 2017 monitoring event that the overflow for Dam 3 was depositing small amounts of sediment into the receiving environment with water being retained in the bushland east of the basin for a period. It was noted during the 2018 monitoring event that a small trough had been dug to allow the overflow from the dam to drain out of the area and into Bulga Creek. While some minor erosion and sedimentation was observed on the discharge side of the dam wall, it was still contained within the project disturbance area. This management action has remediated the waterlogging issue and no die-back or change in vegetation structure and composition was observed in 2018. No further changes were noted in 2019 or 2020. Ongoing annual monitoring will be required to assess the effectiveness of the drainage and ensure no die-back or change in vegetation structure and composition occurs.

**Photo 3** Sediment fencing down and overtopping within Lot 12

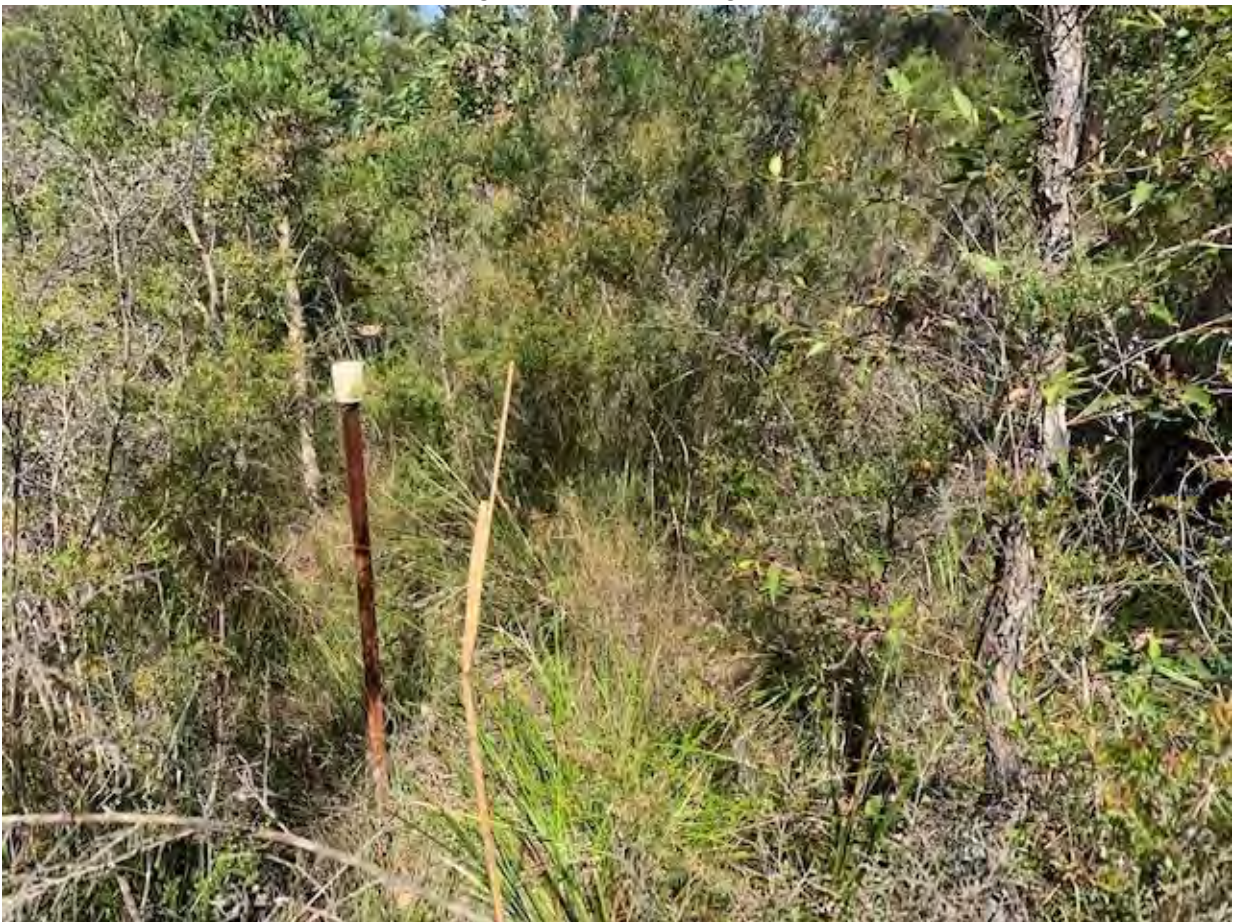
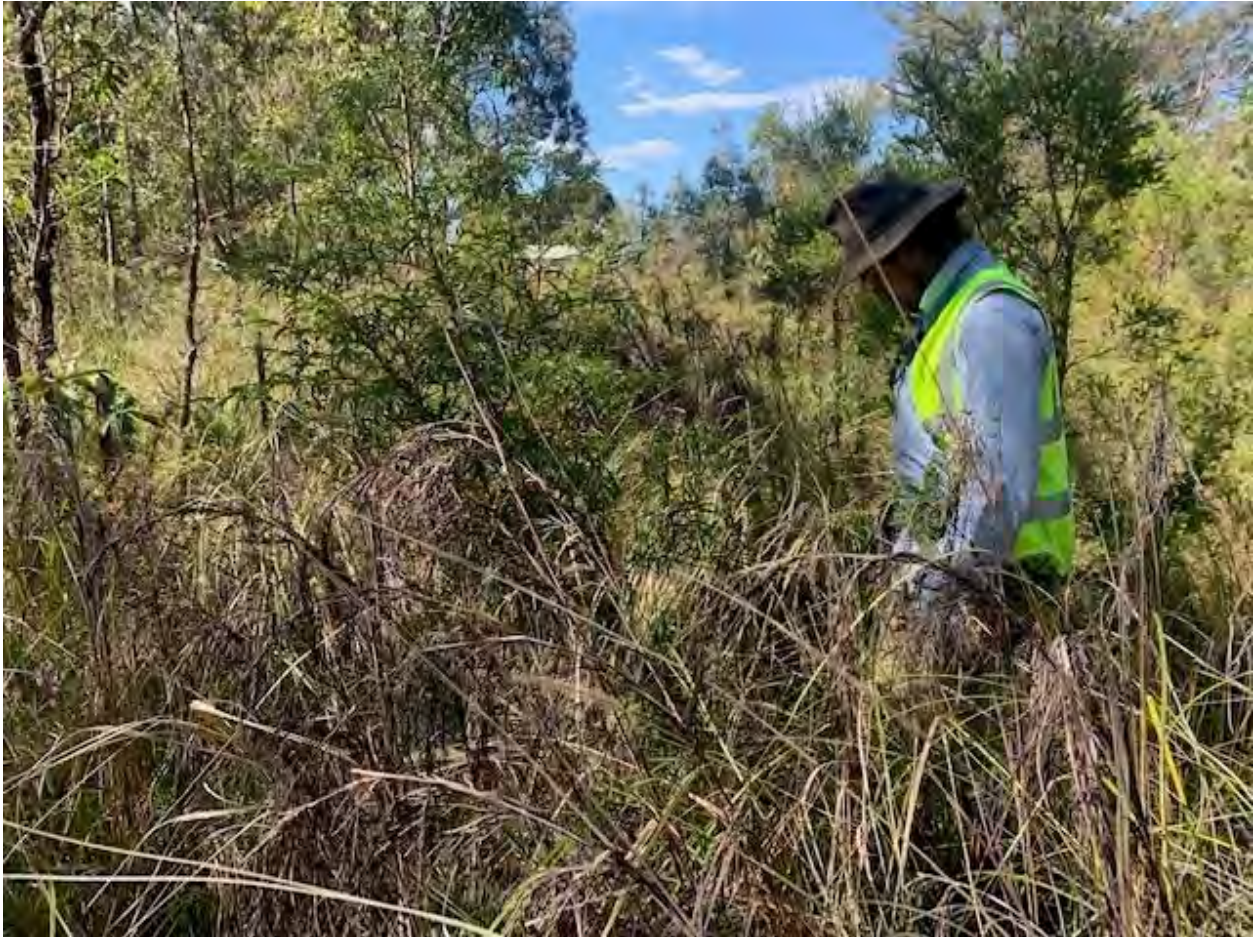
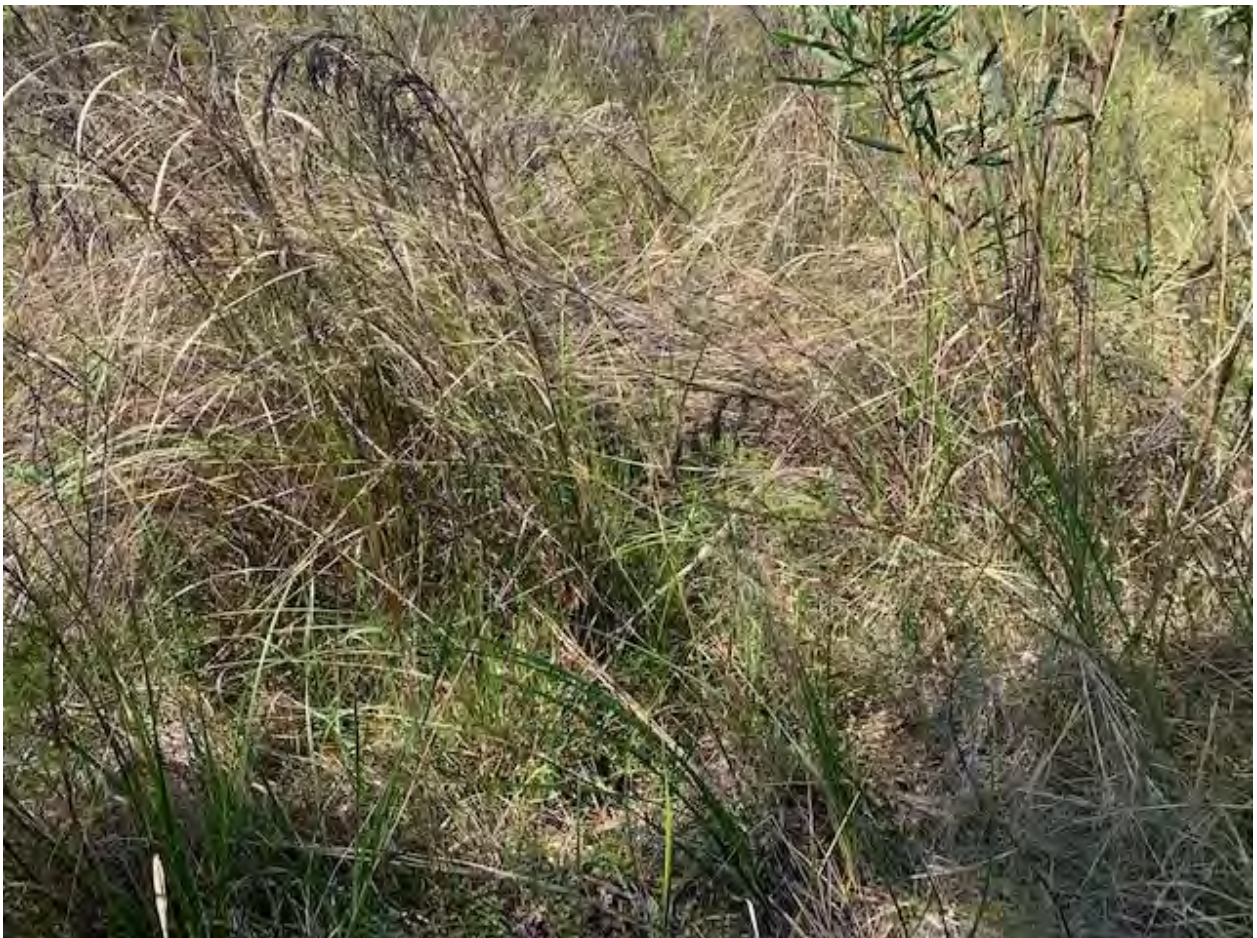
Photo 6 to 8: Considerable regrowth of native vegetation in translocation rows

As discussed in previous section 3, a site visit was undertaken on 12 October 2020, at this time only six of the translocation rows were observed to have *T. juncea* that were in flower, otherwise the *T. juncea* within the translocation site were predominantly not in flower or have browned or died off completely. The translocation site is also extensively overgrown in some areas, particularly rows B1 to B7 which are covered in dense grass growing around 2 m in height. *T. juncea* are extremely difficult to find when not in flower, particularly in densely vegetated areas. Due to the extremely low number of *T. juncea* that were observed to be in flower at this time (seven individuals total), combined with the dense overgrown rows, it was decided that it was not viable to undertake the complete survey for 2020. Instead, rows that contained no flowering individuals were recorded as NFP (no flowering plants) because the number of *T. juncea* existing in these rows cannot be accurately counted. In the rows that did contain flowering plants, only the flowering plants and the number of flowers on each were counted. Refer to photos 1 to 5 in Appendix A for all individuals observed to be in flower as of 12 October 2020. Refer to photos 6 to 8 in Appendix A which show the densely overgrown translocation rows.
