Minutes

19 September 2022

Project name	Karuah East Quarry - Community Consultative Committee	From	Michael Ulph
Subject	Meeting Minutes – September	Tel	0458 049 847
Date / Time	19 September 2022 / 3:56 pm	Project no.	2218437
Attendees	Michael Ulph (Chairperson), Joel Fleming (Karuah East Quarry Pty Ltd), Mat Radnidge (ADW Johnson), Isaac Daley (Karuah East Quarry Pty Ltd), Tessa Hestelow (Community Representative), Bob Trotter (Community Representative), Shane Emmanuel (Community Representative, delegate for Uwe Seil), Wade Cameron (Community Representative), John Lyall (Port Stephens Shellfish Program)	Apologies	Michael Todd (Karuah East Quarry Pty Ltd), Uwe Seil (Community Representative), Dean Coles (Port Stephens Shellfish Program), Janine Reid (North Arm Cove Residents Assoc)
Others not present	Goetz Schraer (Community Representative), Mathew Bell – Midcoast Council Shai Richardson – Karuah LALC		
Objective	Record discussion and actions from this meeting.

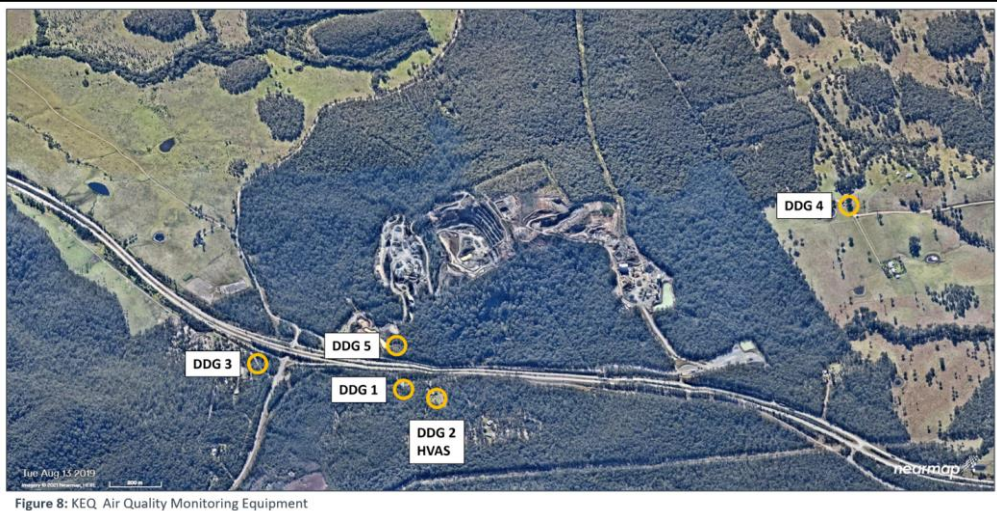
<p>Figure 8: KEQ Air Quality Monitoring Equipment</p> </div> <ul style="list-style-type: none"> Compliance monitoring including: <ul style="list-style-type: none"> Air quality – no issues in the reporting period. The 2019 bushfires caused a spike which is visible on the graph.

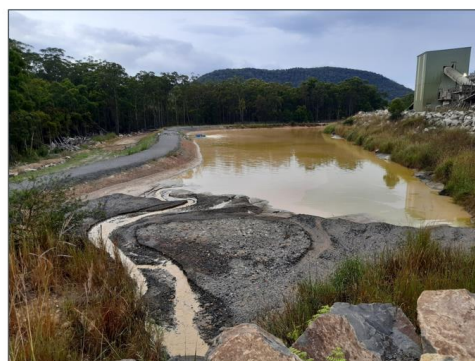
Dam 1 is the primary water storage for KEQ and provides water for operational purposes; such as dust suppression. The designed capacity is 12ML.

There were a total of **15** days of discharging, during which daily monitoring was undertaken. See a summary of results in table below.

Figure 10: Dam 1 (7:12am 7 April 2022)

Dam 1 is the primary water storage for KEQ, designed to have 12ML of water storage. It also collects sediments.

- There were 15 days of uncontrolled discharging with daily sampling. Uncontrolled discharges in early and late March due to rainfall. Messages are sent to the community when this occurs, as well as contact with EPA and DPE. Report to regulators within 7 days.

- Dam 1 is the largest dam.

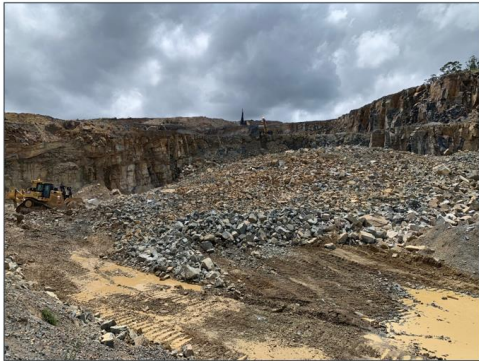
<p>Figure 15: Post blast photo</p> </div> </div>

<ul style="list-style-type: none"> Blast monitoring. There were 13 blasts in the reporting period. All were compliant. Tessa asked if monitoring occurred at the end of her street. Joel replied that it depended on where in the pit the blast occurred – such as higher or lower. Joel played a short video that showed a blast, to illustrate how well controlled the blasts are. Electrical detonators have ‘changed the game’. <p>Complaints: There was one general complaint made to the Department of Planning and Environment about the cumulative impacts from quarries and extractive industries in the region generally, and the contribution to air quality and water pollution issues. KEQ provided a range of information and the issue was closed out.</p>

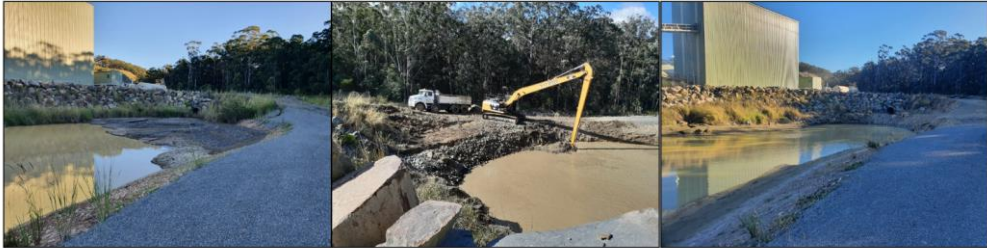
Agenda Item	Notes
	<p>General Business</p> <p><u>KEQ Dam De-silting Project</u></p> <ul style="list-style-type: none"> • The region has experienced above average rainfall for an extended period of time. • The three dams at KEQ have capture rainfall and subsequent material laden surface runoff. • Over the first week of June 2022, a dam de-silting project was undertaken to remove sediment from dams and restore dam storage capacity. • See progressive photos of Dam 1 below.

<p>Figure 19: KEQ Dam des-silting project</p> <ul style="list-style-type: none"> • Shane asked how far the KEQ operation is under the approved production limit of 1.5 million tonnes per annum. • Joel replied they are not over one million tonnes yet. The KEQ has only been fully operational since 2019. Demand is expected to be high for high quality material for upcoming bypasses etc (eg. the Heatherbrae bypass project) in the medium term. The 1.5 million tonne productivity is likely still years away. • Shane asked about Karuah South Quarry. It is proposed to be around 600,000 tonnes per annum. Not part of Hunter Quarries Pty Ltd or KEQ Pty Ltd. • Wade described the site visit. • Mat described the proposed MOD 10 offset arrangements (including land based 'like for like' replacement offsets) for vegetation proposed to be removed under Mod 10. • John described the oyster industry as being pretty ordinary. Many oyster growers have shut down. Constant fresh water from flooding has damaged the oysters' immune systems and they have suffered badly. Chemicals can be purchased and used by any resident and development nearby has increased. Sewage in the water has been another impact. Many growers are older and can't continue. Some younger growers will continue.

General Business	<ul style="list-style-type: none"> • Joel showed images of a contractor using a long-reach front end loader to de-silt all of the dams and some retention basins. (see below). • Wade asked where the silt goes. Joel advised that the silt will be taken higher in the quarry to dry out, for either mixing with other material for sale or re-use. • Wade asked if the silt was tested. Joel advised it was not tested. • Michael asked for any other questions from CCC members or community members via the CCC members. • Joel mentioned that demand for quarry products was high.
