Karuah Hard Rock Quarry

Summary of Environmental Monitoring Data

For the Period: September 2016

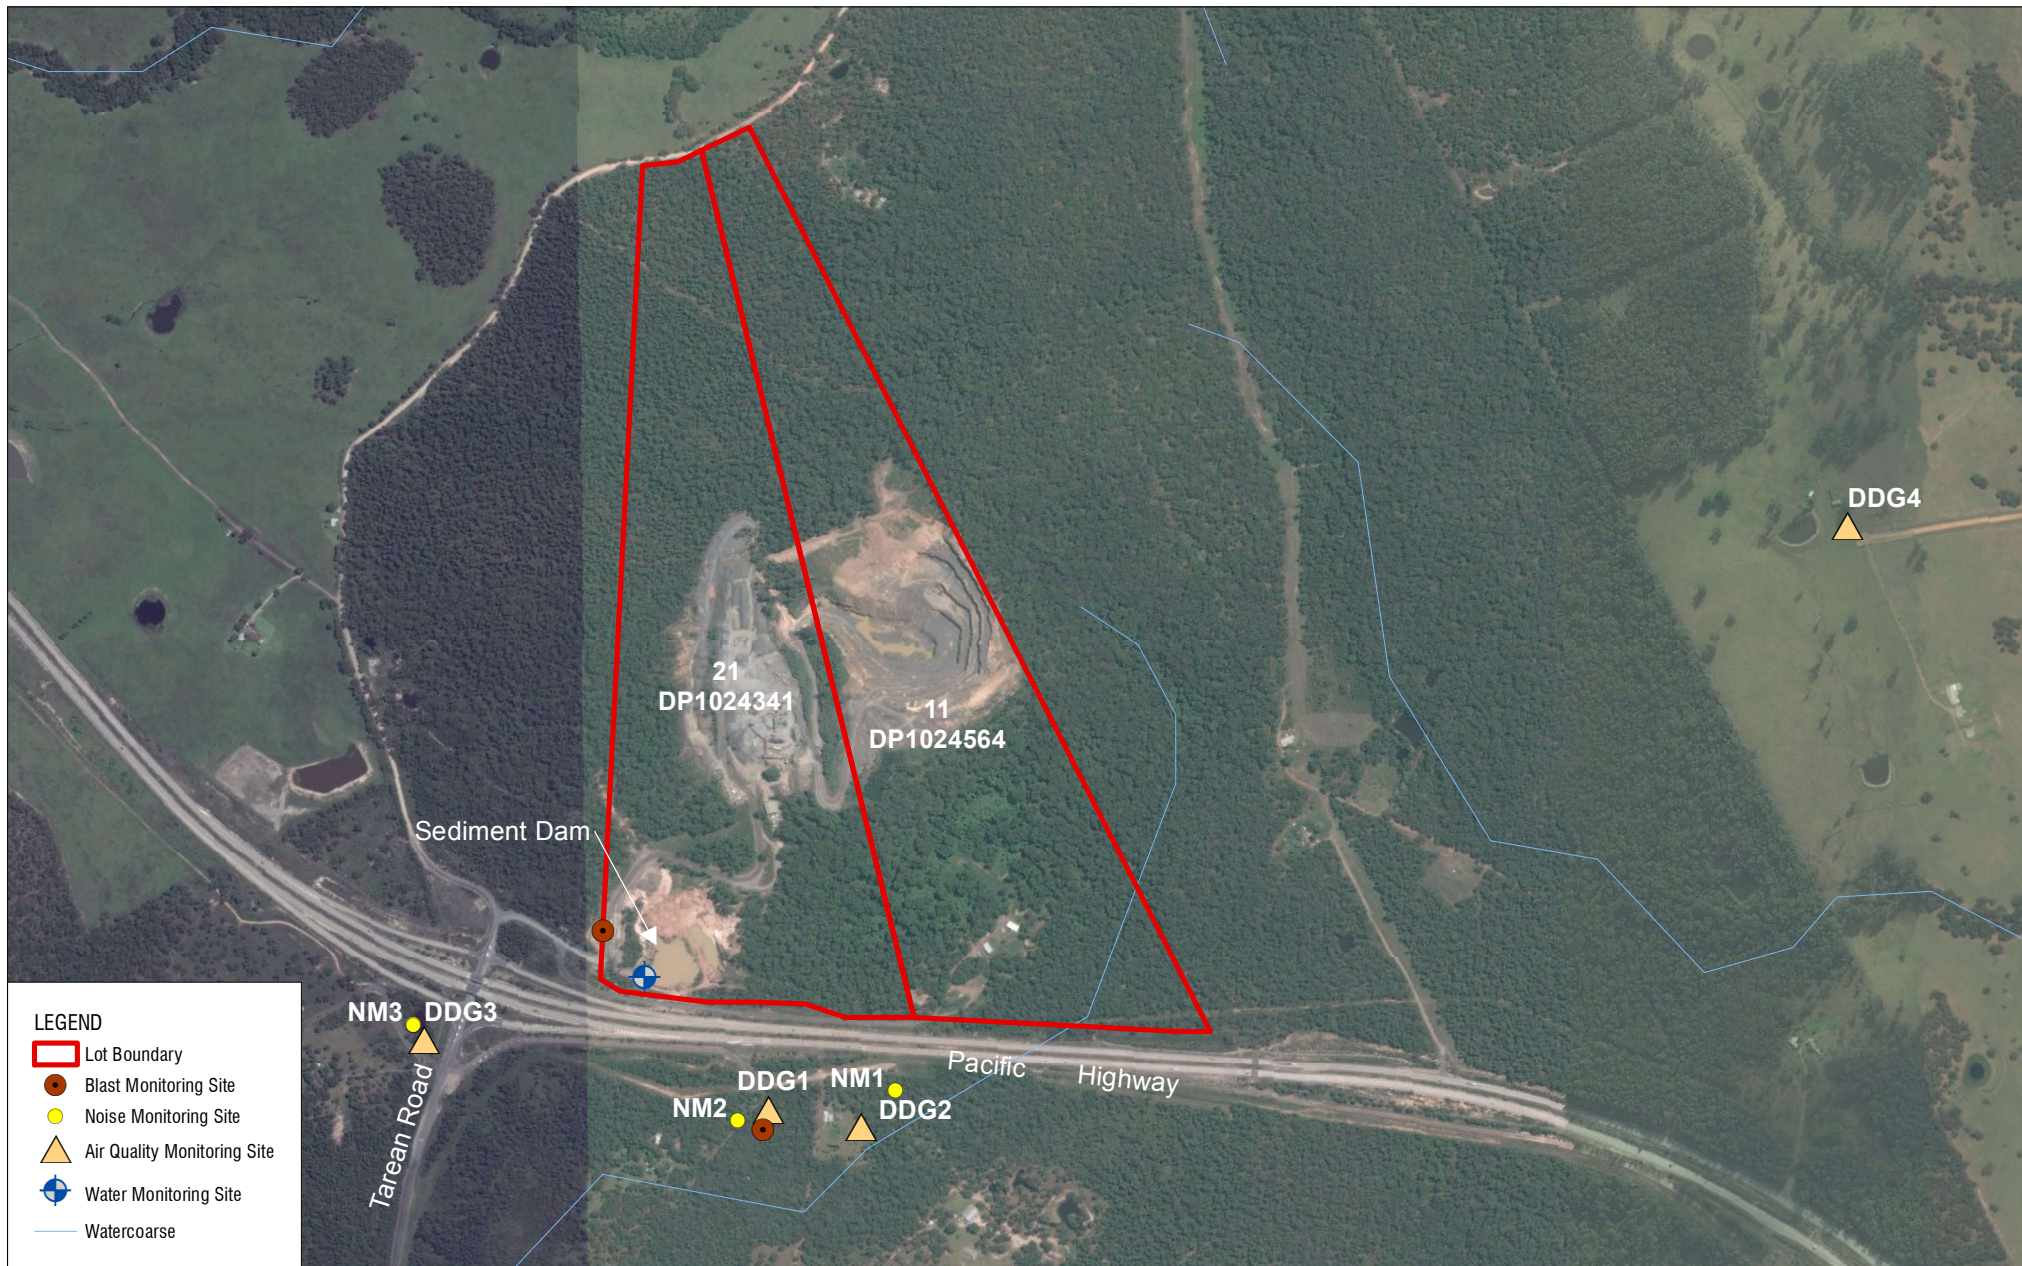
FIGURE 1

Appendix 1 Illustrates the air quality monitoring locations at Karuah Quarry.

**Karuah Hard Rock Quarry
Environmental Monitoring Locations**
