Karuah Hard Rock Quarry

Environmental Monitoring Report:

July 2021

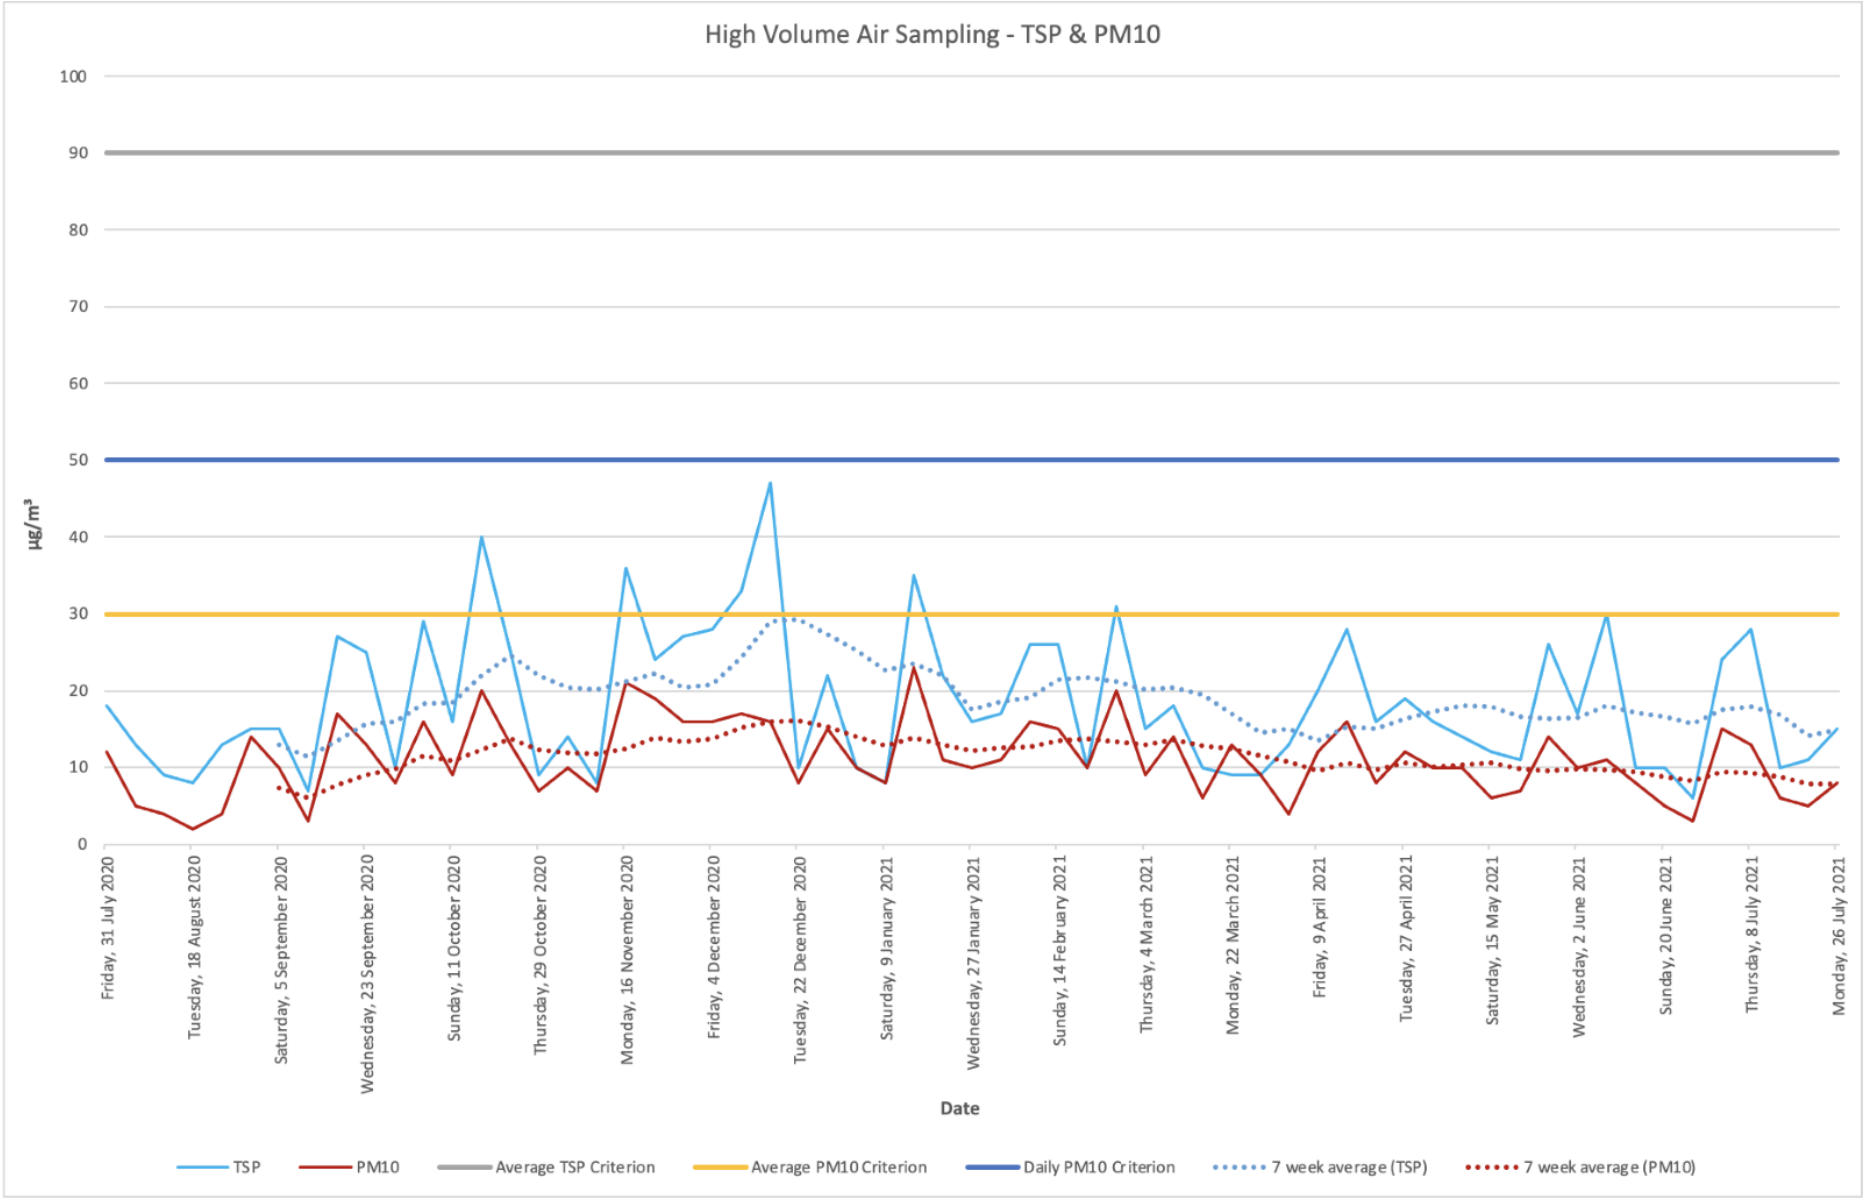
Figure 1 High Volume Air Sampling: Year-to-date results

The TSP and PM₁₀ results for July 2021, the report average and a rolling annual average are shown in are shown in Table 8. Figure 1 illustrates the year-to-date results for HVAS monitoring.

Run Date	HVAS TSP (µg/m ³)	HVAS PM ₁₀ (µg/m ³)
2/07/2021	24	15
8/07/2021	28	13
14/07/2021	10	6
20/07/2021	11	5
26/07/2021	15	8
24hr Average Criteria¹	N/A	50
Annual Average Criteria¹	90	30
Progressive Annual Average²	21.0	11.7

All HVAS monitoring results, to the end of July 2021 were compliant with the long term and short term impact assessment criteria outlined in *Schedule 3 Condition 13* of the Consent (see Table 3, Table 4 and Table 5).

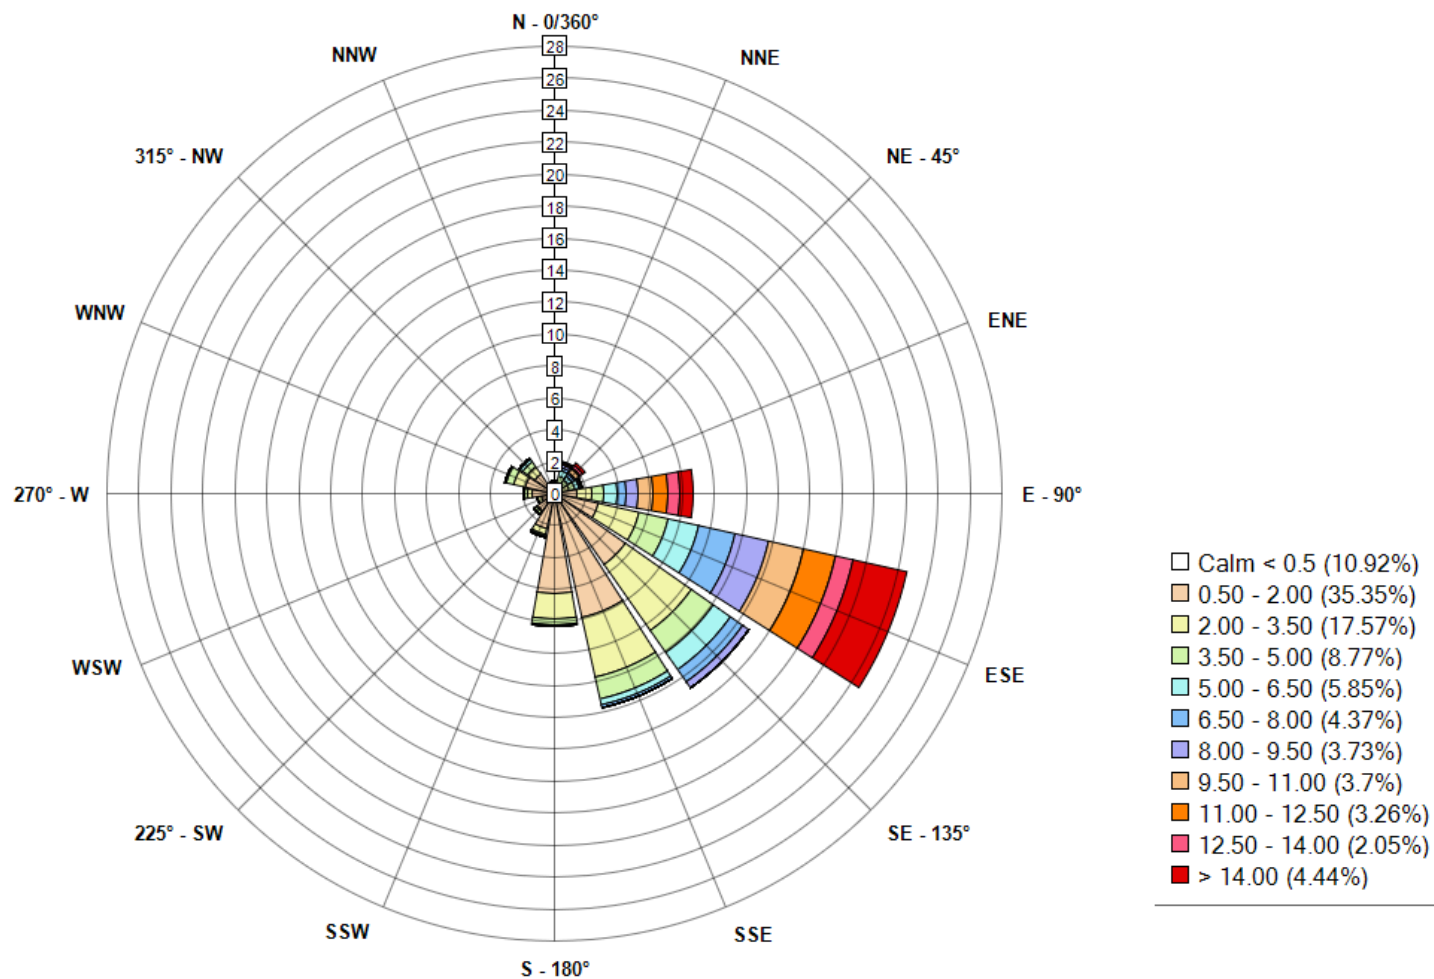
Figure 3 Wind rose September 2021

A wind rose is a graphic tool used to depict the average direction and speed of the wind over a recorded period. Figure 3 shows the wind rose generated from data gathered during July 2021.

Wind Rose Report for: Karuah East - 15 Min Data

Period: 2021-07-01 00:00 to 2021-07-31 23:59

Direction the Wind is Blowing To
