Karuah Hard Rock Quarry

Environmental Monitoring Report:

August 2021

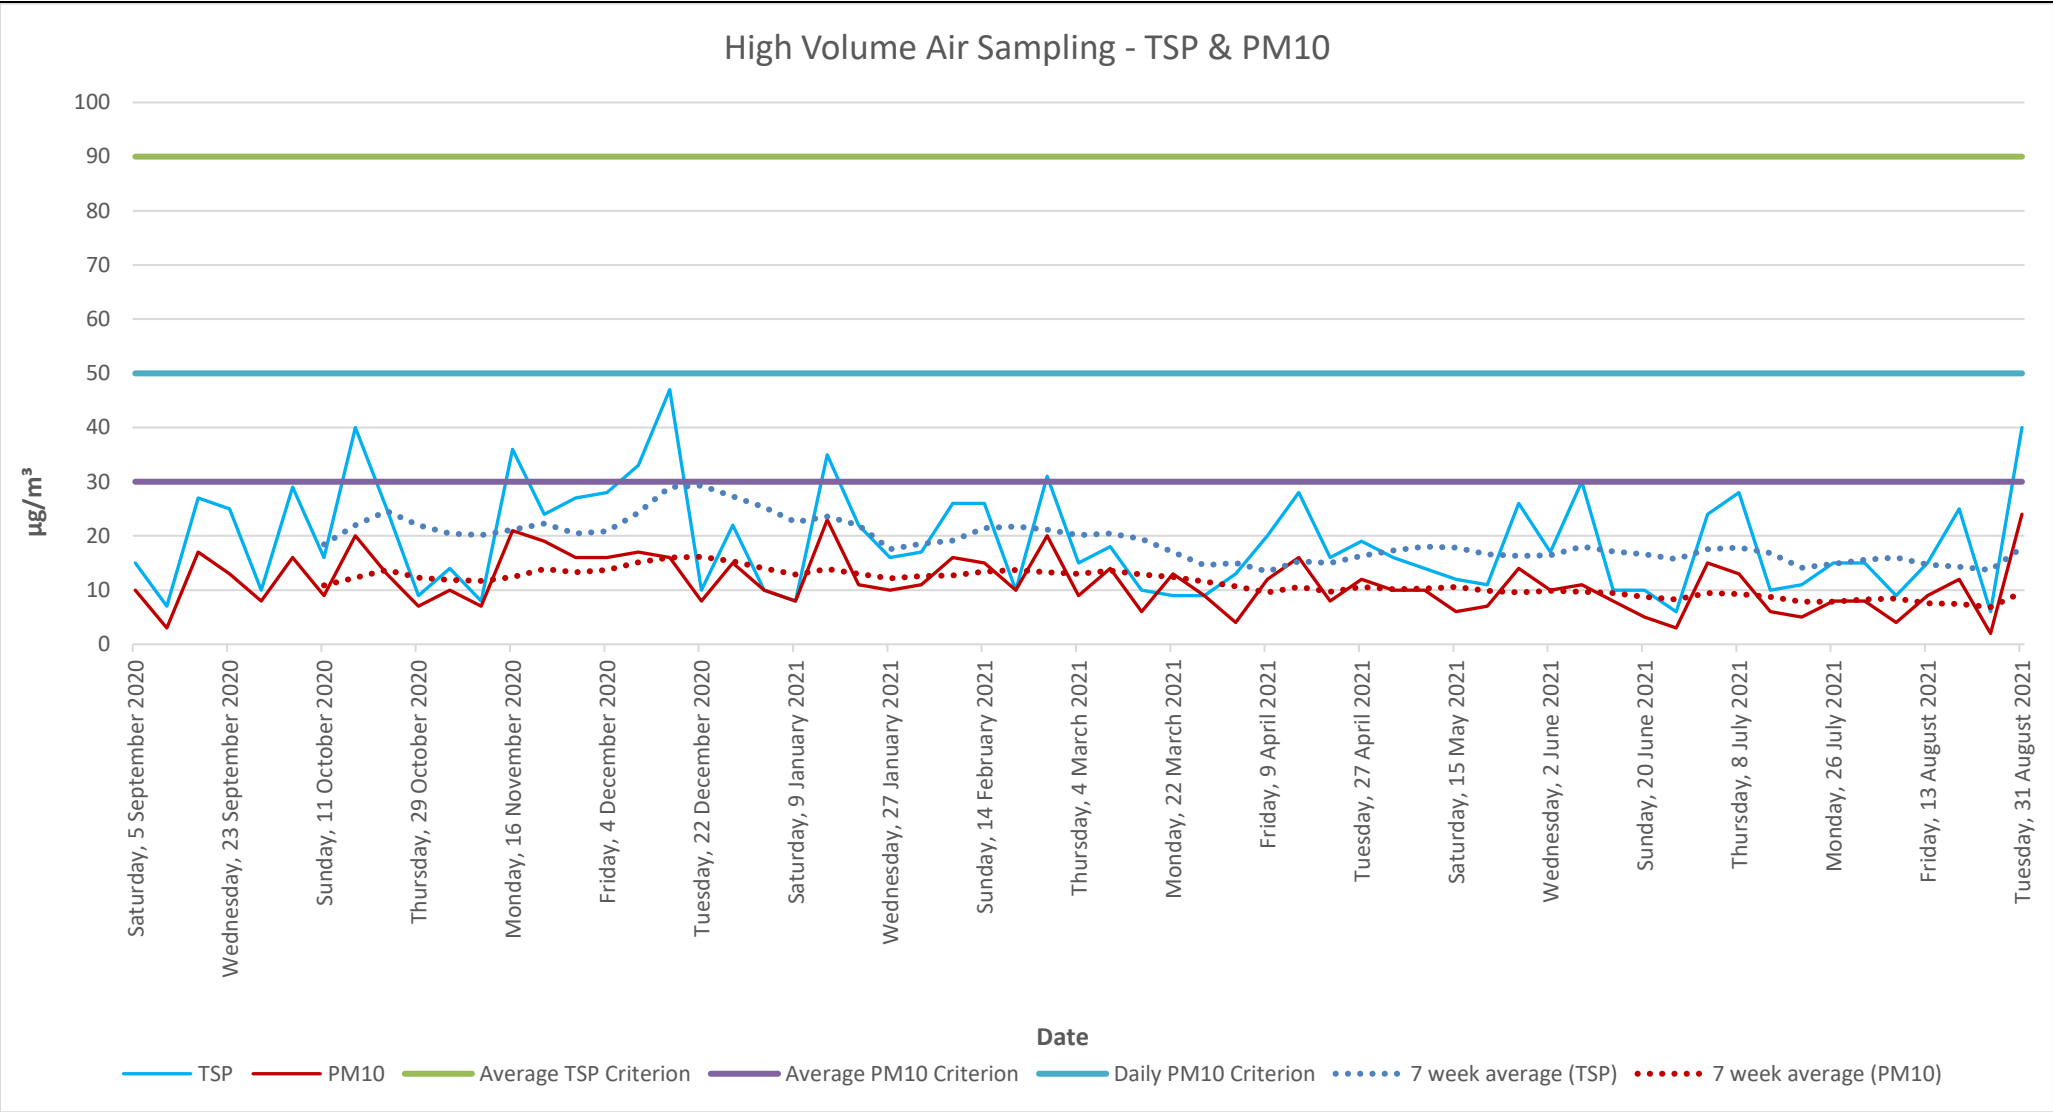
Figure 1 High Volume Air Sampling: Year-to-date results

The TSP and PM₁₀ results for August 2021, the report average and a rolling annual average are shown in are shown in Table 8. Figure 1 illustrates the year-to-date results for HVAS monitoring.

All HVAS monitoring results, to the end of August 2021 were compliant with the long term and short term impact assessment criteria outlined in *Schedule 3 Condition 13* of the Consent (see Table 3, Table 4 and Table 5).

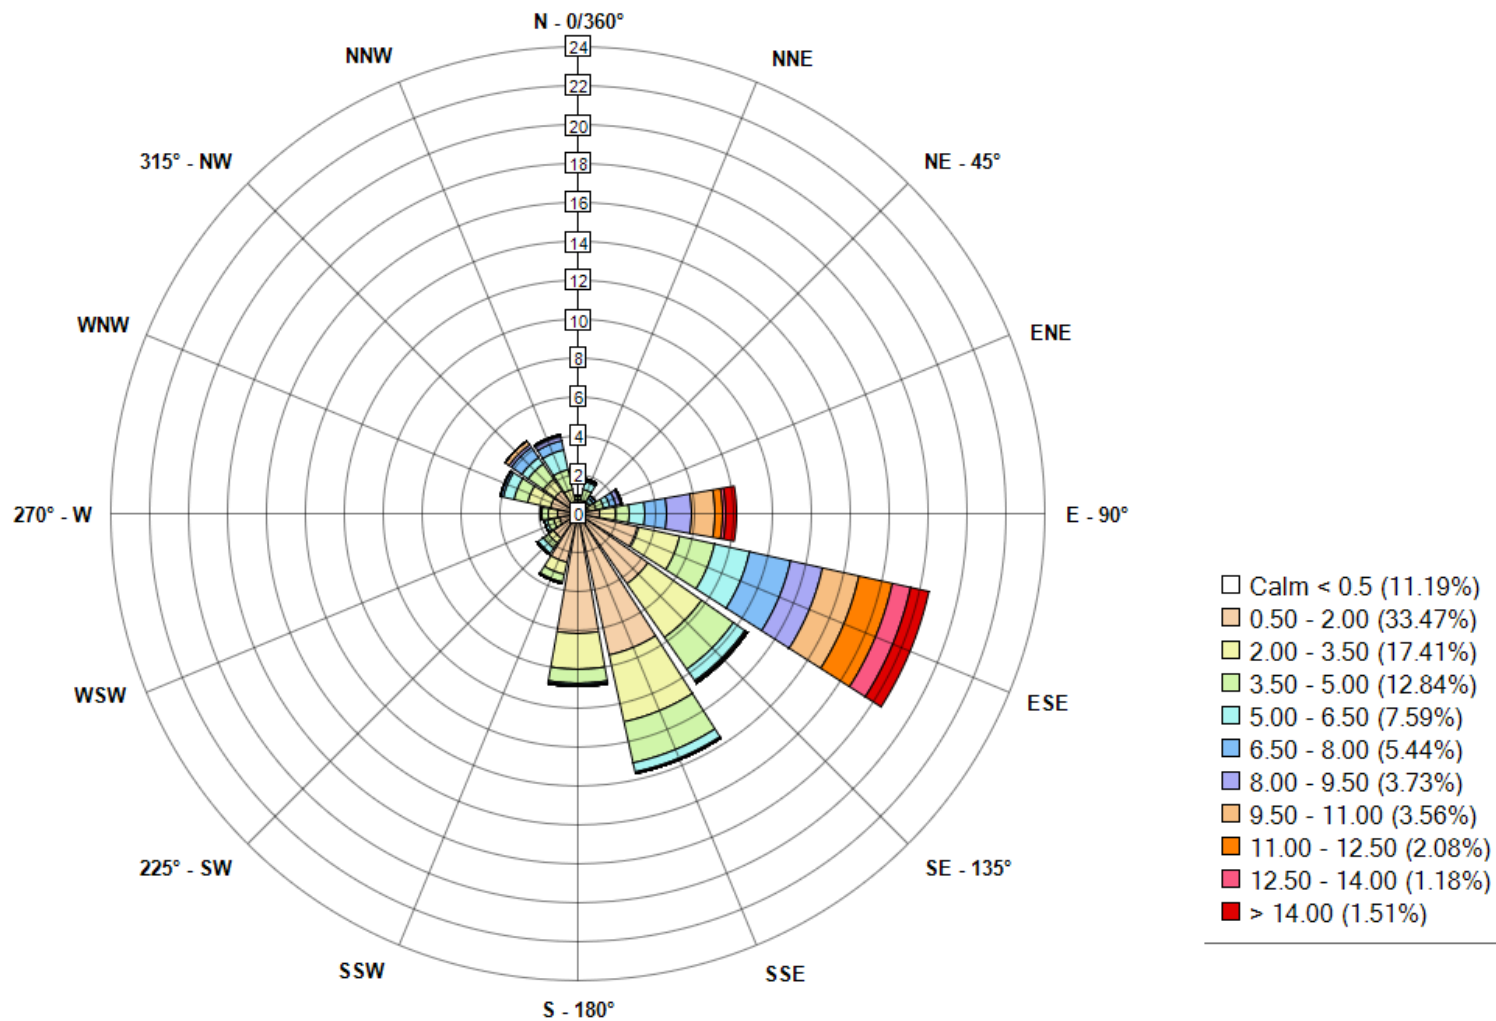
Figure 3 Wind rose September 2021

A wind rose is a graphic tool used to depict the average direction and speed of the wind over a recorded period. Figure 3 shows the wind rose generated from data gathered during August 2021.

Wind Rose Report for: Karuah East - 15 Min Data

Period: 2021-08-01 00:00 to 2021-08-31 23:59
