## **Karuah Hard Rock Quarry**

### **Environmental Monitoring Report:**

**September 2021**

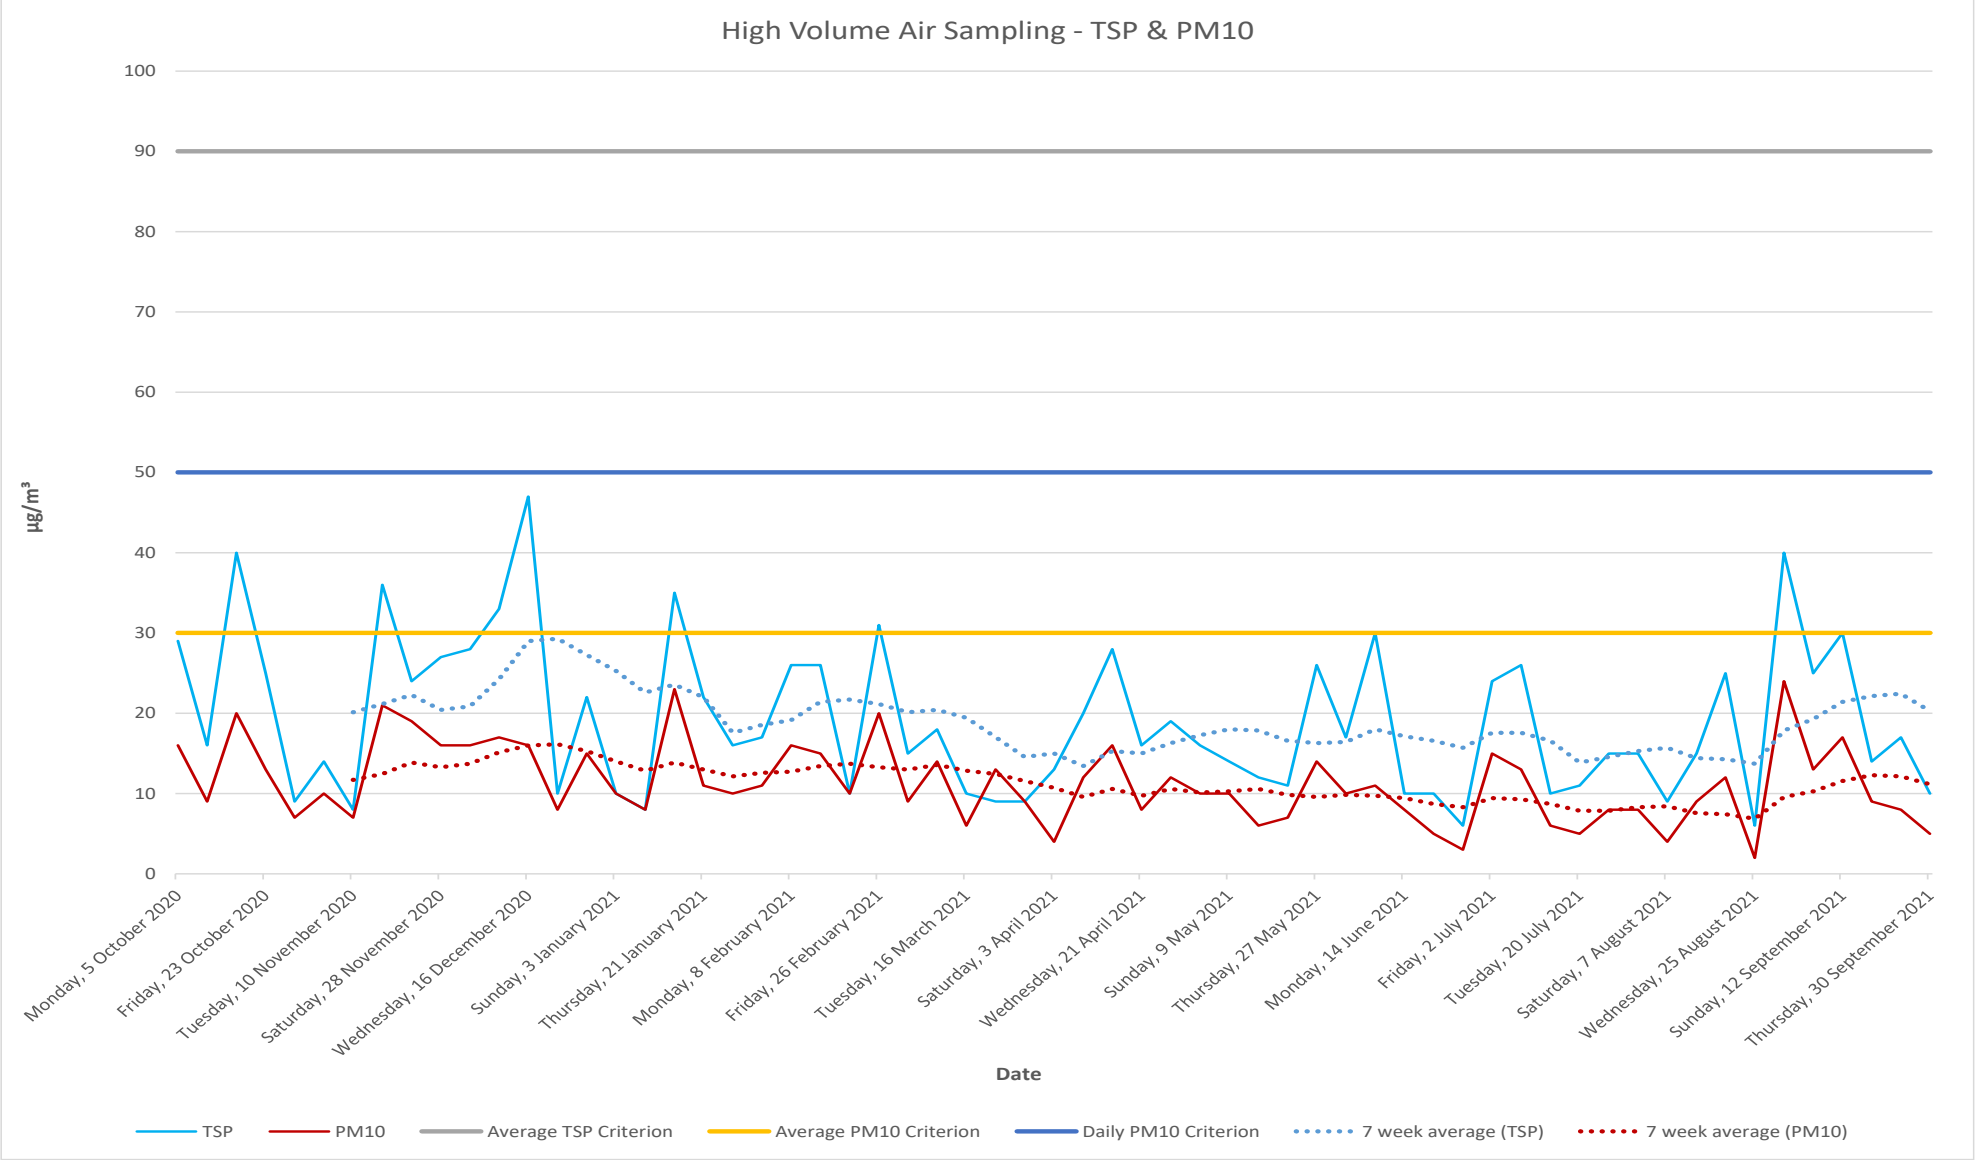
Figure 1 High Volume Air Sampling: Year-to-date results

The TSP and PM<sub>10</sub> results for September 2021, the report average and a rolling annual average are shown in are shown in Table 8. Figure 1 illustrates the year-to-date results for HVAS monitoring.

All HVAS monitoring results, to the end of September 2021 were compliant with the long term and short term impact assessment criteria outlined in *Schedule 3 Condition 13* of the Consent (see Table 3, Table 4 and Table 5).

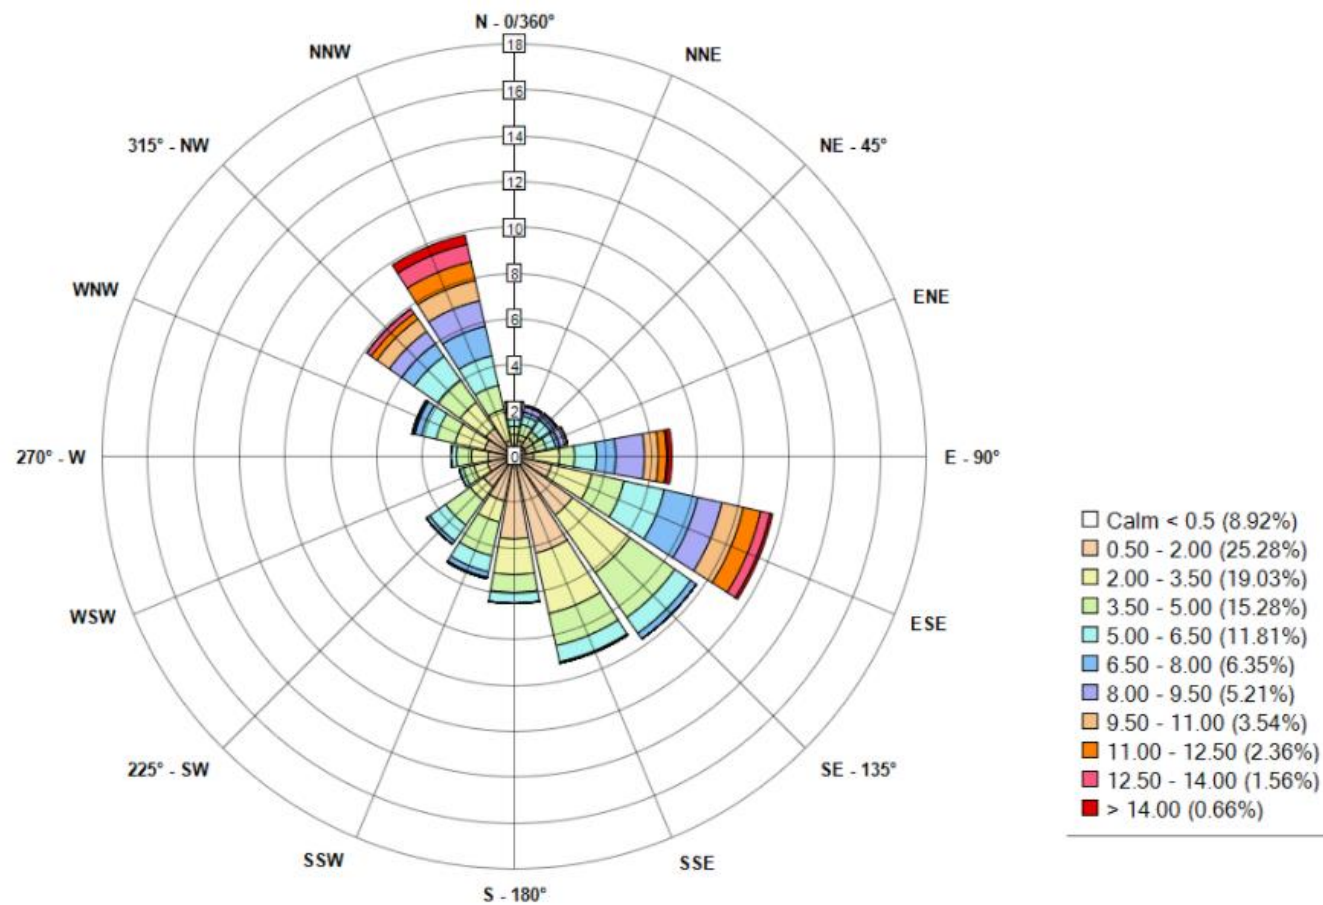
Figure 3 Wind rose September 2021

A wind rose is a graphic tool used to depict the average direction and speed of the wind over a recorded period. Figure 3 shows the wind rose generated from data gathered during September 2021.

### Wind Rose Report for: Karuah East - 15 Min Data

VWDIR Vector Wind Dir and VWSP Vector Wind Spd in km/h

Period: 2021-09-01 00:00 to 2021-09-30 23:59

Direction the Wind is Blowing To
