## **Karuah Hard Rock Quarry**

### **Environmental Monitoring Report:**

**October 2021**

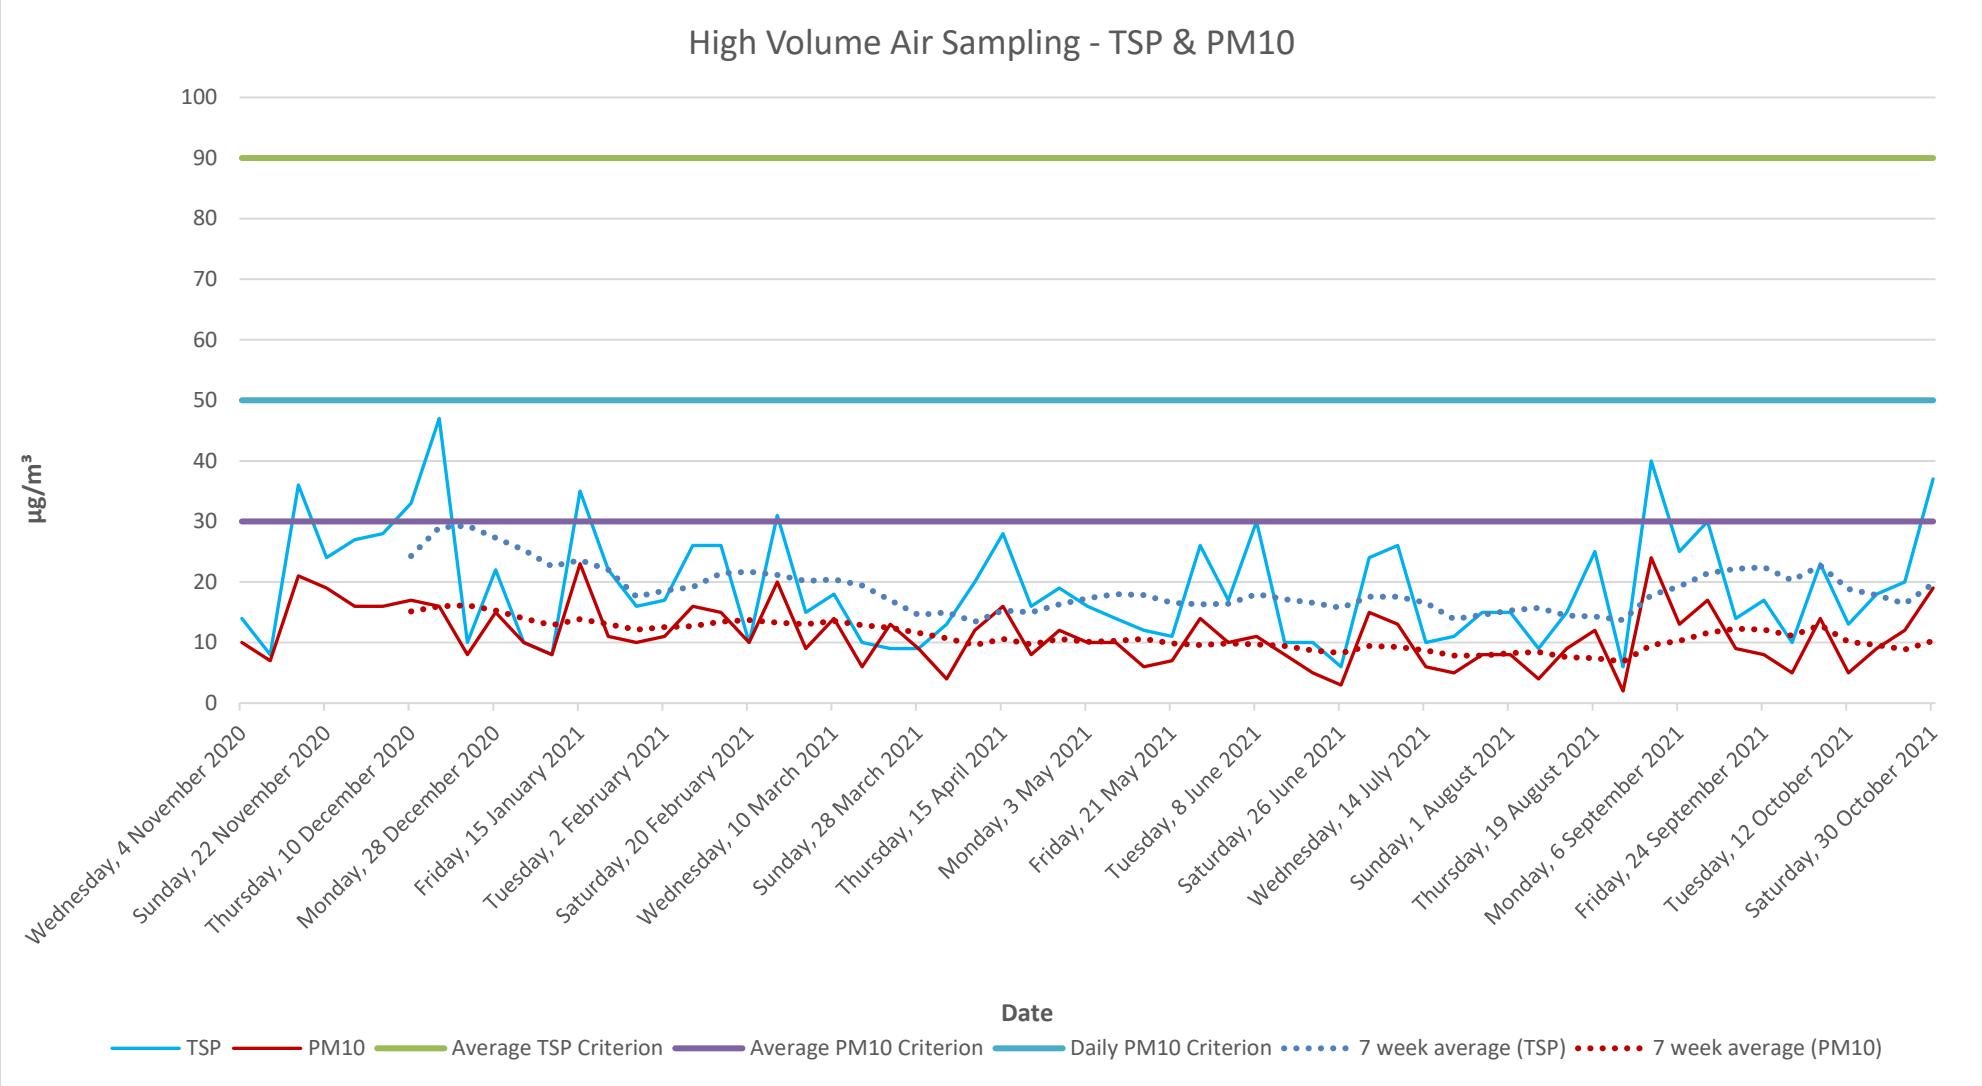
Figure 1 High Volume Air Sampling: Year-to-date results

The TSP and PM<sub>10</sub> results for October 2021, the report average and a rolling annual average are shown in are shown in Table 8. Figure 1 illustrates the year-to-date results for HVAS monitoring.

All HVAS monitoring results, to the end of October 2021 were compliant with the long term and short term impact assessment criteria outlined in *Schedule 3 Condition 13* of the Consent (see Table 3, Table 4 and Table 5).

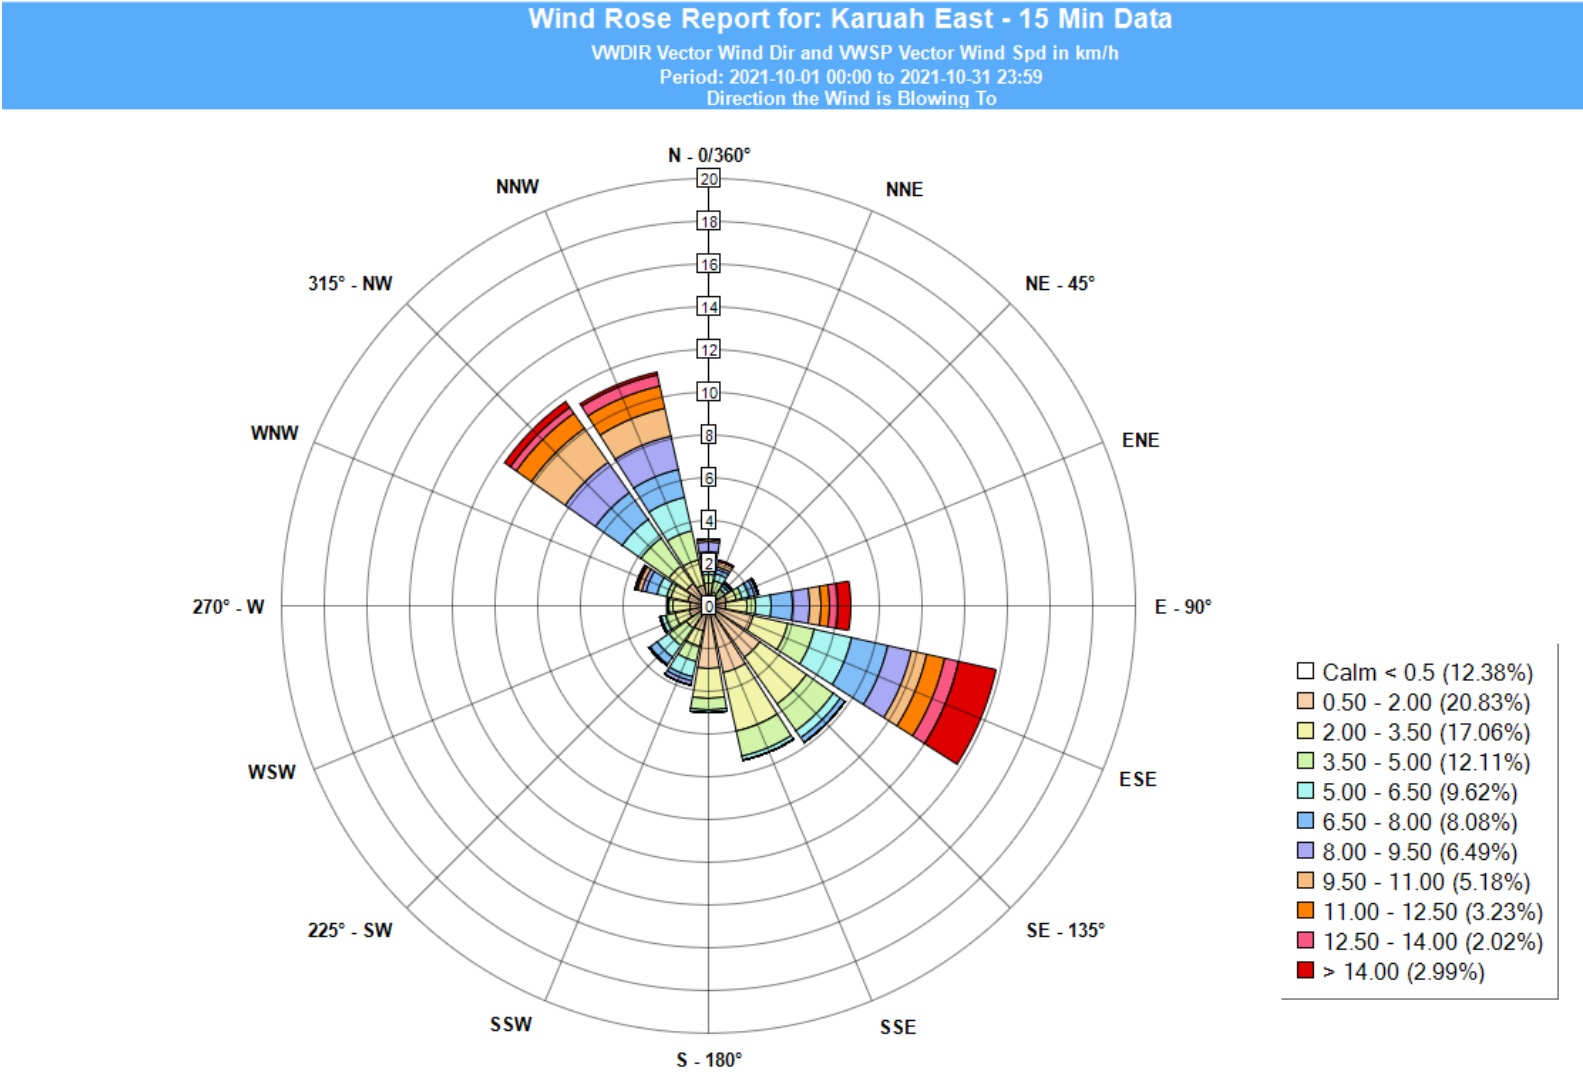
Figure 3 Wind rose October 2021

A wind rose is a graphic tool used to depict the average direction and speed of the wind over a recorded period. Figure 3 shows the wind rose generated from data gathered during October 2021.
