Karuah Hard Rock Quarry

Environmental Monitoring Report:

July 2022

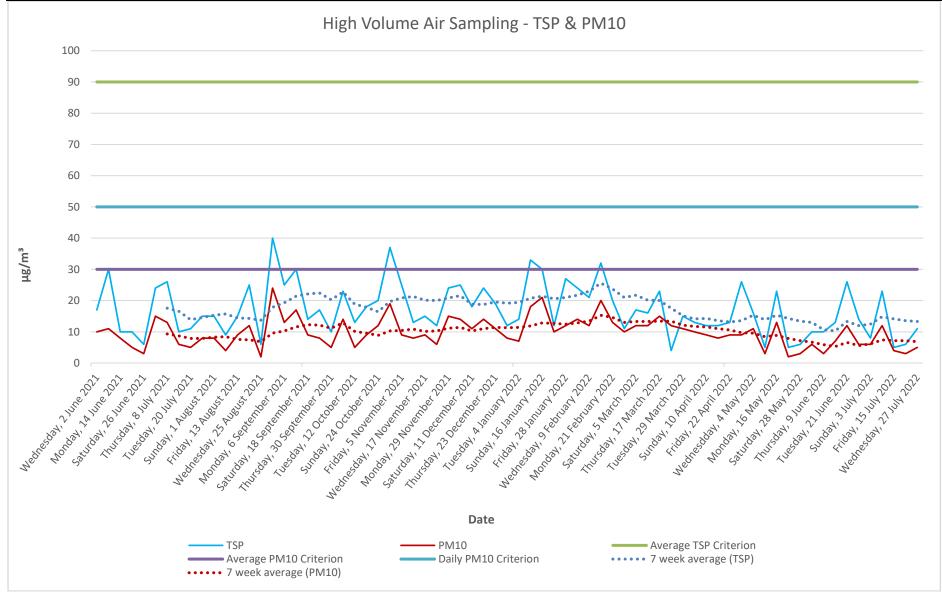
Figure 1 High Volume Air Sampling: Year-to-date results

Figure 1 illustrates the year-to-date results for HVAS monitoring.

Run Date	HVAS TSP (µg/m³)	HVAS PM10 (µg/m³)
03/07/2022	8	6
09/07/2022	23	12
15/07/2022	5	4
21/07/2022	6	3
27/07/2022	11	5
24hr Average Criteria ¹	N/A	50
Annual Average Criteria ¹	90	30
Progressive Annual Average ²	15.9	9.7

All HVAS monitoring results, to the end of July 2022 were compliant with the long term and short term impact assessment criteria outlined in *Schedule 3 Condition 13* of the Consent (see Table 3, Table 4 and Table 5).

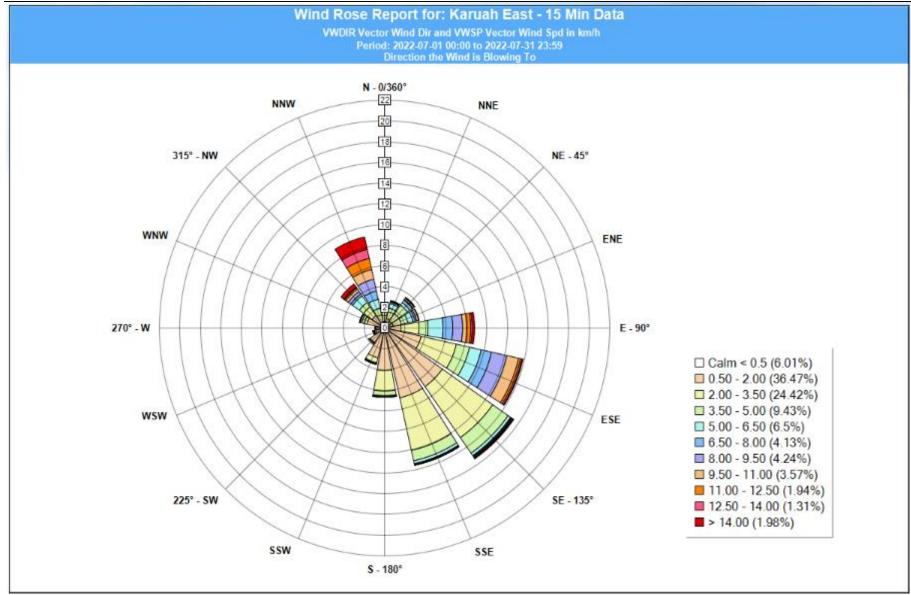
Figure 3 Wind Rose July 2022

A wind rose is a graphic tool used to depict the average direction and speed of the wind over a recorded period. Figure 3 shows the wind rose generated from data gathered during July 2022.

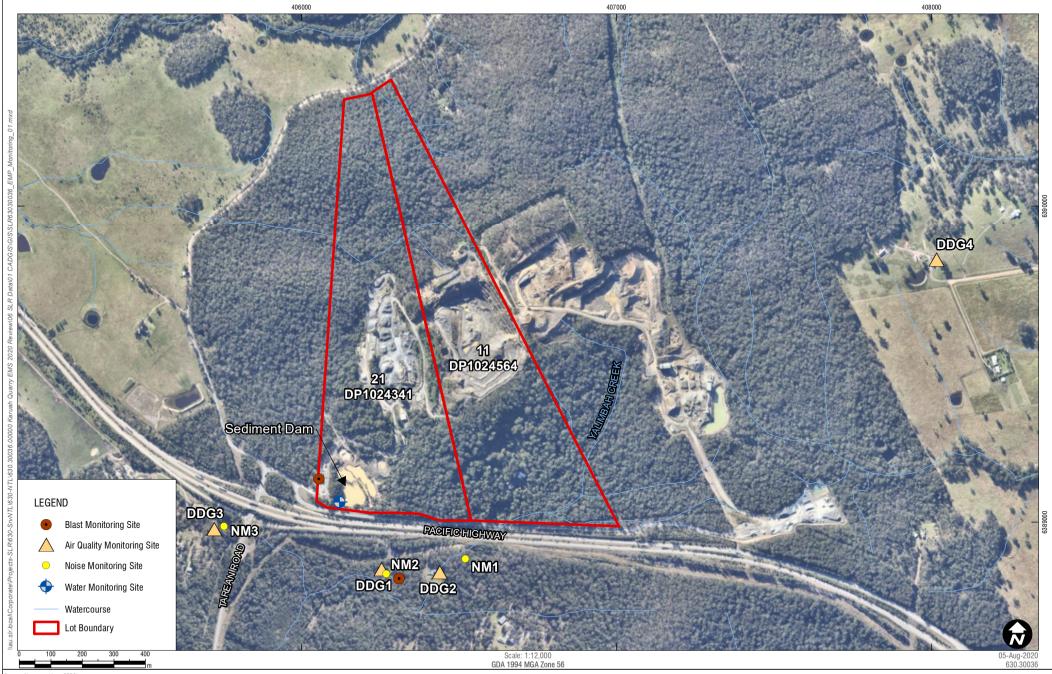
Karuah Hard Rock Quarry Environmental Monitoring Locations

Monitoring locations are identified in in Appendix 1.

Site ID	Location	Address	GPS Coordinates
DDG 1 (South)	South of the Karuah	5760 Pacific Hwy,	32°38'04"S
	Quarry	Karuah NSW 2324	151°59'58"E
DDG 2 (South-	South of the Karuah	5770 Pacific Hwy,	32°38'02"S
East)	Quarry	Karuah NSW 2324	152°00'09"E
DDG 3 (South-	South-West of the	DP 1024341, Karuah	32°37′57"S
West)	Karuah Quarry		151°59′41"E
DDG 4 (East)	East of the Karuah	21 Halloran Rd	32° 37' 30.87"S
	Quarry	North Arm Cove NSW 2324	152°01'10.18"E

Noise Monitoring Location	Property Name	Distance from Karuah Quarry
NM1	Lot 3 DP785172 5772 Pacific Hwy, Karuah	317 metres South of the Karuah Quarry
NM2	Lot 2 DP 785172 5760 Pacific Hwy, Karuah	200 metres South of the Karuah Quarry
