Karuah Hard Rock Quarry

Environmental Monitoring Report:

February 2023

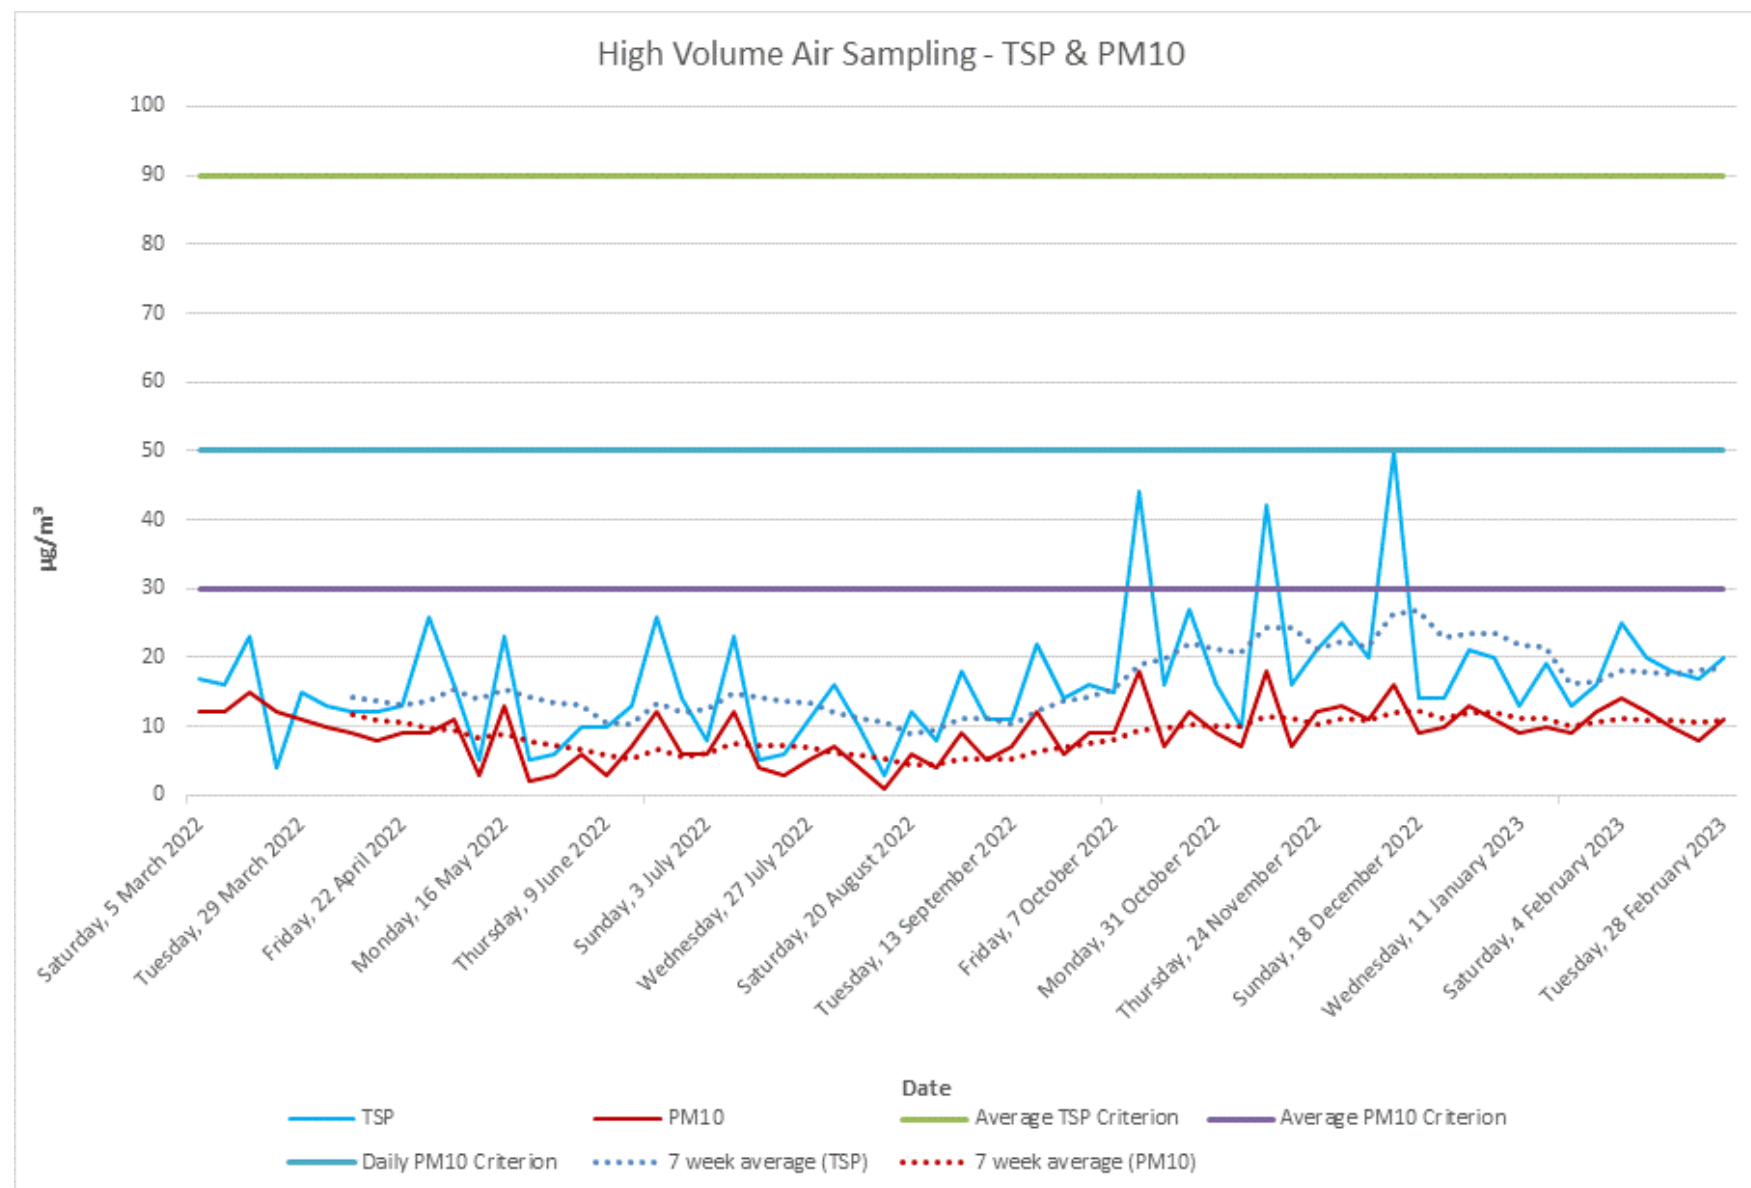
Figure 1 High Volume Air Sampling 2022/2023

The TSP and PM₁₀ results for February 2023, the report average and a rolling annual average are shown in Table 8.

All HVAS monitoring results, to the end of February 2023 were compliant with the long term and short term impact assessment criteria outlined in *Schedule 3 Condition 13* of the Consent (see Table 3, Table 4 and Table 5).

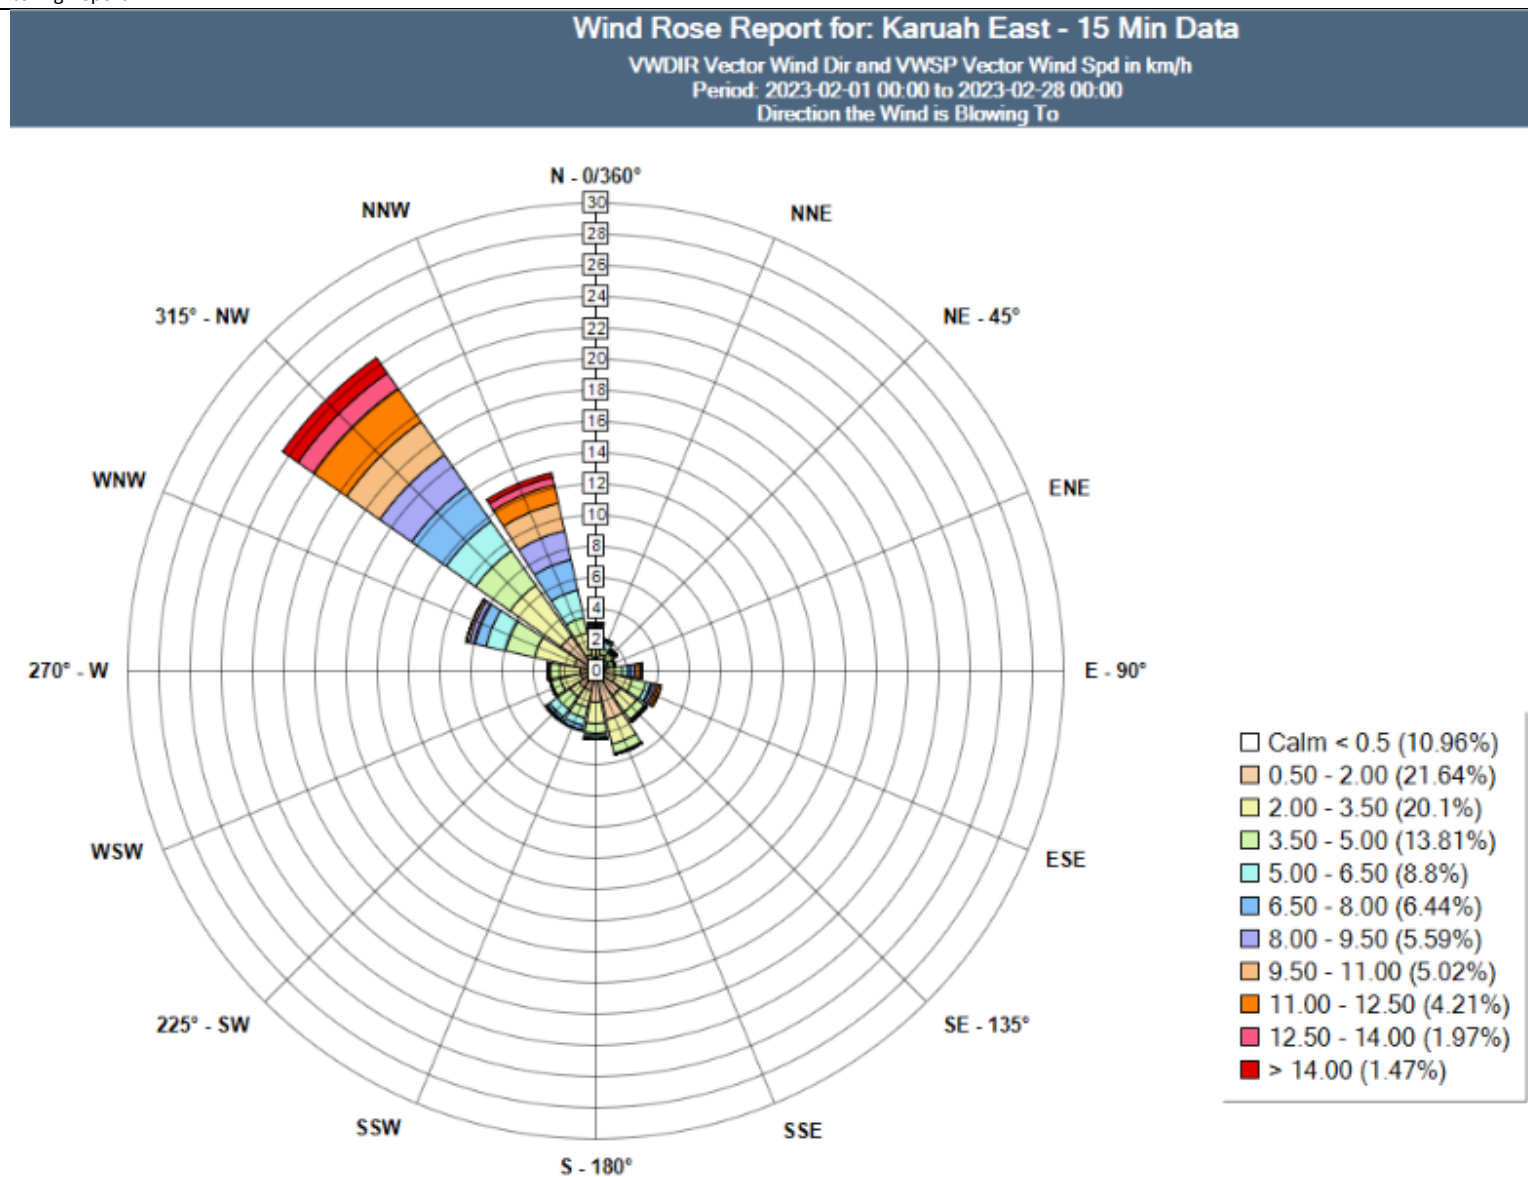
Figure 3 Wind Rose February 2023

A wind rose is a graphic tool used to depict the average direction and speed of the wind over a recorded period. Figure 3 shows the wind rose generated from data gathered during February 2023.

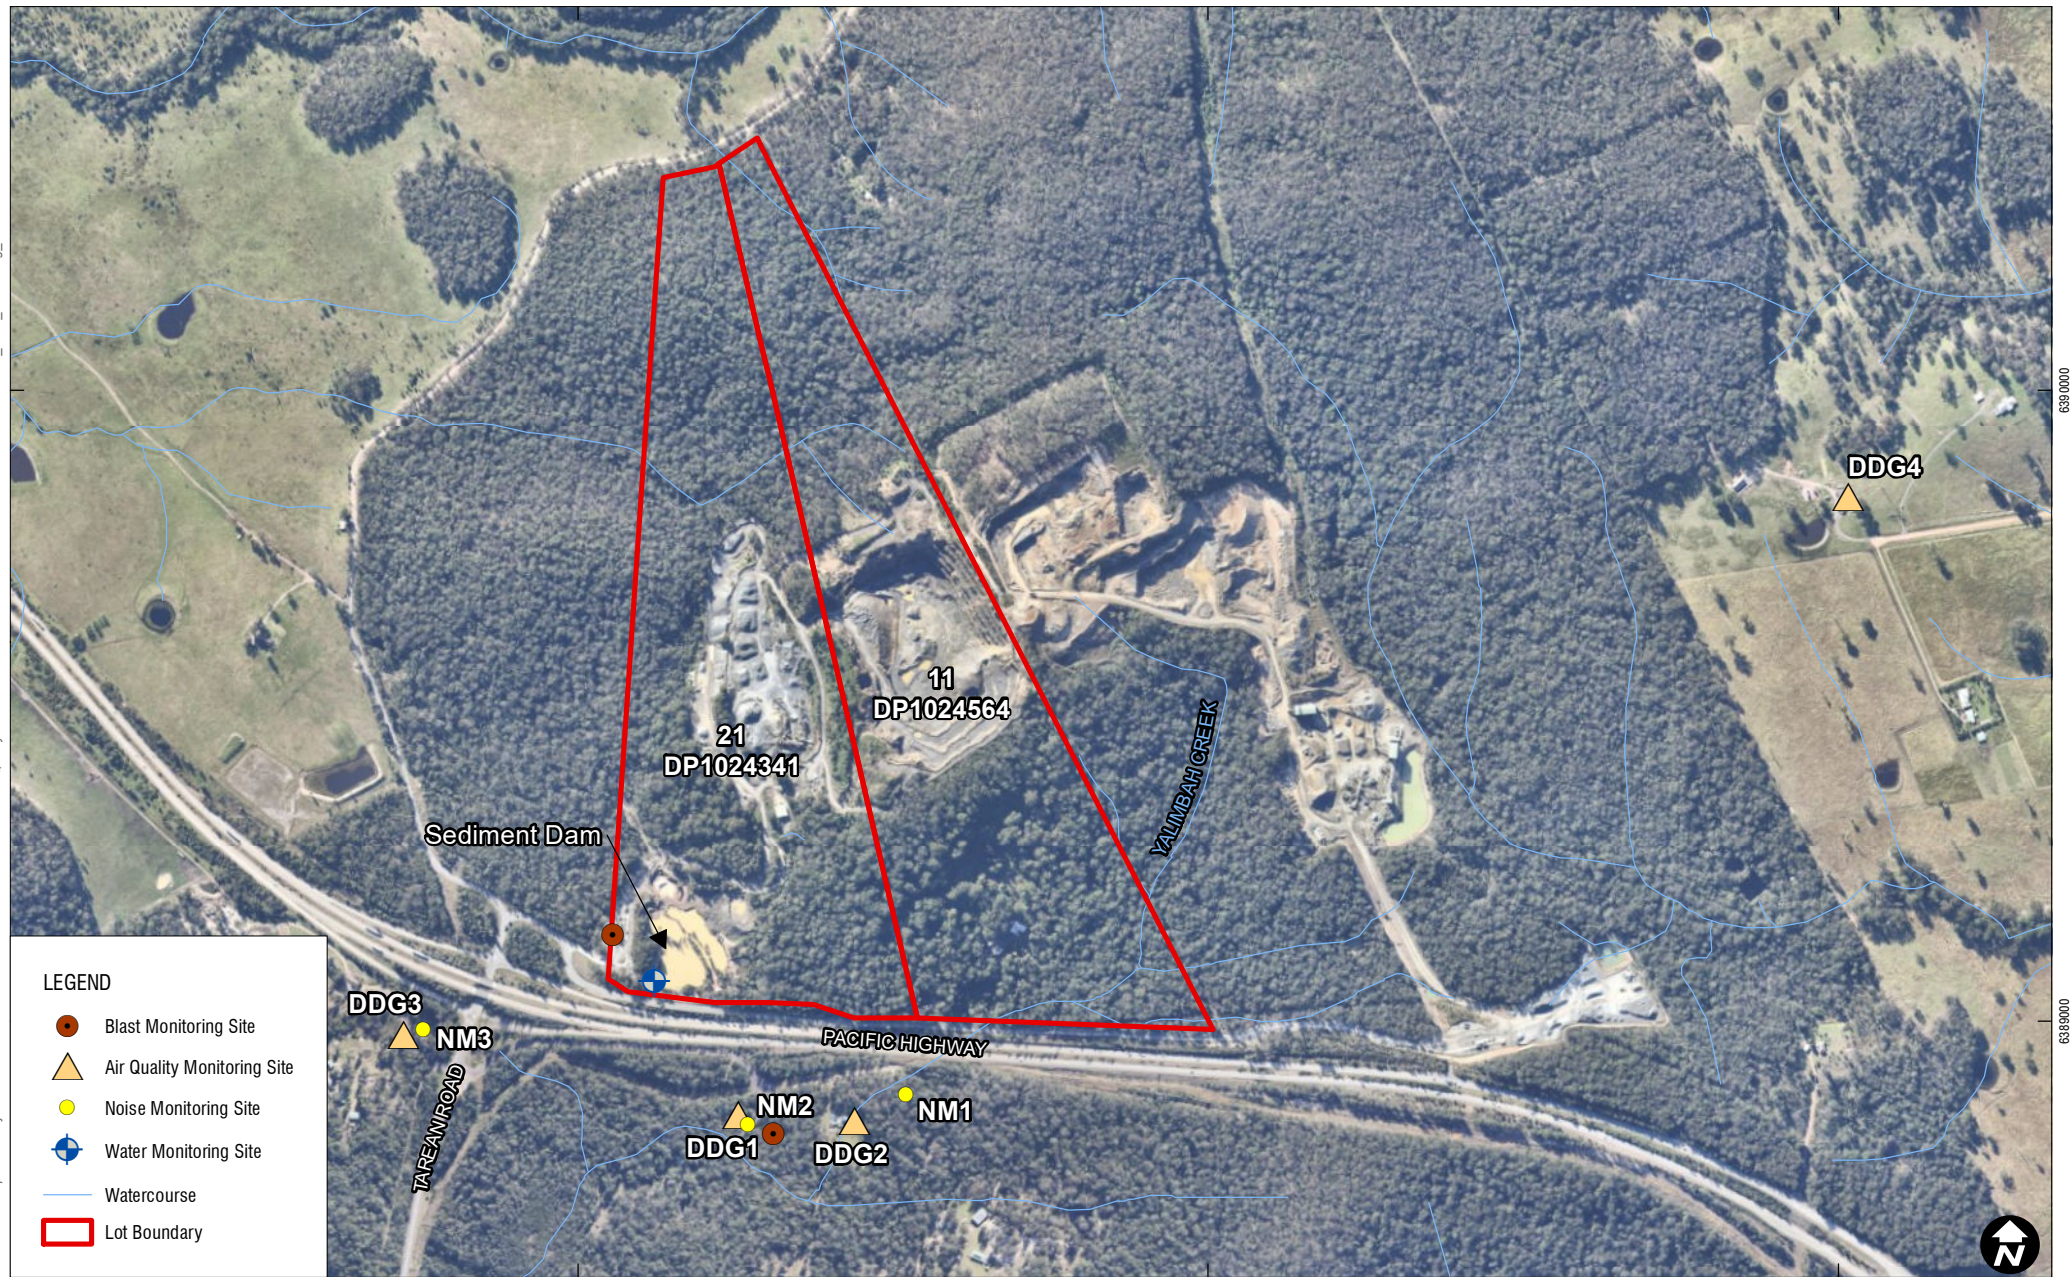
Appendix 1 – Monitoring Location

Monitoring locations are identified in in **Appendix 1**.
