Karuah Hard Rock Quarry

Environmental Monitoring Report:

March 2023

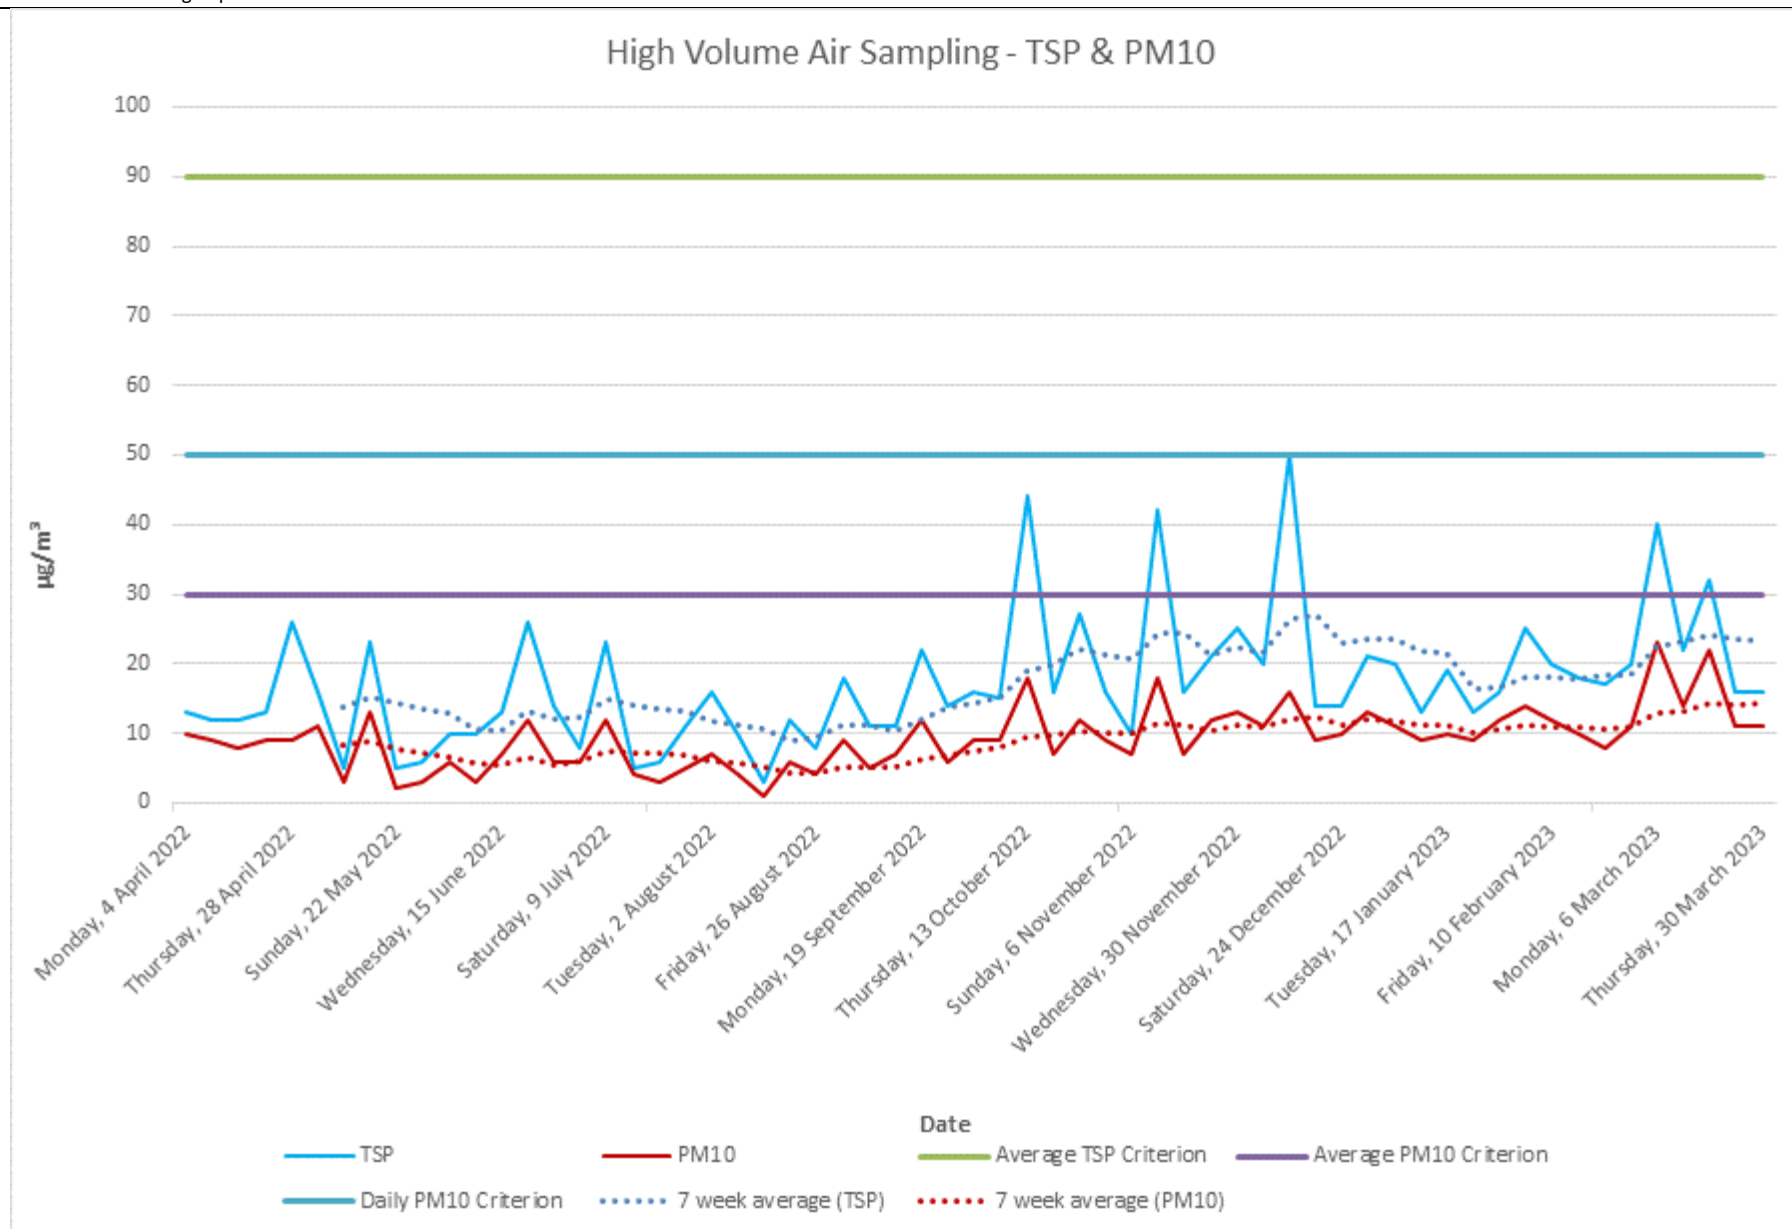
Figure 1 High Volume Air Sampling 2022/2023

All HVAS monitoring results, to the end of March 2023 were compliant with the long term and short term impact assessment criteria outlined in *Schedule 3 Condition 13* of the Consent (see Table 3, Table 4 and Table 5).

The TSP and PM₁₀ results for March 2023, the report average and a rolling annual average are shown in are shown in Table 8.

Run Date	HVAS TSP (µg/m ³)	HVAS PM ₁₀ (µg/m ³)
6/03/2023	40	23
12/03/2023	22	14
18/03/2023	32	22
24/03/2023	16	11
30/03/2023	16	11
24hr Average Criteria¹	N/A	50
Annual Average Criteria¹	90	30
Progressive Annual Average²	20.5	12.5

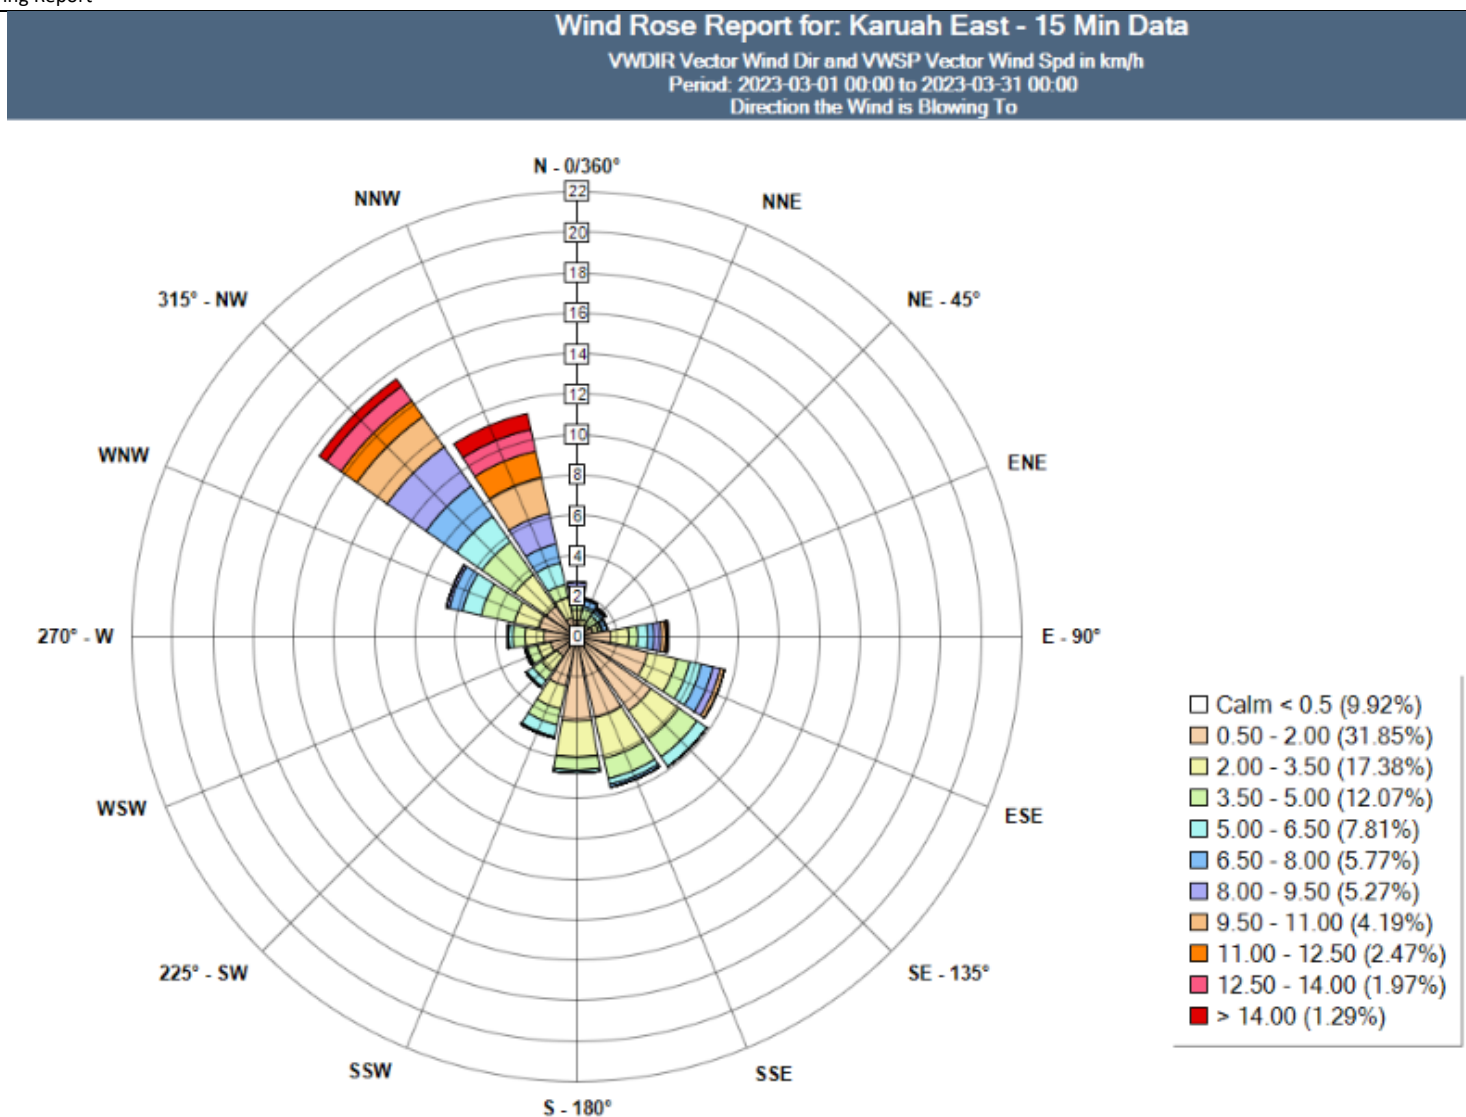
Figure 3 Wind Rose March 2023

A wind rose is a graphic tool used to depict the average direction and speed of the wind over a recorded period. Figure 3 shows the wind rose generated from data gathered during March 2023.

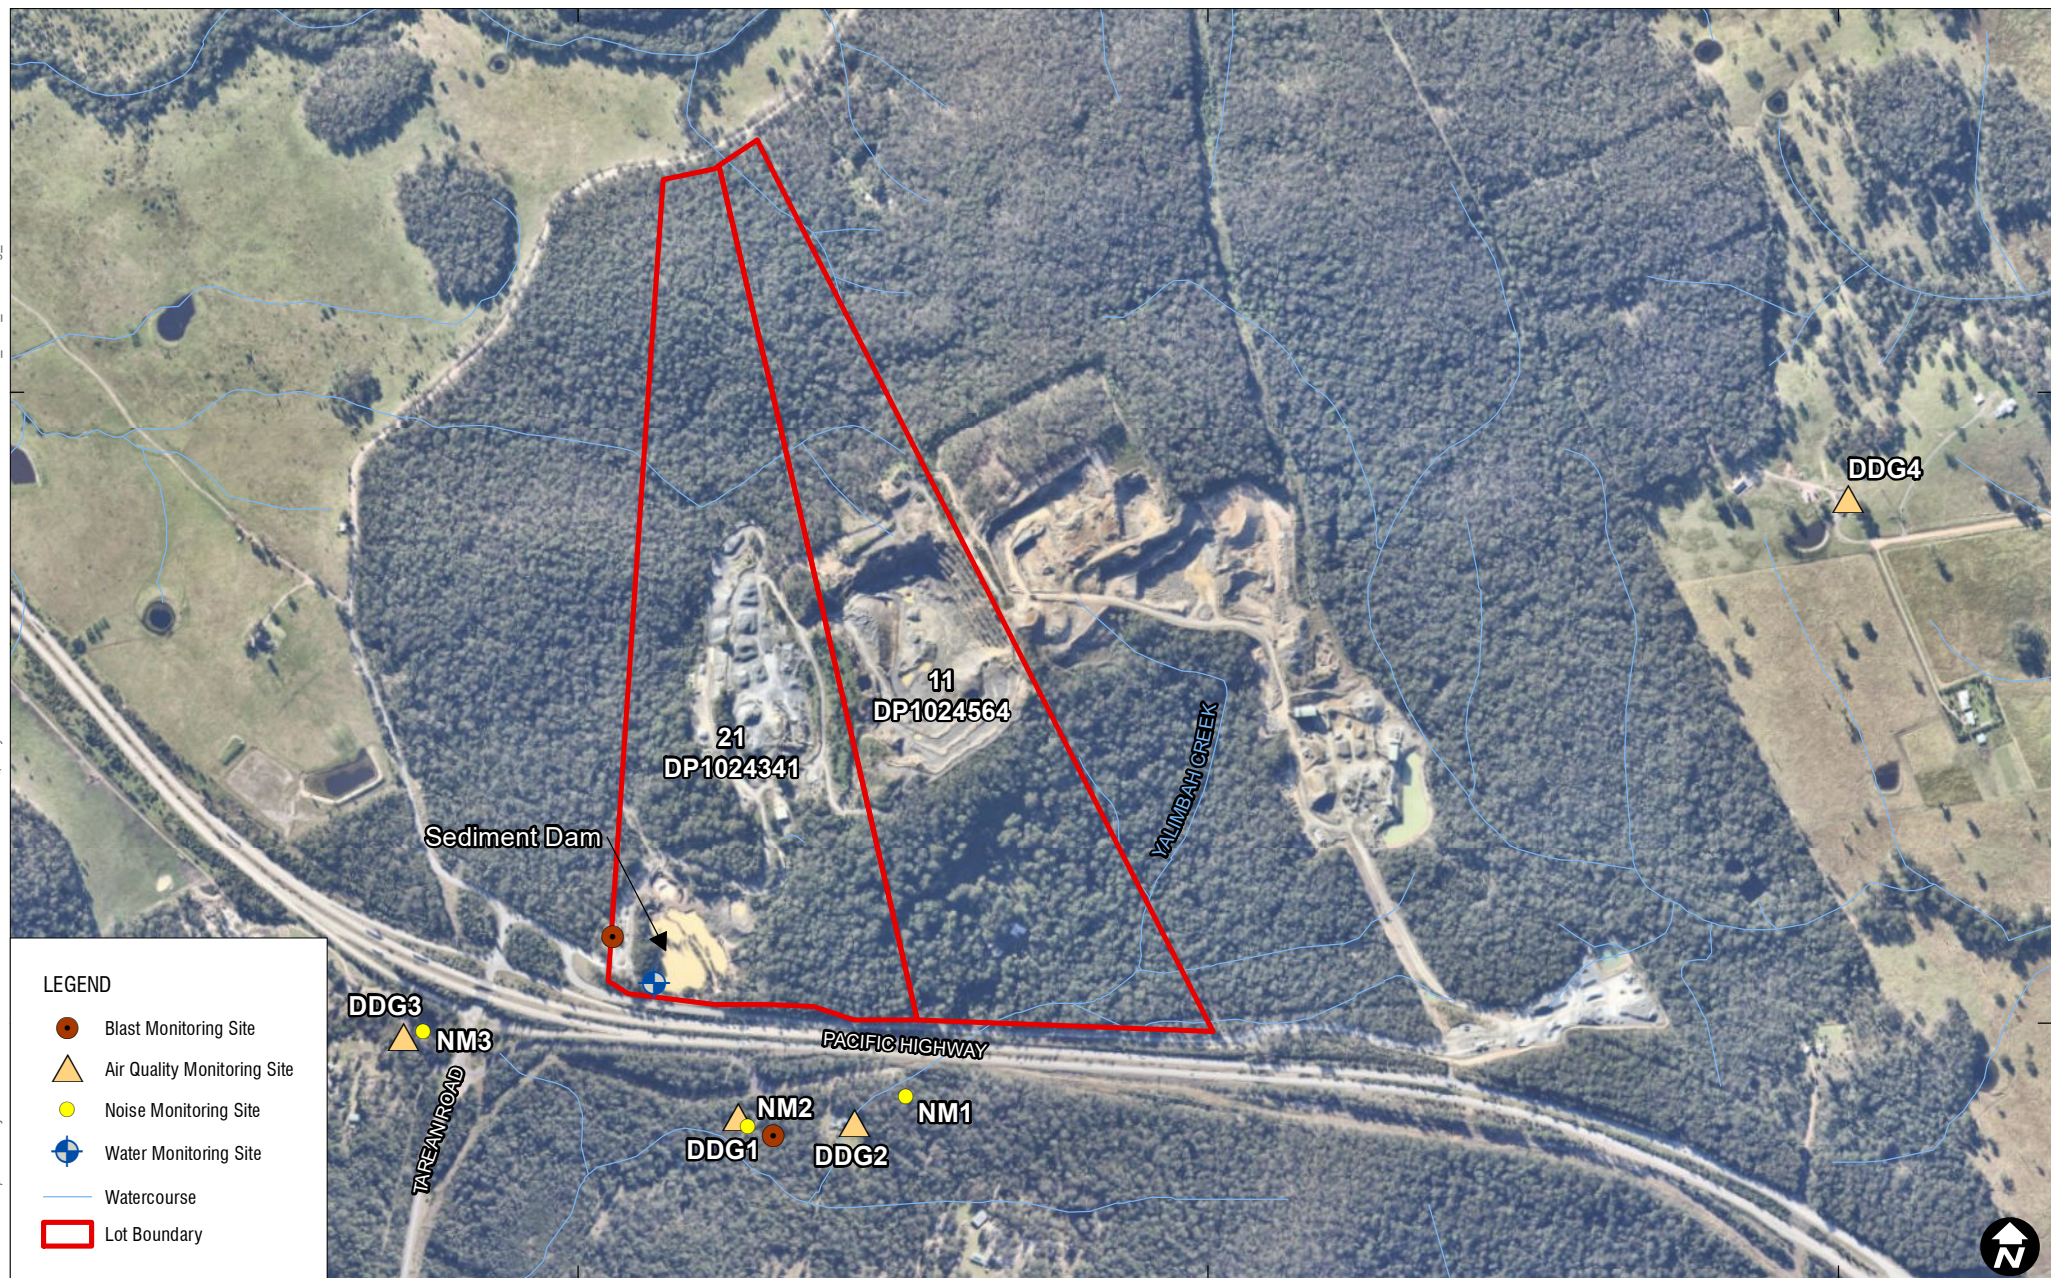
Appendix 1 – Monitoring Location

Monitoring locations are identified in in **Appendix 1**.
