Karuah Hard Rock Quarry

Environmental Monitoring Report:

May 2023

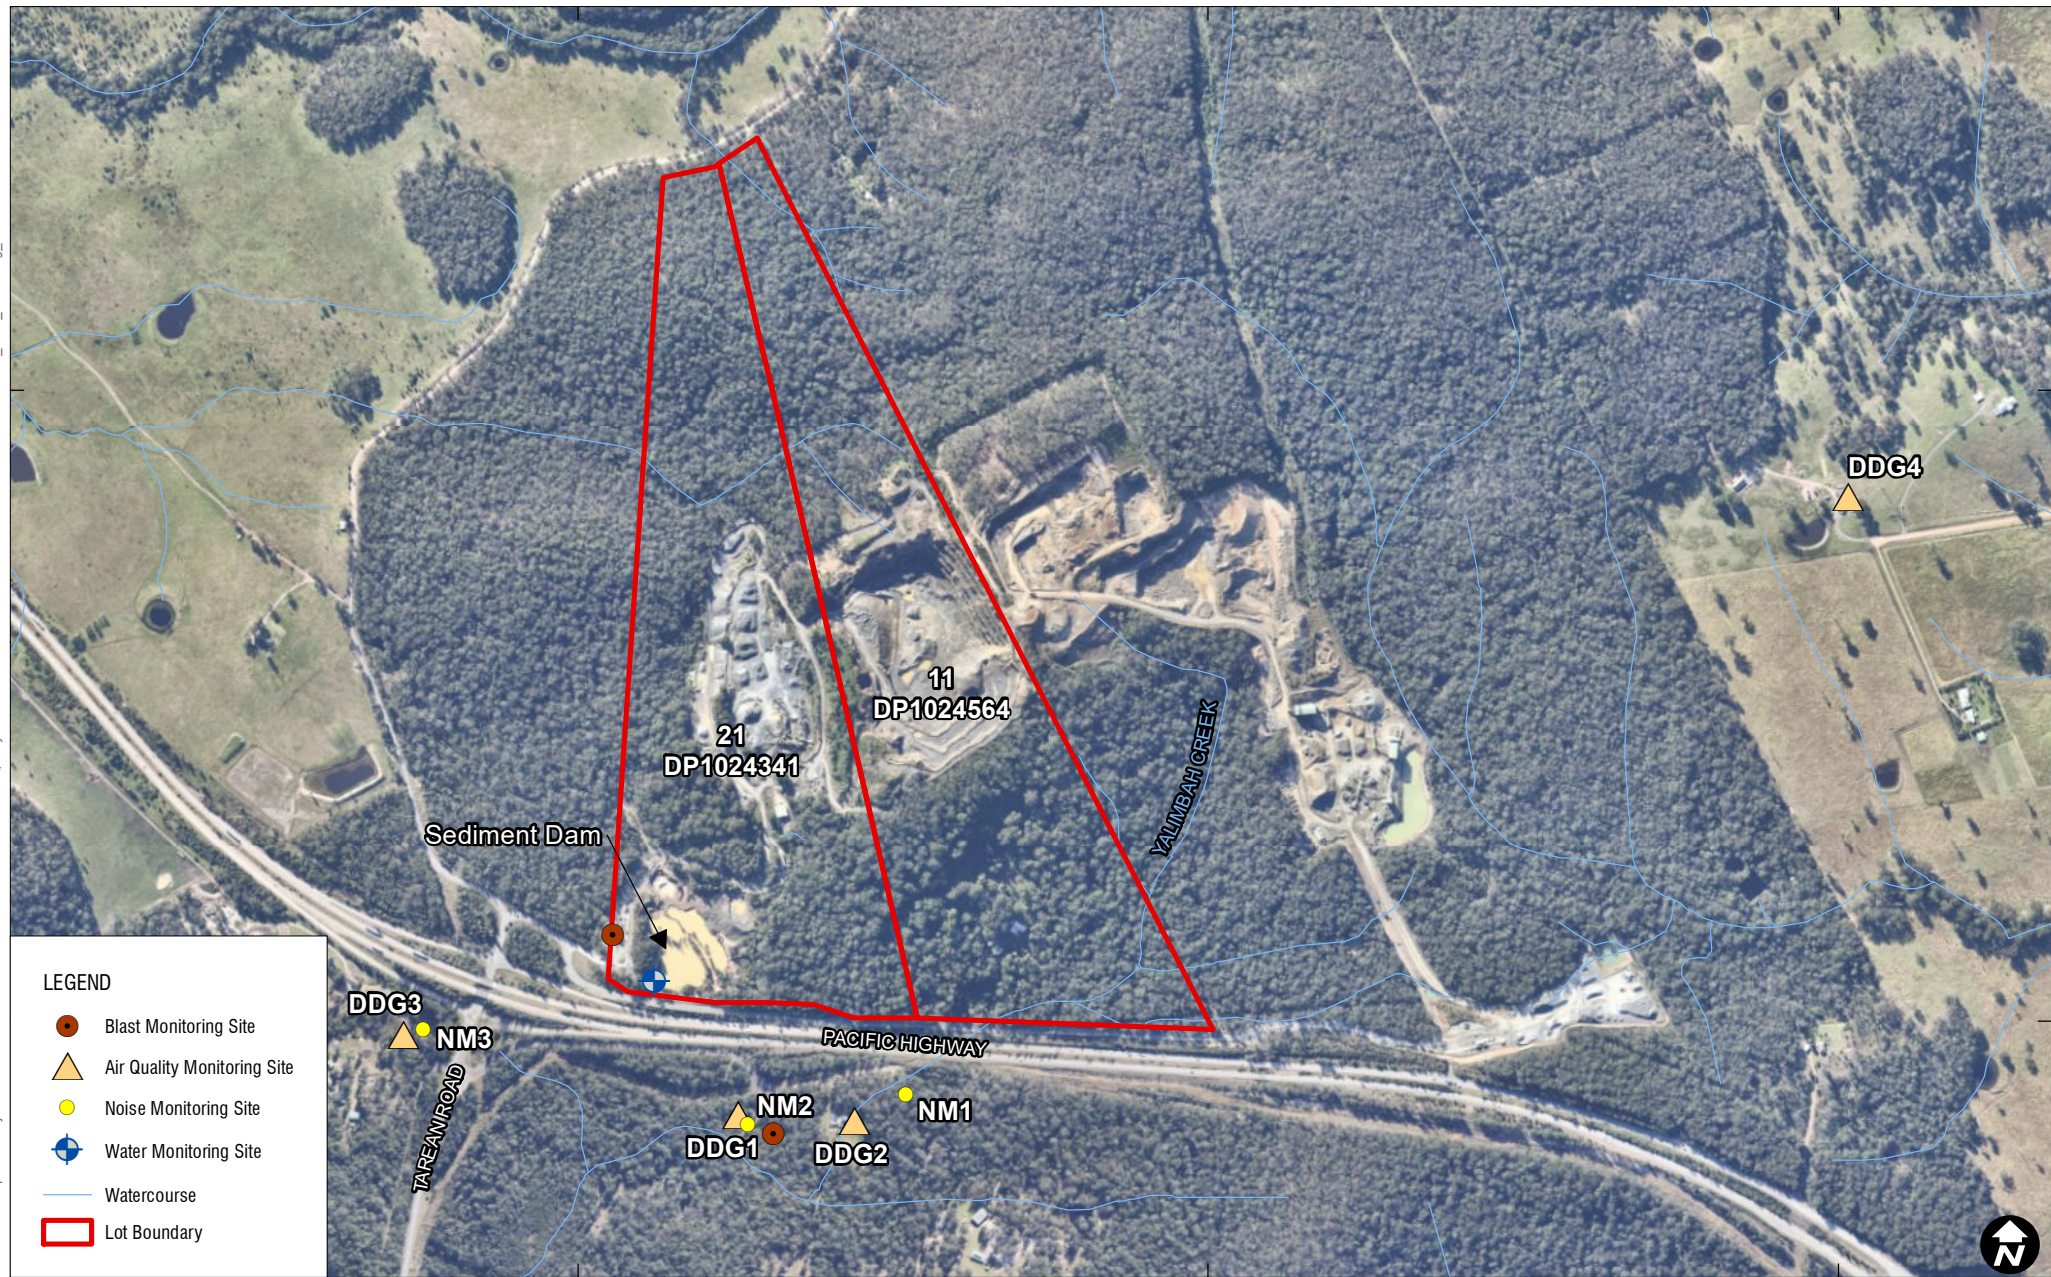
Appendix 1 – Monitoring Location

Monitoring locations are identified in in **Appendix 1**.
