Karuah East Quarry

Environmental Monitoring Report

April 2024

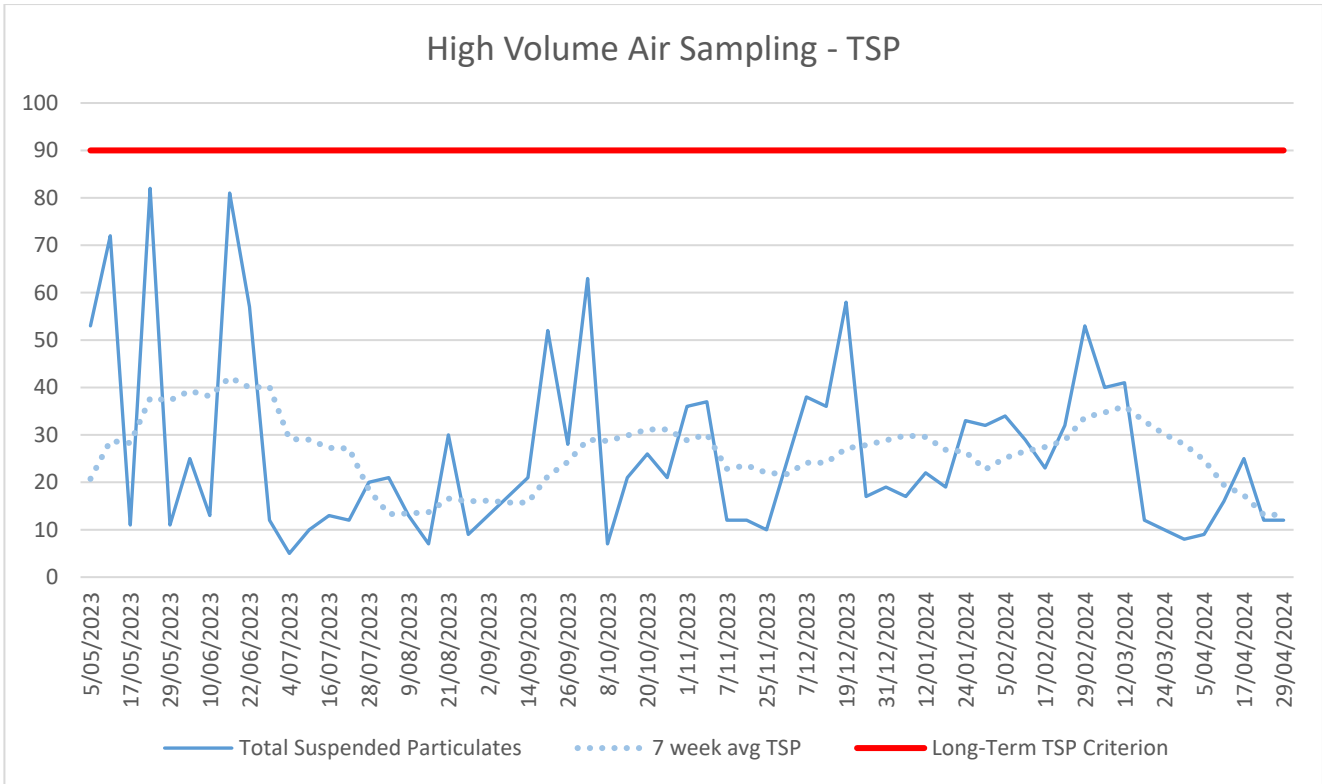
Figure 1 Long-term TSP monitoring trends.

Monitoring results for the five HVAS run days within the Reporting Period were compliant with the long-term limits for TSP and PM10 and short-term limits for PM10.

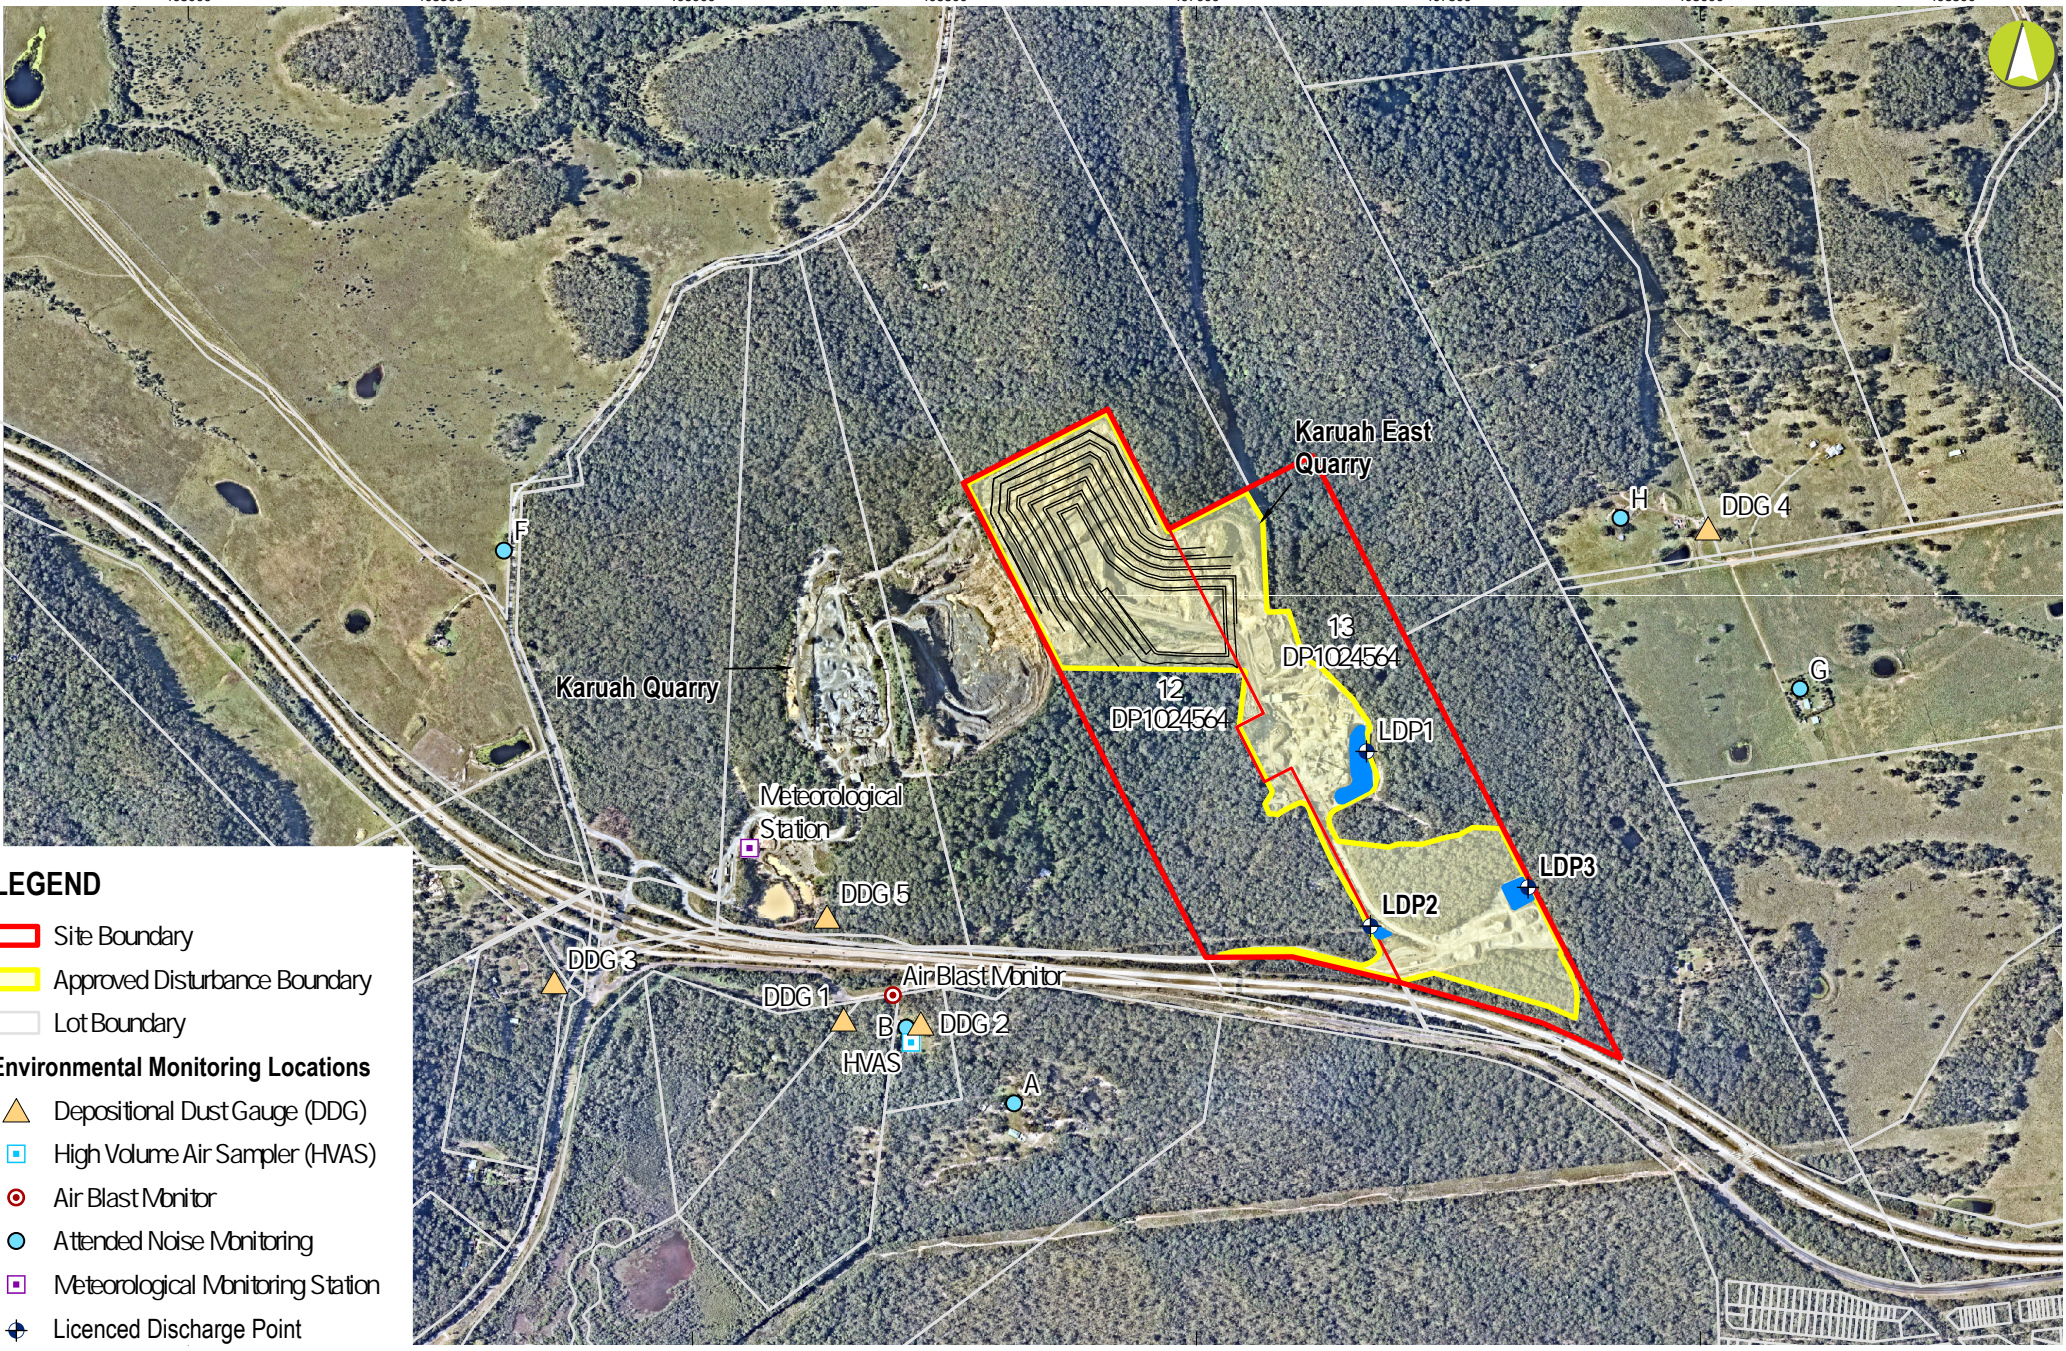
APPENDIX 1 - Environmental Monitoring Locations

Monitoring locations are illustrated by the site plan provided by **Appendix 1**.

Environmental Monitoring Locations

- Depositional Dust Gauge (DDG)
- High Volume Air Sampler (HVAS)
- Air Blast Monitor
- Atended Noise Monitoring
- Meteorological Monitoring Station
- Licenced Discharge Point
