Karuah Hard Rock Quarry

Rehabilitation and Closure Plan

April 2024

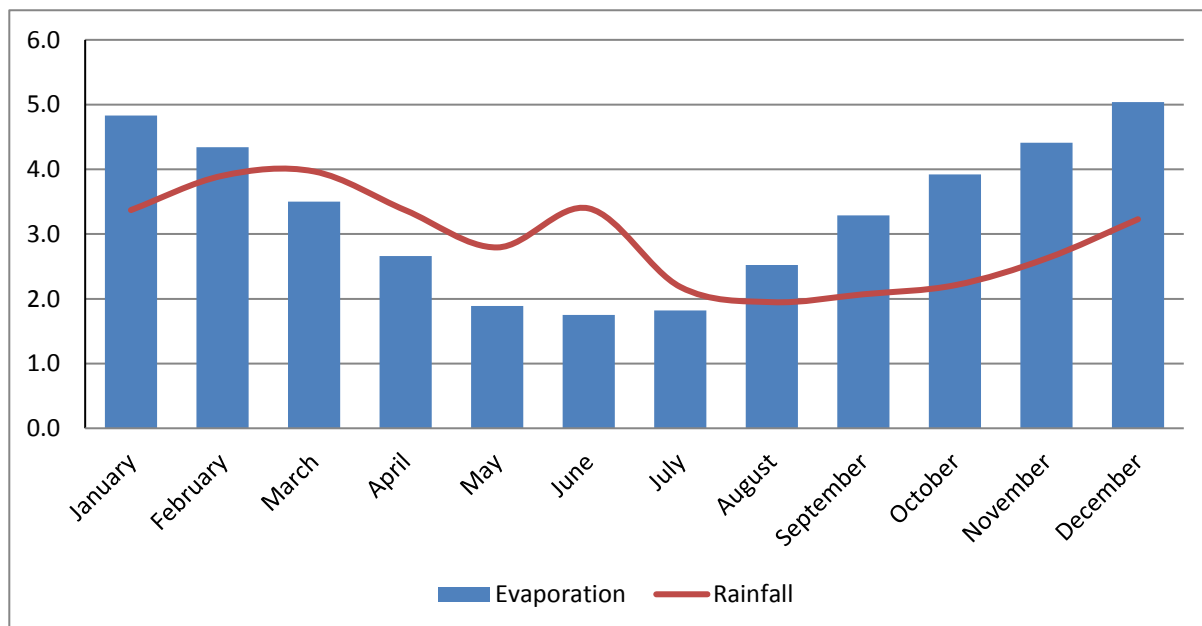
Monthly climate data at the Clarence Town BOM Weather Station is indicated below:

The average annual rainfall is 1067mm. Average annual evaporation is 1753mm. Using a pan coefficient of 0.7 the annual evaporation is reduced to 1217mm.

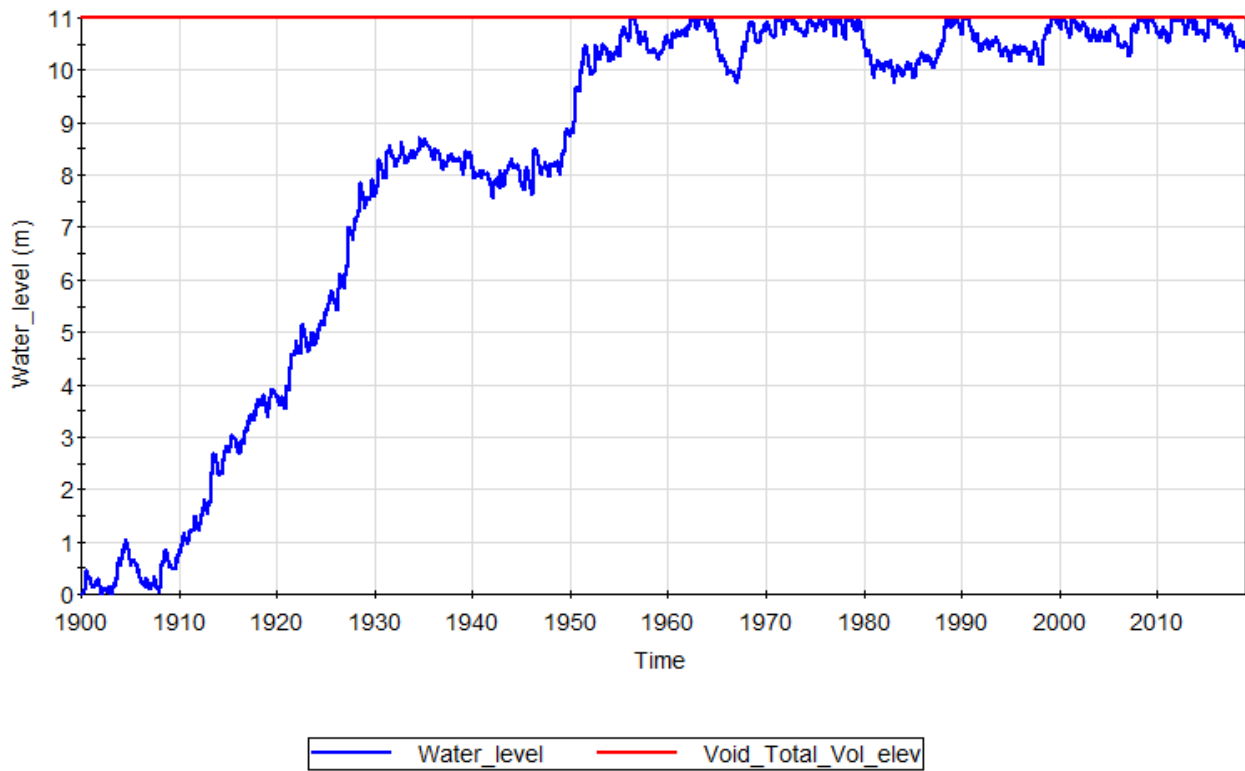
Void_Water_Level_Graph

The x-axis values reflect the period of historical rainfall used in the water balance modelling. Actual rates of water storage filling will of course depend on future rainfall.

It should also be noted that since the average filling rate of the water storage is low, the filling outcome is very sensitive to groundwater leakage. The average filling rate of 13.5ML/year is in the order of 0.4L/s. This means that if the water storage leaks water at an average rate greater than 0.4L/s then it may never fully fill to spillway level.
