Karuah East Quarry

Landscape & Rehabilitation Management Plan

October 2024

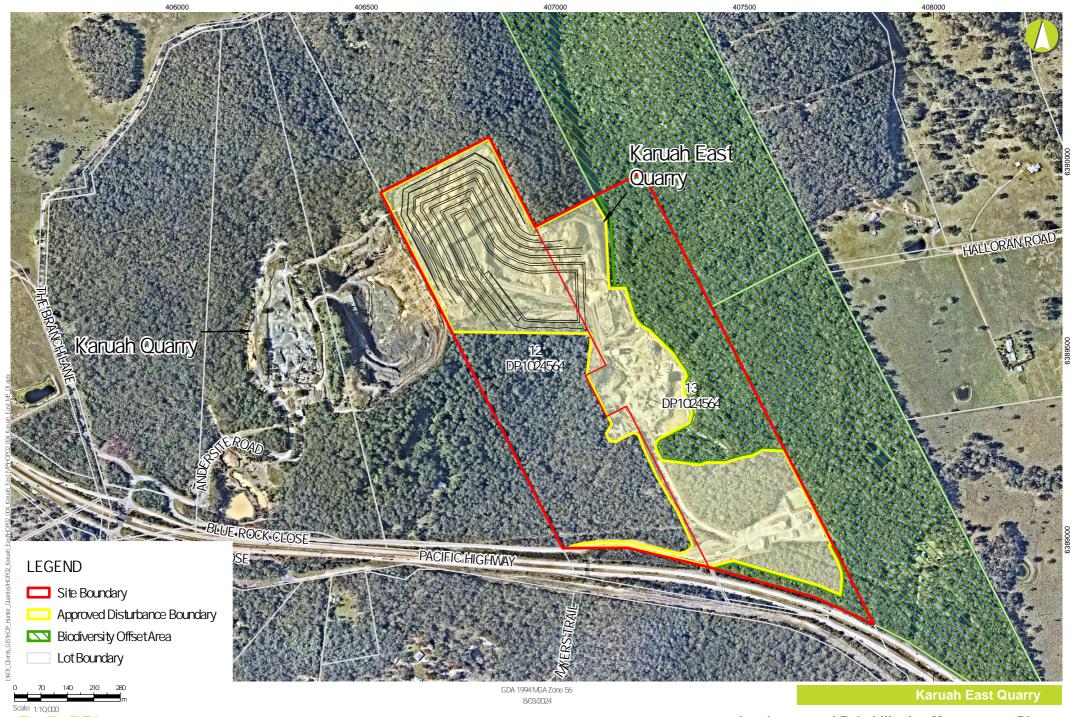
Landscape and Rehabilitation Management Plan FIGURE 2 - Locality Plan

Figure 2 presents the currently approved project site plan and layout.

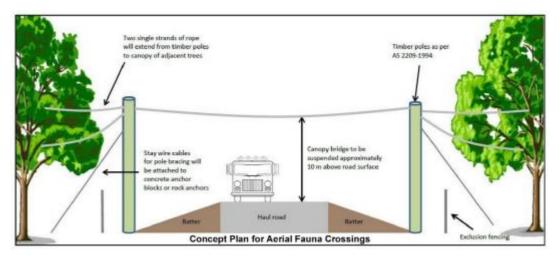
Figure 4 Schematic of Aerial Fauna Crossing and Perimeter Fencing.

The existing fauna crossing of the haul road will be maintained throughout the life of the KEQ, as illustrated by **Figure 4**.

A 12-month monitoring program of the two aerial fauna crossings will be undertaken using remote motion sensing cameras mounted on each pole (four cameras in total) once the crossings have been installed. Data will be collected from the cameras periodically, and the results will be presented in the annual monitoring report. The monitoring will be used to evaluate the effectiveness of the crossings and to inform any modifications or improvements to the crossings.

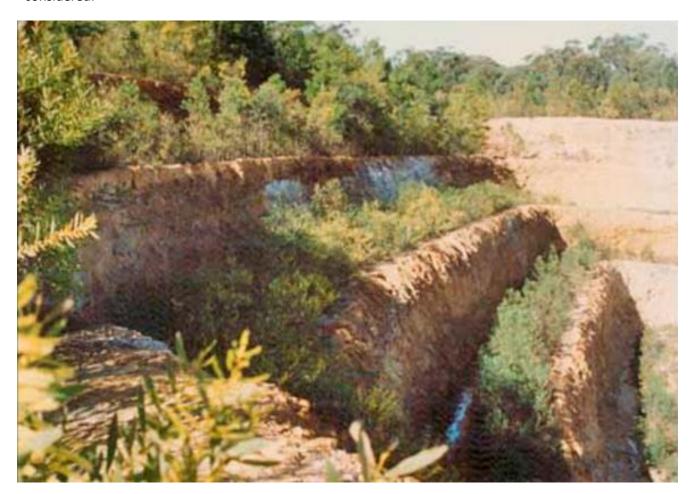
Figure 5 Example of Bench Rehabilitation.

Where benches are not required for future operations (i.e. access or quarrying) then KEQ will rehabilitate the benches where safely possible. Disturbed areas which are no longer required for operational purposes will be progressively rehabilitated.

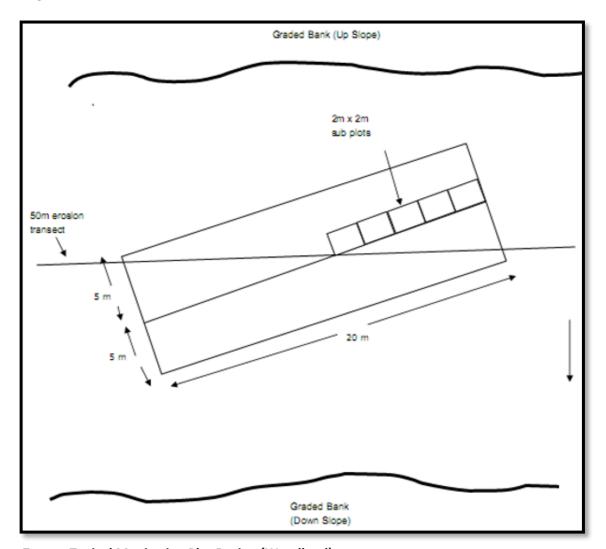
Figure 7 Typical Monitoring Plot Design (Woodland).

- Sites will be monitored 12 months after establishment and then every 2 years.
- A standard monitoring plot design for areas rehabilitated with trees includes:
 - 2 m x 2 m quadrates these will provide some estimate of statistical variance, so that if required, statistical analyses can be undertaken to objectively compare different rehabilitation treatments and changes over time;
 - o a 20 m x 10 m plot overlying the 2 m quadrats and located 5 m either side of the centerline, for ease of monitoring; and
 - o a 50 m erosion monitoring transect on contour, running through the centre of the plot.

Figure 7 illustrates the typical woodland monitoring plot design that is to be adopted for the monitoring an area revegetated with trees.
