Karuah Hard Rock Quarry

Rehabilitation and Closure Plan

March 2025

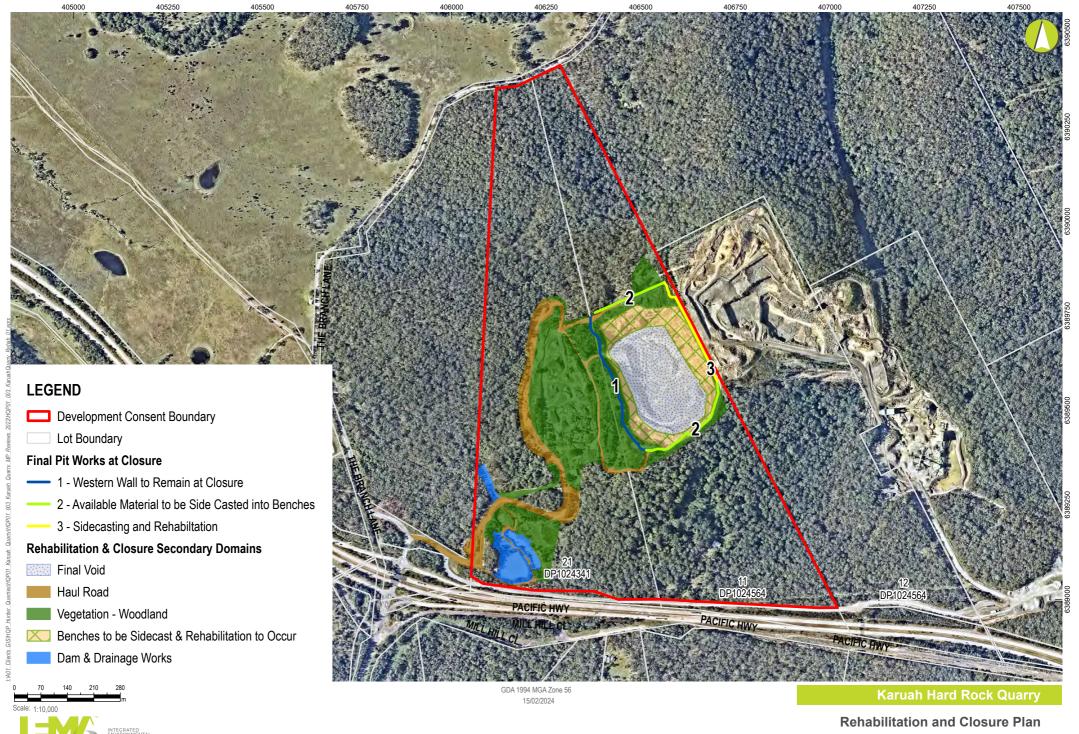
FIGURE 3 - Final Rehabilitation

Final closure land-use domains are illustrated by Figure 3 and include the following units:

- Woodland Rehabilitation woodland rehabilitation will be undertaken across the existing building and infrastructure area, Stage 1 Quarry Operations Area, Stage 2 Extraction Area (excluding final void and perimeter benches), and the Karuah Red Quarry (excluding Sediment Dam 2).
- Benches side-casting will be undertaken across the perimeter of the quarry void.
- Final Void final land-use of the void will be a water storage.
- Haul Roads haul roads to remain for firefighting access and monitoring inspections.
- Dam Sediment Dams that are to remain after quarry operations cease will be reviewed and if necessary reshaped prior to quarry decommissioning to ensure they are safe, stable, and non – polluting and that they also provide safe access for native fauna and to satisfy public safety requirements.

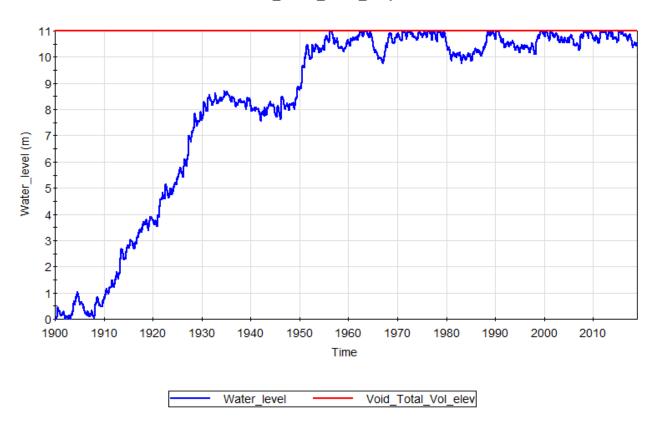
Void_Water_Level_Graph

- Spillway level Water balance modelling was carried out with a spillway level at RL76. It is noted that selection of the final spillway level will be subject to detailed design.

It should also be noted that since the average filling rate of the water storage is low, the filling outcome is very sensitive to groundwater leakage. The average filling rate of 13.5ML/year is in the order of 0.4L/s. This means that if the water storage leaks water at an average rate greater than 0.4L/s then it may never fully fill to spillway level.
