# Tea Gardens Quarry

# **Environmental Monitoring Report**

May 2025

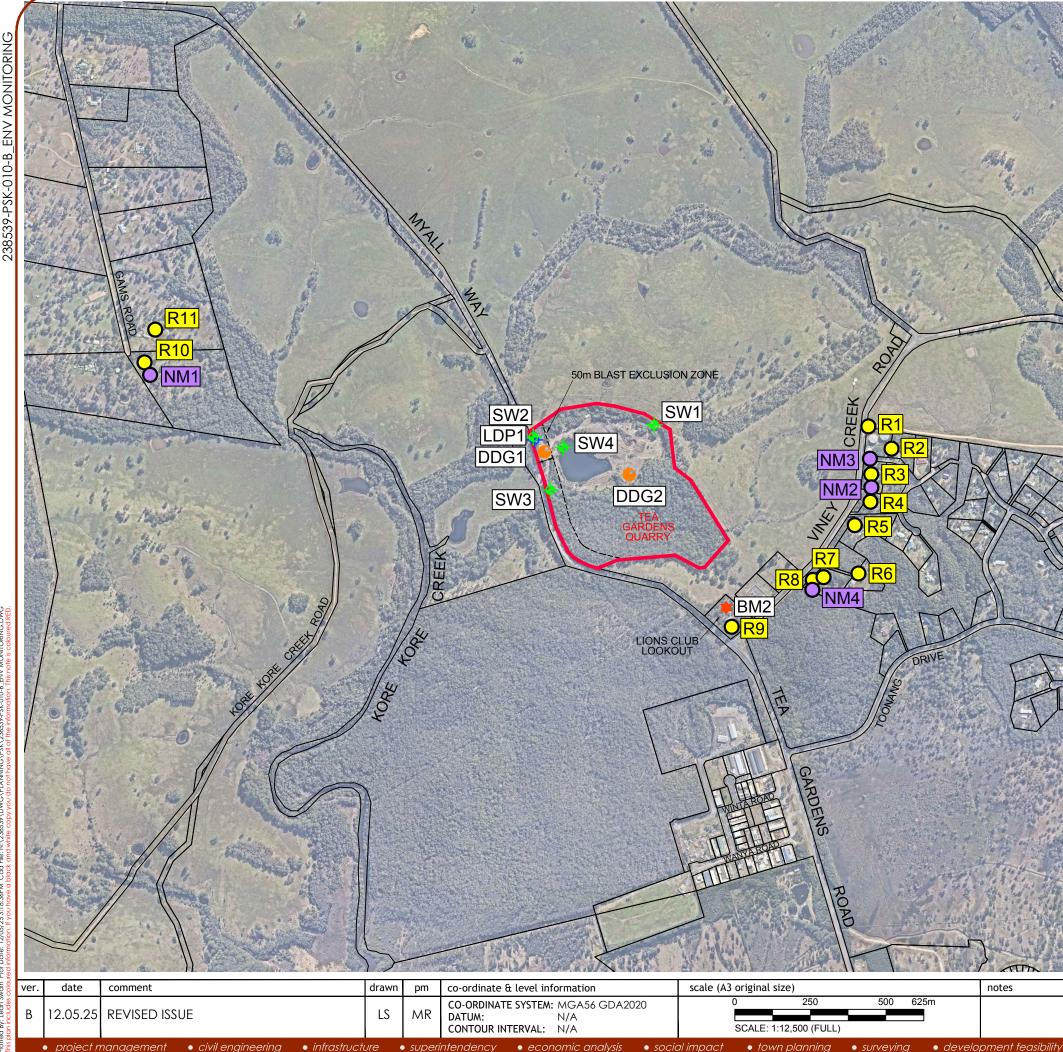
## Appendix 1 – EPL 12133 Monitoring Locations

Monitoring locations are illustrated by the site plan provided by Appendix 1.

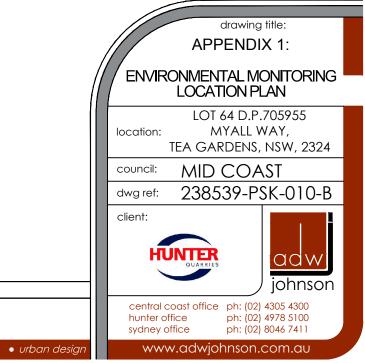
+SW1	
<b>#</b> BM1	
↓LDP1	
ONM1	
OR9	
DDG1	l

TEA GARDENS QUARRY SURFACE WATER MONITORING POINT BLAST MONITORING LOCATION LICENCED DISCHARGE POINT NOISE MONITORING LOCATION SENSITIVE RECEIVER LOCATIONS DUST MONITORING LOCATION 50m BLAST EXCLUSION ZONE
