Karuah Hard Rock Quarry

Environmental Monitoring Report:

October 2022

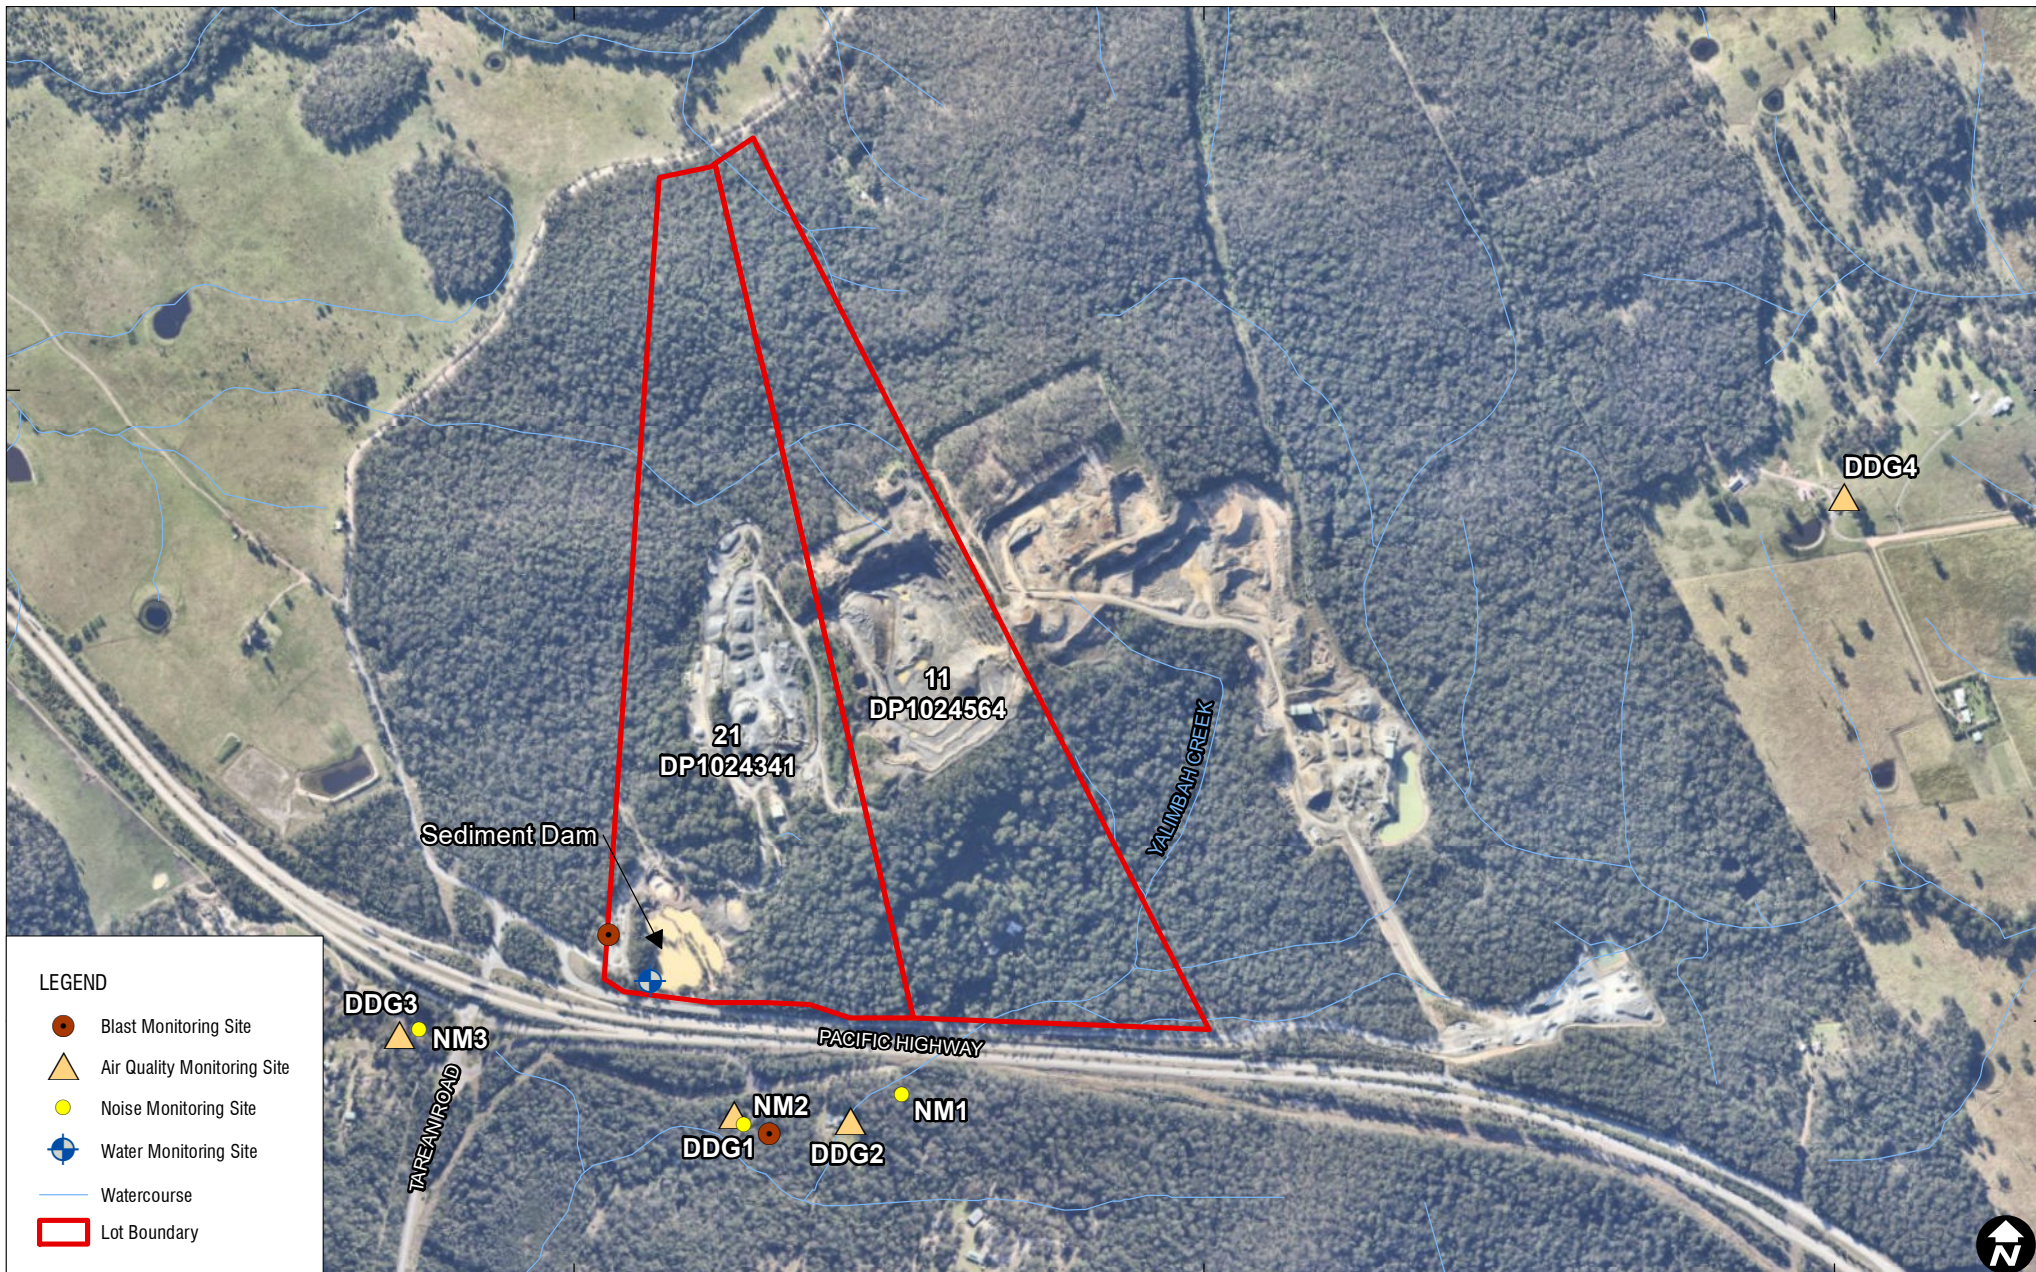
Appendix 1 – Monitoring Location

Monitoring locations are identified in in Appendix 1.
