## **Karuah Hard Rock Quarry**

### **Environmental Monitoring Report:**

**March 2021**

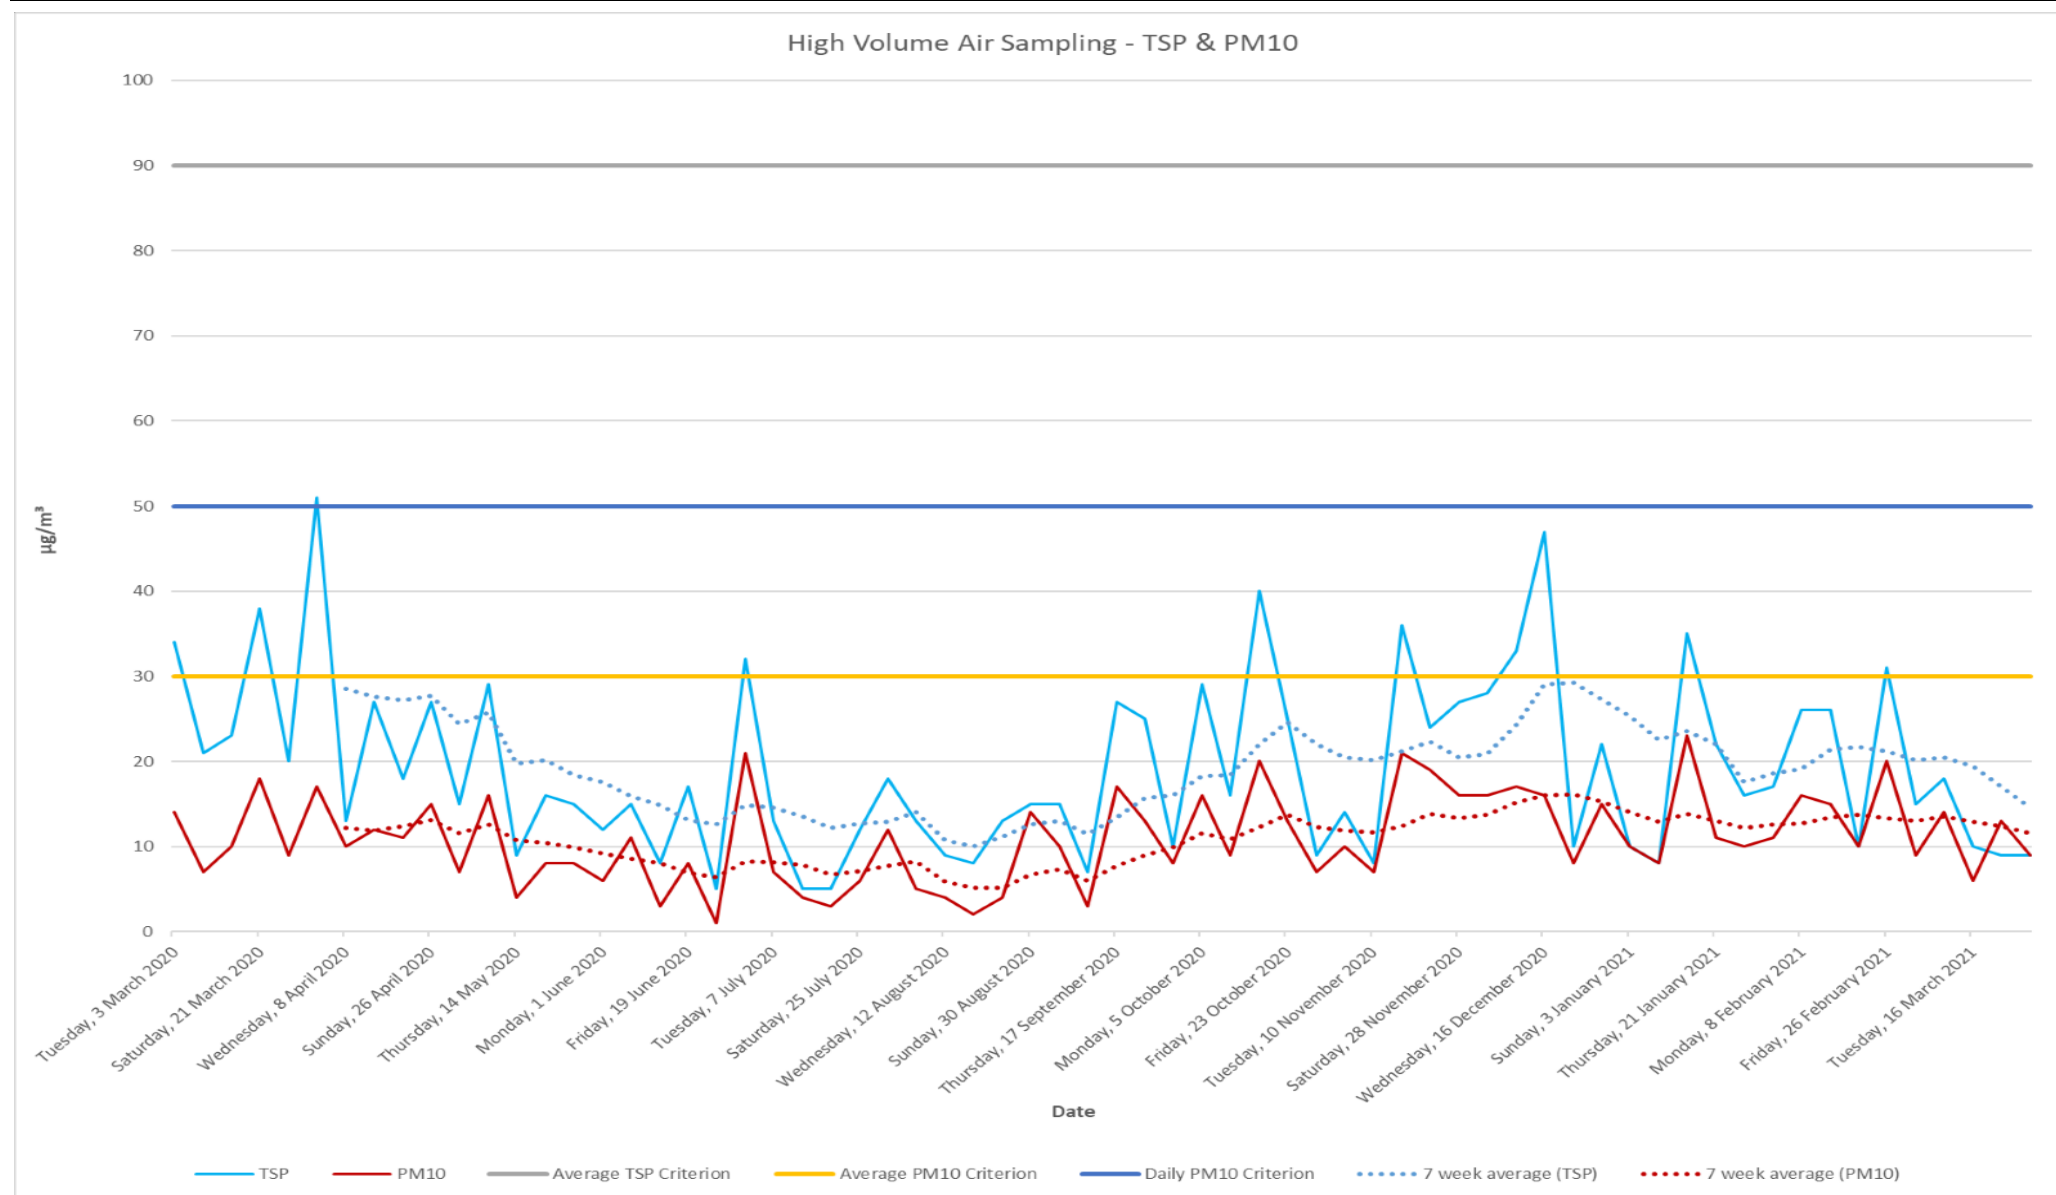
Figure 1 High Volume Air Sampling: Year-to-date results

The TSP and PM<sub>10</sub> results for March 2021, the report average and a rolling annual average are shown in are shown in Table 8. Figure 1 illustrates the year-to-date results for HVAS monitoring.

All HVAS monitoring results, to the end of March 2021 were compliant with the long term and short term impact assessment criteria outlined in *Schedule 3 Condition 13* of the Consent (see Table 3, Table 4 and Table 5).

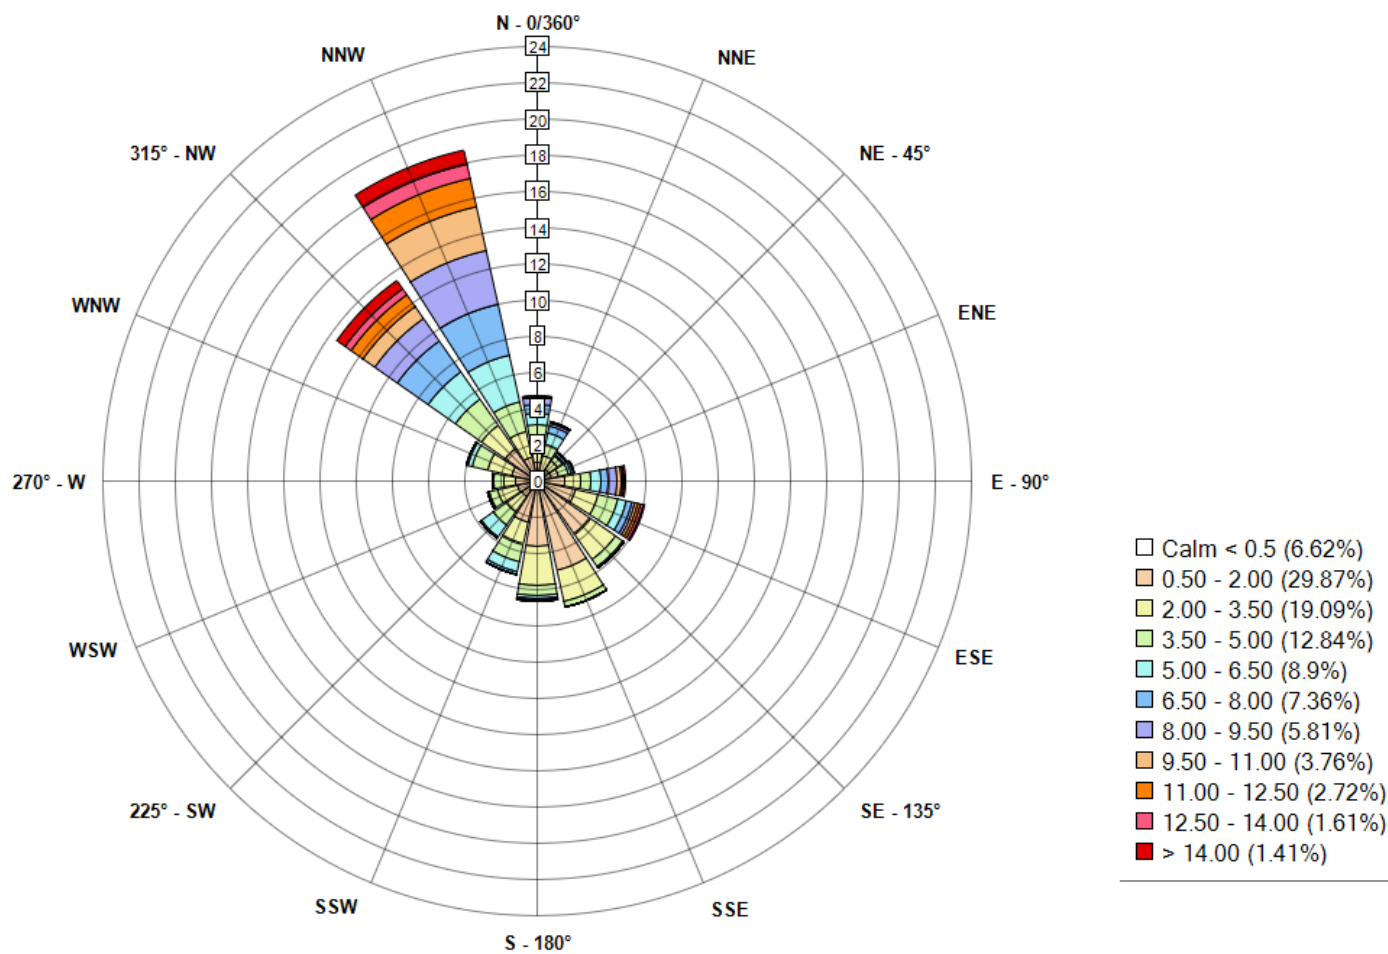
Figure 3 Wind rose March 2021

A wind rose is a graphic tool used to depict the average direction and speed of the wind over a recorded period. Figure 3 shows the wind rose generated from data gathered during March 2021.

### Wind Rose Report for: Karuah East - 15 Min Data

VWDIR Vector Wind Dir and VWSP Vector Wind Spd in km/h

Period: 2021-03-01 00:00 to 2021-03-31 23:59

Direction the Wind is Blowing To
