Karuah East Quarry Biodiversity Offset Area Monitoring Report

Karuah East Quarry Biodiversity Offset Area and Lot 12

**Report prepared for:
Hunter Quarries**

Rev 2
23 March 2023

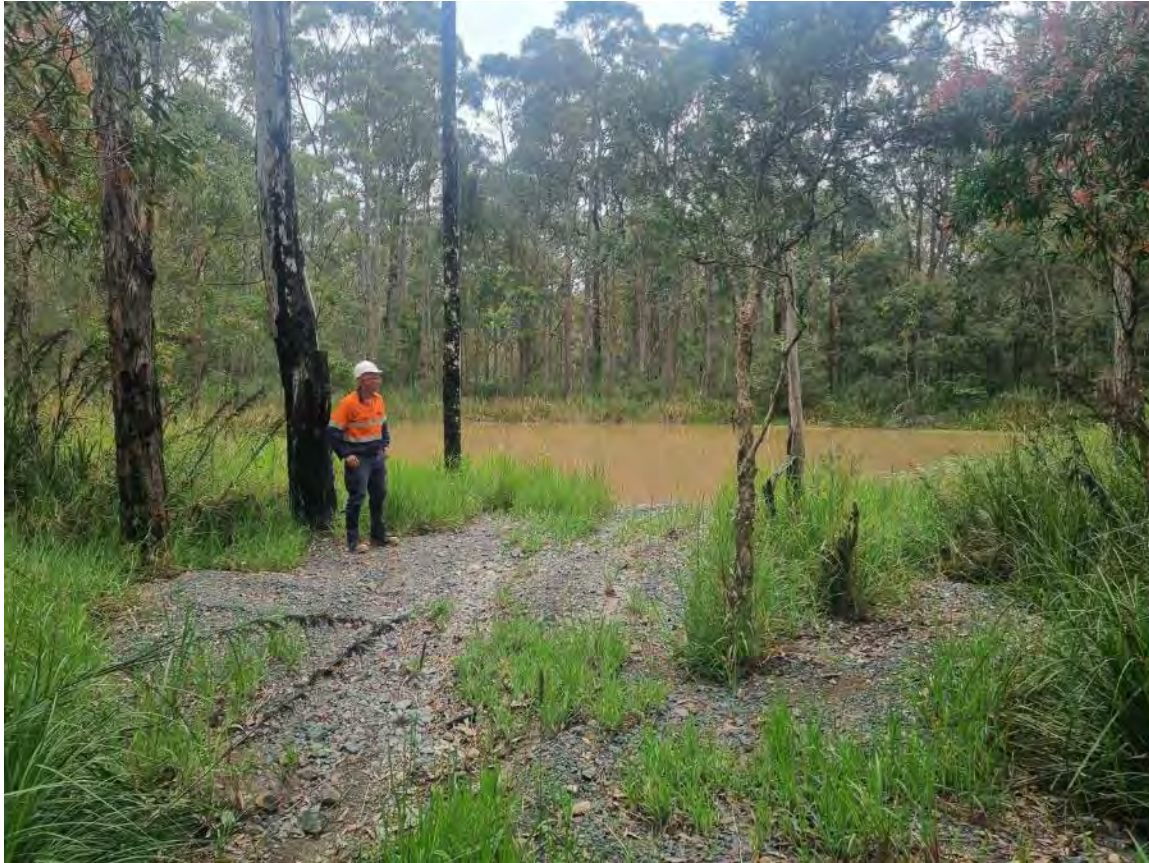
- Evidence of sedimentation and erosion has been observed in a few locations around the extent of the quarry along the south eastern edge of the extraction area and along the western side of the haul road into the Karuah Quarries Conservation Area (**Photo 2**).

Photo 2: Sedimentation and Erosion into the Karuah Quarry Conservation Area into Dam.

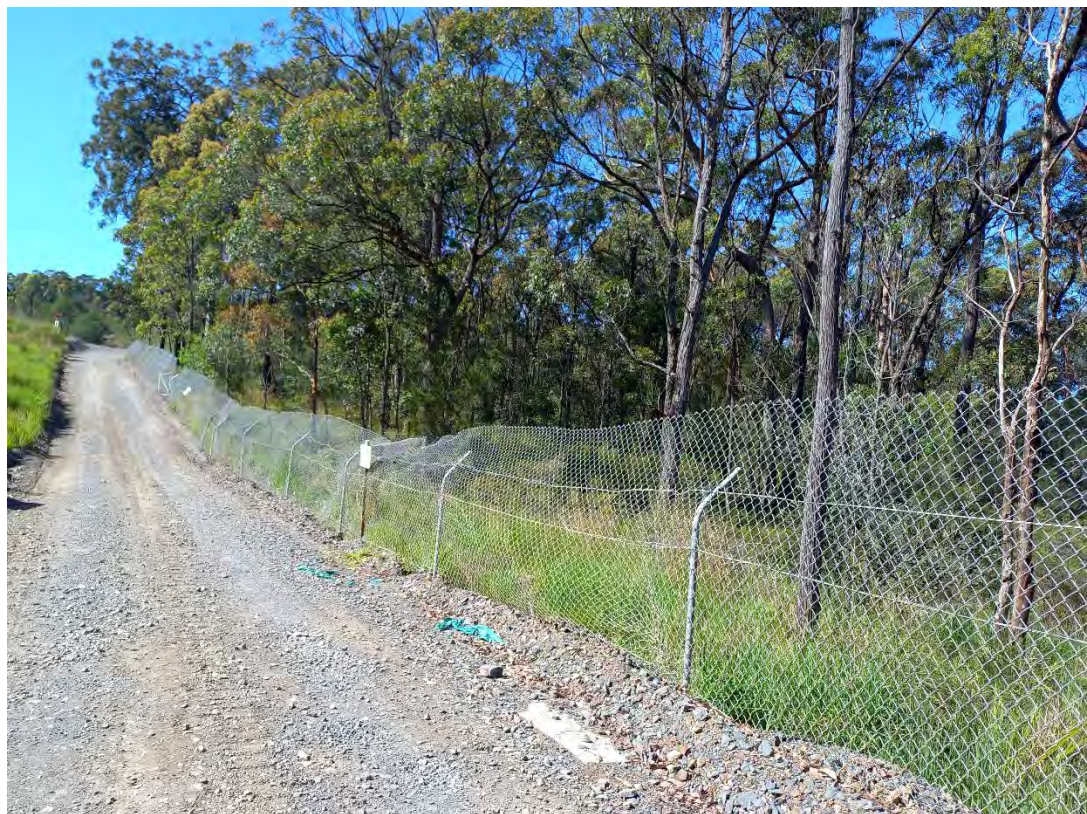
Photo 4: Fixed fence along western boundary of haul road

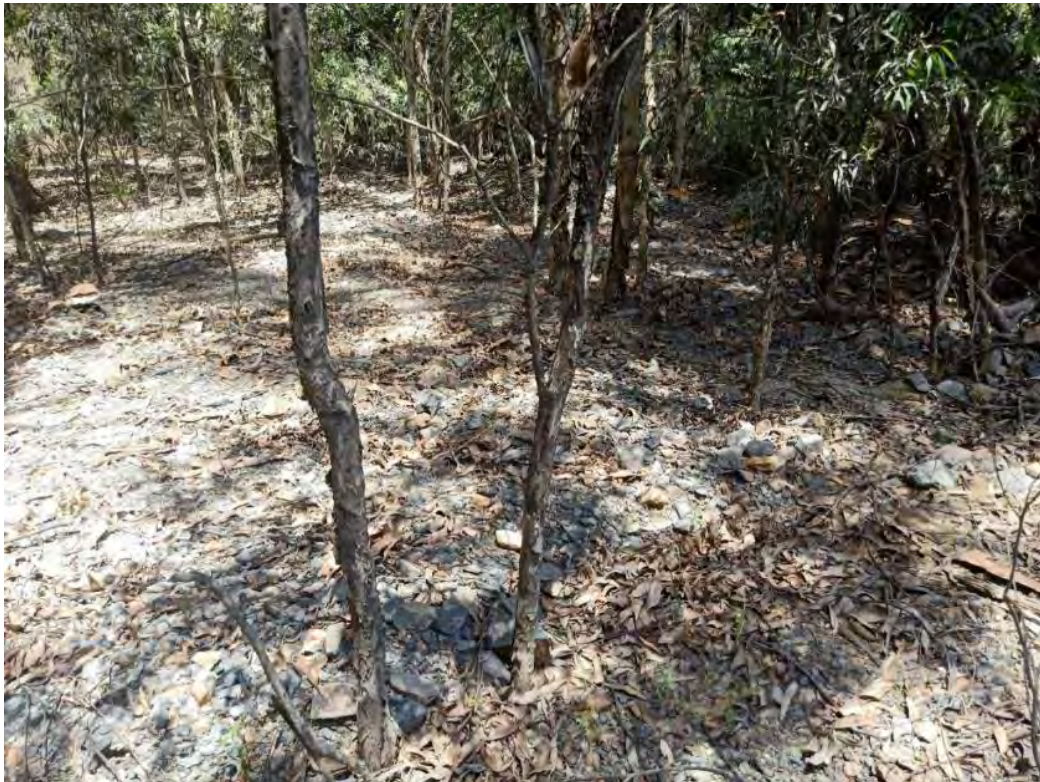
Photo 7: Excavated rock and sediment that has runoff from the eastern boundary of the quarry into the BOA.

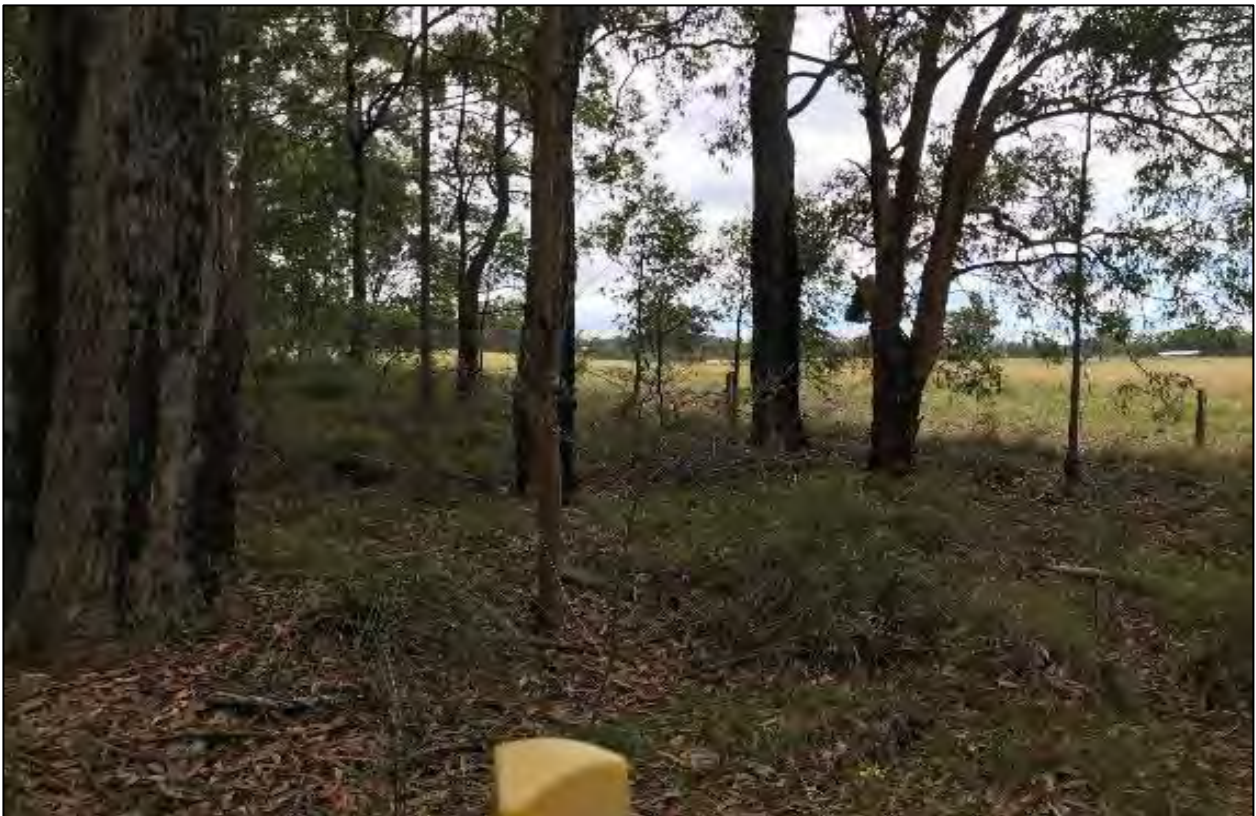
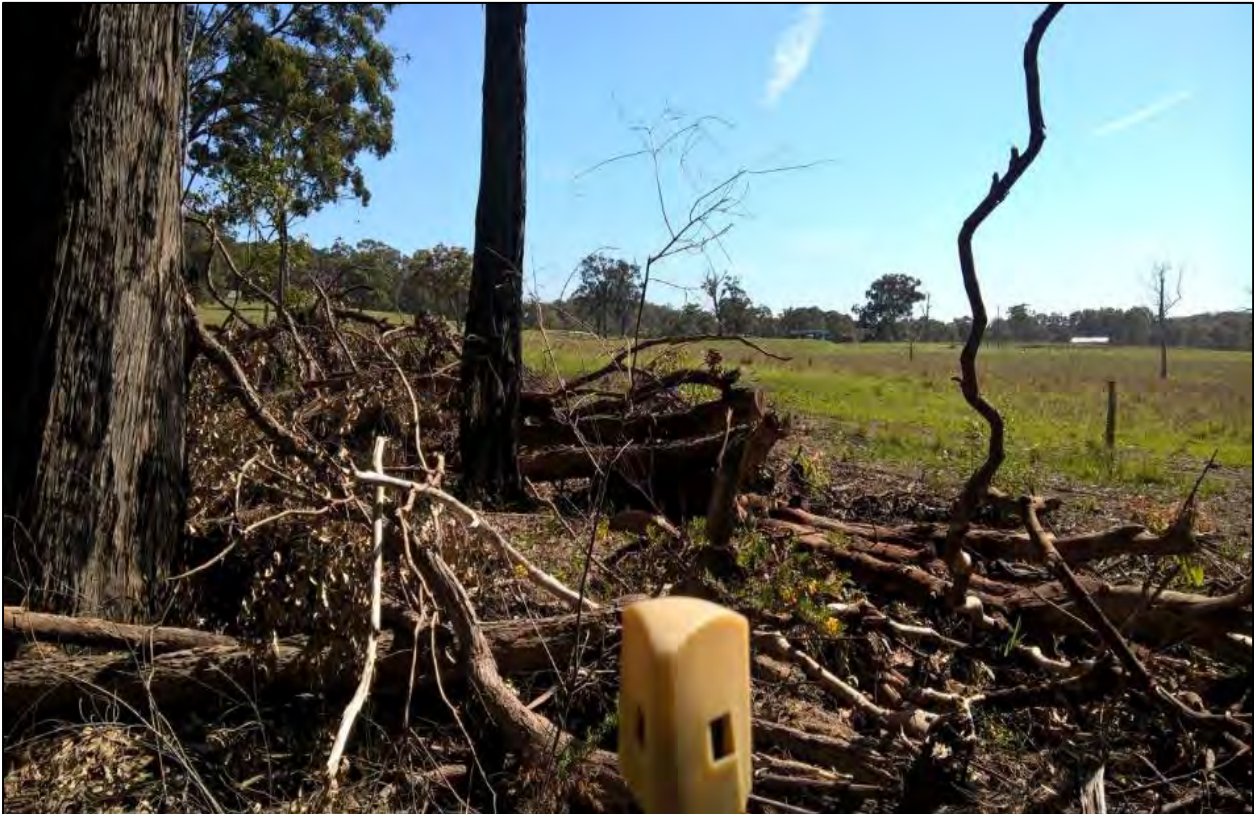
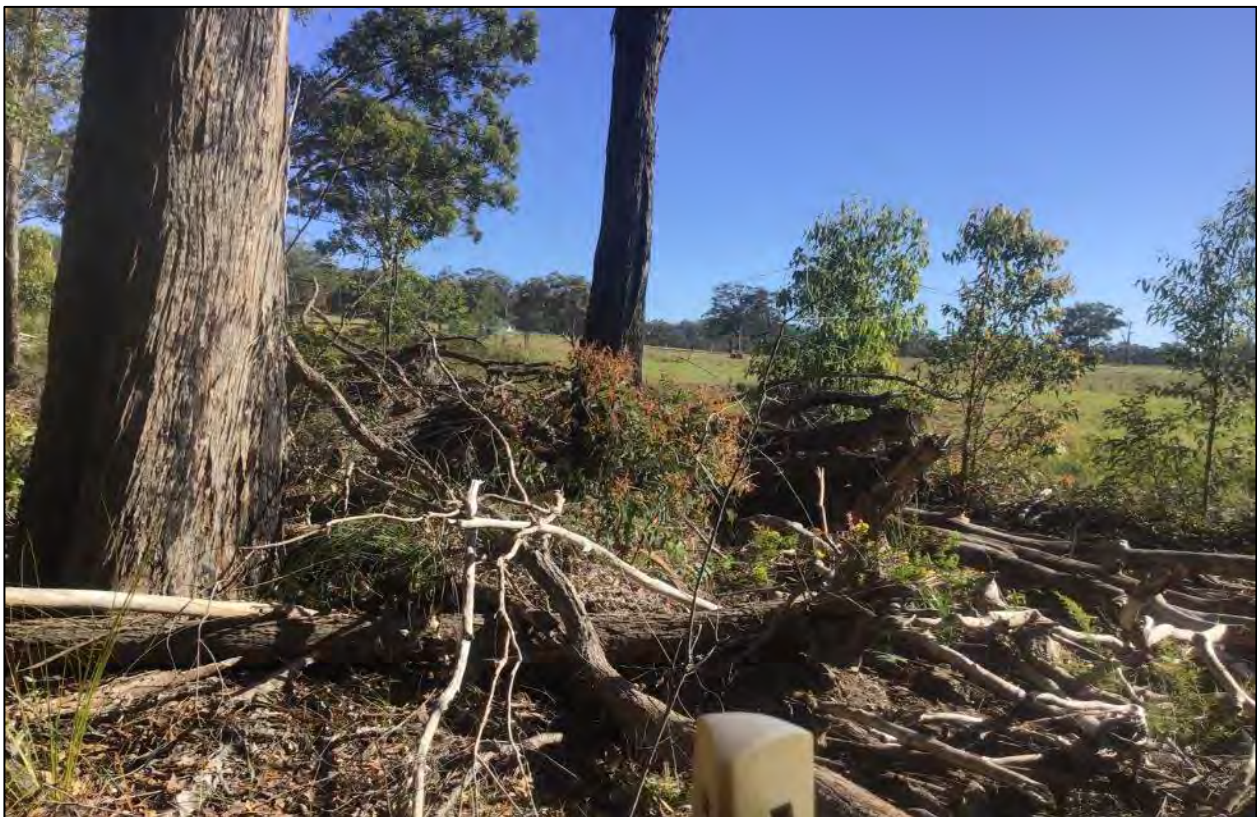
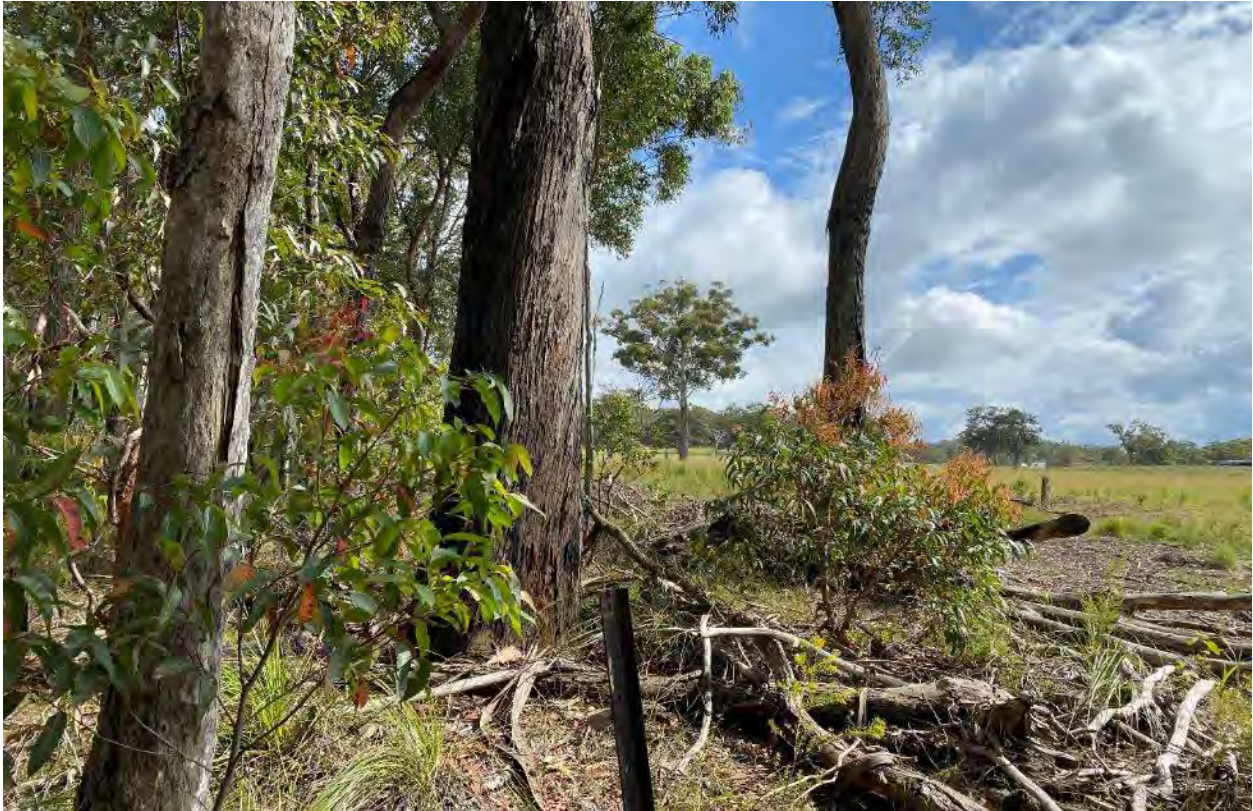
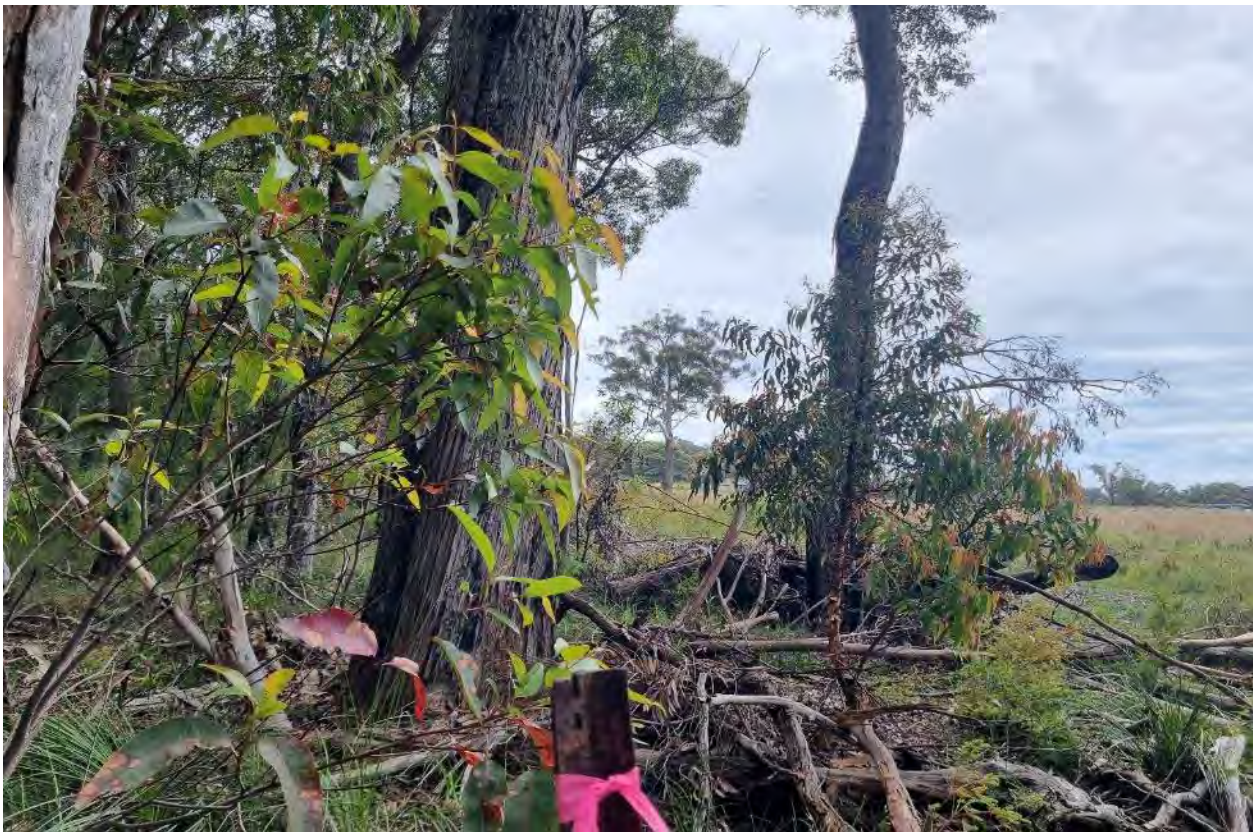
Site	Vegetation Community	Vegetation and Habitat Condition	Evidence of Disturbance	Threatened Flora Monitoring
MP12	Smooth-barked Apple – Red Bloodwood open forest	<ul style="list-style-type: none"> Midstorey reduced compared to surroundings. Very high levels of fallen timber (from clearing). Moderate ground cover. Evidence of regeneration in understorey and midstorey. <p>Conclusion: Felled timber remains (from previous impact due to fence maintenance), however, no significant changes have occurred to vegetation and habitat condition since the previous survey (2021).</p>	<ul style="list-style-type: none"> No evidence of erosion and sedimentation. No recent evidence of disturbance from pest animals, rubbish dumping, rock / timber removal or dust, however area has been previously subject to clearing due to fence line maintenance. No signs of recent fire. Clearing and log stockpiling in order to maintain an adjacent access track has impacted some of the vegetation including at least three <i>Grevillea parviflora</i> individuals. <p>Conclusion: Excluding the maintenance of an adjacent accessway, no evidence of new disturbance was observed since the previous survey (2021).</p>	<ul style="list-style-type: none"> There was a same number of <i>Grevillea parviflora</i> subsp. <i>parviflora</i> plants recorded within the monitoring site, 2021 to 2022 (7). All <i>Grevillea parviflora</i> subsp. <i>parviflora</i> plants within the monitoring site were observed to be in healthy condition. Five <i>Grevillea parviflora</i> subsp. <i>parviflora</i> plants were recorded with flowers in 2022 with one individual fruting. The <i>Grevillea parviflora</i> subsp. <i>parviflora</i> population at MP 11 remains stable with surveys completed in 2015 (seven individuals recorded).

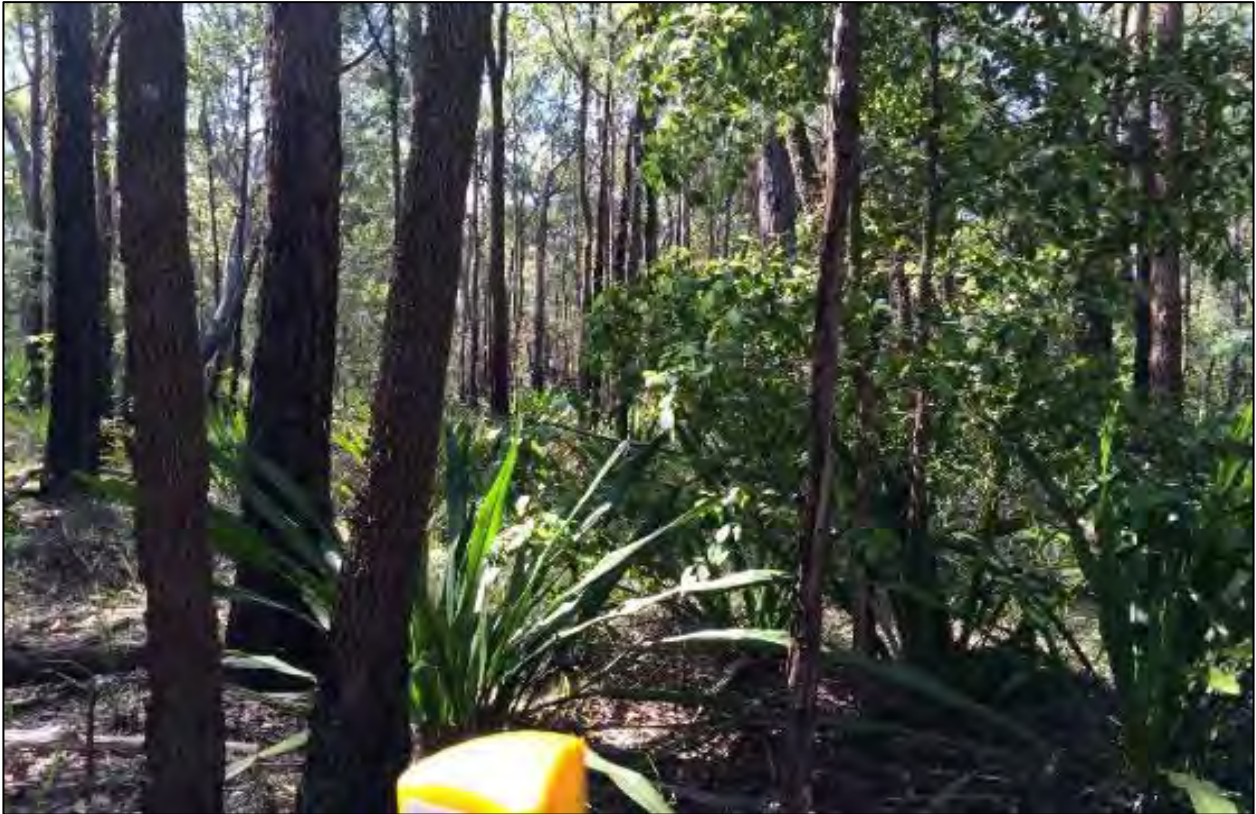
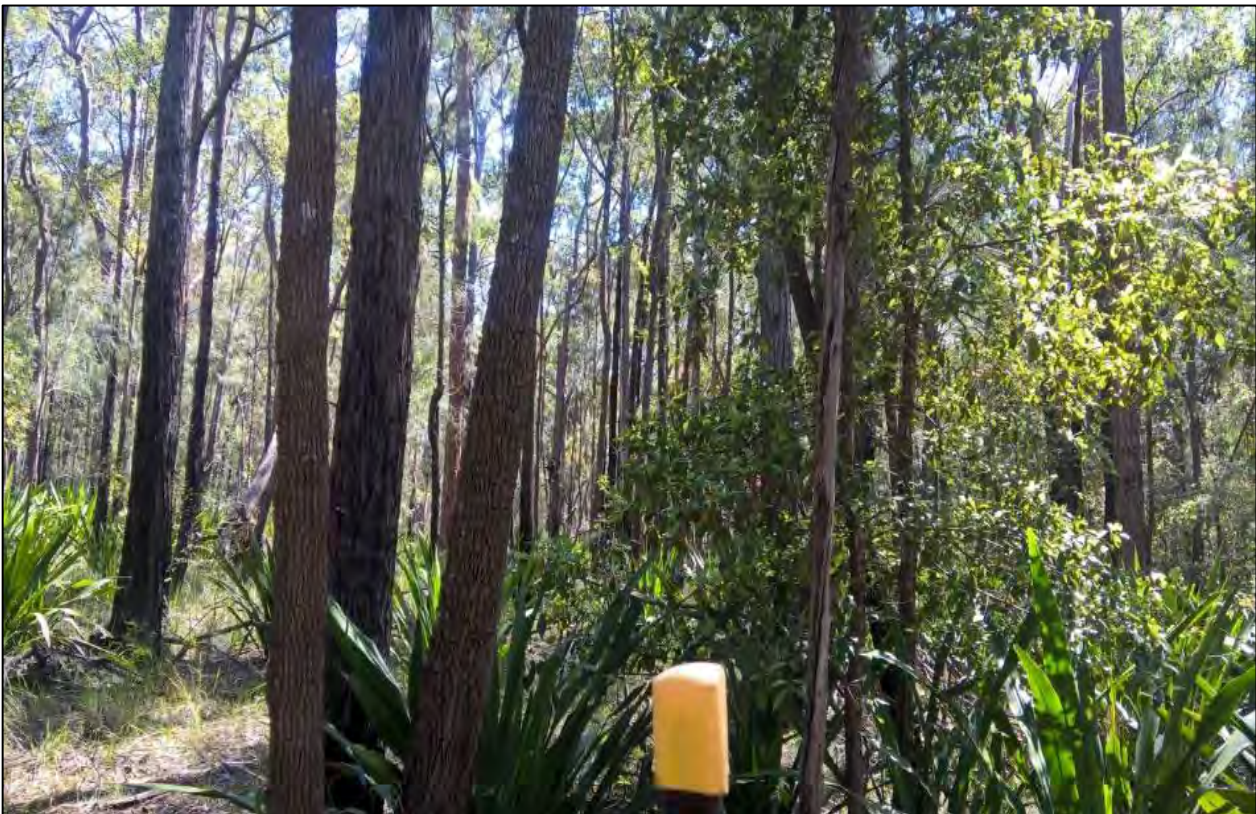
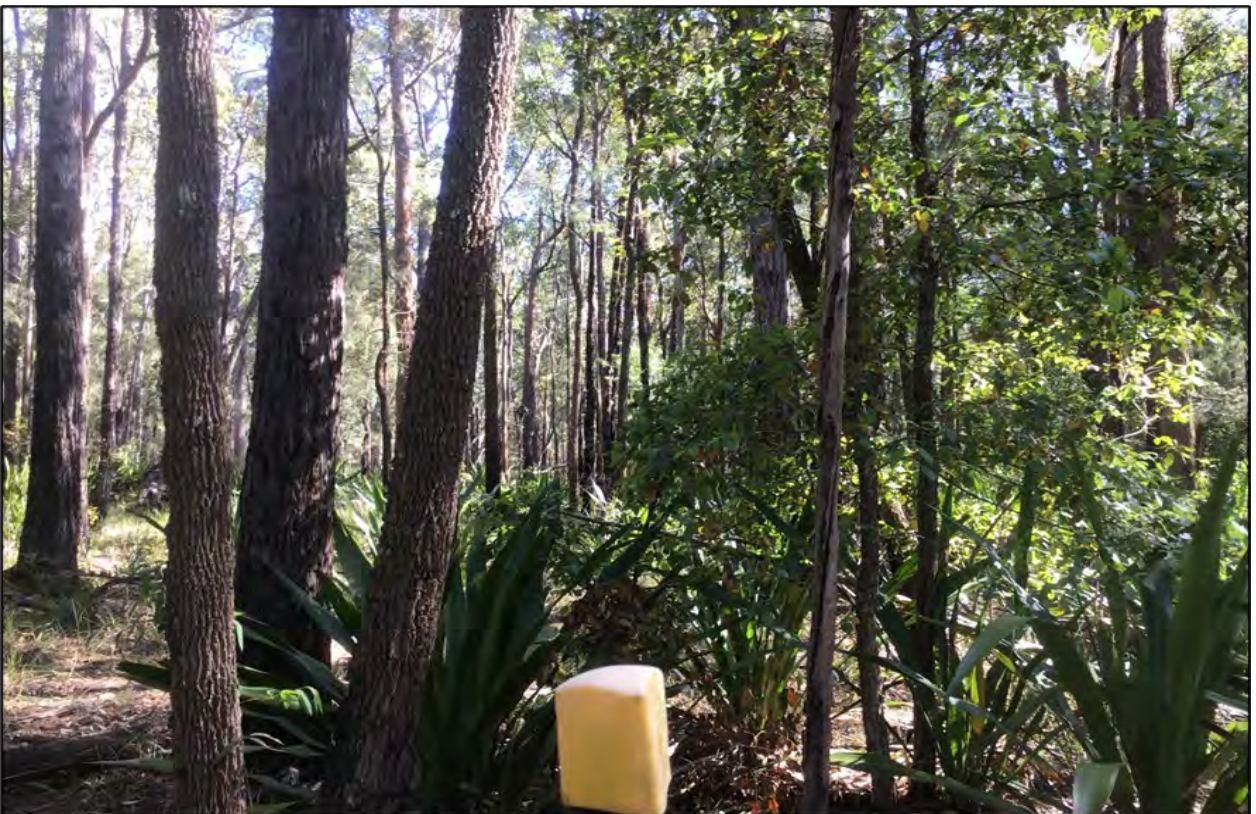
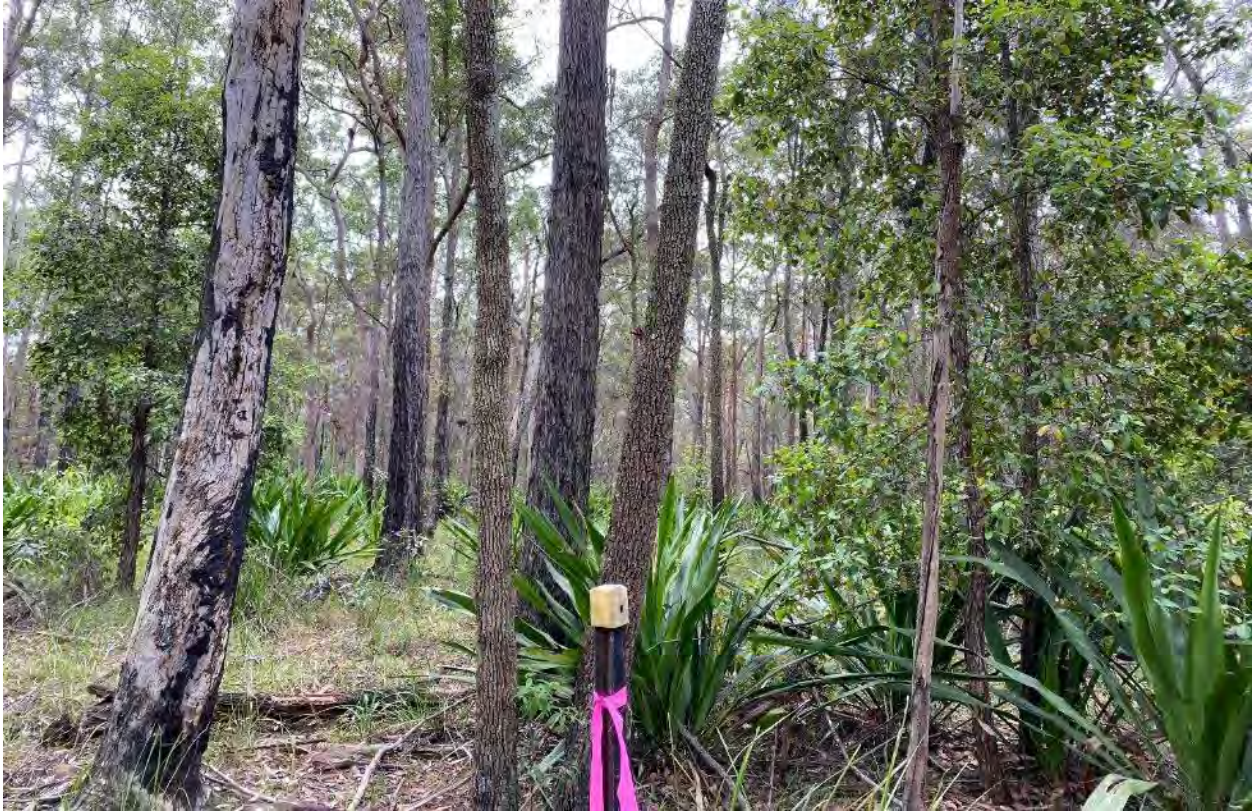
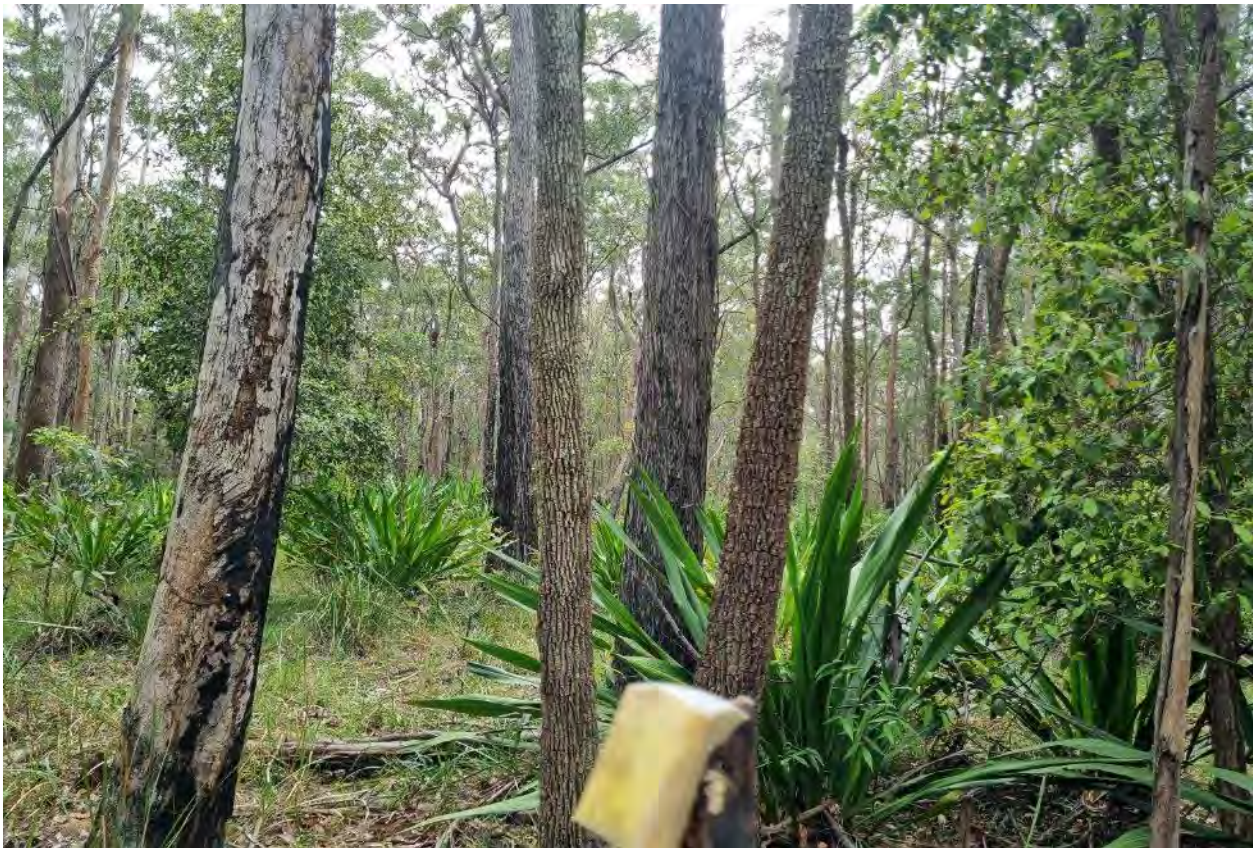
Monitoring Point 13 (MP 13)

MP13	Spotted Gum – Grey Ironbark open forest	<ul style="list-style-type: none"> Some dieback in mature <i>Allocasuarina torulosa</i> individuals. Regeneration observed within the canopy and mid-storey due to previous dieback. Low level of fallen logs / timber. Dense ground cover. Low rock cover. Substantial dieback in canopy directly adjacent to the monitoring point. Eucalypt and Midstory seedlings present. <p>Conclusion: Regeneration is occurring within the monitoring point with still some dieback of <i>A.torulosa</i>.</p>	<ul style="list-style-type: none"> No evidence of erosion and sedimentation. No recent evidence of disturbance from grazing, pest animals, rubbish dumping, rock / timber removal, or dust. Significant dust settlement recorded here in 2021. No signs of recent fire. <p>Conclusion: No evidence of new disturbance was observed since the previous survey (2021).</p>	N/A

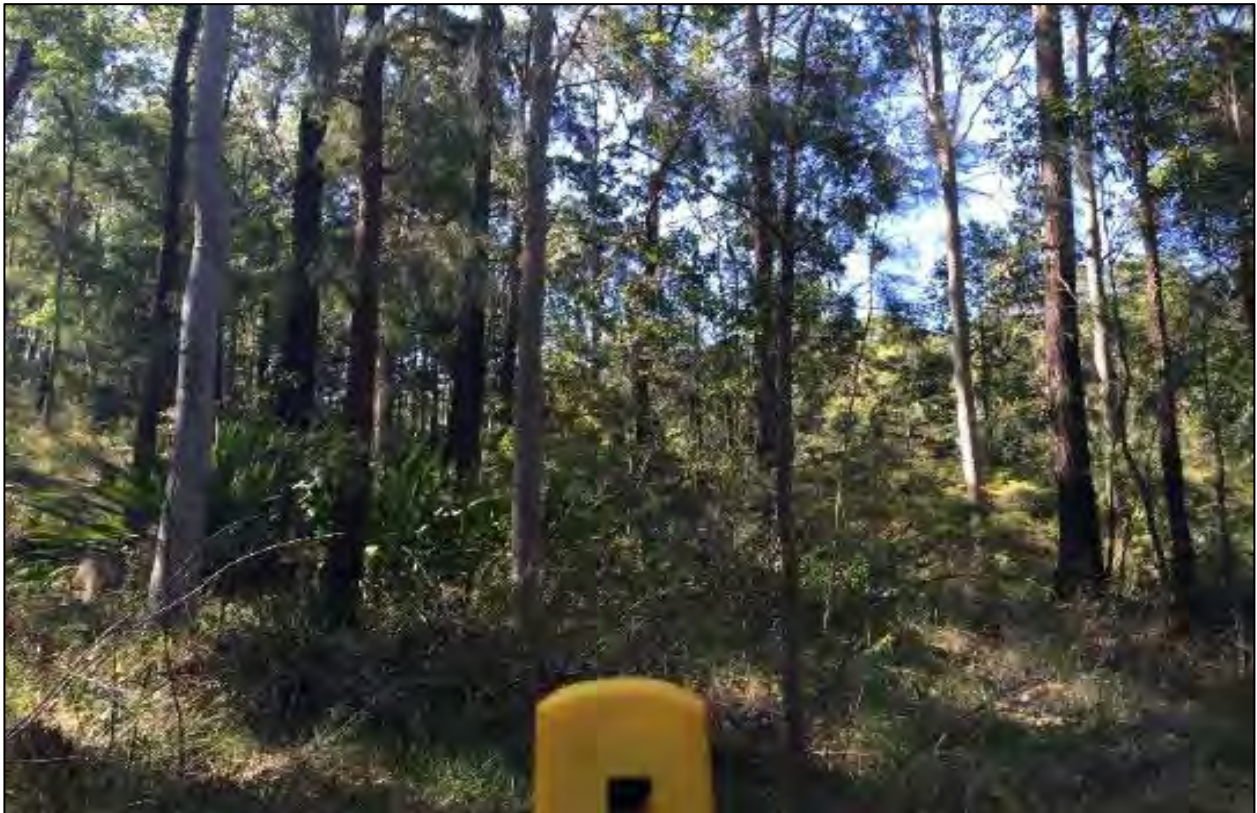
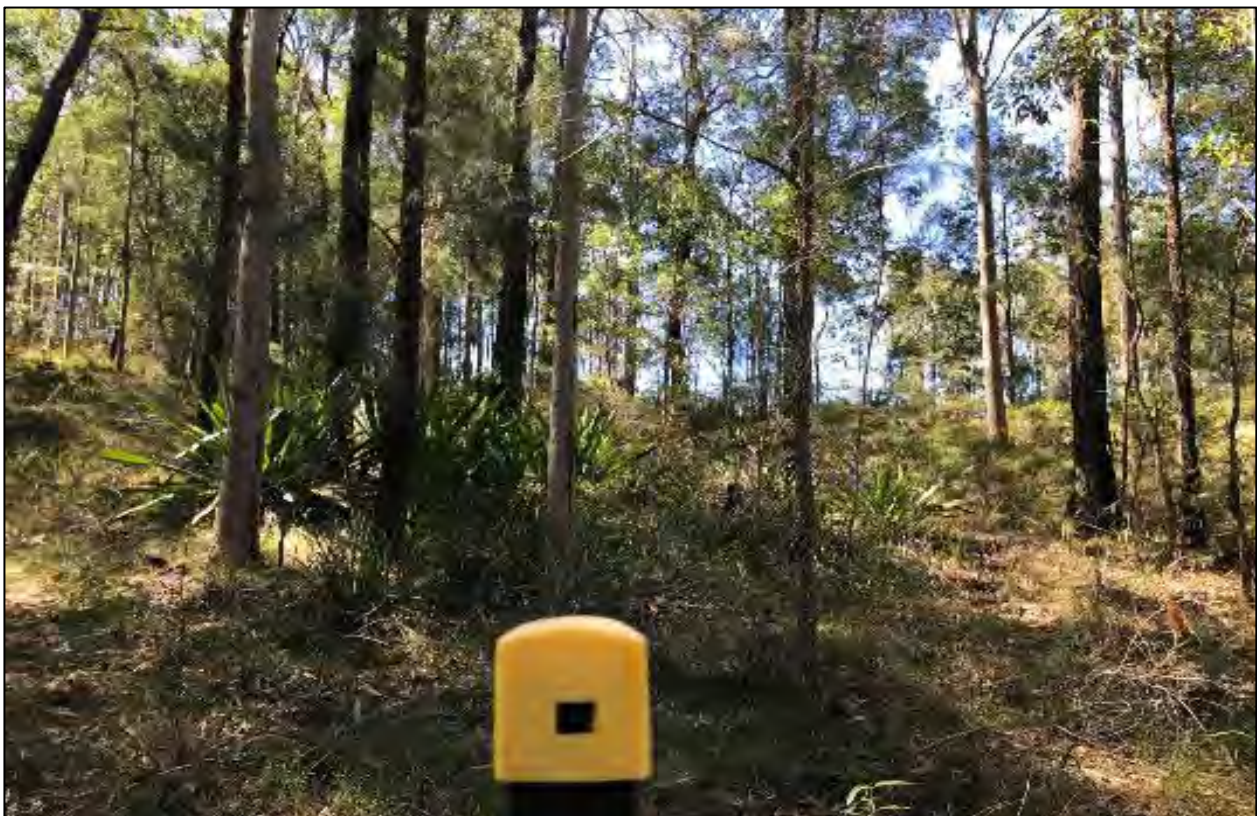
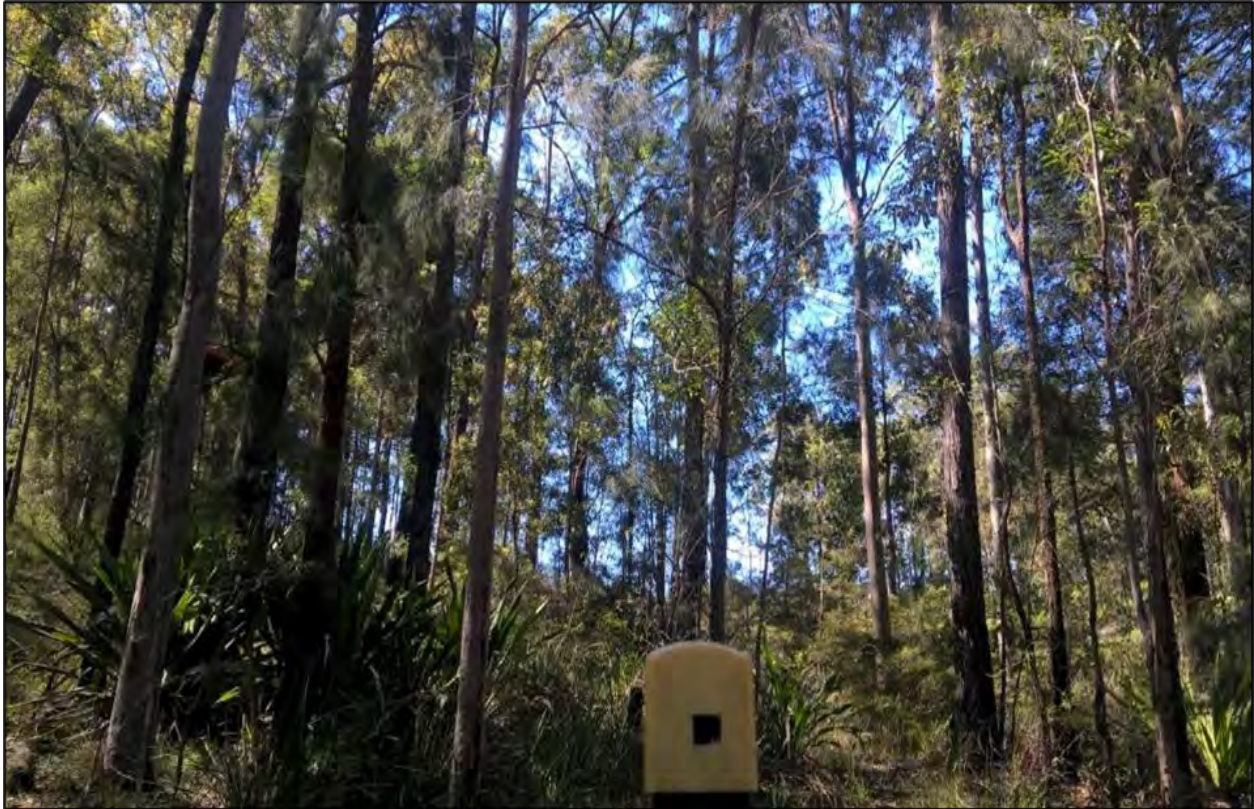
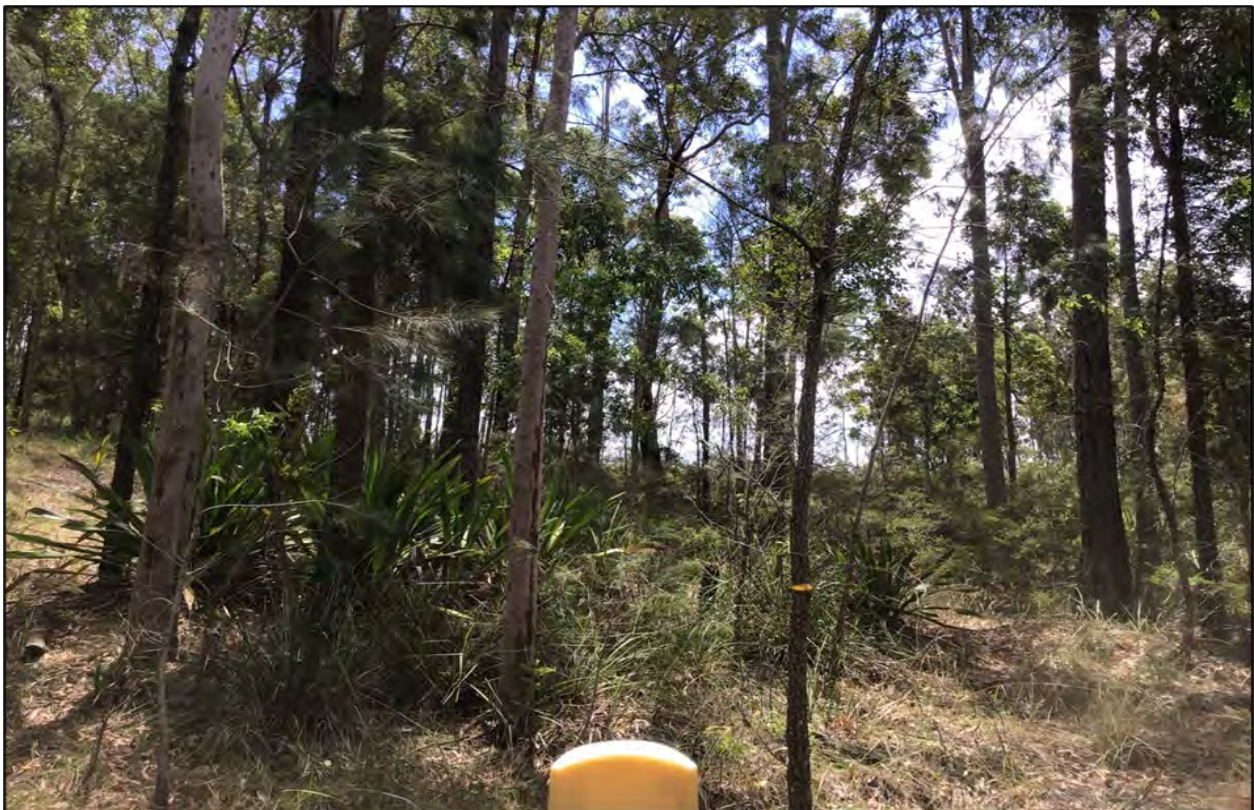
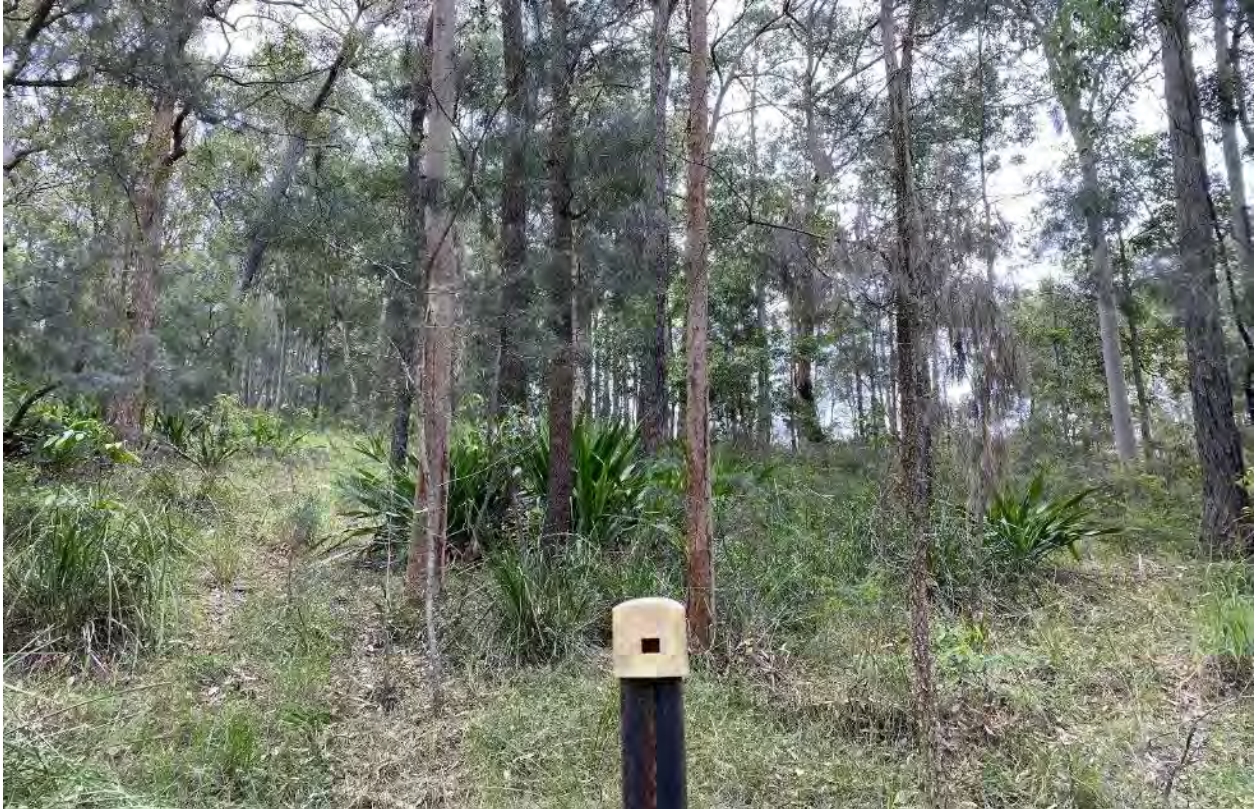
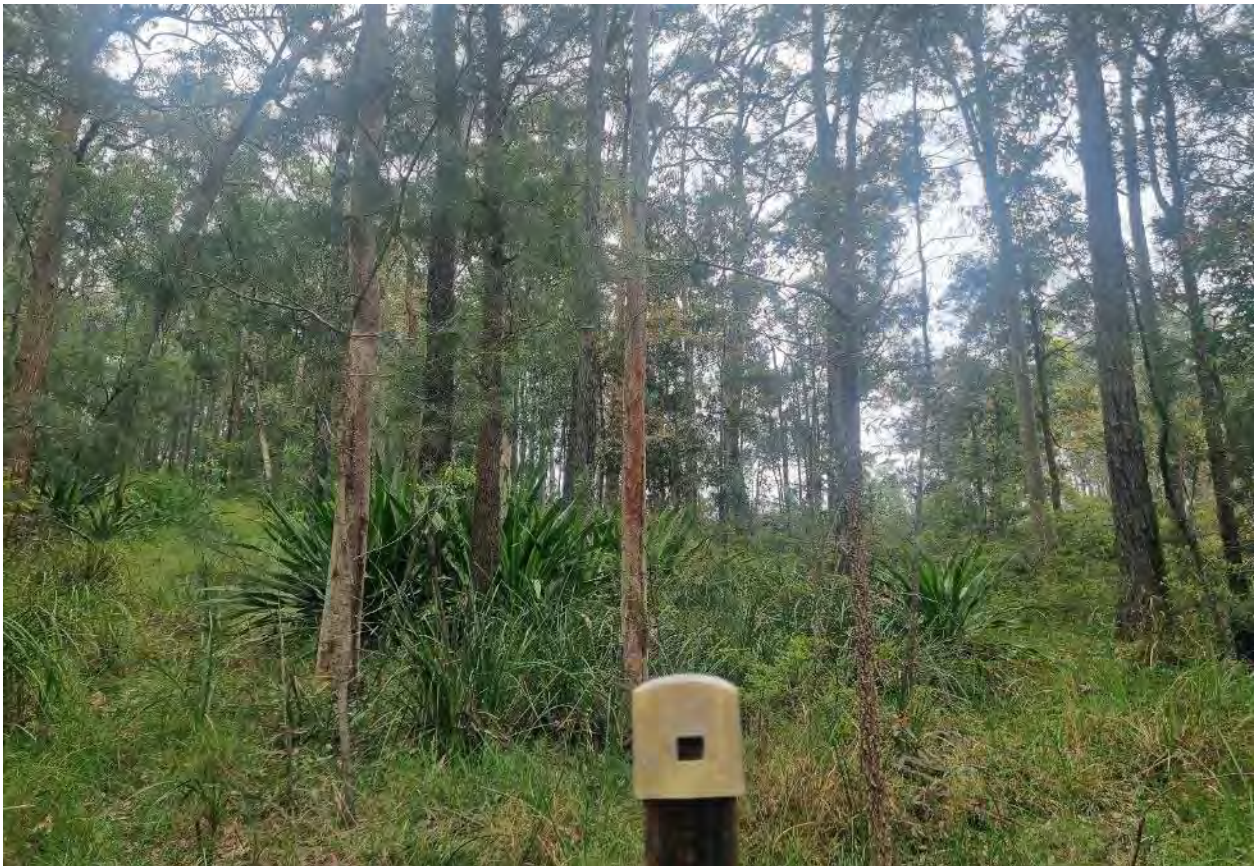
Monitoring Point 14 (MP 14)

Site	Vegetation Community	Vegetation and Habitat Condition	Evidence of Disturbance	Threatened Flora Monitoring
MP14	Smooth-barked Apple - Red Bloodwood open forest	<ul style="list-style-type: none"> Two individuals of <i>Setaria sphacelata</i>. All vegetation strata in healthy condition. Canopy and midstorey regeneration present. Low fallen/ timber. Dense ground cover. <p>Conclusion: No significant or notable changes in vegetation and habitat condition since the previous survey (2021).</p>	<ul style="list-style-type: none"> No evidence of erosion. Evidence of sedimentation of quarry rock material adjacent to monitoring plot from haul road into the nearby dam. No recent evidence of disturbance from grazing, pest animals, rubbish dumping, or rock / timber removal. No signs of recent fire. Dust accumulation on foliage from Quarry. Light cover of exotic grasses around dam to south and along access track. <p>Conclusion: New evidence of sedimentation was observed since the previous survey (2021).</p>	N/A
