Karuah East Quarry Biodiversity Offset Area Monitoring Report

Karuah East Quarry Biodiversity Offset Area and Lot 12

**Report prepared for:
Hunter Quarries**

Rev 2
23 March 2023

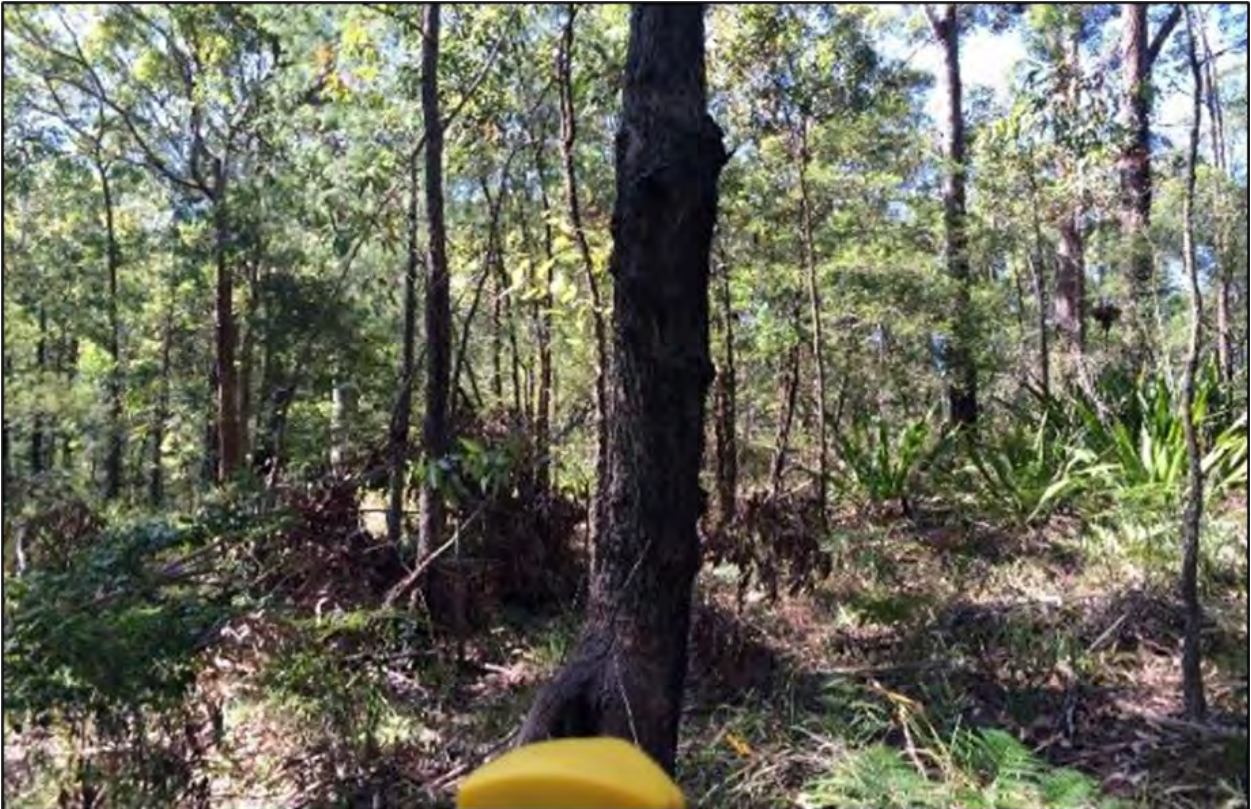
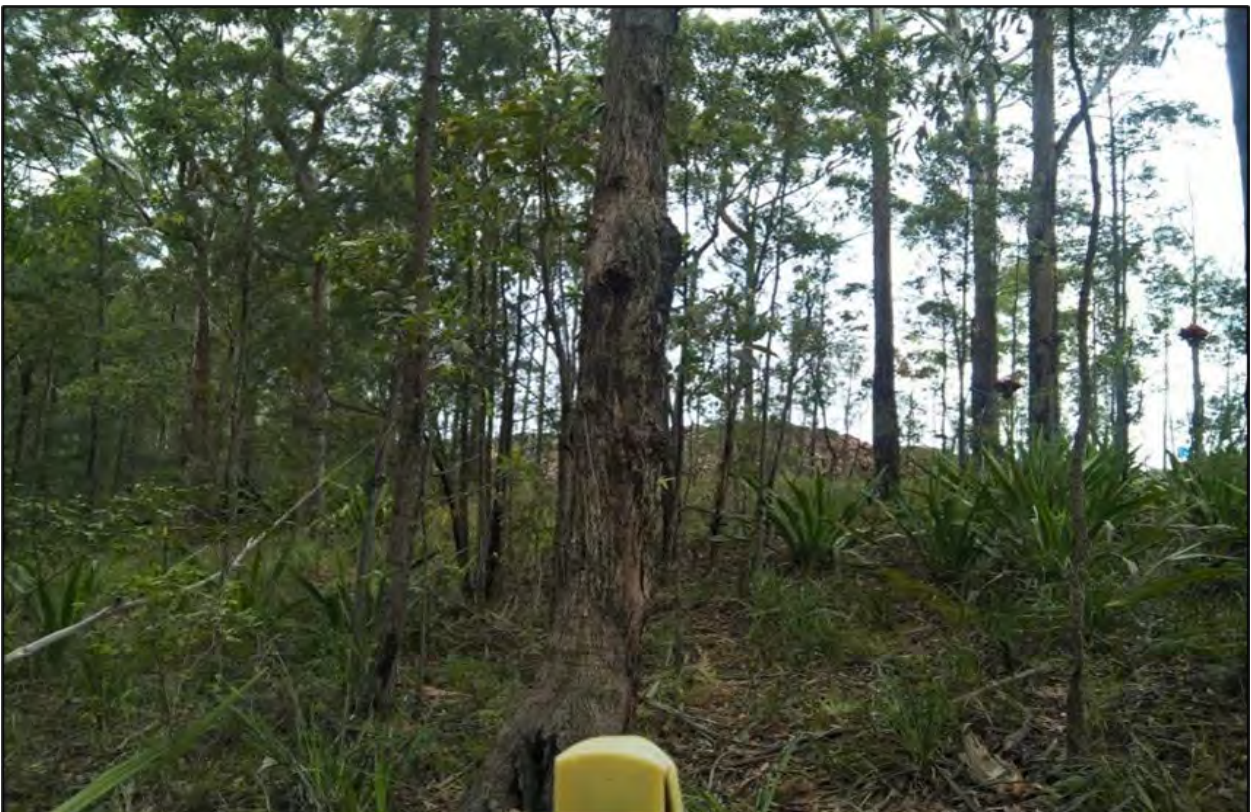
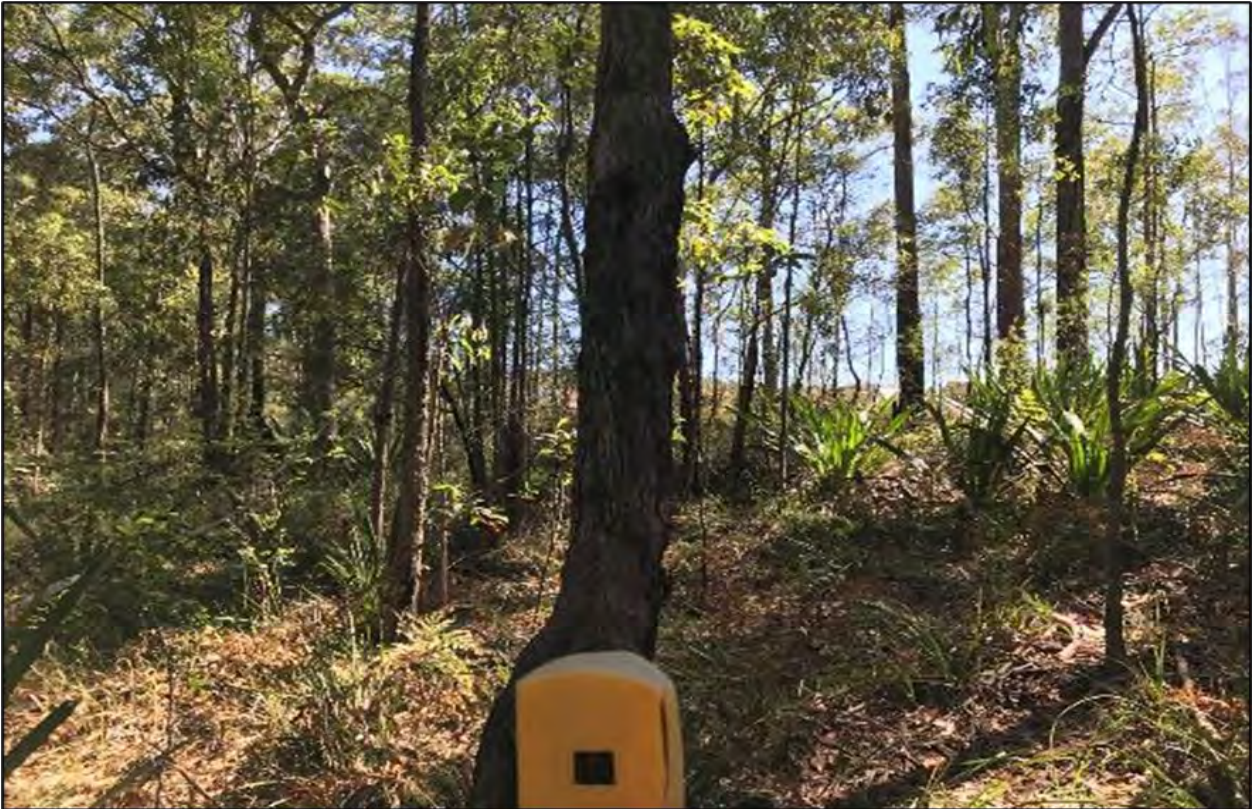
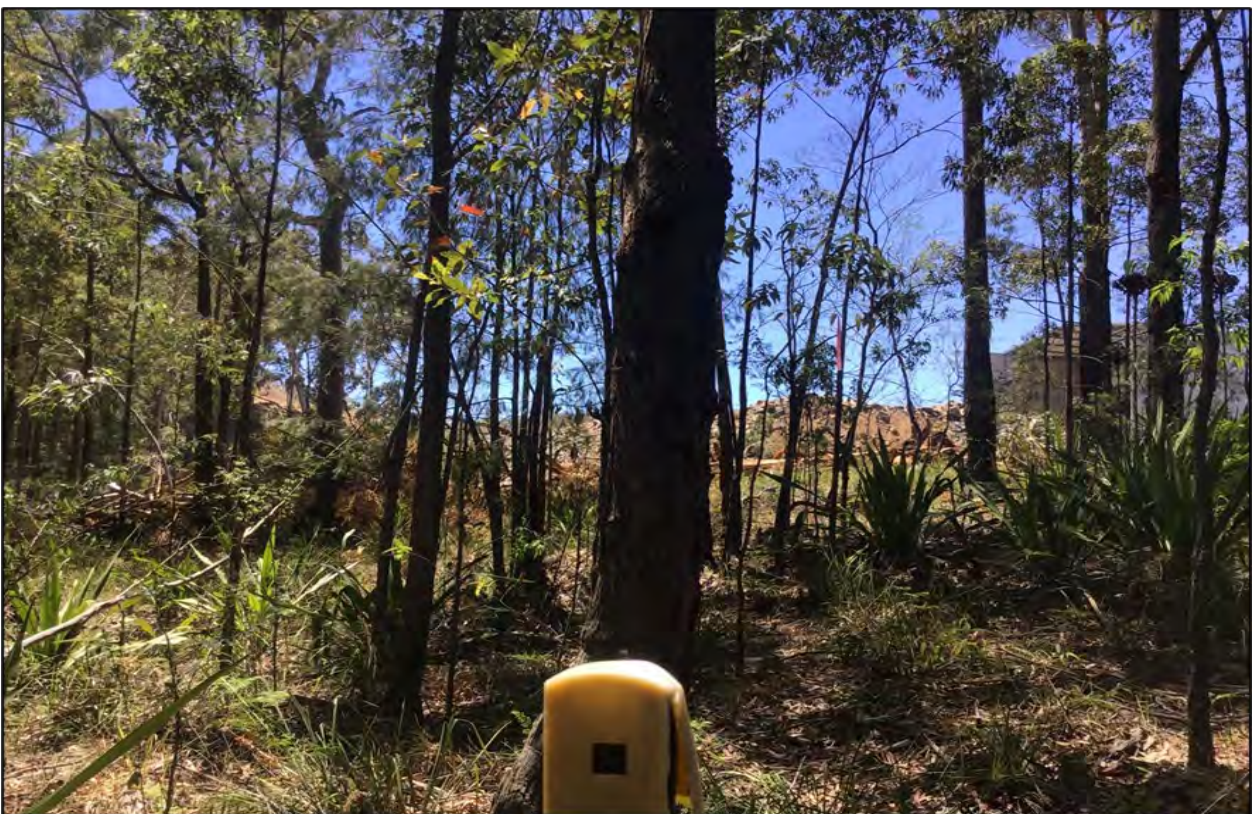
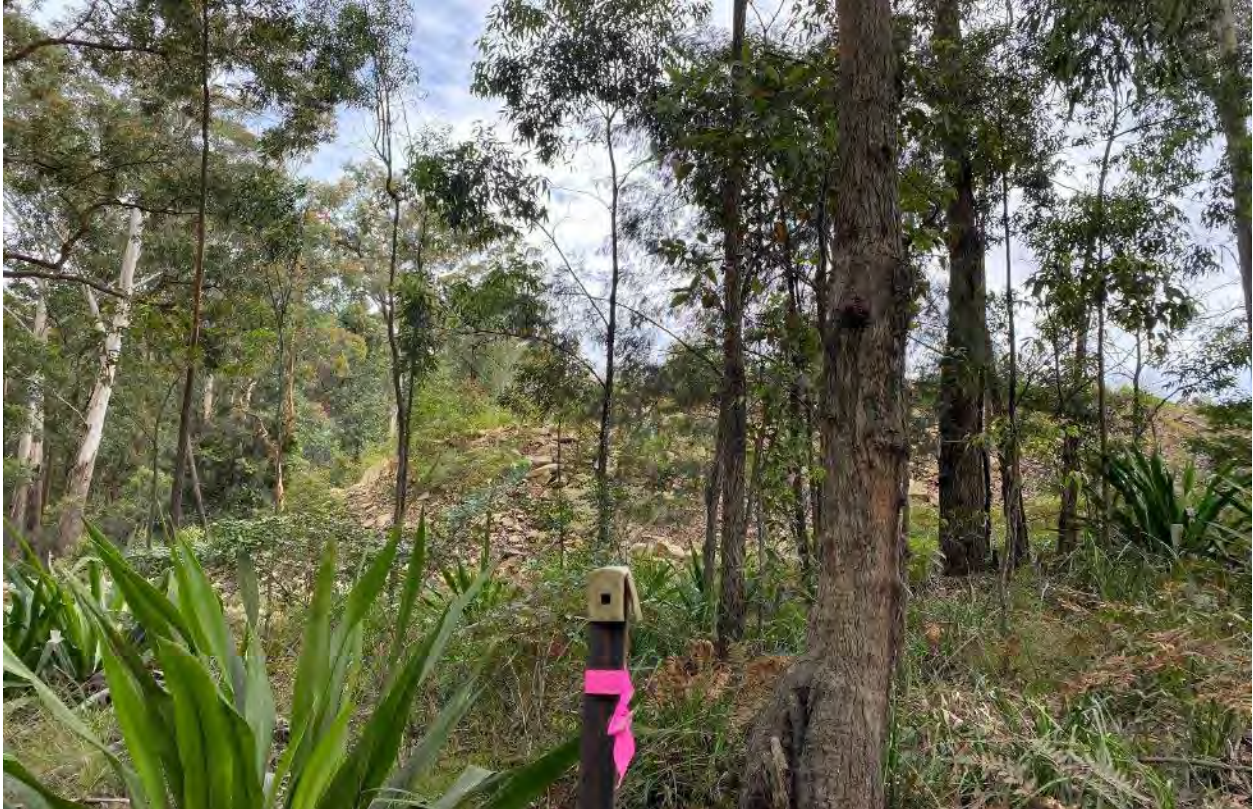
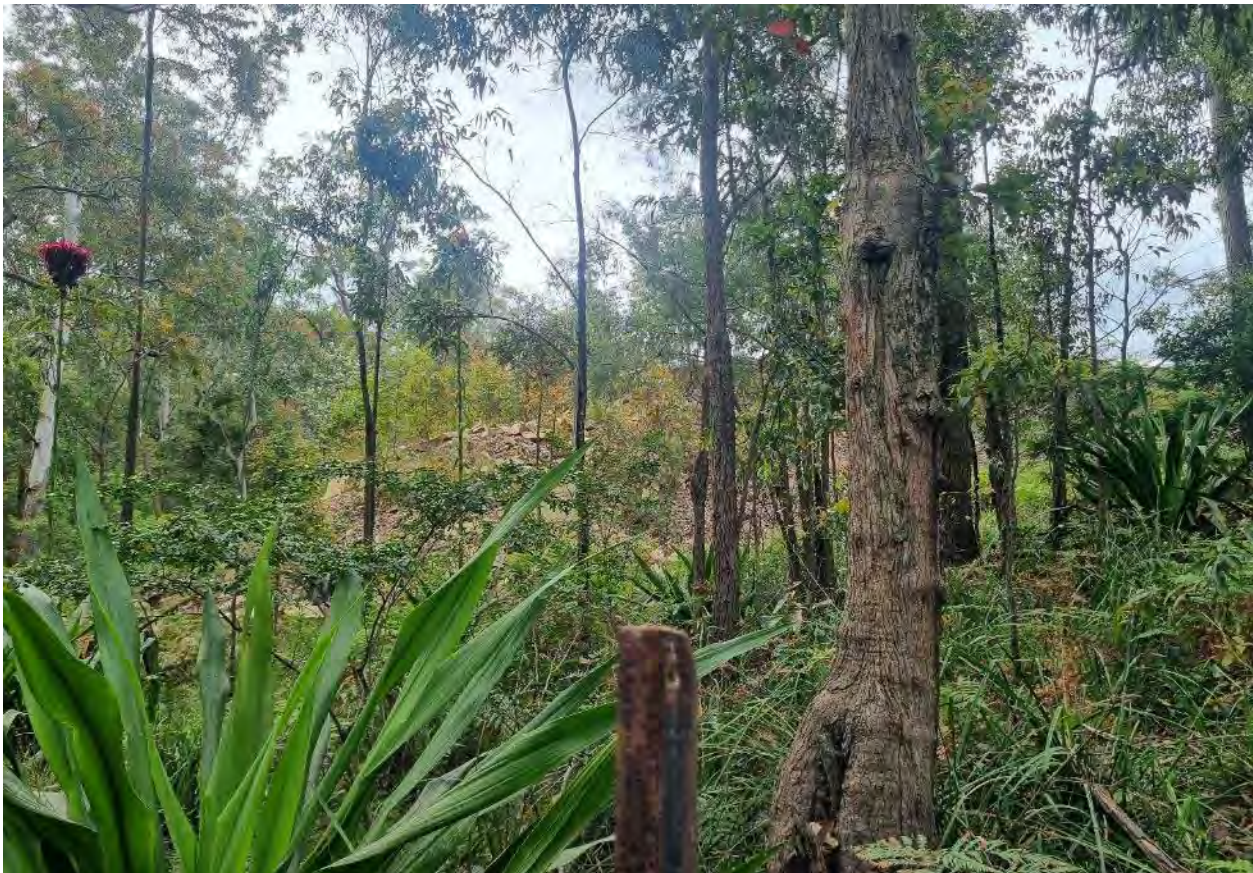
Monitoring Point 15 (MP 15)

Site	Vegetation Community	Vegetation and Habitat Condition	Evidence of Disturbance	Threatened Flora Monitoring
MP15	Blackbutt - Turpentine - Tallowood shrubby open forest	<ul style="list-style-type: none"> • Increase in Canopy cover since the 2021 survey. • All vegetation strata in moderately healthy condition. • Moderate fallen timber. • Dense ground cover and leaf litter. • Rocky areas present. <p>Conclusion: Only minor changes in vegetation and habitat condition since the previous survey (2021).</p>	<ul style="list-style-type: none"> • No evidence of erosion and sedimentation. • There are some edge effects from adjacent clearing. • No recent evidence of disturbance from grazing, pest animals, rubbish dumping, or rock / timber removal. • No signs of recent fire. • Thick dust coating on foliage. <p>Conclusion: Dust cover on foliage was observed within the monitoring site in 2021 and again in 2022 seemingly becoming thicker.</p>	<ul style="list-style-type: none"> • There was an decrease in the number of <i>Tetratheca juncea</i> clumps recorded within the monitoring site, from 12 in 2021 to 7 in 2021. • One new <i>Tetratheca juncea</i> clump was recorded in 2022. • Six <i>Tetratheca juncea</i> plants were recorded flowering during monitoring. • No <i>Tetratheca juncea</i> plants were recorded with fruits during monitoring. • All <i>Tetratheca juncea</i> plants within the monitoring site were observed to be in healthy condition. • The <i>Tetratheca juncea</i> population at MP 15 has declined since 2015 baseline (30 individuals recorded). This decline in the <i>T. juncea</i> at MP 15 is most likely due to the lower than average rainfall during 2019, exacerbated by the location of the monitoring point; upper slopes of exposed hill side.

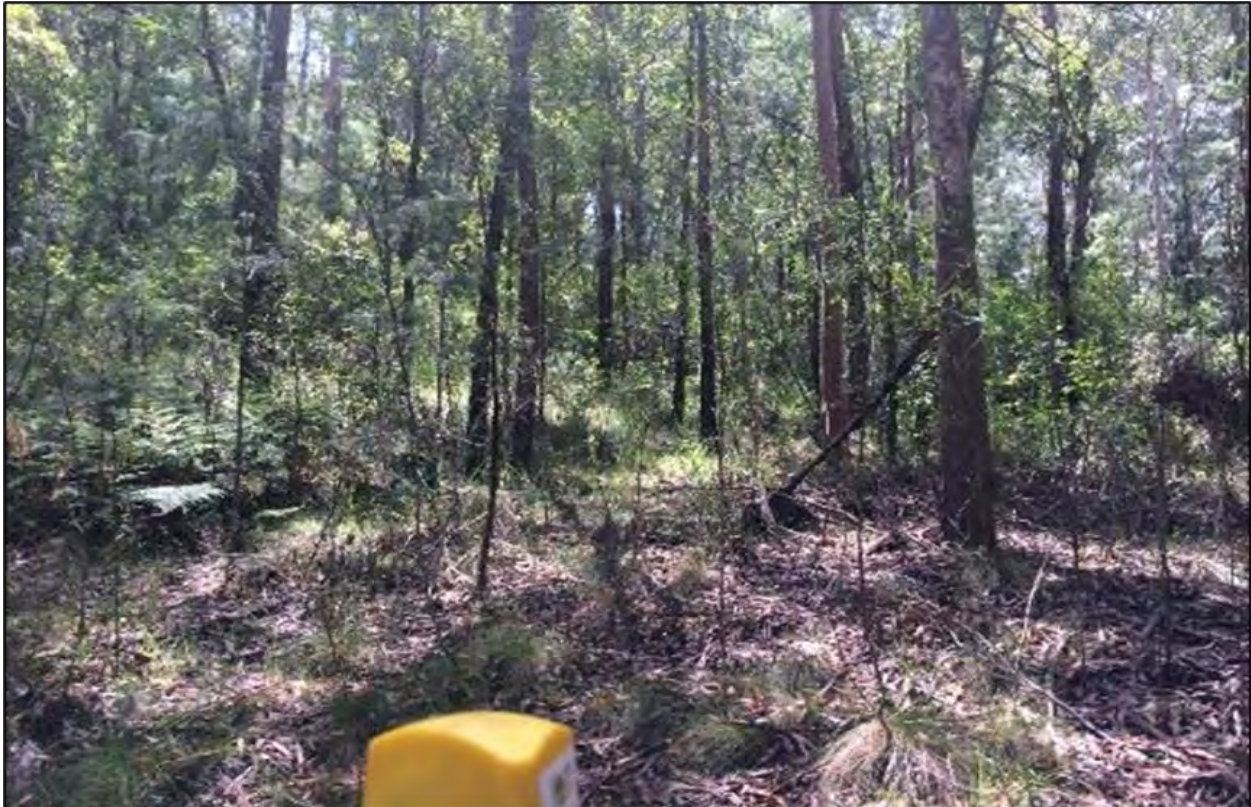
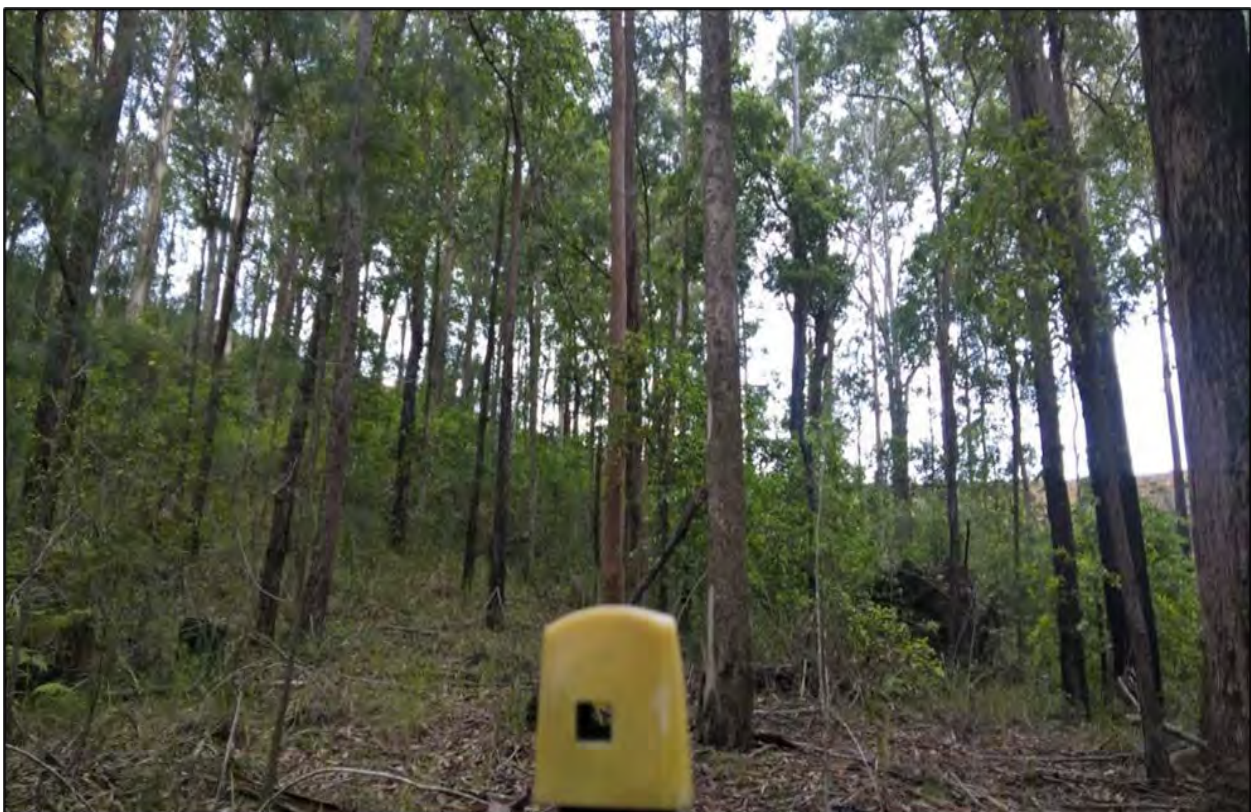
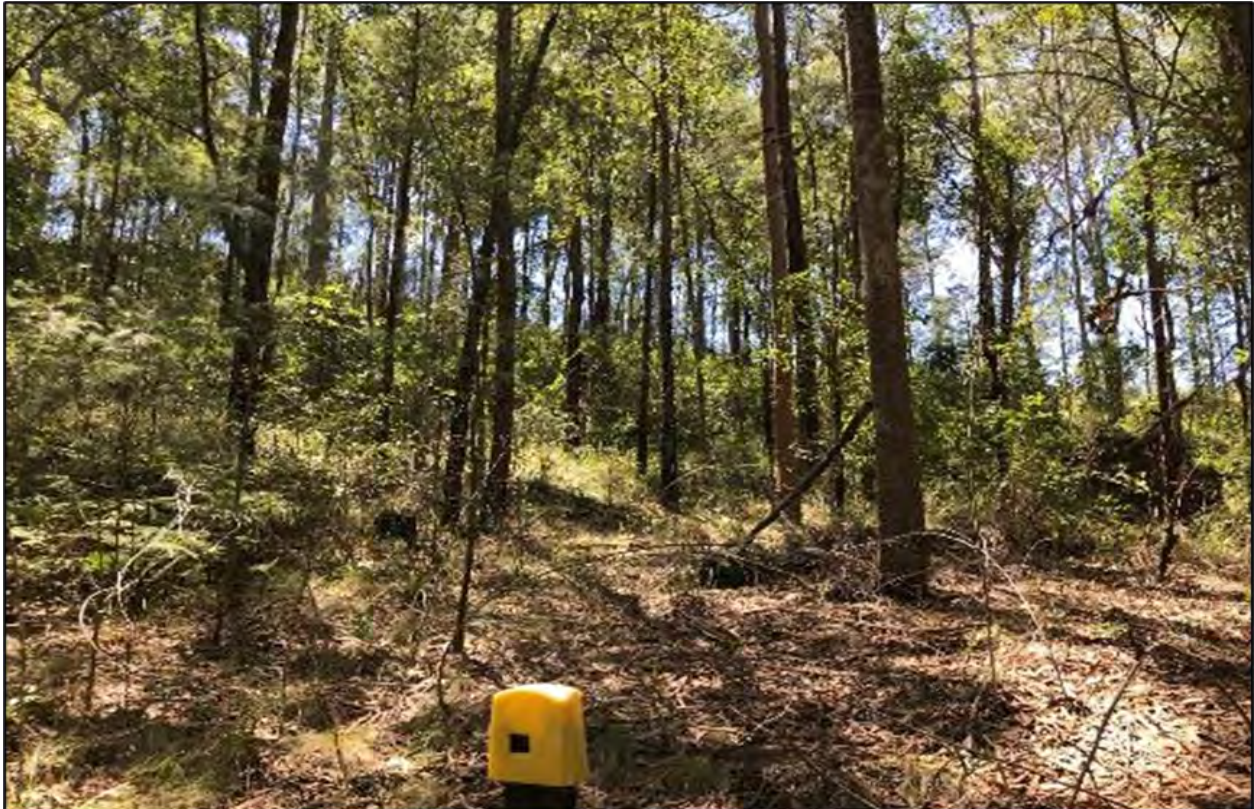
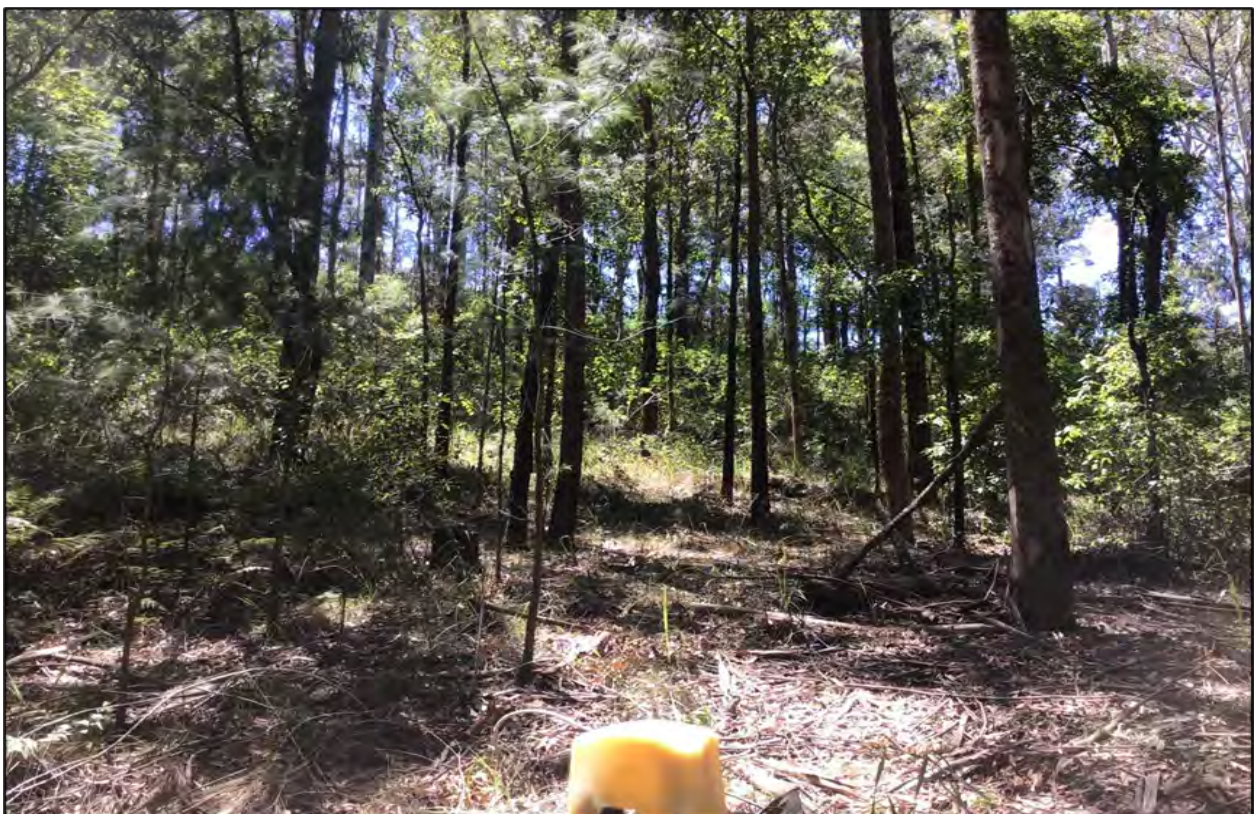
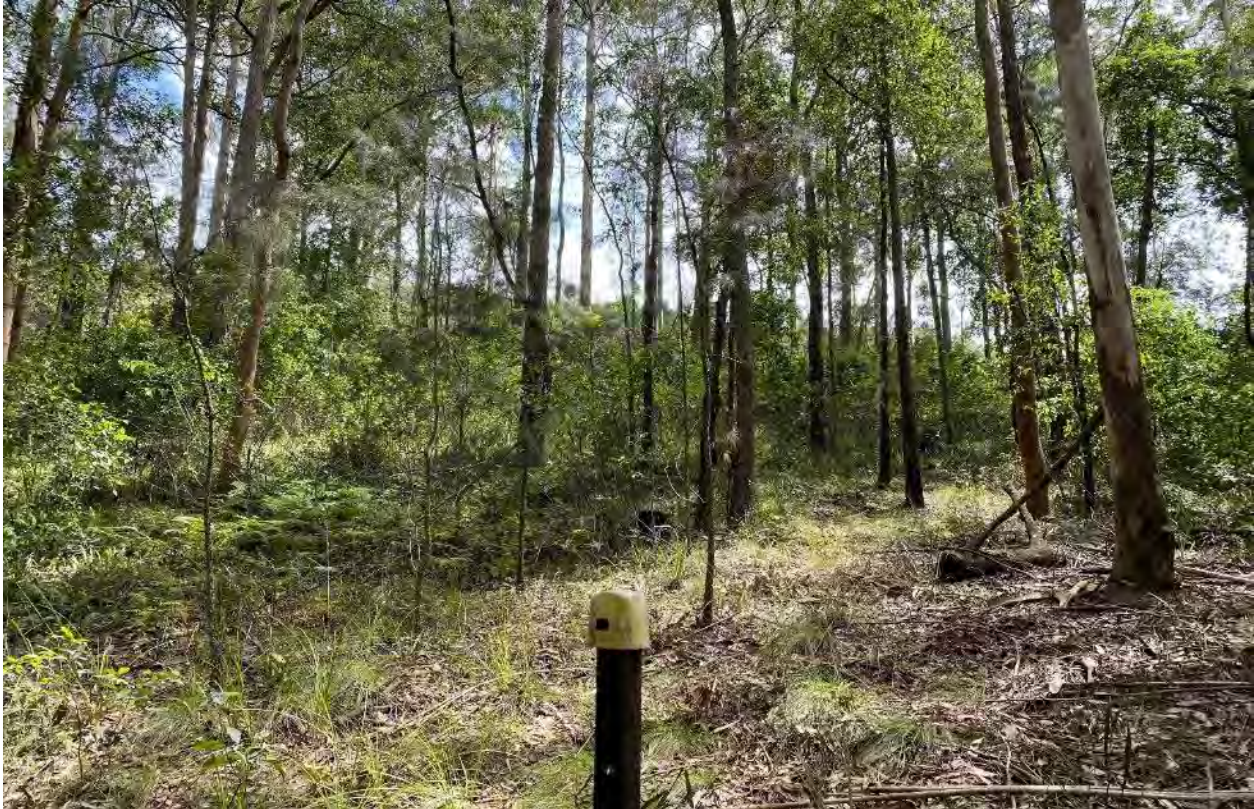
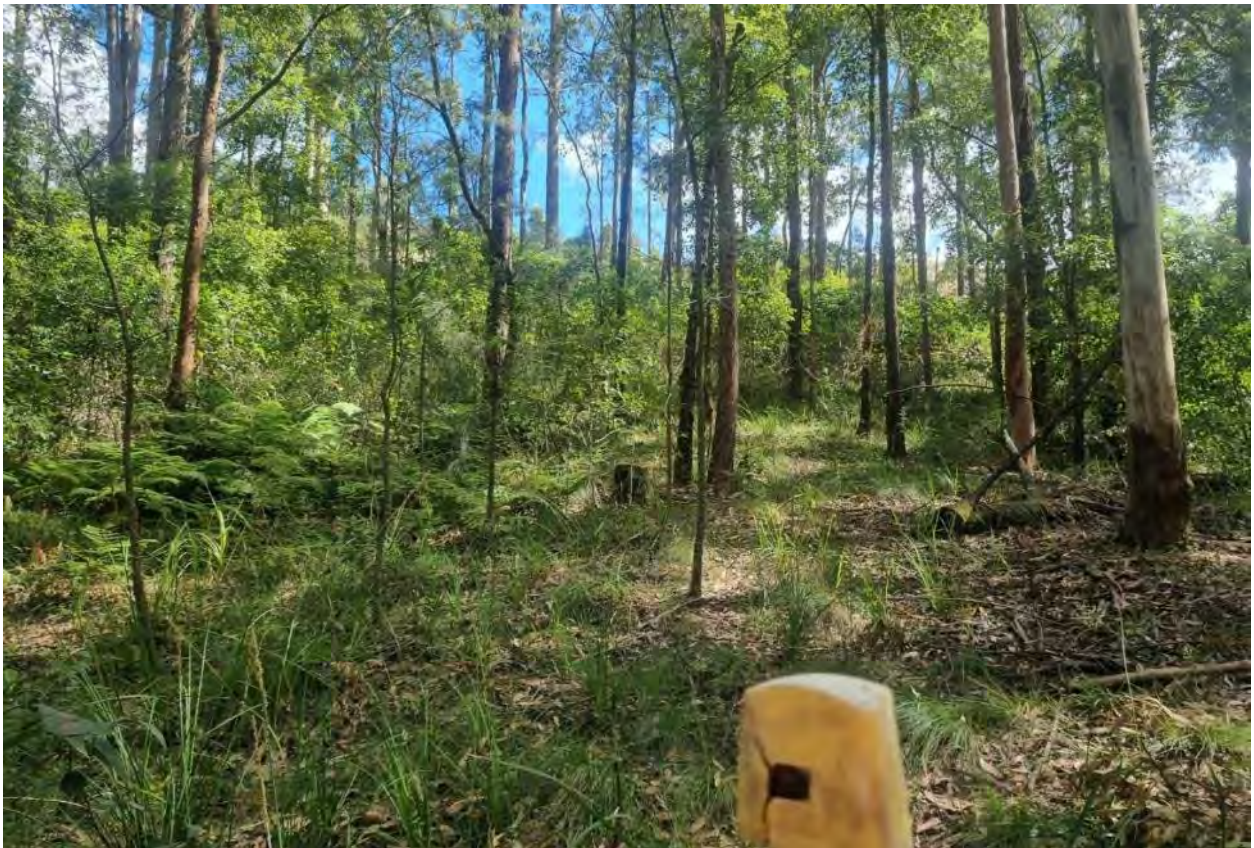
Monitoring Point 16 (MP 16)

Site	Vegetation Community	Vegetation and Habitat Condition	Evidence of Disturbance	Threatened Flora Monitoring
MP16	Spotted Gum – Grey Ironbark open forest	<ul style="list-style-type: none"> Increased non-grass groundcover in response to increased <i>Doodia aspera</i> abundance. All vegetation strata in healthy condition. Canopy and midstory regeneration present. Moderate fallen timber. Dense leaf litter and moderate ground cover. Low rock cover. <p>Conclusion: Minor changes in vegetation and habitat condition since the previous survey (2021).</p>	<ul style="list-style-type: none"> No evidence of erosion and sedimentation. No recent evidence of disturbance from grazing, pest animals, rubbish dumping, rock / timber removal, or dust. No signs of recent fire. Several old dead stags present. <p>Conclusion: No evidence of new disturbance was observed since the previous survey (2021).</p>	<ul style="list-style-type: none"> <i>Asperula asthenes</i> detected within monitoring plot for first time (2021). Six individual plants identified in 2022. All six <i>Asperula asthenes</i> plants were recorded flowering during monitoring. Two <i>Asperula asthenes</i> plants were recorded fruiting during monitoring. All <i>Asperula asthenes</i> plants within the monitoring site were observed to be in healthy condition

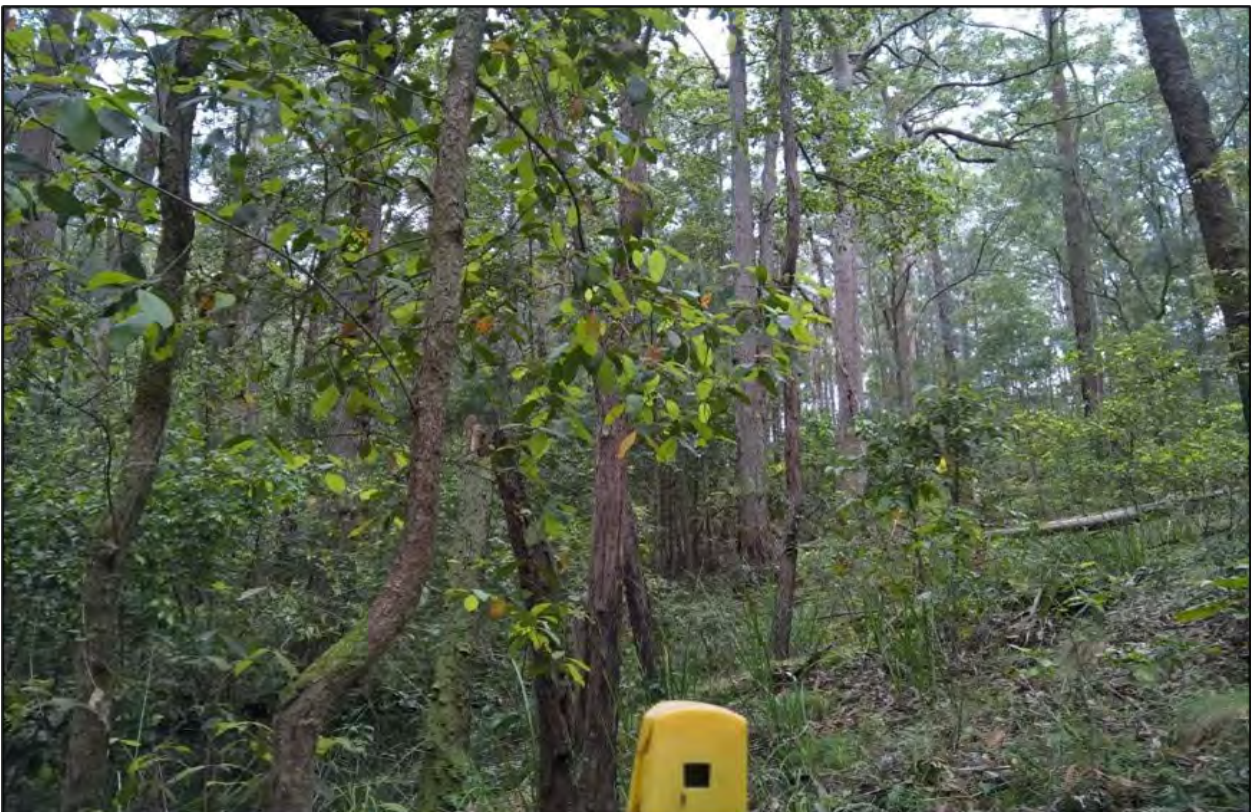
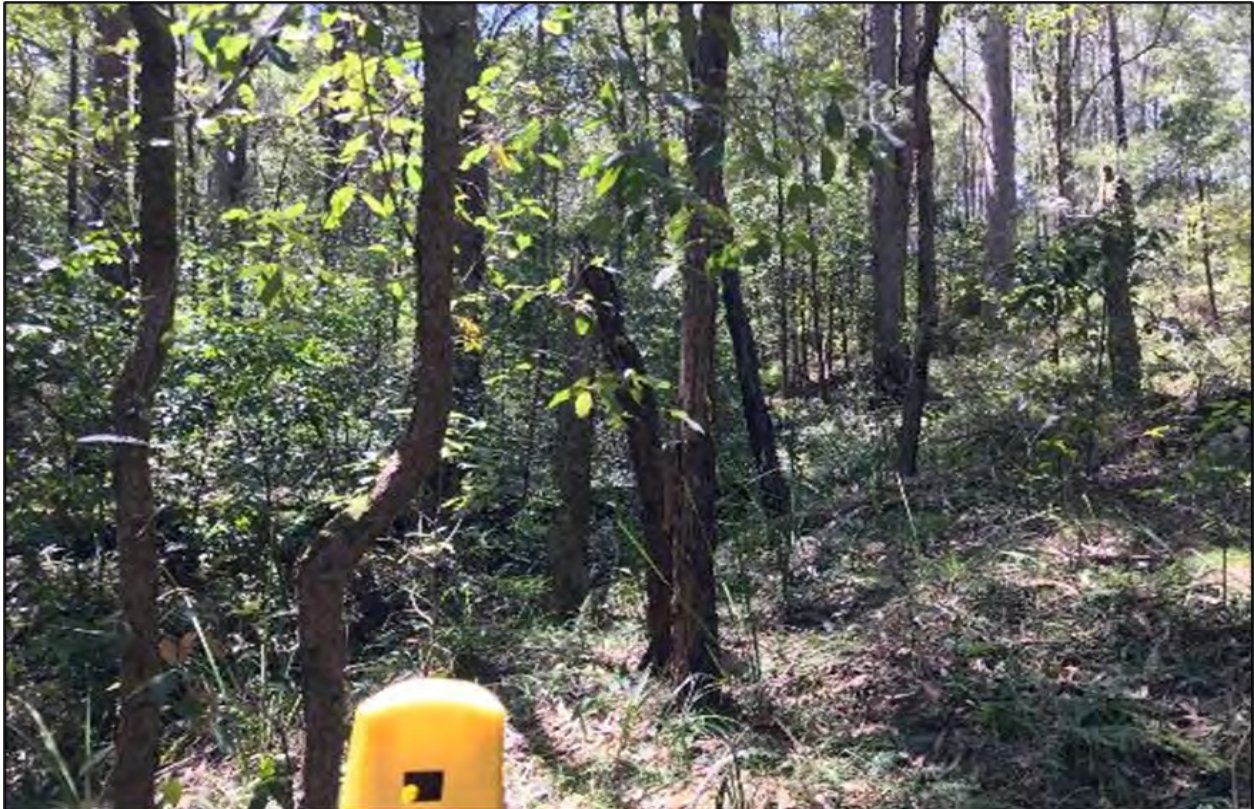
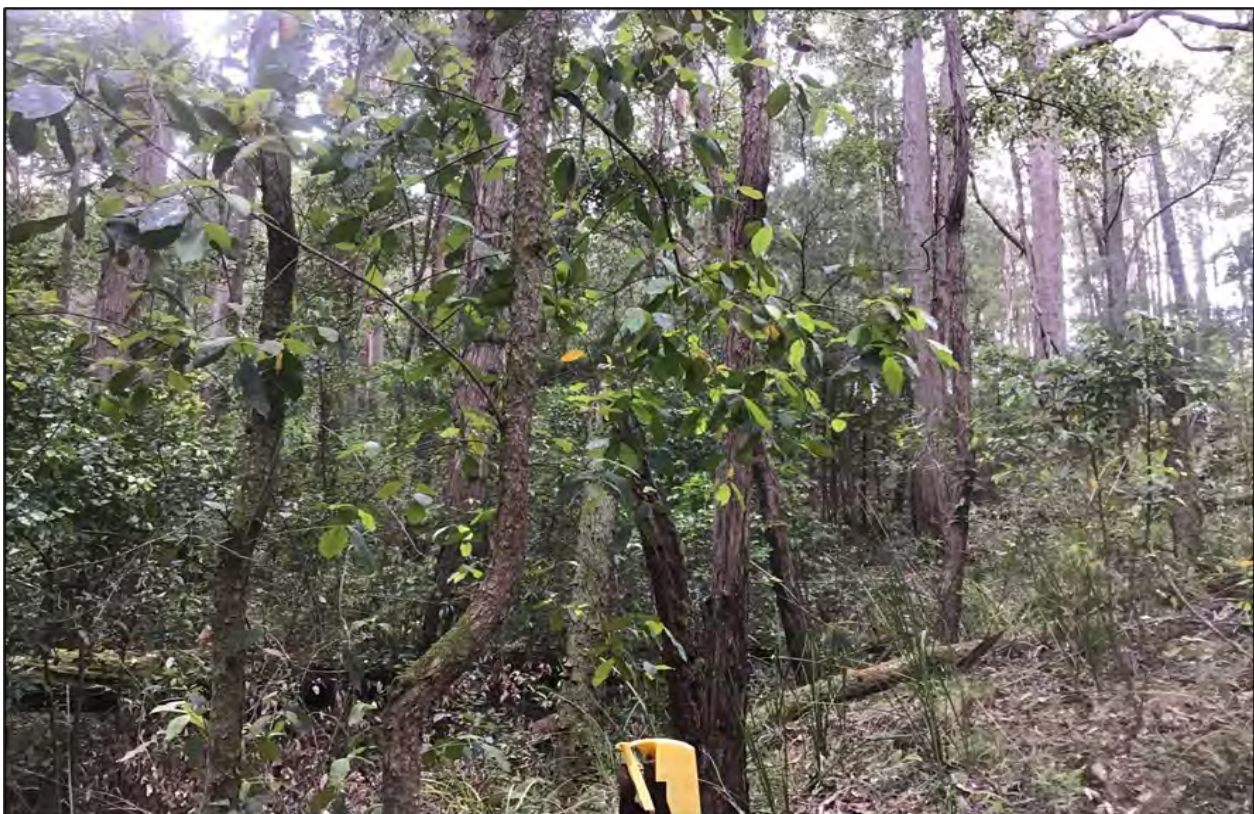
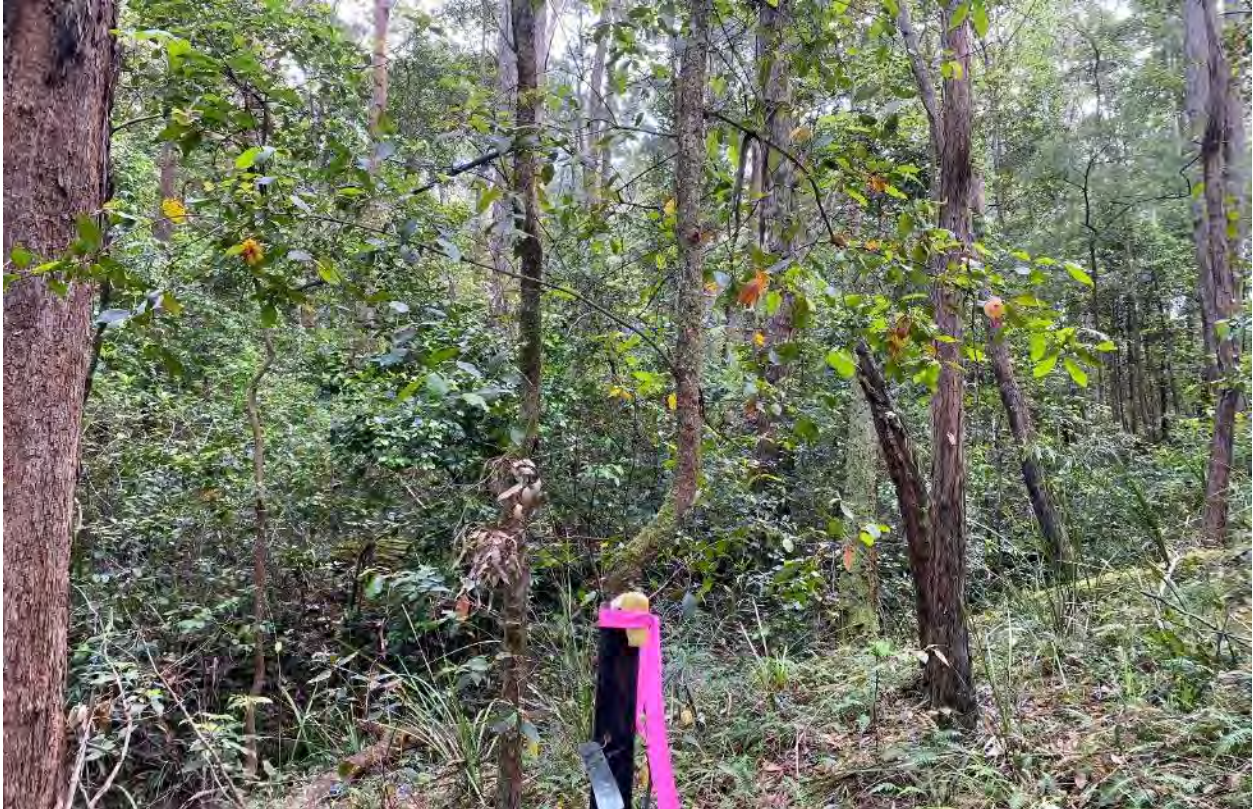
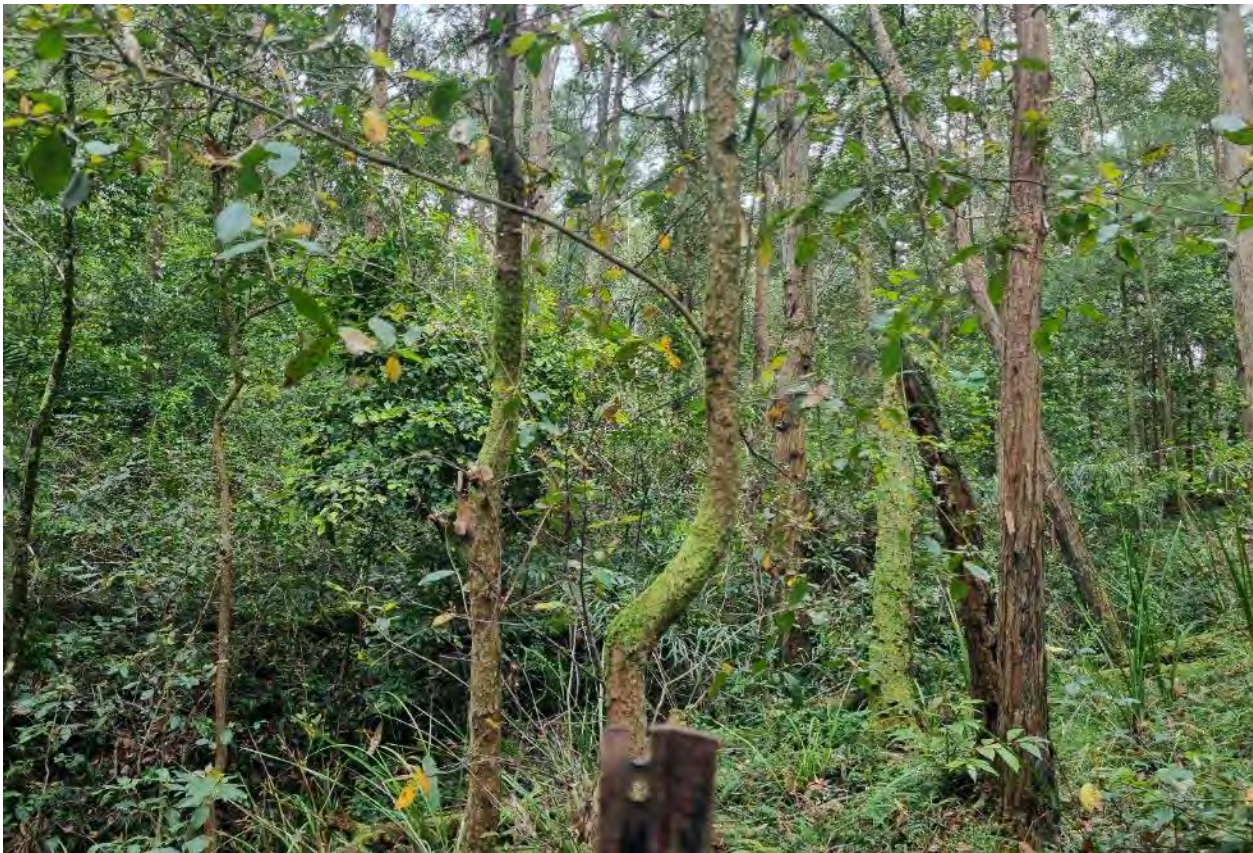
Monitoring Point 17 (MP 17)

MP17	Brush Box - Turpentine shrubby open forest	<ul style="list-style-type: none"> No evidence of foliage die-back, evidence of midstorey and canopy regeneration. All vegetation strata in healthy condition. Abundance of juvenile <i>Backhousia myrtifolia</i> in midstorey, subsequently increasing mid-storey cover. <i>Lantana camara</i> abundance remains stable. Moderate fallen timber. Dense ground cover. Rocky areas along ephemeral creek. <p>Conclusion: No significant or notable changes in vegetation and habitat condition since the previous survey (2021).</p>	<ul style="list-style-type: none"> Very minor scouring along creek bank. No recent evidence of disturbance from grazing, pest animals, rubbish dumping, rock / timber removal, or dust. Stable exotic plant community (<i>Lantana camara</i>). No signs of recent fire. Dirty water running within the creek after recent rainfall. <p>Conclusion: Evidence of new disturbance was observed since the previous survey (2021) with dirty water running within the creek.</p>	<ul style="list-style-type: none"> There was a decrease in number of <i>Asperula asthenes</i> individuals within the monitoring site from 10 in 2021 to 6 in 2022. Six <i>Asperula asthenes</i> plants were recorded flowering during monitoring. All <i>Asperula asthenes</i> plants within the monitoring site were observed to be in healthy condition. The population at MP 17 has decreased since 2015 baseline (11 individuals recorded).
