Karuah East Quarry Biodiversity Offset Area Monitoring Report

Karuah East Quarry Biodiversity Offset Area and Lot 12

**Report prepared for:
Hunter Quarries**

Rev 2
23 March 2023

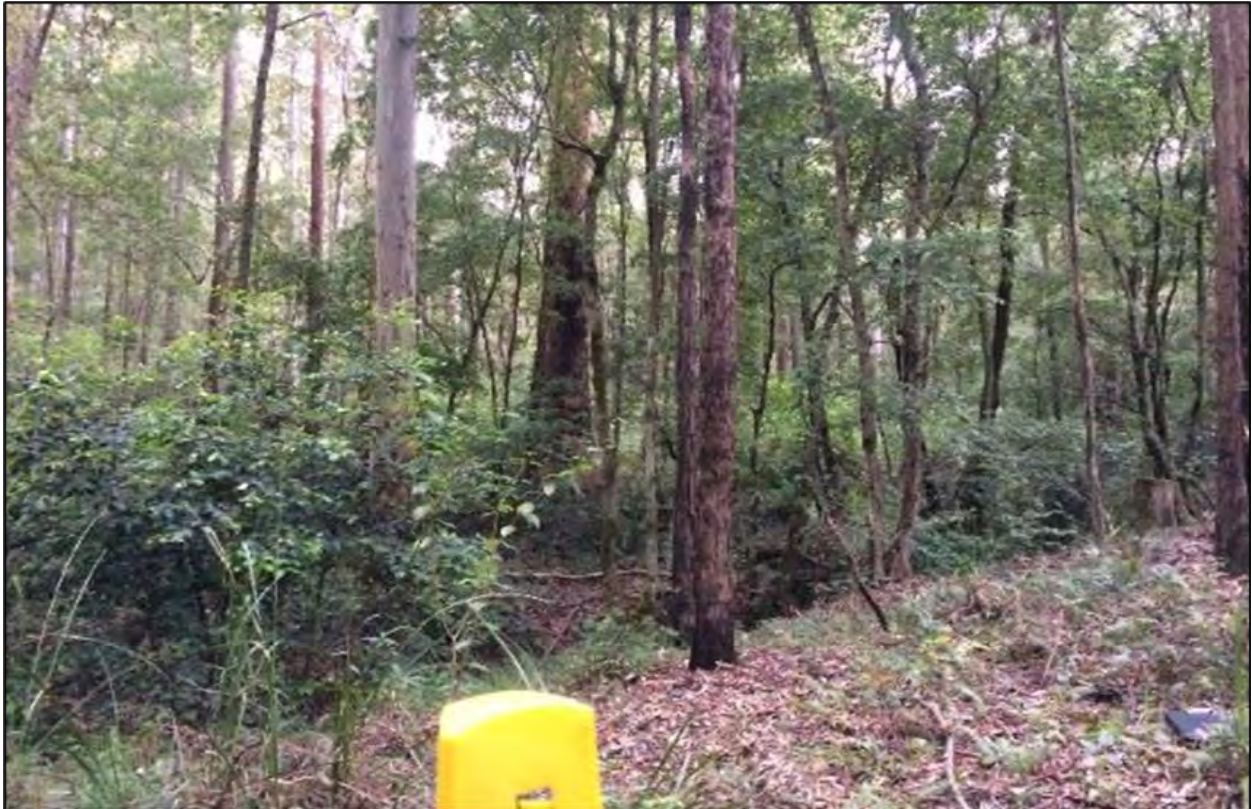
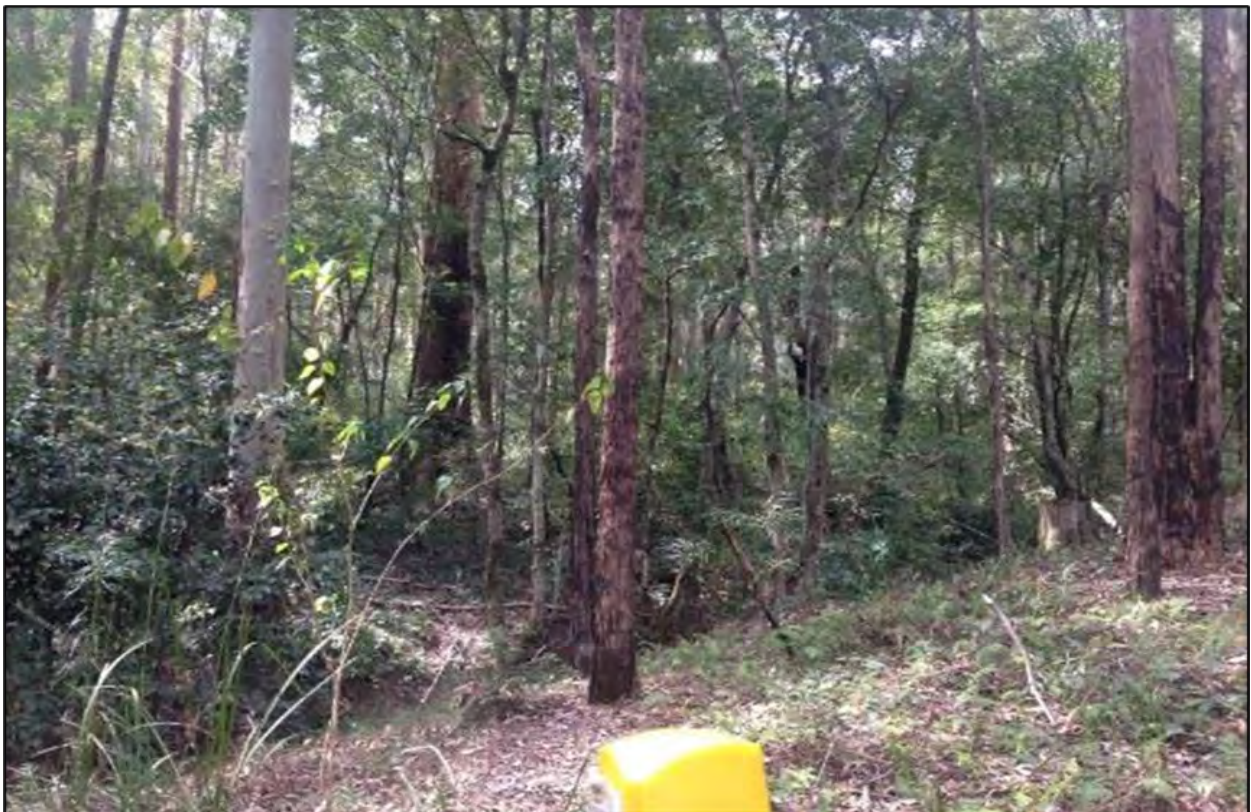
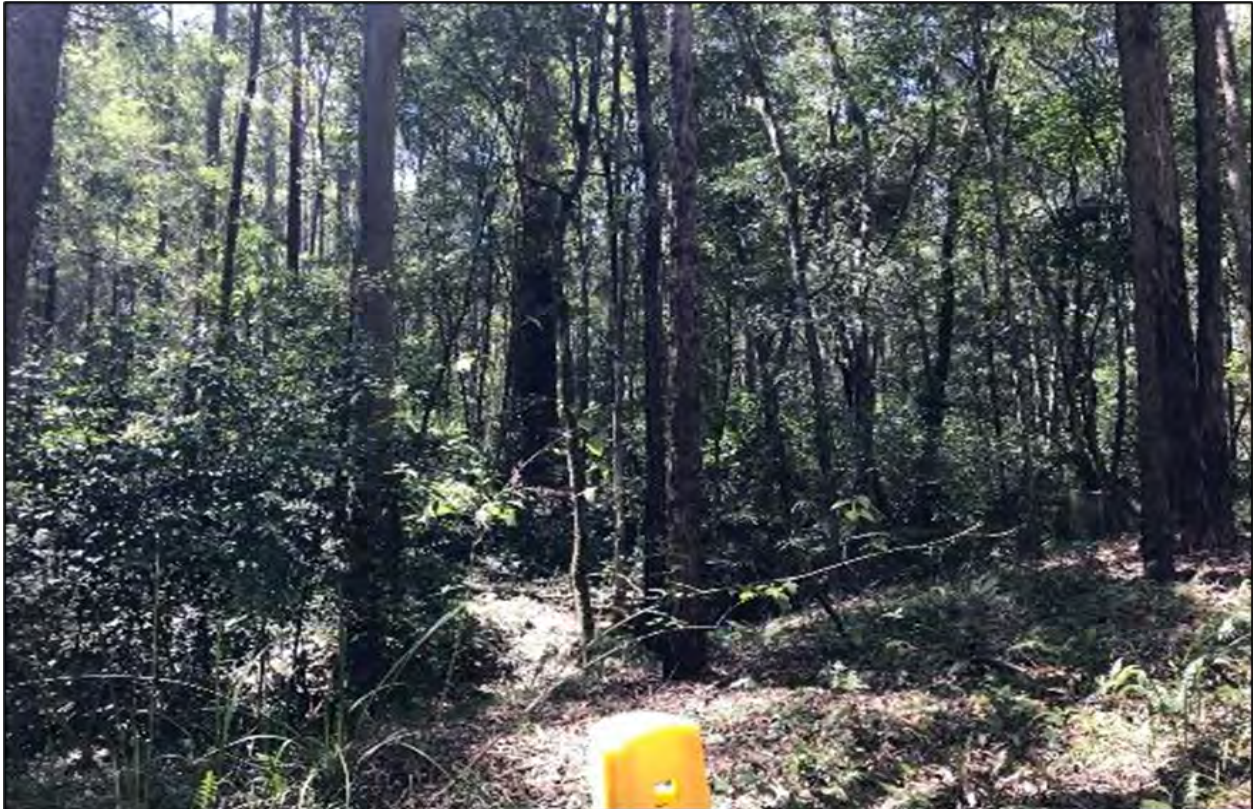
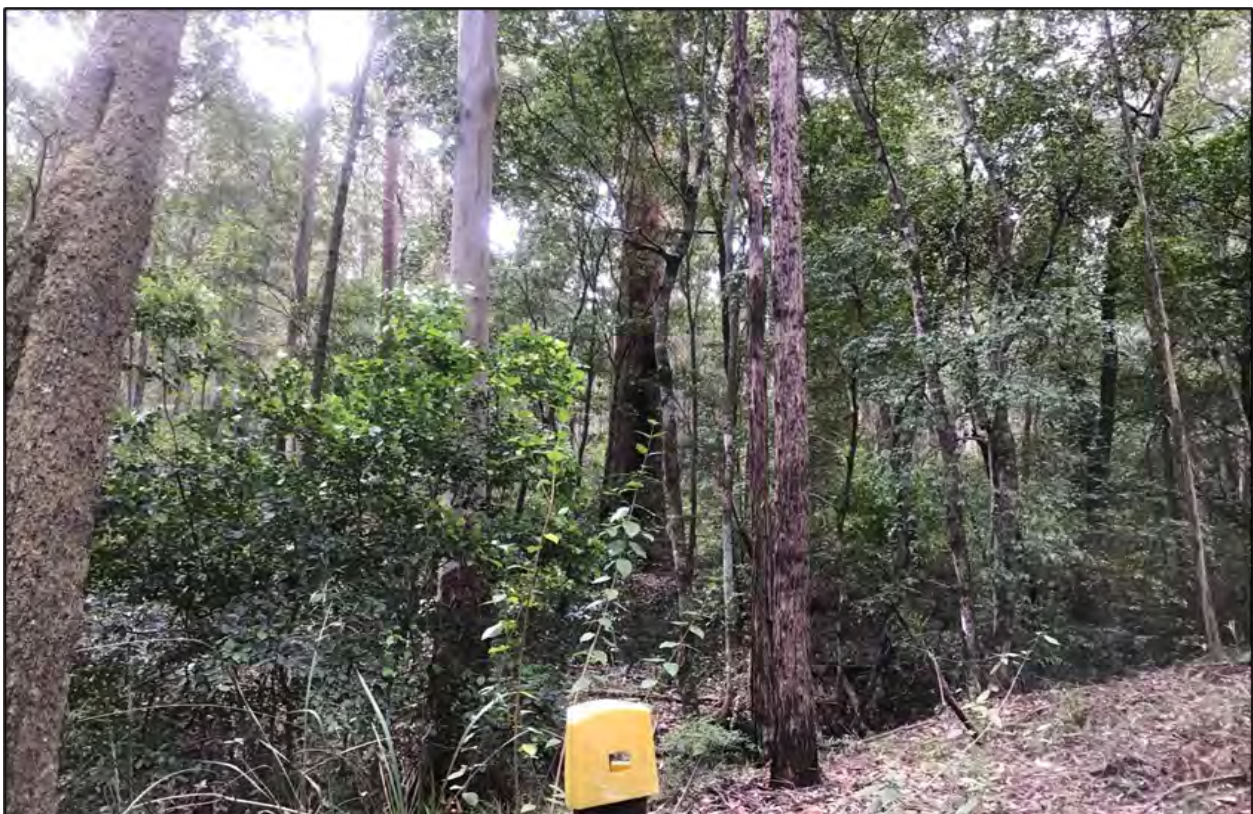
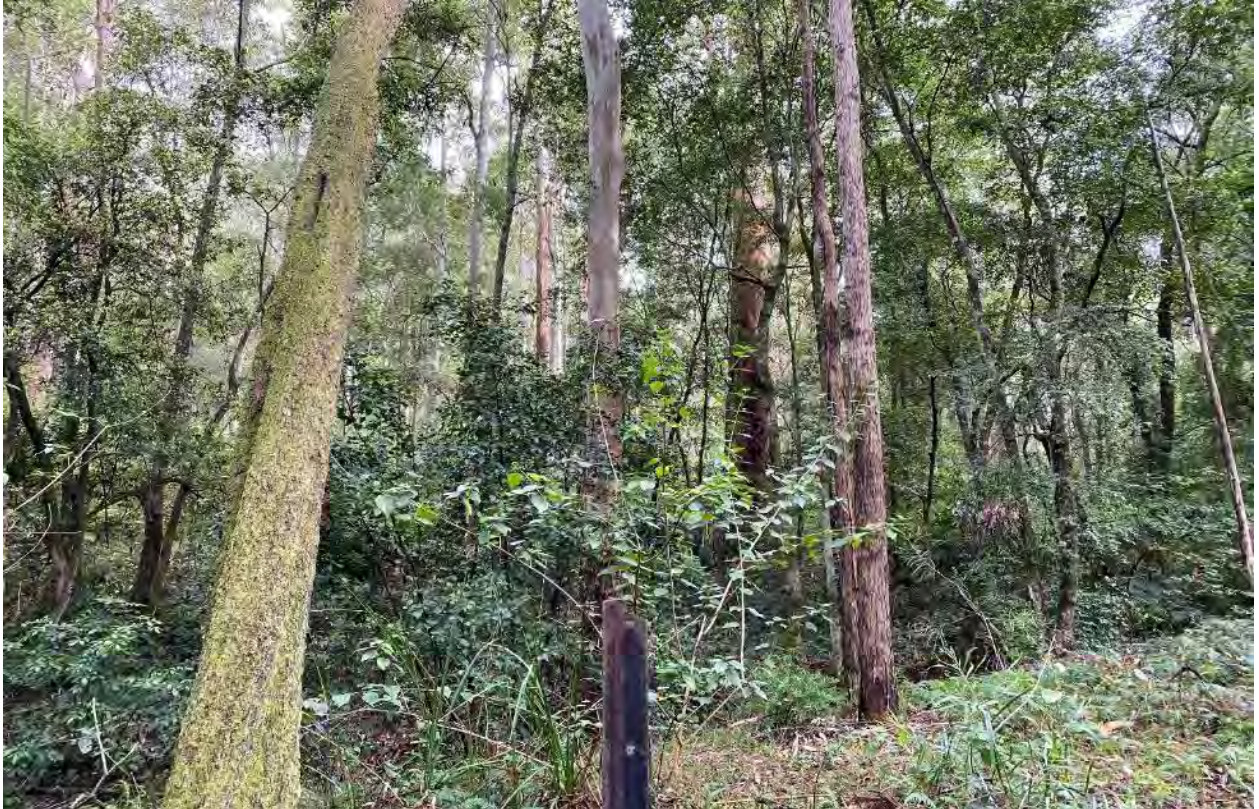
Monitoring Point 18 (MP 18)

Site	Vegetation Community	Vegetation and Habitat Condition	Evidence of Disturbance	Threatened Flora Monitoring
MP18	Brush Box - Turpentine shrubby open forest	<ul style="list-style-type: none"> All vegetation strata in healthy condition Canopy and midstorey regeneration present Low fallen timber High level of leaf litter present. Moderate ground cover Rocky areas along ephemeral creek. <p>Conclusion: No significant or notable changes in vegetation and habitat condition since the previous survey (2021).</p>	<ul style="list-style-type: none"> Very minor scouring along creek bank. No recent evidence of disturbance from grazing, pest animals, rubbish dumping, or rock / timber removal. Minor dust coverage on foliage. No signs of recent fire. <p>Conclusion: No evidence of new disturbance was observed since the previous survey (2020).</p>	<ul style="list-style-type: none"> There was a small increase in number of <i>Asperula asthenes</i> individuals within the monitoring site from 9 in 2021 to 10 in 2022. One new <i>Asperula asthenes</i> plants was recorded in 2022. Two <i>Asperula asthenes</i> plant was recorded flowering during monitoring. All <i>Asperula asthenes</i> plants within the monitoring site were observed to be in healthy condition. The population at MP 18 has declined slightly since 2015 baseline (13 individuals recorded). Previous years of below average rainfall have likely impacted this population, however with signs of plants reshooting and flowering, as well as plants sighted outside the monitoring point, this population has potential to recover.
