# **Karuah East Quarry Biodiversity Offset Area Monitoring Report**

Karuah East Quarry Biodiversity Offset Area and Lot 12

**Report prepared for:  
Hunter Quarries**

Rev 1  
22 December 2023

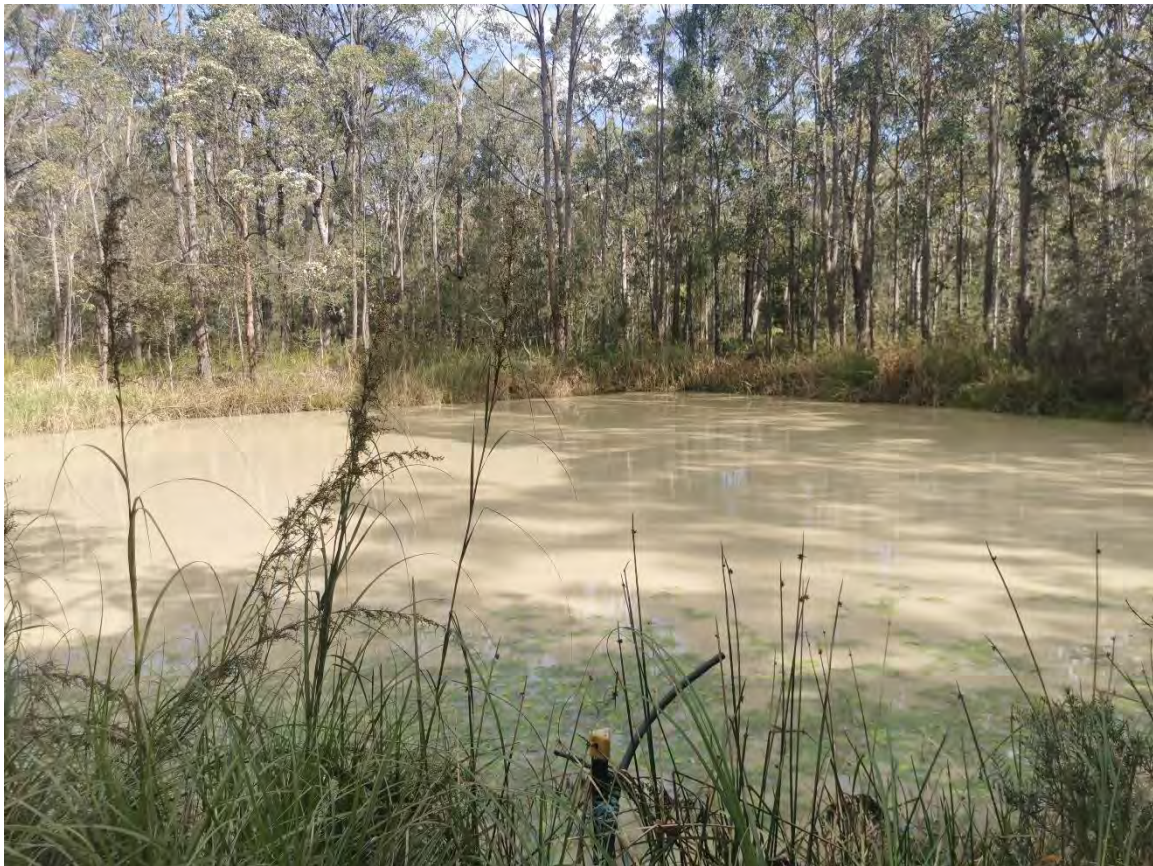
- Evidence of sedimentation and erosion has been observed in a few locations including MP14, and around the extent of the quarry along the south eastern edge of the extraction area and along the western side of the haul road into the Karuah Quarries Conservation Area (**Photo 2**, **Photo 3** and **Photo 4**

**Photo 2: Sedimentation and Erosion into the Karuah Quarry Conservation Area into Dam (2023).**

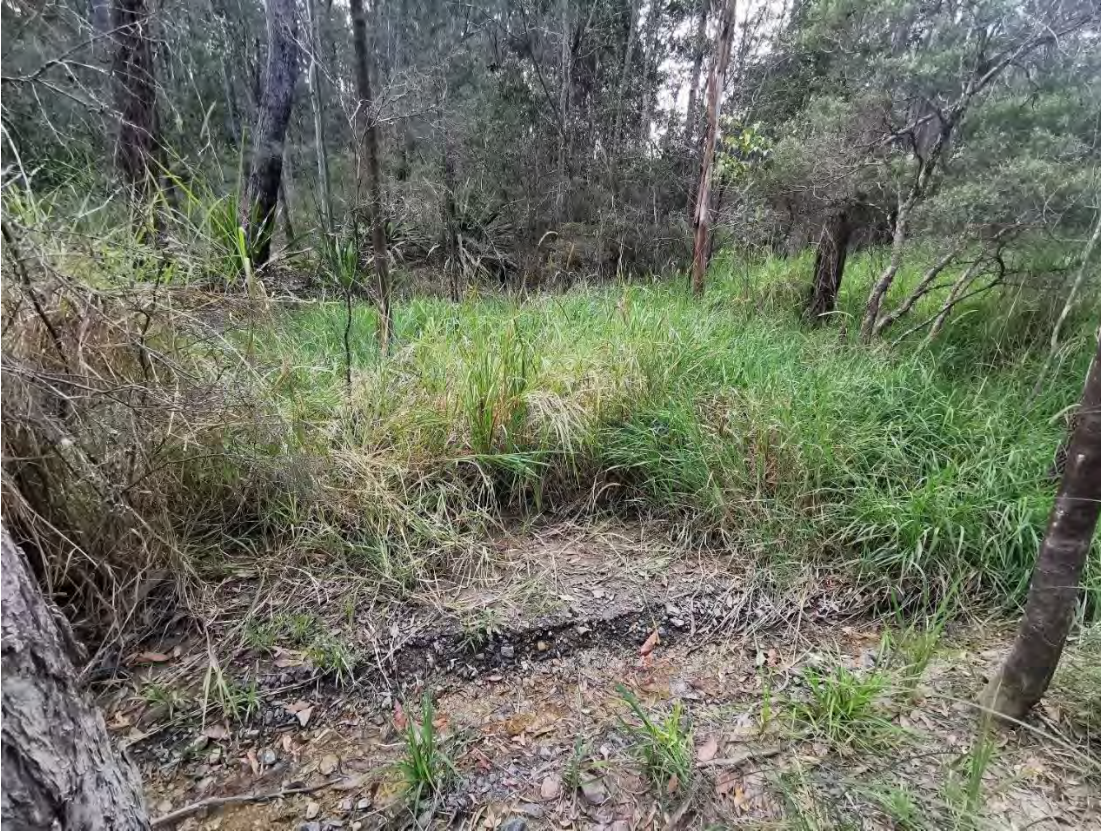
**Photo 4: Further erosion into the Karuah Quarry Conservation Area Dam and the area overgrown with *Setaria parviflora*.**

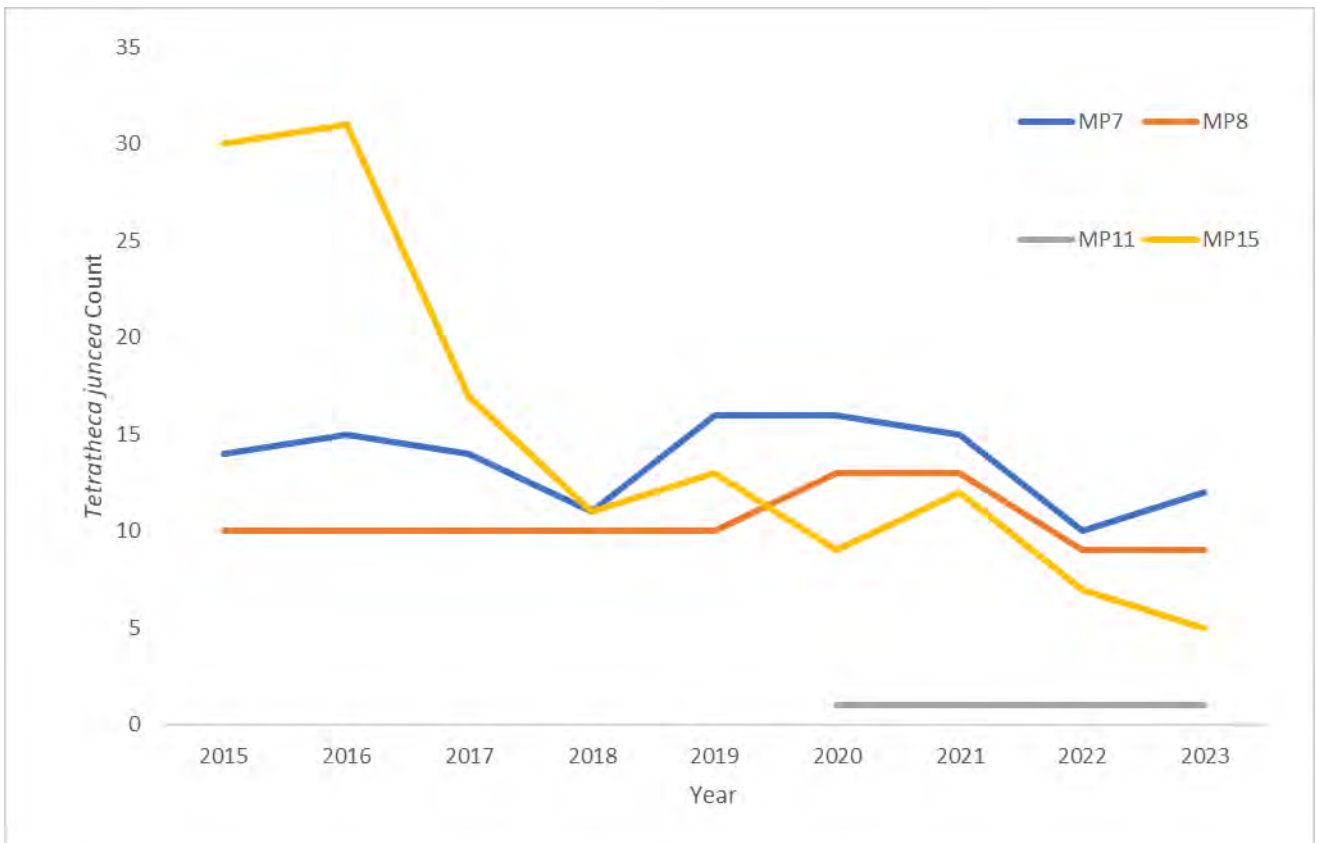
Unfortunately, a major reduction in population numbers was observed at MP15, in which less than half the original plants remain. A thick layer of dust was observed on the foliage which has seemingly increased over the years. It is likely that the reduction in plant numbers is linked to edge effects from quarry operations, i.e. increasing dust pollution. No other major disturbances were noted during monitoring (**Plate 9**).

**Plate 9: *Tetratheca juncea* abundance at monitoring sites (2015-2023)**

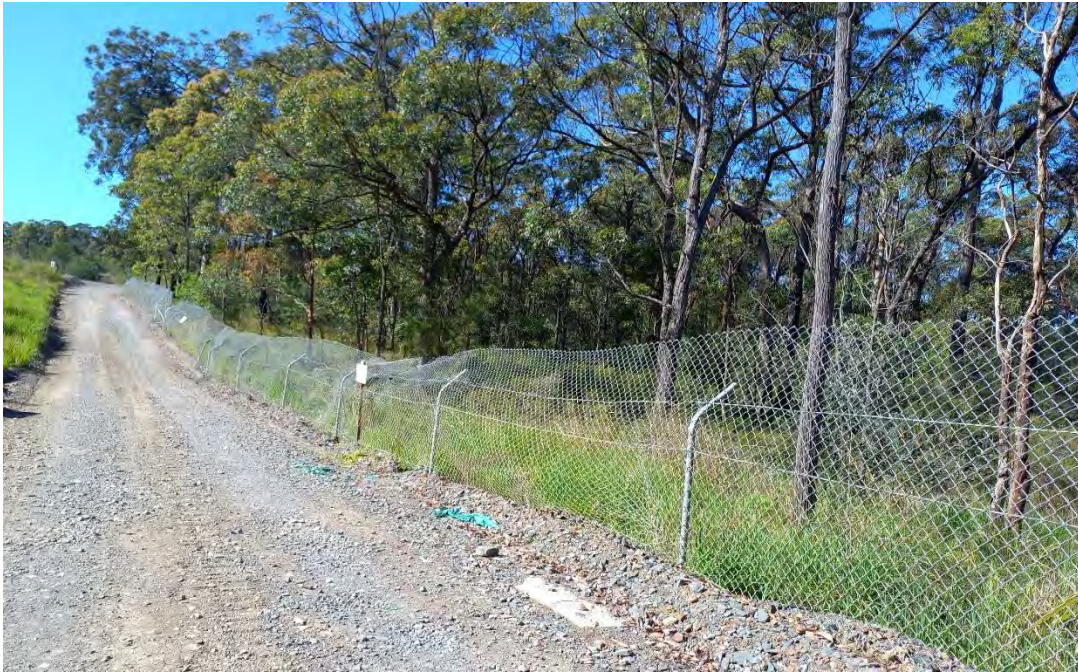
**Photo 6: Fixed fence along western boundary of haul road**

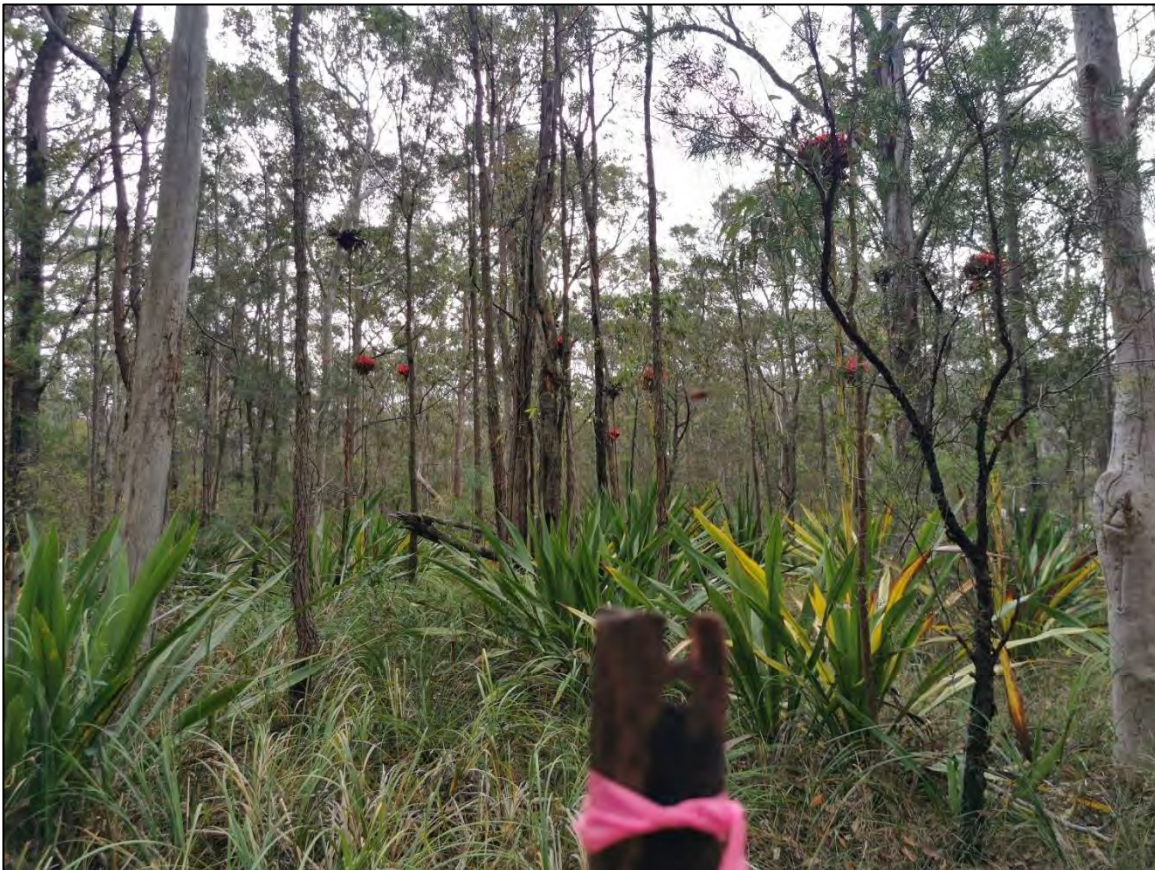
**MP 10      2023**

Site	Vegetation Community	Vegetation and Habitat Condition	Evidence of Disturbance	Threatened Flora Monitoring
MP10	Sydney Peppermint - Smooth-barked Apple shrubby open forest	<ul style="list-style-type: none"> <li>• Same PFC in midstorey from <i>Allocasuarina litoralis</i> growth as 2022.</li> <li>• All vegetation strata in healthy condition.</li> <li>• Canopy and midstorey regeneration present.</li> <li>• Low-moderate fallen timber and high litter coverage..</li> <li>• Moderate to dense ground cover.</li> </ul> <p><b>Conclusion:</b> No major changes in vegetation and habitat condition since the previous survey (2022).</p>	<ul style="list-style-type: none"> <li>• No evidence of erosion and sedimentation.</li> <li>• No recent evidence of disturbance from grazing, pest animals, rubbish dumping, rock / timber removal, or dust.</li> <li>• No signs of recent fire.</li> <li>• Three old dead stags present.</li> </ul> <p><b>Conclusion:</b> No new disturbance or changes in existing disturbance severity were observed since the previous survey (2022).</p>	N/A

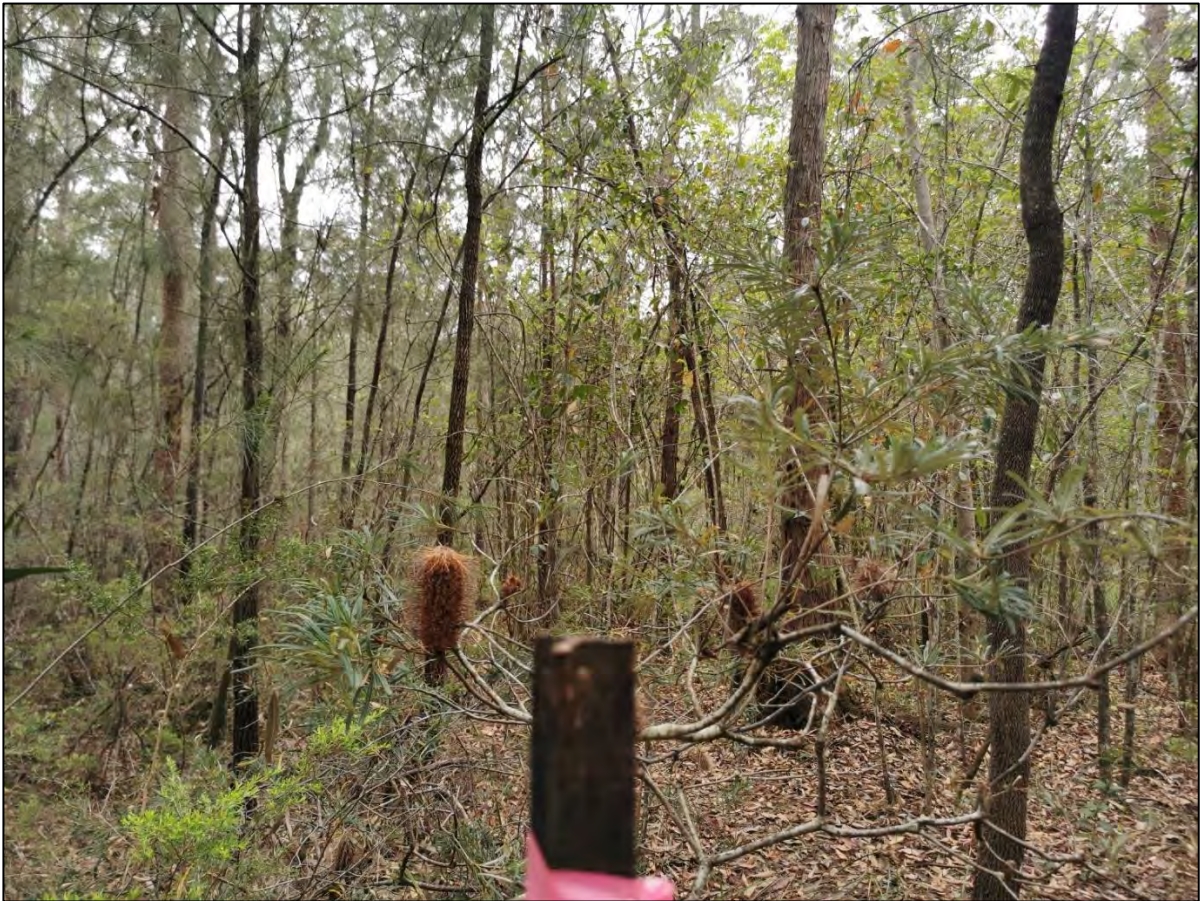
**MP 11      2023**

Site	Vegetation Community	Vegetation and Habitat Condition	Evidence of Disturbance	Threatened Flora Monitoring
MP11	Sydney Peppermint - Smooth-barked Apple shrubby open forest	<ul style="list-style-type: none"> <li>• Marginal evidence of foliage die-back.</li> <li>• All present vegetation strata in healthy condition.</li> <li>• Canopy and midstory regeneration present.</li> <li>• Low fallen timber.</li> <li>• Moderate ground cover.</li> <li>• High leaf litter coverage.</li> </ul> <p><b>Conclusion:</b> No significant or notable changes in vegetation and habitat condition since the previous survey (2022).</p>	<ul style="list-style-type: none"> <li>• No evidence of erosion and sedimentation.</li> <li>• No recent evidence of disturbance from grazing, pest animals, rubbish dumping, rock / timber removal, or dust.</li> </ul> <p><b>Conclusion:</b> No recent disturbance was observed since the previous survey (2022).</p>	<ul style="list-style-type: none"> <li>• There was a slight increase in the number of <i>Grevillea parviflora</i> subsp. <i>parviflora</i> plants recorded within the monitoring site, from 9 in 2022 to 10 in 2023.</li> <li>• One new <i>Grevillea parviflora</i> subsp. <i>parviflora</i> plants were recorded in 2023.</li> <li>• All <i>Grevillea parviflora</i> subsp. <i>parviflora</i> plants within the monitoring site were observed to be in healthy condition.</li> <li>• The <i>Grevillea parviflora</i> subsp. <i>parviflora</i> population at MP 11 has declined since 2015 baseline (16 individuals recorded).</li> <li>• The one <i>Tetratheca juncea</i> clump recorded at MP 11 in 2020 continues to be in a healthy condition with 78 flowers and 25 fruits.</li> </ul>

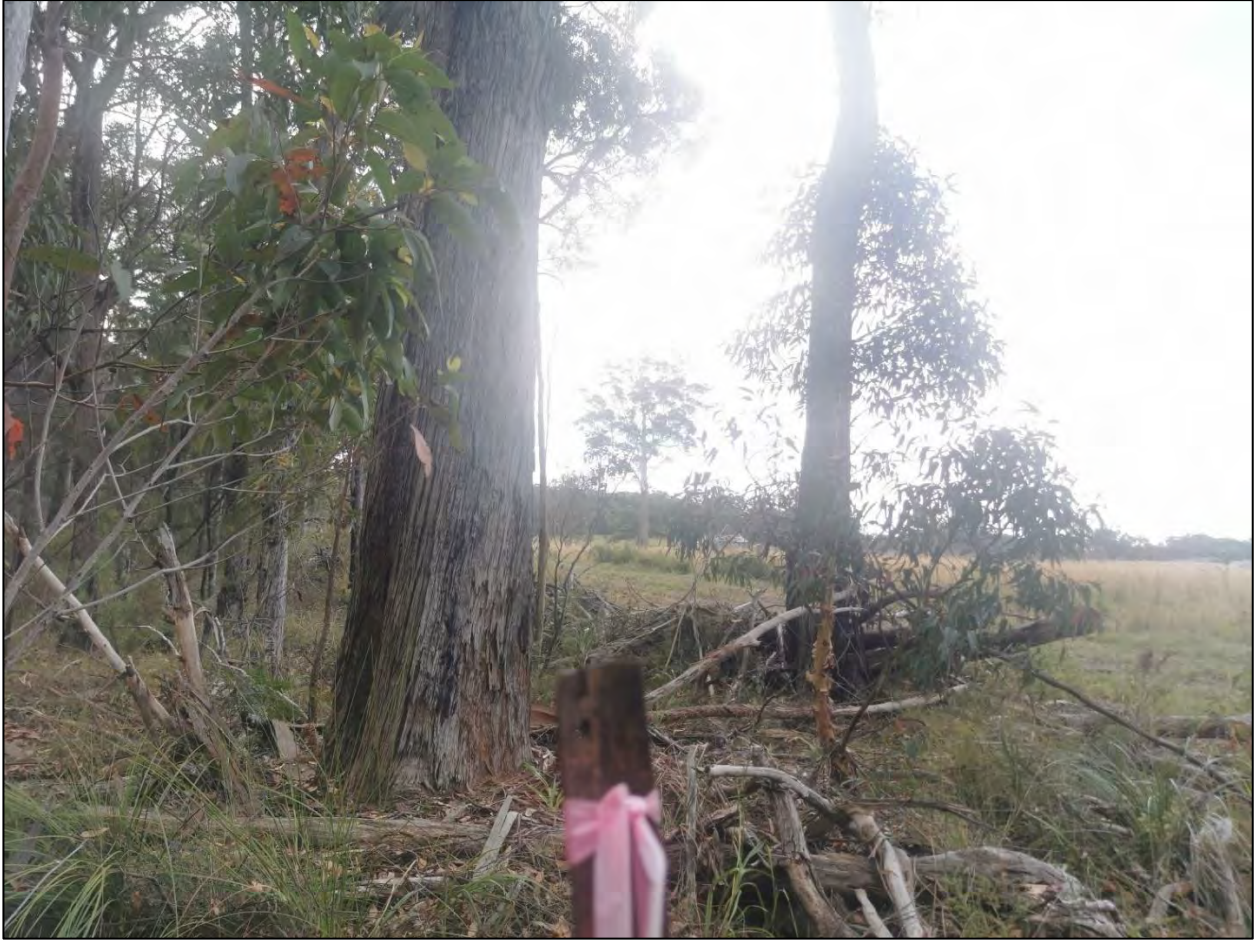
Site	Vegetation Community	Vegetation and Habitat Condition	Evidence of Disturbance	Threatened Flora Monitoring
MP12	Smooth-barked Apple – Red Bloodwood open forest	<ul style="list-style-type: none"> <li>Midstorey reduced compared to surroundings due to vehicle tracks</li> <li>Very high levels of fallen timber (from clearing).</li> <li>High leaf litter coverage.</li> <li>Moderate ground cover.</li> <li>Evidence of regeneration in understory and midstorey.</li> </ul> <p><b>Conclusion:</b> Felled timber remains (from previous impact due to fence maintenance), however, no significant changes have occurred to vegetation and habitat condition since the previous survey (2022).</p>	<ul style="list-style-type: none"> <li>No evidence of erosion and sedimentation.</li> <li>Area has been previously subject to clearing due to fence line maintenance.</li> <li>Clearing and log stockpiling in order to maintain an adjacent access track has impacted some of the vegetation including at least three <i>Grevillea parviflora</i> individuals.</li> </ul> <p><b>Conclusion:</b> Excluding the maintenance of an adjacent accessway, no evidence of new disturbance was observed since the previous survey (2022).</p>	<ul style="list-style-type: none"> <li>There was a same number of <i>Grevillea parviflora</i> subsp. <i>parviflora</i> plants recorded within the monitoring site, 2022 to 2023 (7).</li> <li>All <i>Grevillea parviflora</i> subsp. <i>parviflora</i> plants within the monitoring site were observed to be in healthy condition.</li> <li>All 7 <i>Grevillea parviflora</i> subsp. <i>parviflora</i> plants were recorded with flowers in 2023 with one individual fruiting.</li> <li>The <i>Grevillea parviflora</i> subsp. <i>parviflora</i> population at MP 11 remains stable with surveys completed in 2015 (7 individuals recorded).</li> </ul>

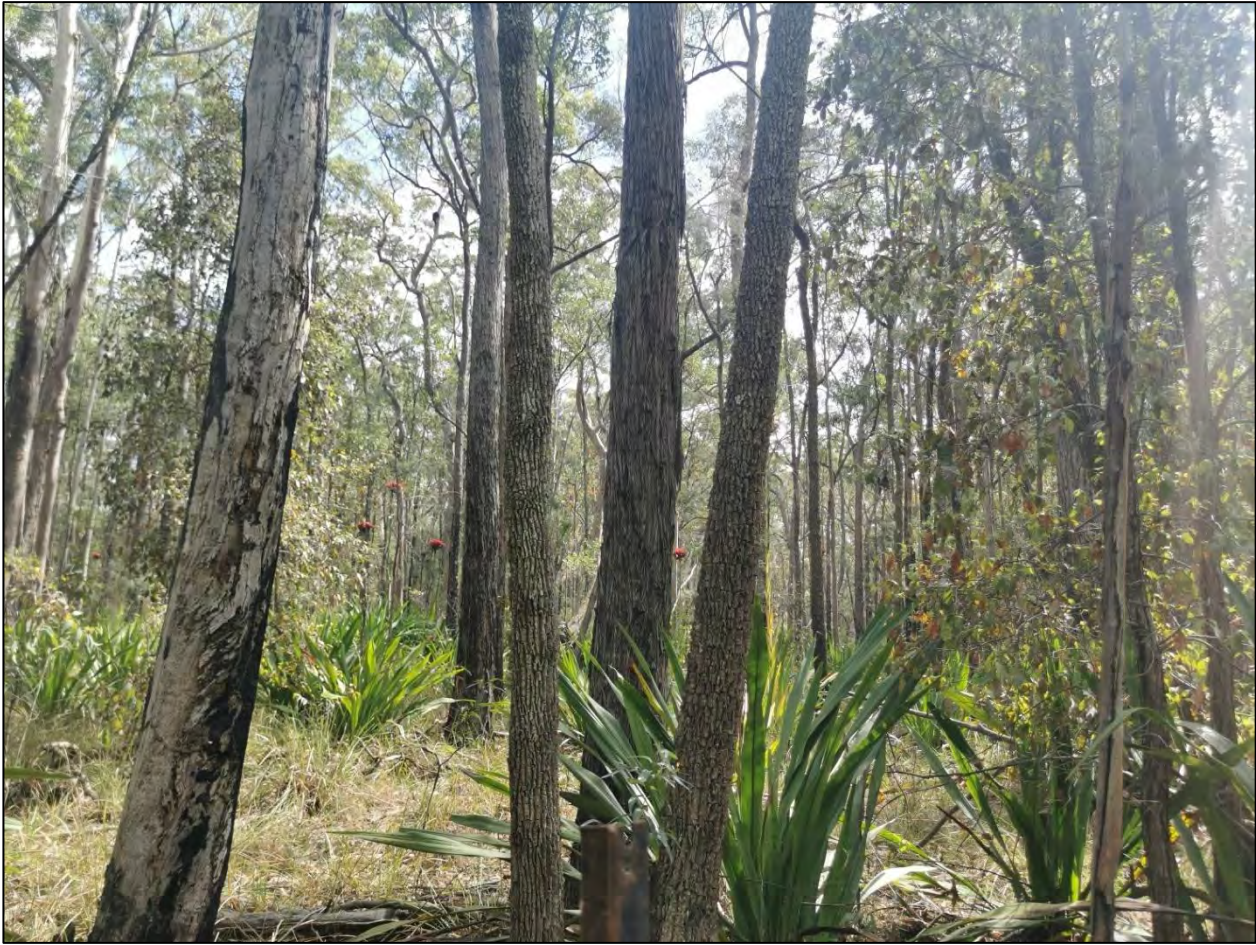
MP13	Spotted Gum – Grey Ironbark open forest	<ul style="list-style-type: none"> <li>Minimal dieback in mature <i>Allocasuarina torulosa</i> individuals although healthy regeneration is observed within the canopy and midstorey.</li> <li>Low level of fallen logs / timber.</li> <li>Dense ground cover.</li> <li>Low rock cover.</li> <li>Eucalypt and Midstorey seedlings present.</li> </ul> <p><b>Conclusion:</b> Regeneration is occurring within the monitoring point with minimal dieback of <i>A.torulosa</i>.</p>	<ul style="list-style-type: none"> <li>No evidence of erosion and sedimentation.</li> <li>No recent evidence of disturbance from grazing, pest animals, rubbish dumping, rock / timber removal, or dust.</li> <li>Significant dust settlement recorded here in 2022.</li> </ul> <p><b>Conclusion:</b> No evidence of new disturbance was observed since the previous survey (2022).</p>	N/A

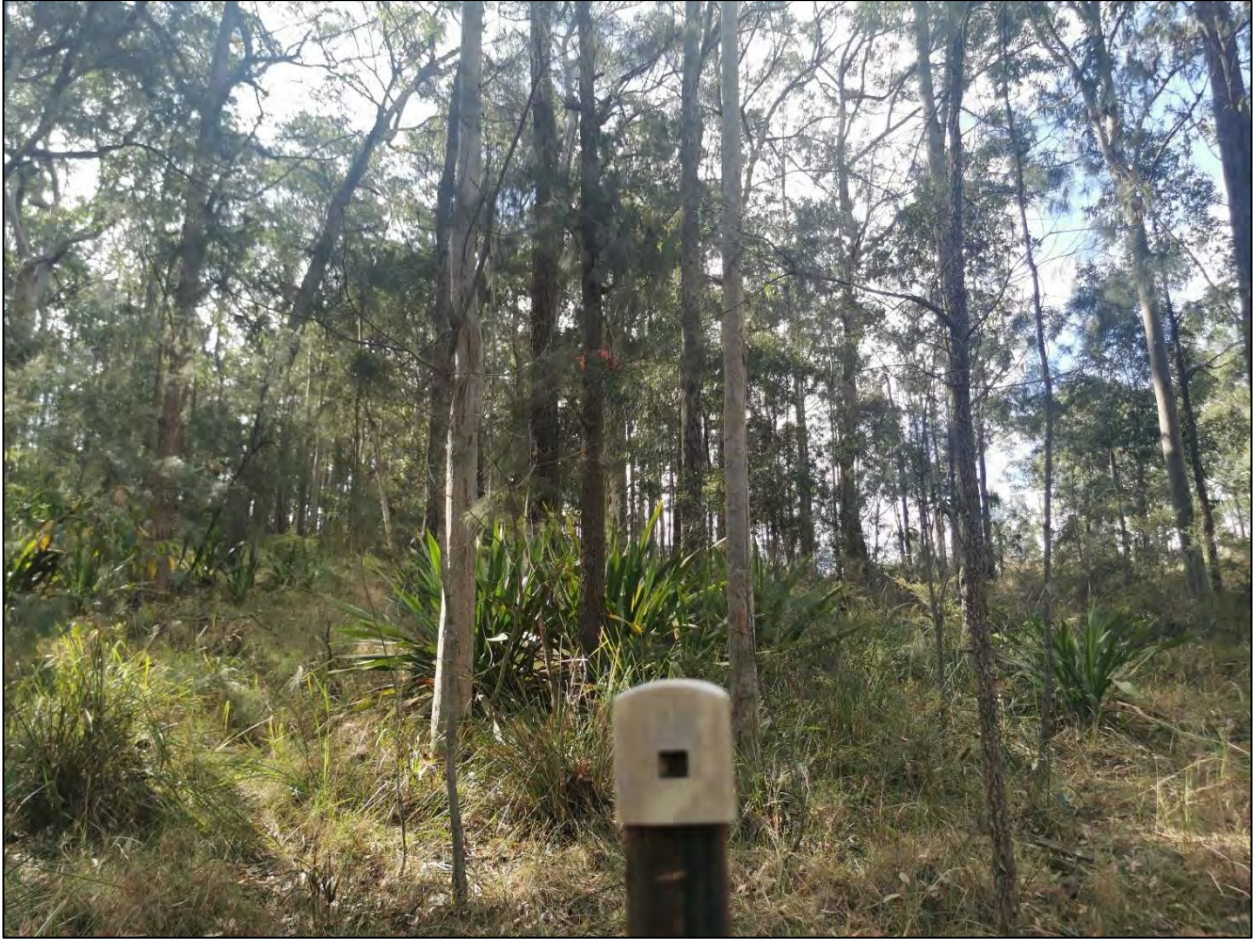
Site	Vegetation Community	Vegetation and Habitat Condition	Evidence of Disturbance	Threatened Flora Monitoring
MP14	Smooth-barked Apple - Red Bloodwood open forest	<ul style="list-style-type: none"> <li>• Five individual <i>Setaria sphacelata</i>.</li> <li>• Most vegetation strata in healthy condition.</li> <li>• Canopy and midstorey regeneration present.</li> <li>• Low fallen/ timber.</li> <li>• Dense ground and leaf litter cover.</li> </ul> <p><b>Conclusion:</b> No significant or notable changes in vegetation and habitat condition since the previous survey (2022).</p>	<ul style="list-style-type: none"> <li>• Evidence of sedimentation of quarry rock material adjacent to monitoring plot from haul road into the nearby dam.</li> <li>• Dust accumulation on foliage from Quarry.</li> <li>• Moderate cover of exotic grasses around dam to south and along access track.</li> </ul> <p><b>Conclusion:</b> Prevailing evidence of sedimentation was observed since the previous survey (2022).</p>	N/A

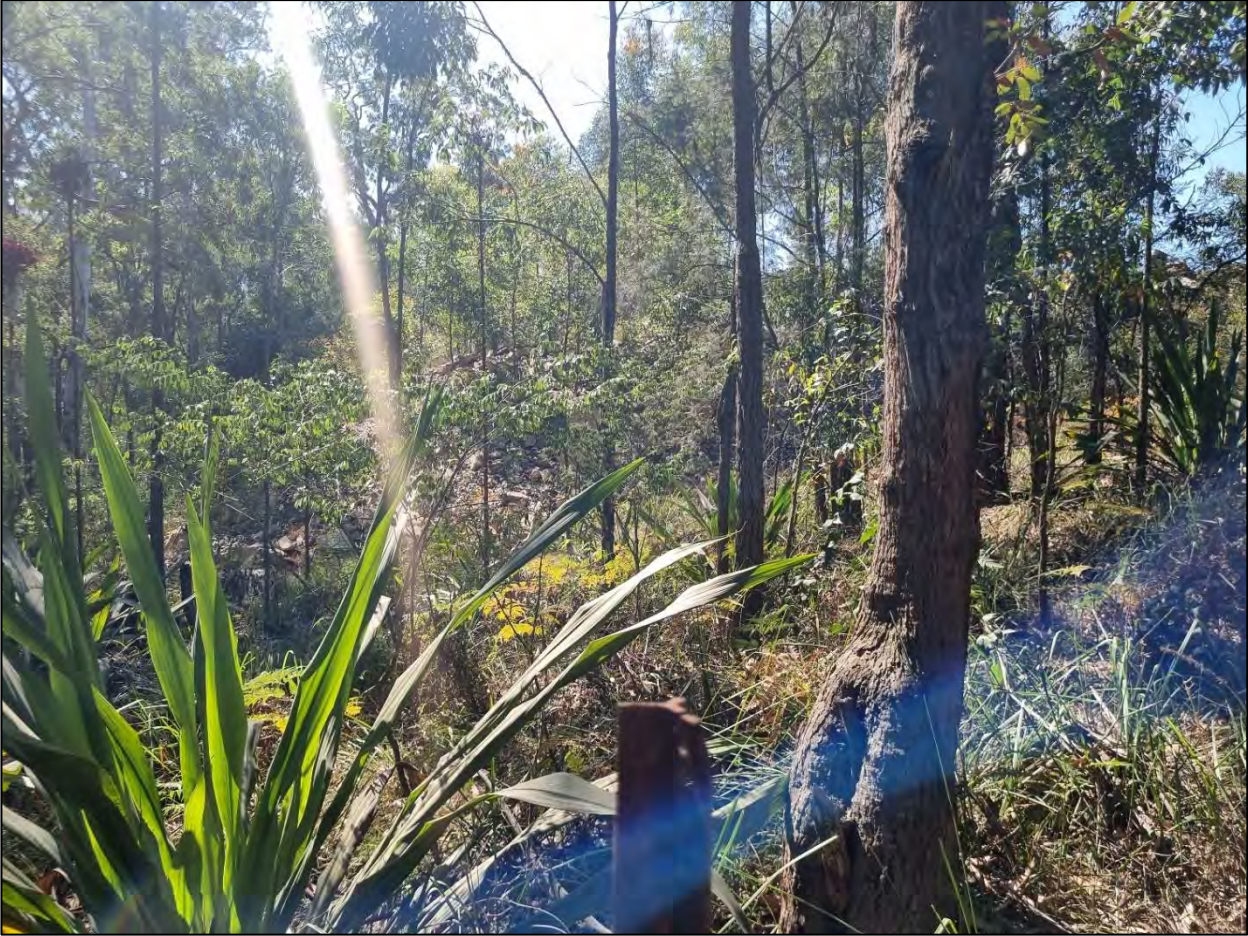
Site	Vegetation Community	Vegetation and Habitat Condition	Evidence of Disturbance	Threatened Flora Monitoring
MP15	Blackbutt - Turpentine - Tallowood shrubby open forest	<ul style="list-style-type: none"> <li>• Marginal increase in Canopy cover since the 2022 survey.</li> <li>• All vegetation strata in moderately healthy condition.</li> <li>• Moderate fallen timber.</li> <li>• Dense ground cover and leaf litter.</li> <li>• Rocky areas in low abundance.</li> </ul> <p><b>Conclusion:</b> Only minor changes in vegetation and habitat condition since the previous survey (2022).</p>	<ul style="list-style-type: none"> <li>• No evidence of erosion and sedimentation.</li> <li>• There are some edge effects from adjacent clearing.</li> <li>• Thick dust coating on foliage.</li> </ul> <p><b>Conclusion:</b> Dust cover on foliage was observed within the monitoring site in 2022 and again in 2023 seemingly becoming thicker.</p>	<ul style="list-style-type: none"> <li>• There was a decrease in the number of <i>Tetratheca juncea</i> clumps recorded within the monitoring site, from 7 in 2021, to 5 in 2023.</li> <li>• One new <i>Tetratheca juncea</i> clump was recorded in 2022 but was not detected in 2023.</li> <li>• All 5 <i>Tetratheca juncea</i> plants were recorded flowering during monitoring.</li> <li>• No <i>Tetratheca juncea</i> plants were recorded with fruits during monitoring.</li> <li>• All <i>Tetratheca juncea</i> plants within the monitoring site were observed to be in healthy condition.</li> <li>• The <i>Tetratheca juncea</i> population at MP 15 has declined since 2015 baseline (30 individuals recorded). This decline in the <i>T. juncea</i> at MP 15 is most likely due to the lower than average rainfall during 2019, exacerbated by the location of the monitoring point; upper slopes of exposed hill side and thick dust cover.</li> </ul>

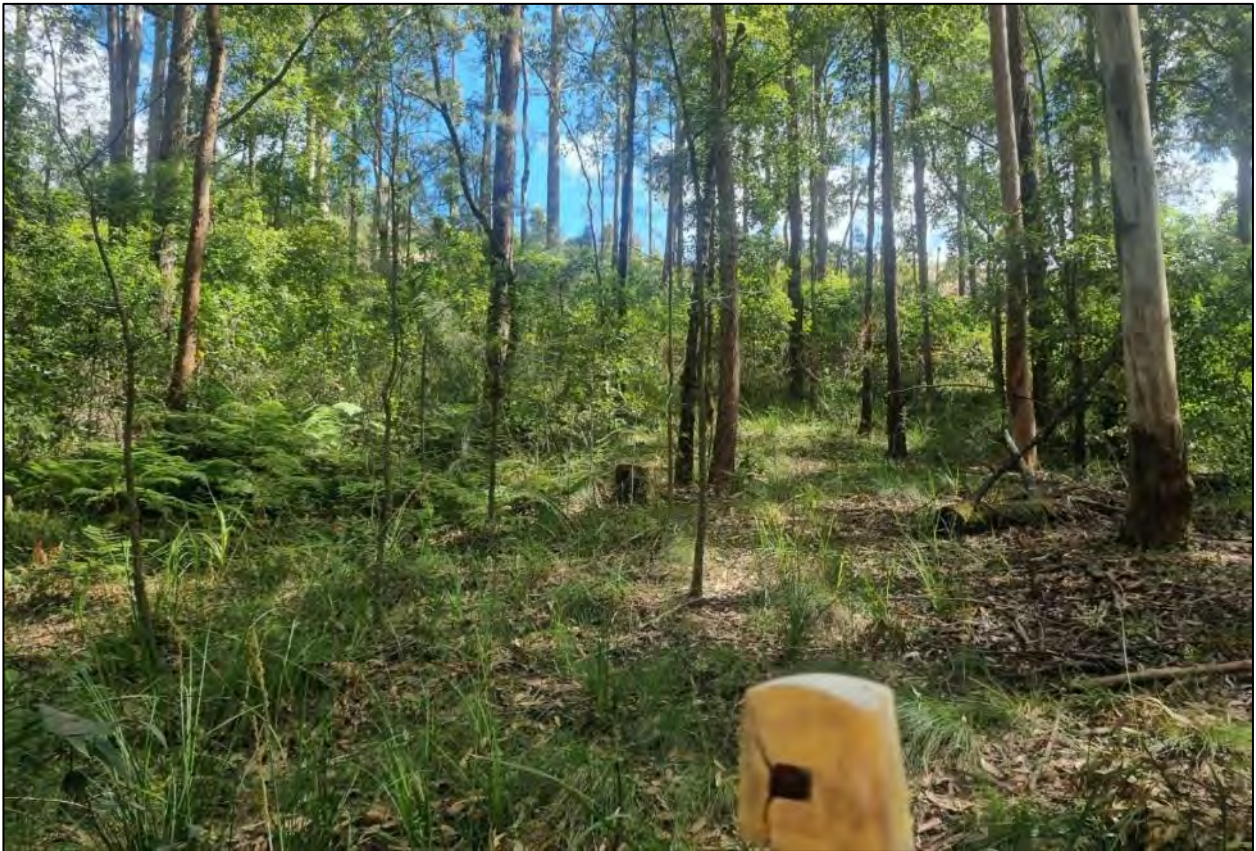
**MP 16      2022**

Site	Vegetation Community	Vegetation and Habitat Condition	Evidence of Disturbance	Threatened Flora Monitoring
MP16	Spotted Gum – Grey Ironbark open forest	<ul style="list-style-type: none"> <li>Increased non-grass groundcover in response to increased <i>Doodia aspera</i> abundance that has stabilized since previous monitoring.</li> <li>All vegetation strata in healthy condition.</li> <li>Canopy and midstory regeneration present.</li> <li>Moderate fallen timber.</li> <li>Dense leaf litter and moderate ground cover.</li> </ul> <p><b>Conclusion:</b> Minor changes in vegetation and habitat condition since the previous survey (2022).</p>	<ul style="list-style-type: none"> <li>No evidence of erosion and sedimentation.</li> <li>No recent evidence of disturbance from grazing, pest animals, rubbish dumping, rock / timber removal.</li> <li>Very high dust cover.</li> </ul> <p><b>Conclusion:</b> Very high dust cover that has increased since previous monitoring (2022). No evidence of new disturbance was observed.</p>	<ul style="list-style-type: none"> <li><i>Asperula asthenes</i> detected within monitoring plot for first time (2021).</li> <li>Six individual plants identified in 2022 and all remain in 2023.</li> <li>Two <i>Asperula asthenes</i> plants were recorded flowering during monitoring.</li> <li>All <i>Asperula asthenes</i> plants within the monitoring site were observed to be in healthy condition</li> </ul>

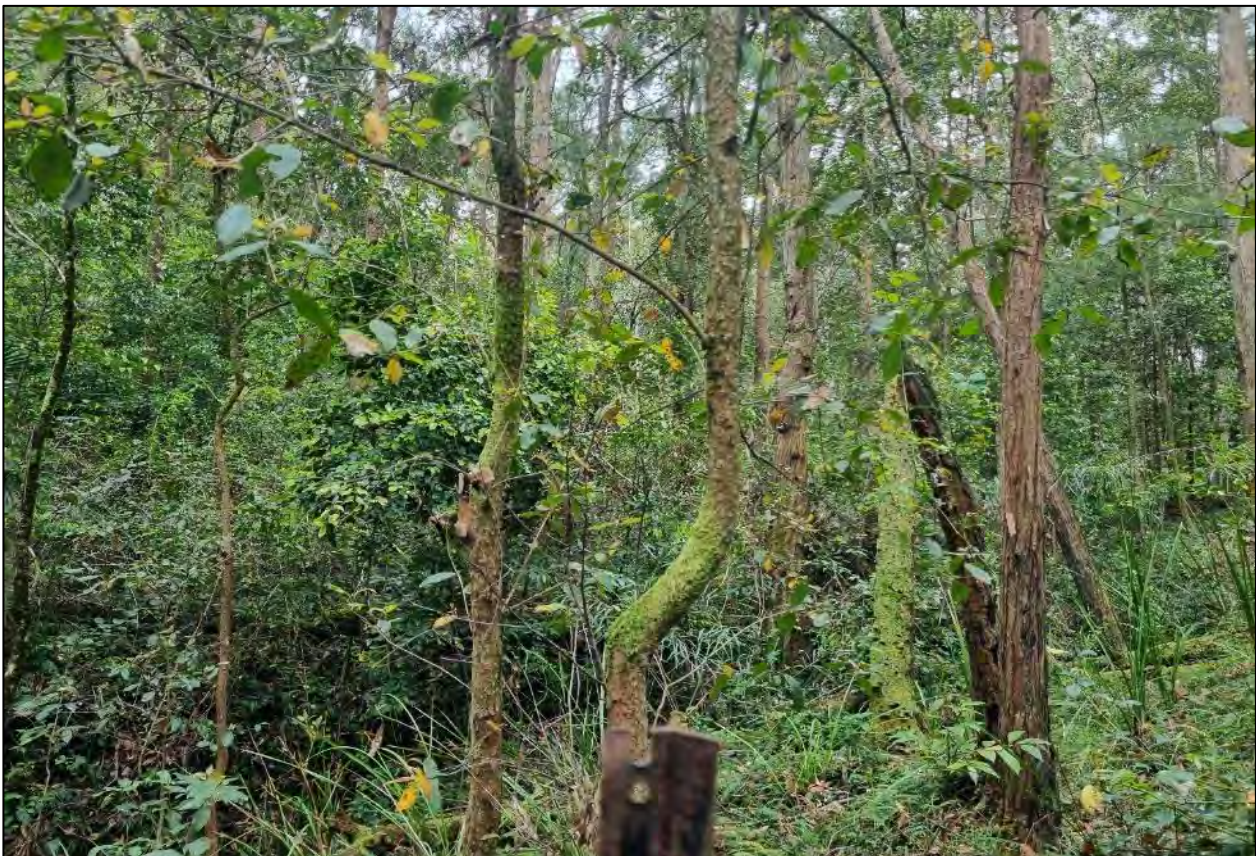
**MP 17      2022**

Site	Vegetation Community	Vegetation and Habitat Condition	Evidence of Disturbance	Threatened Flora Monitoring
MP17	Brush Box - Turpentine shrubby open forest	<ul style="list-style-type: none"> <li>No evidence of foliage die-back, evidence of midstorey and canopy regeneration.</li> <li>All vegetation strata in healthy condition.</li> <li>Abundance of juvenile <i>Backhousia myrtifolia</i> in midstorey, subsequently increasing mid-storey cover.</li> <li><i>Lantana camara</i> abundance remains stable.</li> <li>Moderate fallen timber.</li> <li>Moderate ground cover.</li> <li>Rocky areas along ephemeral creek.</li> </ul> <p><b>Conclusion:</b> No significant or notable changes in vegetation and habitat condition since the previous survey (2022).</p>	<ul style="list-style-type: none"> <li>Very minor scouring along creek bank.</li> <li>No recent evidence of disturbance from grazing, pest animals, rubbish dumping, rock / timber removal.</li> <li>Moderate dust cover on foliage.</li> <li>Stable exotic plant community (<i>Lantana camara</i>).</li> <li>No signs of recent fire.</li> <li>Dirty water running within the creek after recent rainfall.</li> </ul> <p><b>Conclusion:</b> No evidence of new disturbance observed since the previous survey (2022). Creek water remains polluted.</p>	<ul style="list-style-type: none"> <li>There was a decrease in number of <i>Asperula asthenes</i> individuals within the monitoring site from 10 in 2021 to 6 in 2022 and 6 plants remain in 2023</li> <li>Four <i>Asperula asthenes</i> plants were recorded flowering during monitoring.</li> <li>All <i>Asperula asthenes</i> plants within the monitoring site were observed to be in healthy condition.</li> <li>The population at MP 17 has decreased since 2015 baseline (11 individuals recorded).</li> </ul>

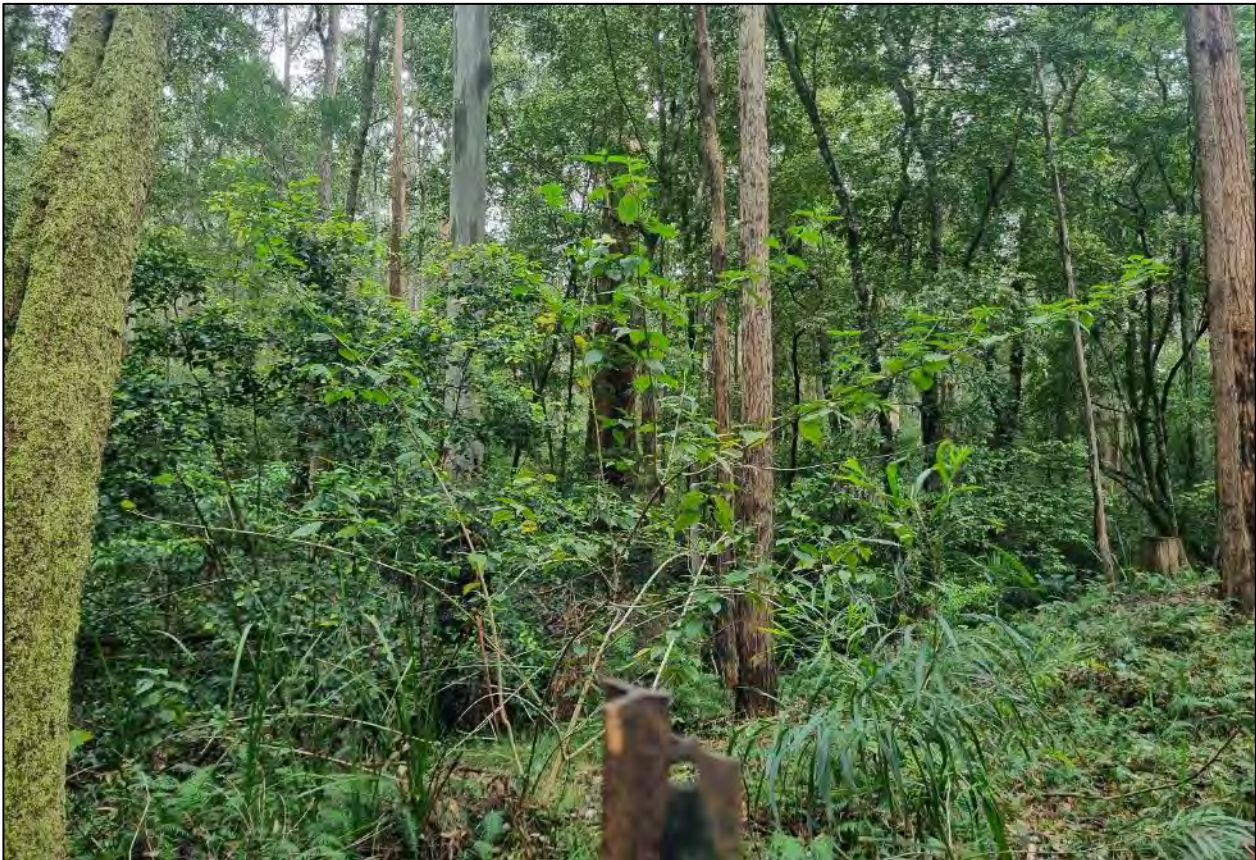
**MP 18      2022**

Site	Vegetation Community	Vegetation and Habitat Condition	Evidence of Disturbance	Threatened Flora Monitoring
MP18	Brush Box - Turpentine shrubby open forest	<ul style="list-style-type: none"> <li>All vegetation strata in healthy condition</li> <li>Canopy and midstorey regeneration present</li> <li>Low fallen timber</li> <li>High level of leaf litter present.</li> <li>High leaf litter and ground cover</li> <li>Rocky areas along ephemeral creek.</li> </ul> <p><b>Conclusion:</b> No significant or notable changes in vegetation and habitat condition since the previous survey (2022).</p>	<ul style="list-style-type: none"> <li>Very minor scouring along creek bank.</li> <li>No recent evidence of disturbance from grazing, pest animals, rubbish dumping, or rock / timber removal.</li> <li>Moderate dust coverage on foliage.</li> </ul> <p><b>Conclusion:</b> No evidence of new disturbance was observed since the previous survey (2022).</p>	<ul style="list-style-type: none"> <li>There was a small increase in number of <i>Asperula asthenes</i> individuals within the monitoring site from 10 in 2022 to 11 in 2023.</li> <li>One new <i>Asperula asthenes</i> plants was recorded in 2023.</li> <li>Four <i>Asperula asthenes</i> plant was recorded flowering during monitoring.</li> <li>All <i>Asperula asthenes</i> plants within the monitoring site were observed to be in healthy condition.</li> <li>The population at MP 18 has declined slightly since 2015 baseline (13 individuals recorded). Previous years of below average rainfall have likely impacted this population, however with signs of plants reshooting and flowering, as well as plants sighted outside the monitoring point, this population has potential to recover.</li> </ul>
