Karuah East Quarry Biodiversity Offset Area Monitoring Report

Karuah East Quarry Biodiversity Offset Area and Lot 12

Rev 1
22 December 2023

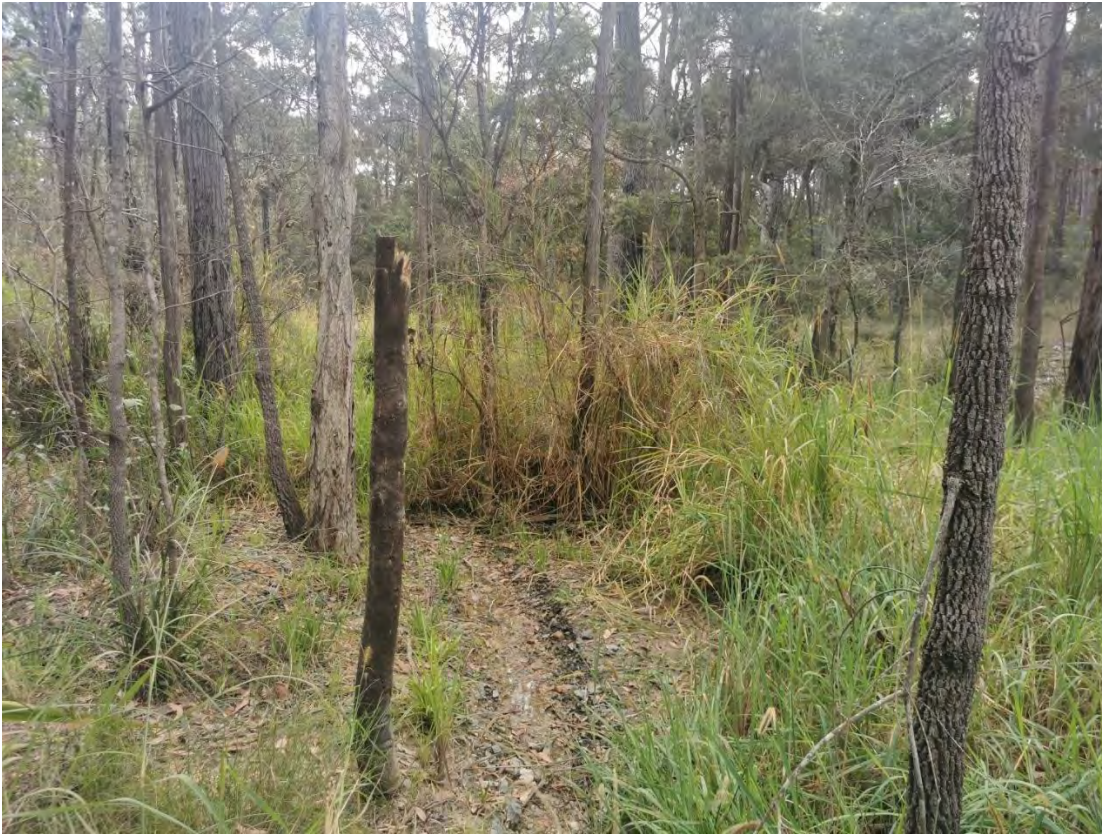
- Evidence of sedimentation and erosion has been observed in a few locations including MP14, and around the extent of the quarry along the south eastern edge of the extraction area and along the western side of the haul road into the Karuah Quarries Conservation Area (**Photo 2**, **Photo 3** and **Photo 4**

Photo 3: Erosion into the Karuah Quarry Conservation Area Dam and the area overgrown with *Setaria sphacelata*.

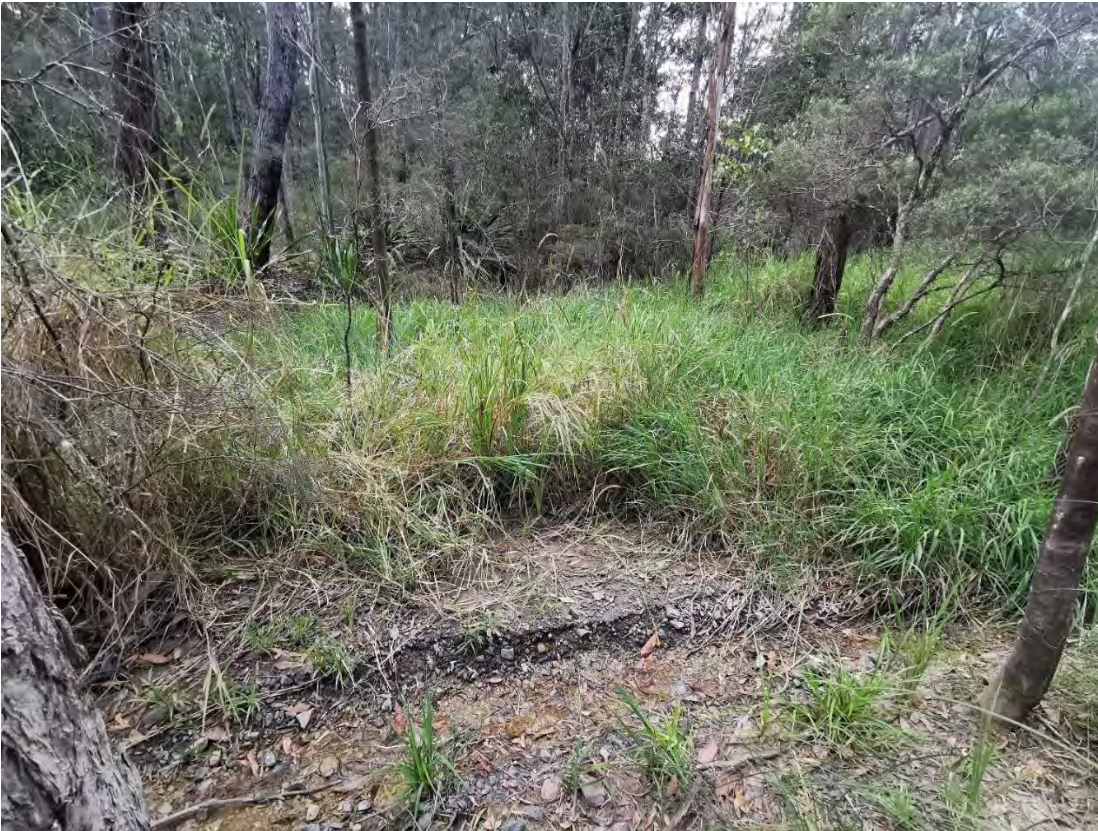
Photo 4: Further erosion into the Karuah Quarry Conservation Area Dam and the area overgrown with *Setaria parviflora*.

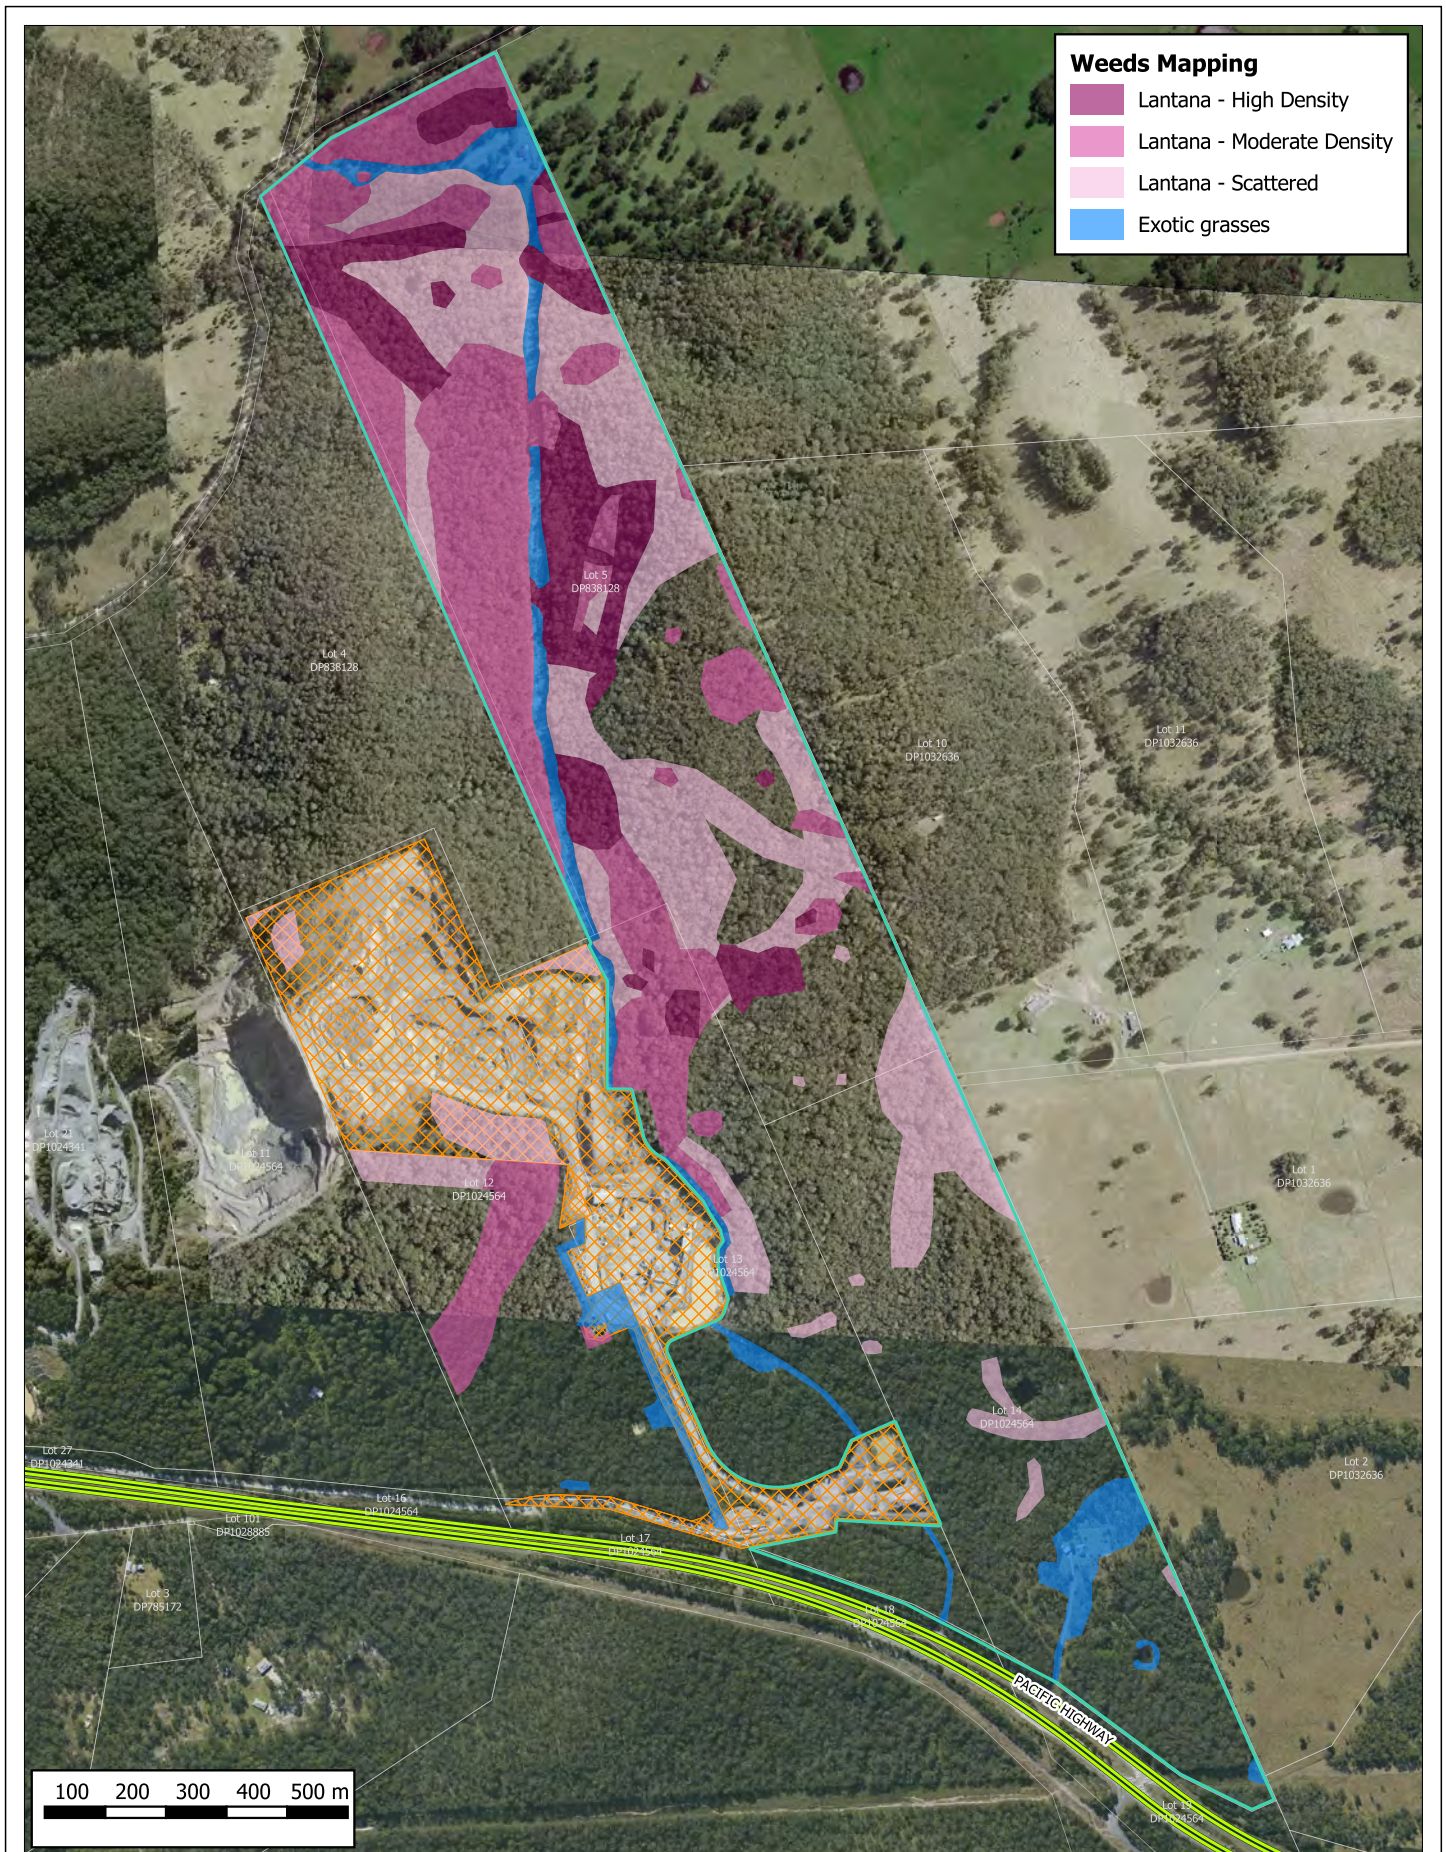
Weed mapping was conducted across the BOA during field surveys on the 28th and 29th 2023, within the project disturbance area, within 50 m of the project disturbance area, and along Yalimbah Creek on Lot 12. The resulting weed map (**Figure 5**) illustrates the cover of the most abundant weed species across the site, *Lantana camara* var. *camara* (Lantana) (Priority Weed within the MidCoast LGA). As with previous monitoring events, major infestations occur throughout the site, with most infestations occurring across the northern extent of the BOA (**Figure 5**).

Notable areas of exotic perennial grasses previously mapped along road and track sides, were recorded again in 2023 (**Figure 5**). The dominant exotic grass species in these areas include *Setaria sphacelata* (South African Pigeon Grass), *Andropogon virginicus* (Whisky Grass), and *Axonopus fissifolius* (Narrow-leaved Carpet Grass), as well as a variety of annual and perennial exotic herbs. The areas dominated by exotic grasses are primarily restricted to the power line easement, around

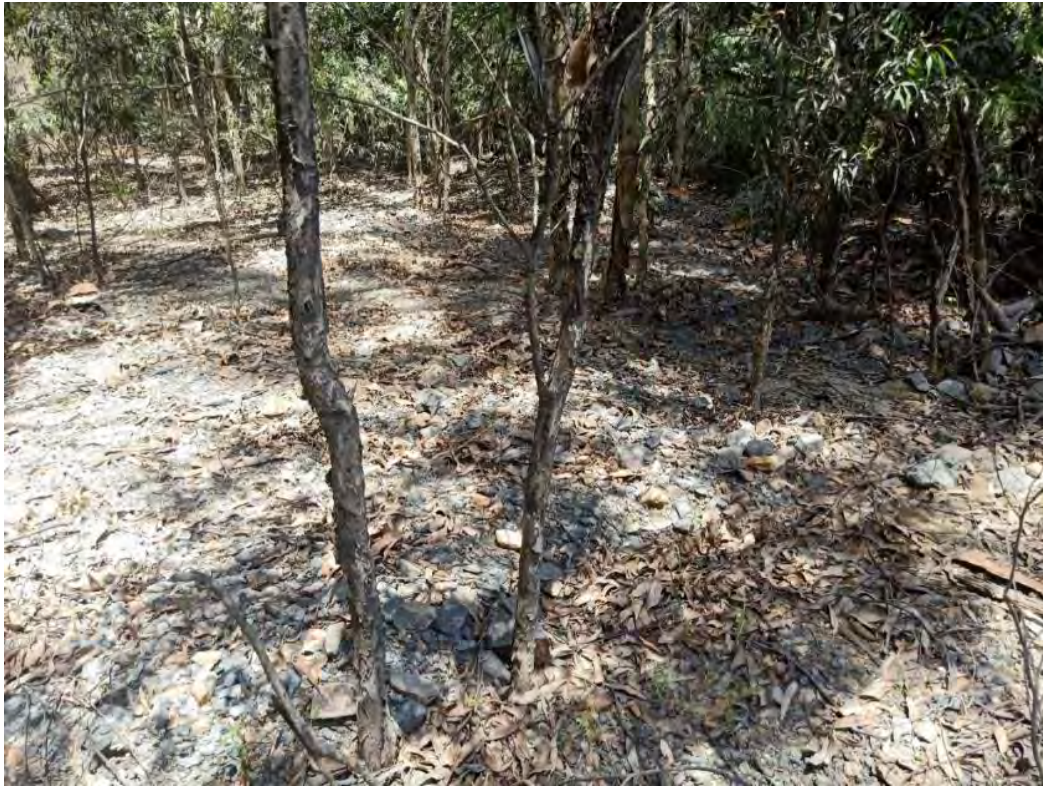
Photo 10: Excavated rock and sediment that has runoff from the eastern boundary of the quarry into the BOA.

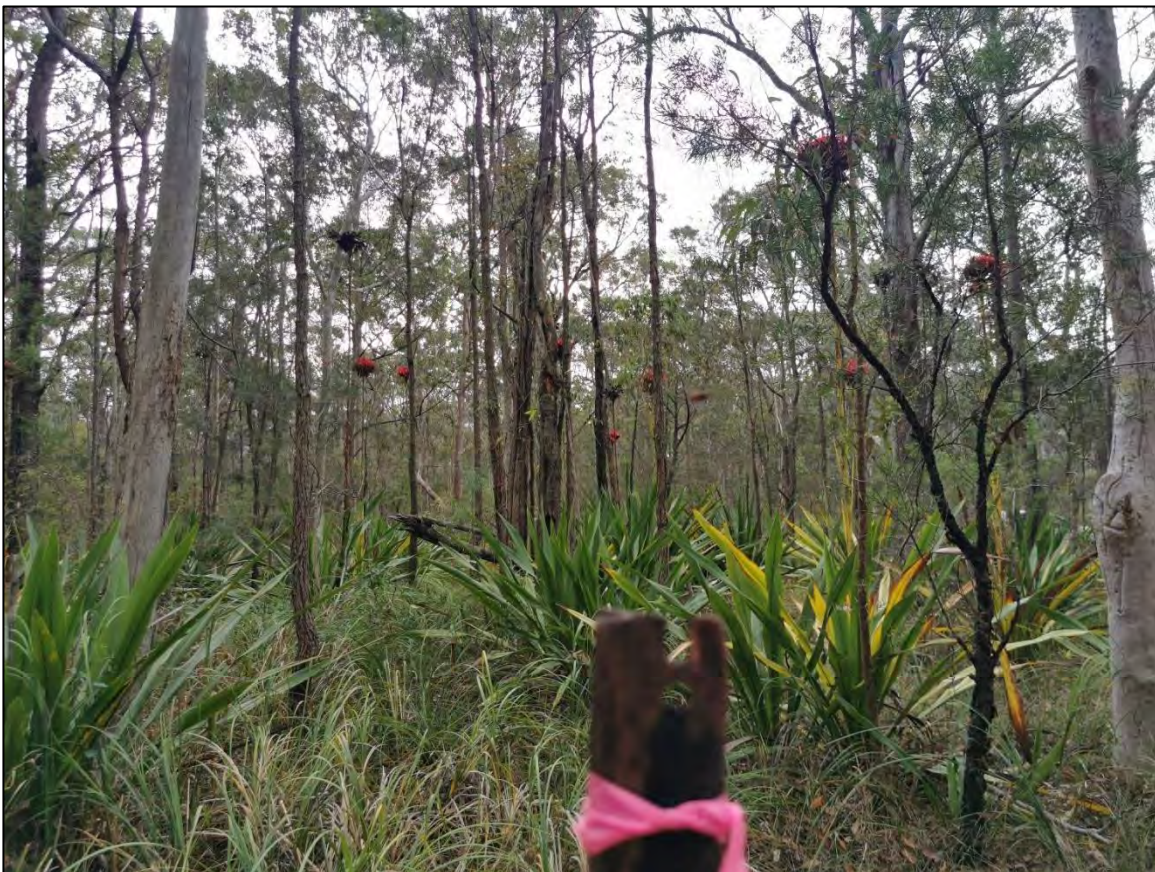
MP 10 2023

Site	Vegetation Community	Vegetation and Habitat Condition	Evidence of Disturbance	Threatened Flora Monitoring
MP10	Sydney Peppermint - Smooth-barked Apple shrubby open forest	<ul style="list-style-type: none"> • Same PFC in midstorey from <i>Allocasuarina litoralis</i> growth as 2022. • All vegetation strata in healthy condition. • Canopy and midstorey regeneration present. • Low-moderate fallen timber and high litter coverage.. • Moderate to dense ground cover. <p>Conclusion: No major changes in vegetation and habitat condition since the previous survey (2022).</p>	<ul style="list-style-type: none"> • No evidence of erosion and sedimentation. • No recent evidence of disturbance from grazing, pest animals, rubbish dumping, rock / timber removal, or dust. • No signs of recent fire. • Three old dead stags present. <p>Conclusion: No new disturbance or changes in existing disturbance severity were observed since the previous survey (2022).</p>	N/A

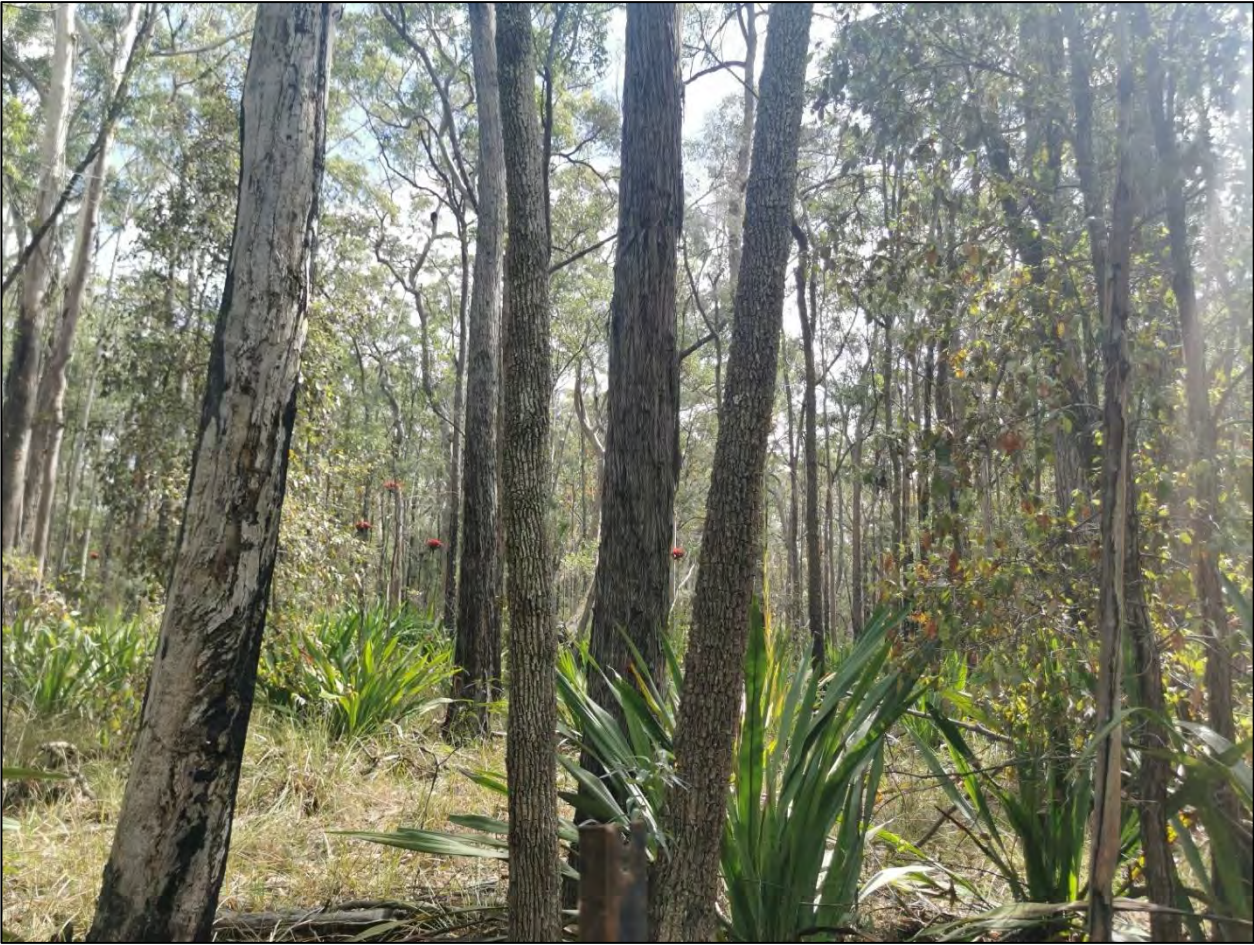
MP13	Spotted Gum – Grey Ironbark open forest	<ul style="list-style-type: none"> Minimal dieback in mature <i>Allocasuarina torulosa</i> individuals although healthy regeneration is observed within the canopy and midstorey. Low level of fallen logs / timber. Dense ground cover. Low rock cover. Eucalypt and Midstorey seedlings present. <p>Conclusion: Regeneration is occurring within the monitoring point with minimal dieback of <i>A.torulosa</i>.</p>	<ul style="list-style-type: none"> No evidence of erosion and sedimentation. No recent evidence of disturbance from grazing, pest animals, rubbish dumping, rock / timber removal, or dust. Significant dust settlement recorded here in 2022. <p>Conclusion: No evidence of new disturbance was observed since the previous survey (2022).</p>	N/A
