Appendix 5 – Biodiversity Offset Area Monitoring Report

Karuah East Quarry Biodiversity Offset Area Monitoring Report

**Report prepared for:
Karuah East Quarry Pty Limited**

Report Prepared by Wedgetail Project Consulting

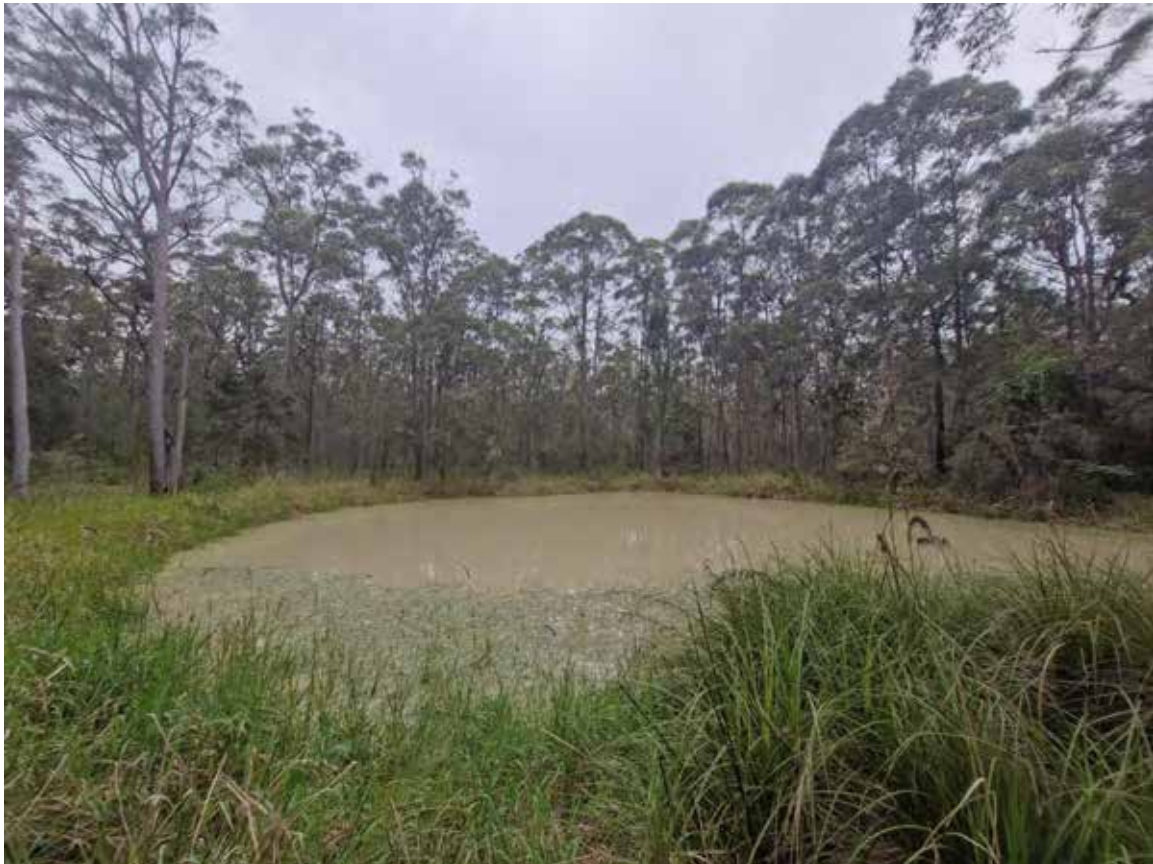
- Evidence of sedimentation and erosion has been observed in a few locations including MP14, and around the extent of the quarry along the south eastern edge of the extraction area and along the western side of the haul road into the Karuah Quarries Conservation Area (**Photo 2, Photo 3** and **Photo 4**).

Photo 2: Sedimentation and Erosion into the Karuah Quarry Conservation Area into Dam (2024).

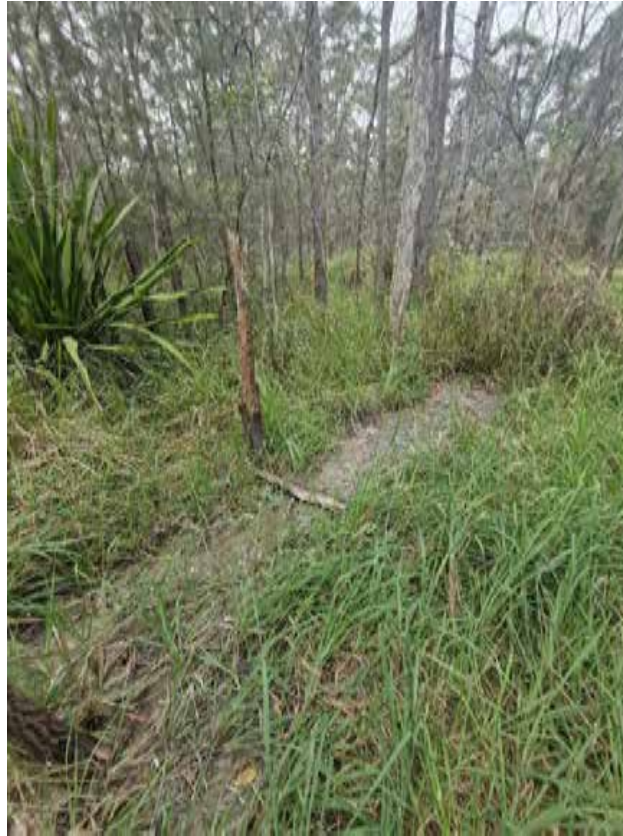
Photo 3: Erosion into the Karuah Quarry Conservation Area Dam and the area overgrown with *Setaria sphacelata* 2024.

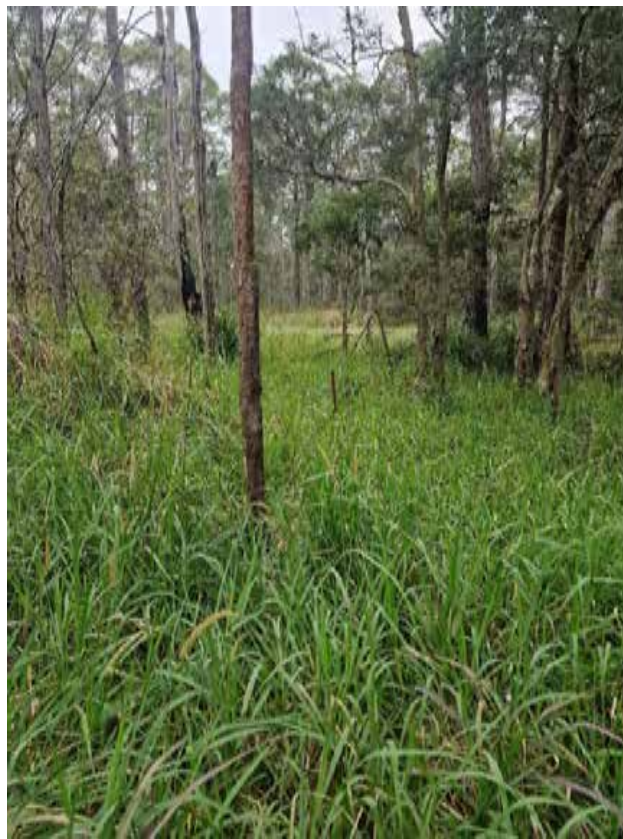
Photo 4: Area overgrown with *Setaria sphacelata* 2024.

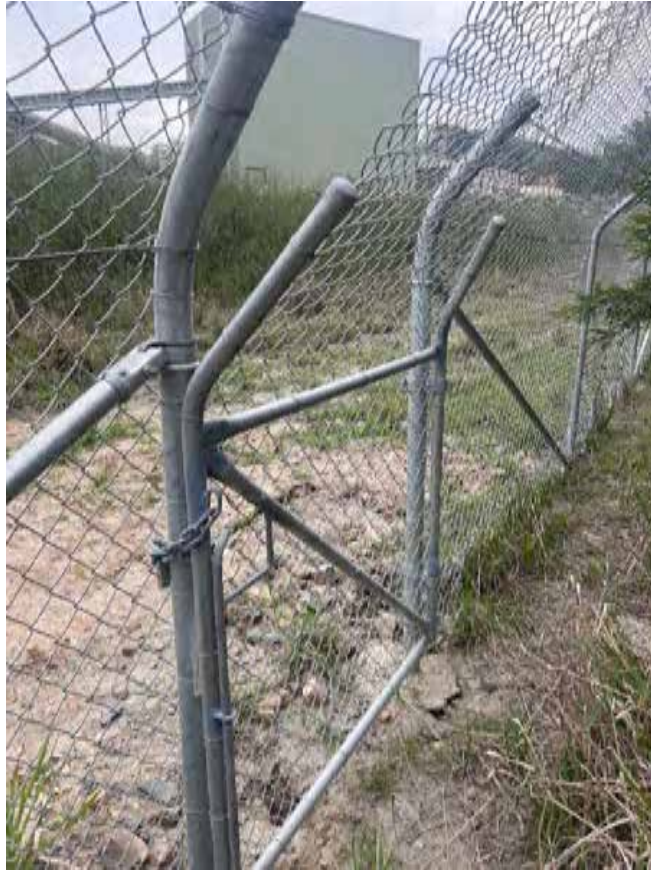
Photo 7: New gate and fencing installed in 2024 along the eastern border of the rock crushing area within Lot 13.

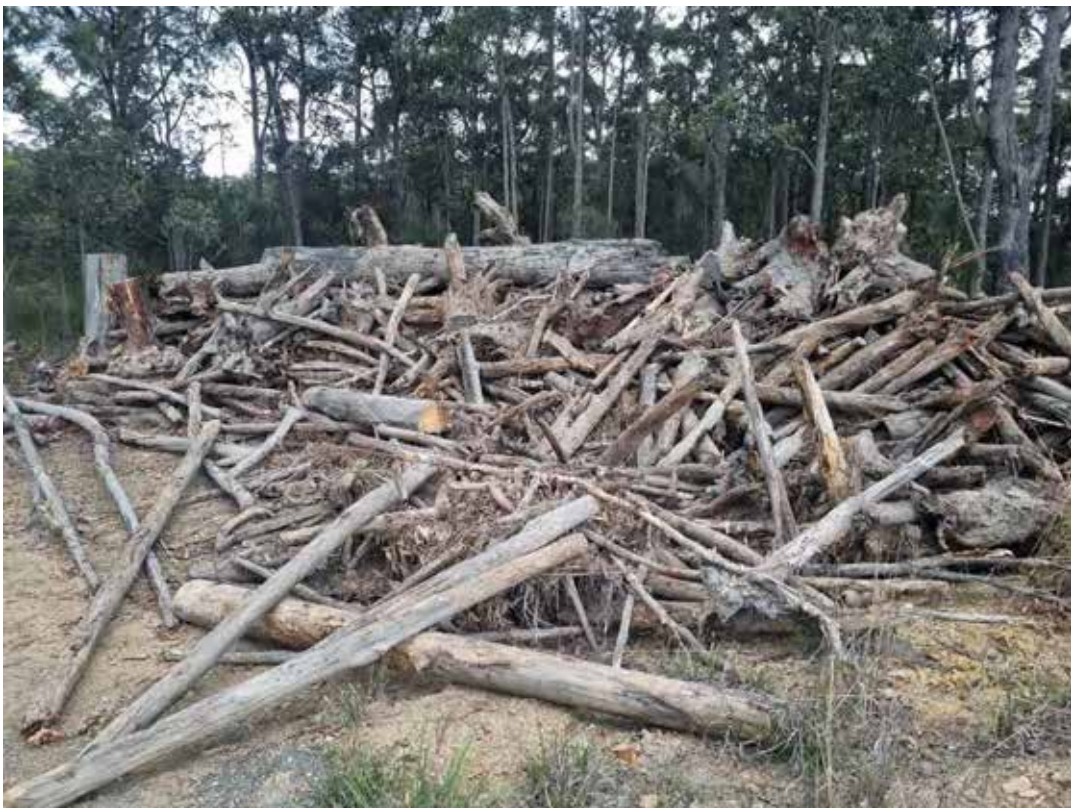
- Many timber stockpiles were observed outside of the disturbance area along fence lines and at the end of the access track southeast of the rock quarry (**Photo 8**).
- All fencing works are required to be undertaken in accordance with **Section 3.2** of the BOAMP.

Photo 8: Large timber stockpile outside of the disturbance area towards the southeastern access track from the rock quarry.

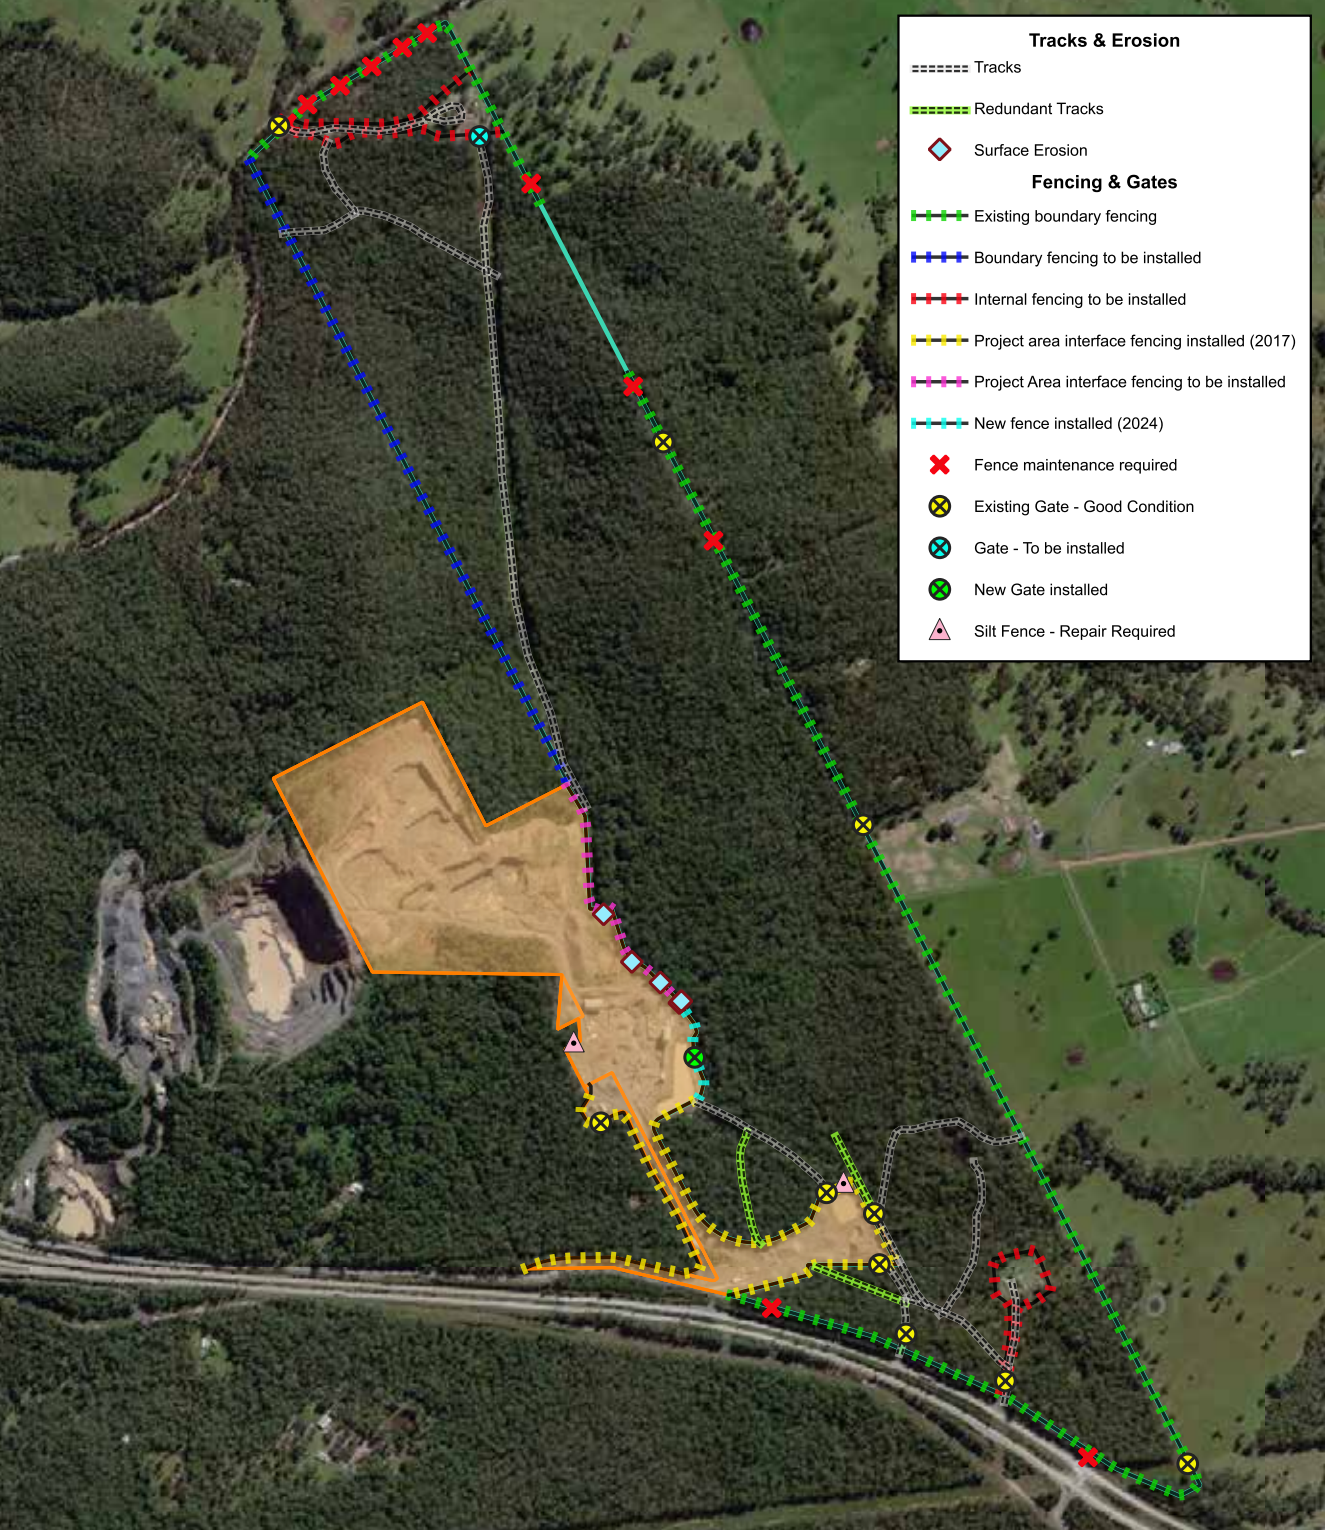
- Internal fencing is also required around the existing dwellings on Lot 5 and Lot 14.
- The barbed-wire fence alongside the far northern boundary of Lot 5 requires repair throughout due to the fence having either fallen, lost tension or damage from fallen trees (**Figure 6**).
- Fencing alongside the north-eastern boundary of Lot 5 has been removed with the intention of replacing it.
- Fencing is absent along the western boundary of Lot 5 and will need installation
- Fencing along the western boundary of Lot 13 and haul road has been repaired from prior damage (see **Photo 5**).
- Fencing (Koala Fence) has been removed from the large dam to the south-east of the rock crushing area due to dam wall repairs. Repairs have now been completed and the fence was re-installed in 2024 (**Photo 6**).

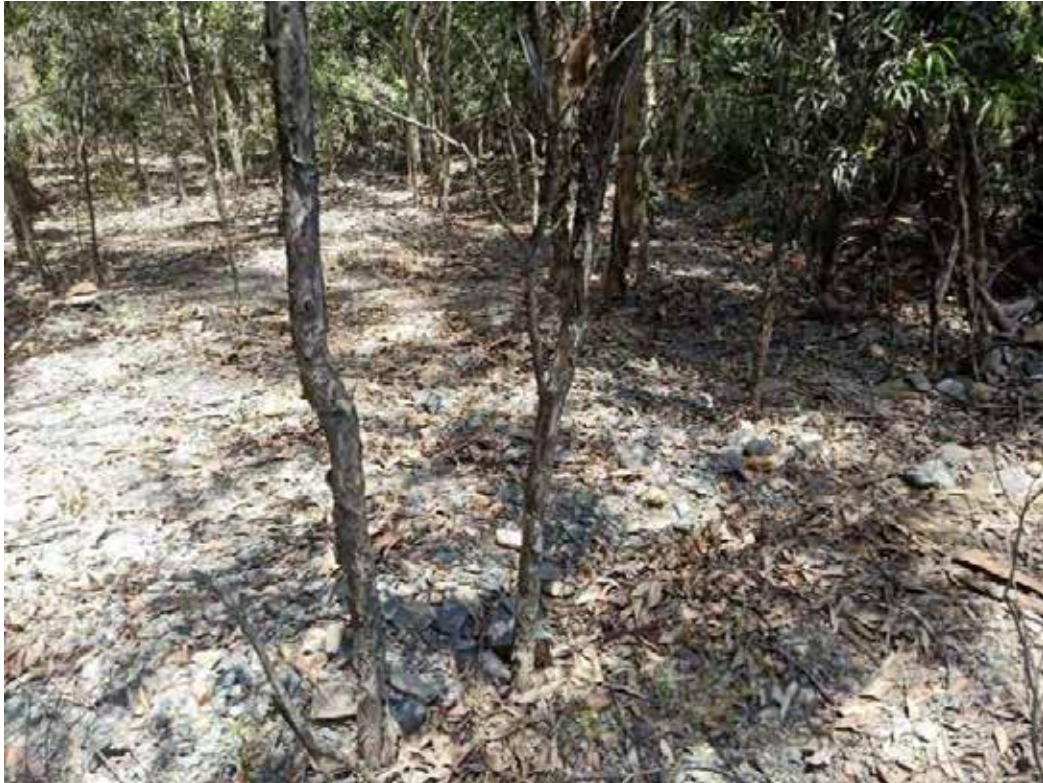
Photo 10: Excavated rock and sediment that has runoff from the eastern boundary of the quarry into the BOA.

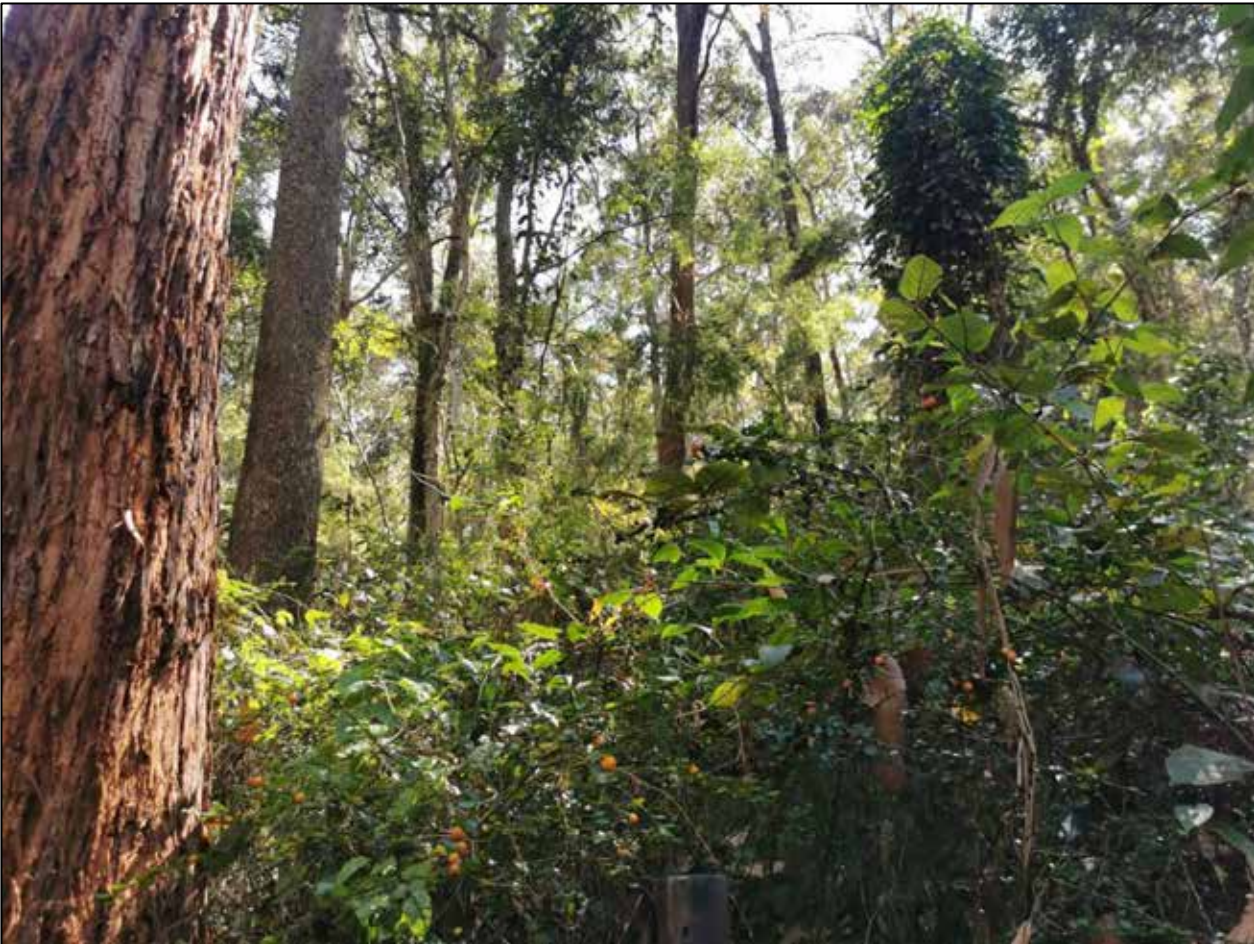
Site	Vegetation Community	Vegetation and Habitat Condition	Evidence of Disturbance	Threatened Flora Monitoring
MP3	Brush Box – Turpentine shrubby open forest	<ul style="list-style-type: none"> • All vegetation strata within the monitoring site in healthy condition. • A small increase in canopy cover, though all other vegetation strata remain stable since previous monitoring events. • High structural complexity of vegetation. • High leaf litter. • Light-Moderate cover of fallen timber. • Weed cover (<i>Lantana</i> and <i>Tradescantia</i>) within the monitoring site has significantly increased, potentially in response to high rainfall in 2023. <p>Conclusion: Excluding an increase in the abundance of exotic plants, no significant or notable changes in vegetation and habitat condition since the previous survey (2023).</p>	<ul style="list-style-type: none"> • No evidence of erosion and sedimentation. • No recent evidence of disturbance from grazing, pest animals, rubbish dumping, or rock / timber removal. • No signs of recent fire. <p>Conclusion: No new disturbance or changes in existing disturbance severity were observed since the previous survey (2023).</p>	<ul style="list-style-type: none"> • There was a decrease in number of <i>Asperula asthenes</i> individuals within the monitoring site from 11 in 2023 to 9 in 2024. • Two <i>Asperula asthenes</i> plants were recorded flowering during monitoring. • All <i>Asperula asthenes</i> plants within the monitoring site were observed to be in healthy condition. • The population at MP 3 has declined significantly since 2021 (18 individuals recorded). <p>Conclusion: <i>Asperula asthenes</i> continues to decrease since previous monitoring events despite appearing healthy. This may be due to being outcompeted by heavy exotic cover and smothering by high leaf litter.</p>

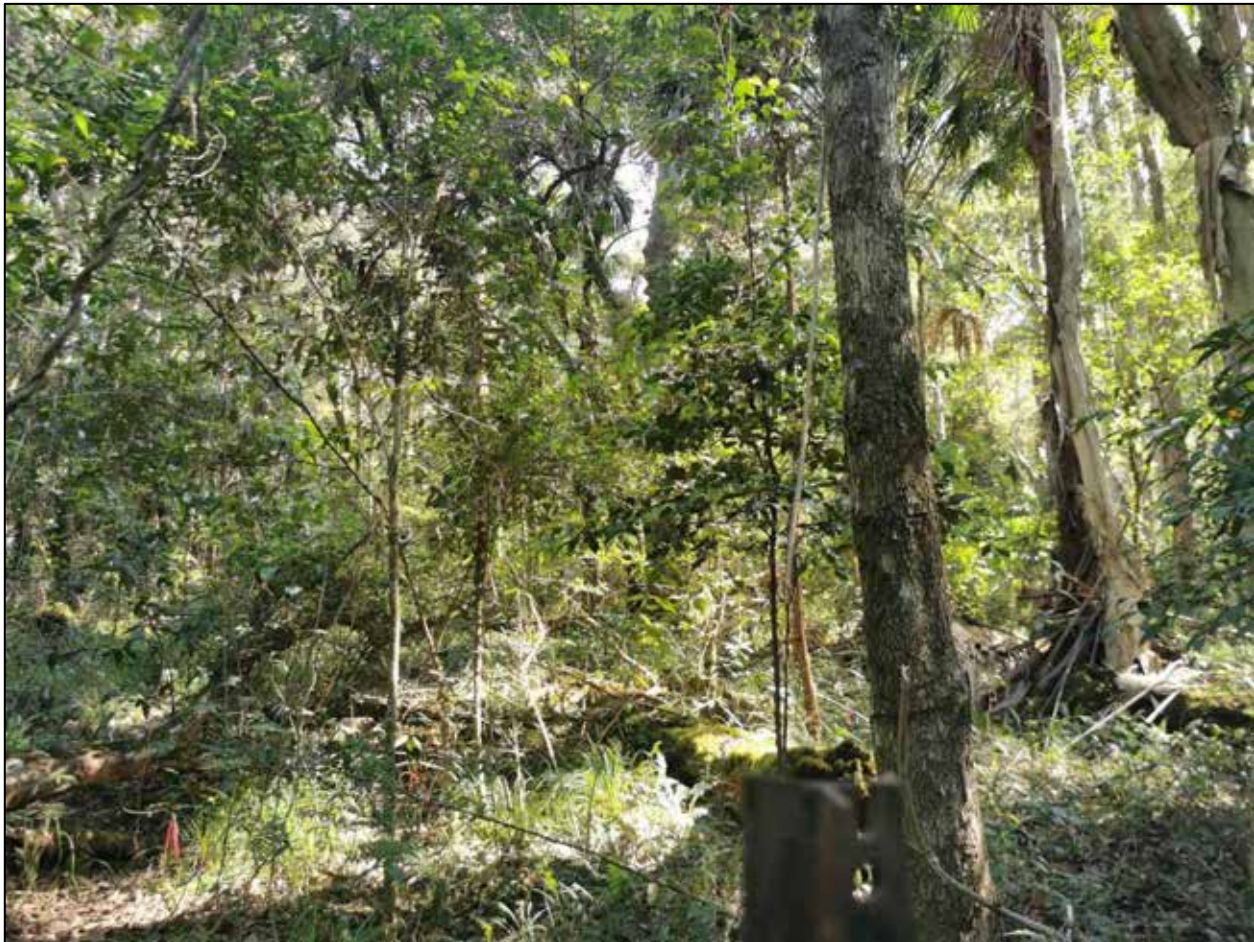
Site	Vegetation Community	Vegetation and Habitat Condition	Evidence of Disturbance	Threatened Flora Monitoring
MP4	Brush Box – Turpentine shrubby open forest	<ul style="list-style-type: none"> • Large increase in <i>Doodia aspera</i> abundance within the understory of the monitoring plot. • Shrub cover remains stable despite a decrease in previous monitoring events. • Apart from the minor shrub dieback all vegetation strata within the monitoring site in healthy condition. • Canopy and midstory remain stable. • High structural complexity of vegetation. • Moderate fallen timber. • Weed cover (<i>Lantana</i> and <i>Tradescantia</i>) within the monitoring site has increased slightly. <p>Conclusion: A notable increase in the abundance of ferns in the understory, since previous monitoring events. There has been a slight increase weed abundance. No other significant or notable changes in vegetation and habitat condition since the previous survey (2023).</p>	<ul style="list-style-type: none"> • No recent evidence of disturbance from grazing, pest animals, rubbish dumping, or rock / timber removal. • No recent evidence of disturbance from grazing, rubbish dumping, rock / timber removal. • Light dust cover observed on foliage. • No signs of recent fire. • Weed abundance slightly increased. • Flow of water from heavy rain has possibly some <i>Asperula asthenes</i> individuals. • High litter cover with no bare ground. <p>Conclusion: No new disturbance or significant changes in existing disturbance severity were observed since the previous survey (2023).</p>	<ul style="list-style-type: none"> • There was a decrease in number of <i>Asperula asthenes</i> individuals recorded in recent years from 32 in 2021 then to 16 in 2024. • Two <i>Asperula asthenes</i> plants were recorded flowering during monitoring. • All <i>Asperula asthenes</i> plants within the monitoring site were observed to be in healthy condition. • The population at MP 4 remains stable in recent monitoring events (16 individuals recorded) with a large decrease in population in 2021 likely the result of heavy rainfall and flow of water through the monitoring point removing some individuals. • Though some individuals were likely washed away, new growth and resprouting plants were observed in previous empty locations. <p>Conclusion: <i>Asperula asthenes</i> abundance remain stable with small increased in exotic weed cover and light dust cover on surrounding foliage. Though plants appear healthy future monitoring may benefit to focus on minimizing dust and weed cover.</p>

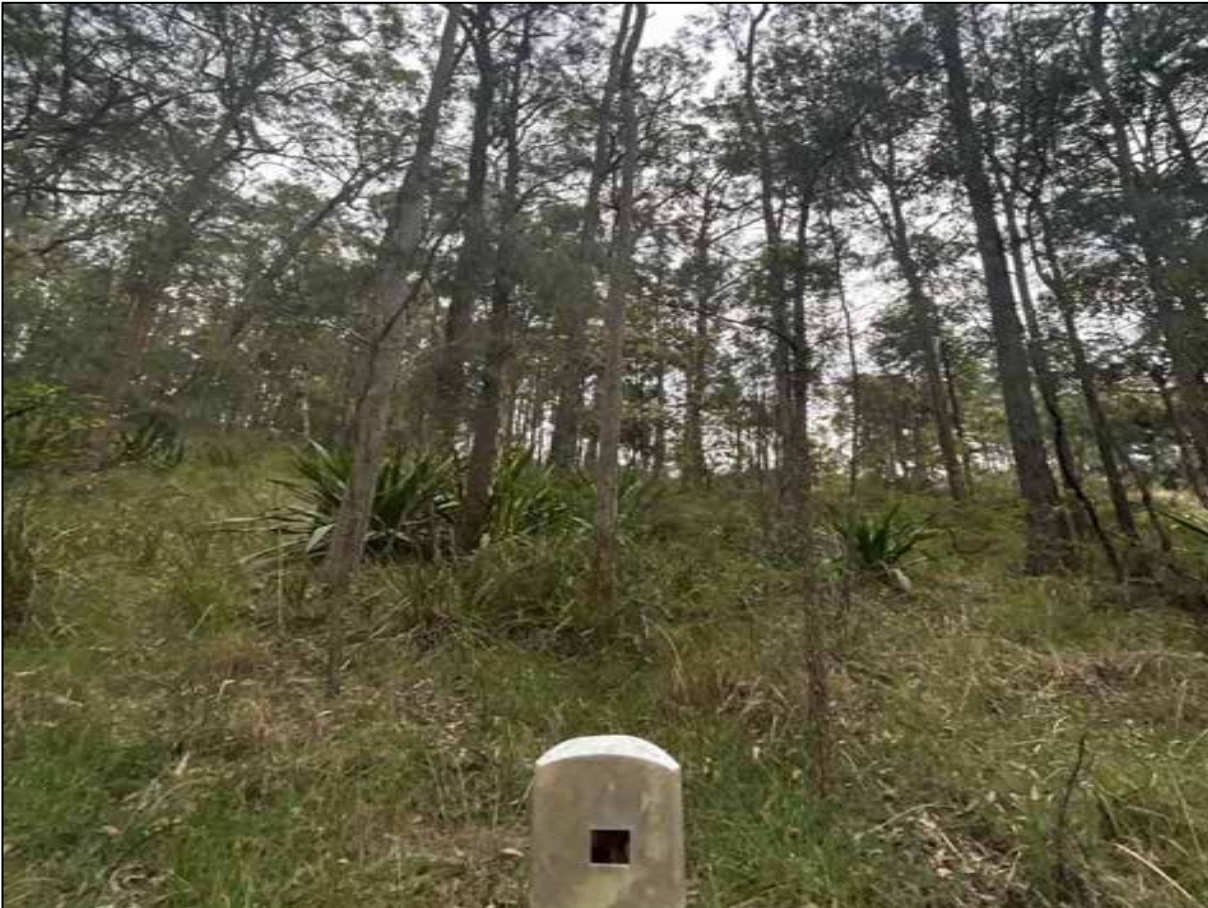
MP 14 2024

Site	Vegetation Community	Vegetation and Habitat Condition	Evidence of Disturbance	Threatened Flora Monitoring
MP14	Smooth-barked Apple - Red Bloodwood open forest	<ul style="list-style-type: none"> • One individual <i>Setaria sphacelata</i>. • Most vegetation strata in healthy condition. • Canopy and midstory regeneration present. • Low fallen/ timber. • Dense ground and leaf litter cover. <p>Conclusion: No significant or notable changes in vegetation and habitat condition since the previous survey (2023).</p>	<ul style="list-style-type: none"> • Evidence of sedimentation of quarry rock material adjacent to monitoring plot from haul road into the nearby dam. • High occurrence of <i>Setaria sphacelata</i> occurring south of the monitoring point. • Dust accumulation on foliage from Quarry. • Sediment runoff occurring south of the monitoring point contaminating the dam. • Moderate cover of exotic grasses around dam to south and along access track. <p>Conclusion: Prevailing evidence of sedimentation was observed and high weed coverage still persist within the area since the previous survey (2023).</p>	N/A

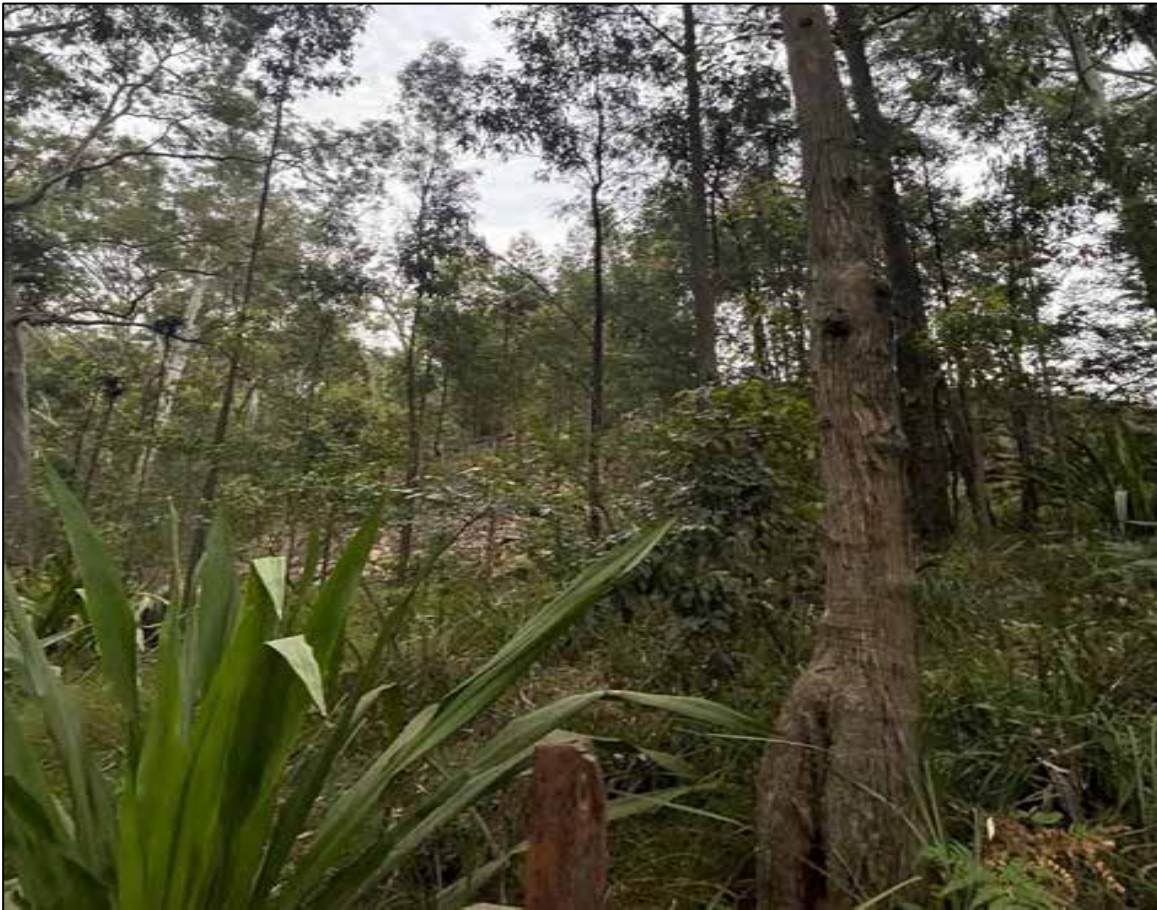
MP 15 2024

Site	Vegetation Community	Vegetation and Habitat Condition	Evidence of Disturbance	Threatened Flora Monitoring
MP15	Blackbutt - Turpentine - Tallowood shrubby open forest	<ul style="list-style-type: none"> • Marginal increase in Canopy cover since the 2023 survey. • All vegetation strata in moderately healthy condition. • Moderate fallen timber. • Dense ground cover and leaf litter. • Rocky areas in low abundance. • Large hollow present. <p>Conclusion: No significant changes in vegetation and habitat condition since the previous survey (2023).</p>	<ul style="list-style-type: none"> • No evidence of erosion and sedimentation. • There are some edge effects from adjacent clearing. • Thick dust coating on foliage. <p>Conclusion: Dust cover on foliage was observed within the monitoring site in 2023 and again in 2024 seemingly becoming thicker.</p>	<ul style="list-style-type: none"> • There was a decrease in the number of <i>Tetratheca juncea</i> clumps recorded within the monitoring site, from 5 in 2023, to 4 in 2024. • One new <i>Tetratheca juncea</i> that has not been detected in more recent years was observed reshooting. • All 4 <i>Tetratheca juncea</i> plants were recorded flowering during monitoring. • One <i>Tetratheca juncea</i> plant was observed fruiting. • All <i>Tetratheca juncea</i> plants within the monitoring site were observed to be in healthy condition. <p>Conclusion: The <i>Tetratheca juncea</i> population at MP 15 has declined since 2015 baseline (30 individuals recorded). This decline in the <i>T. juncea</i> at MP 15 is most likely due to the lower than average rainfall during 2019, exacerbated by the location of the monitoring point; upper slopes of exposed hill side and thick dust cover.</p>

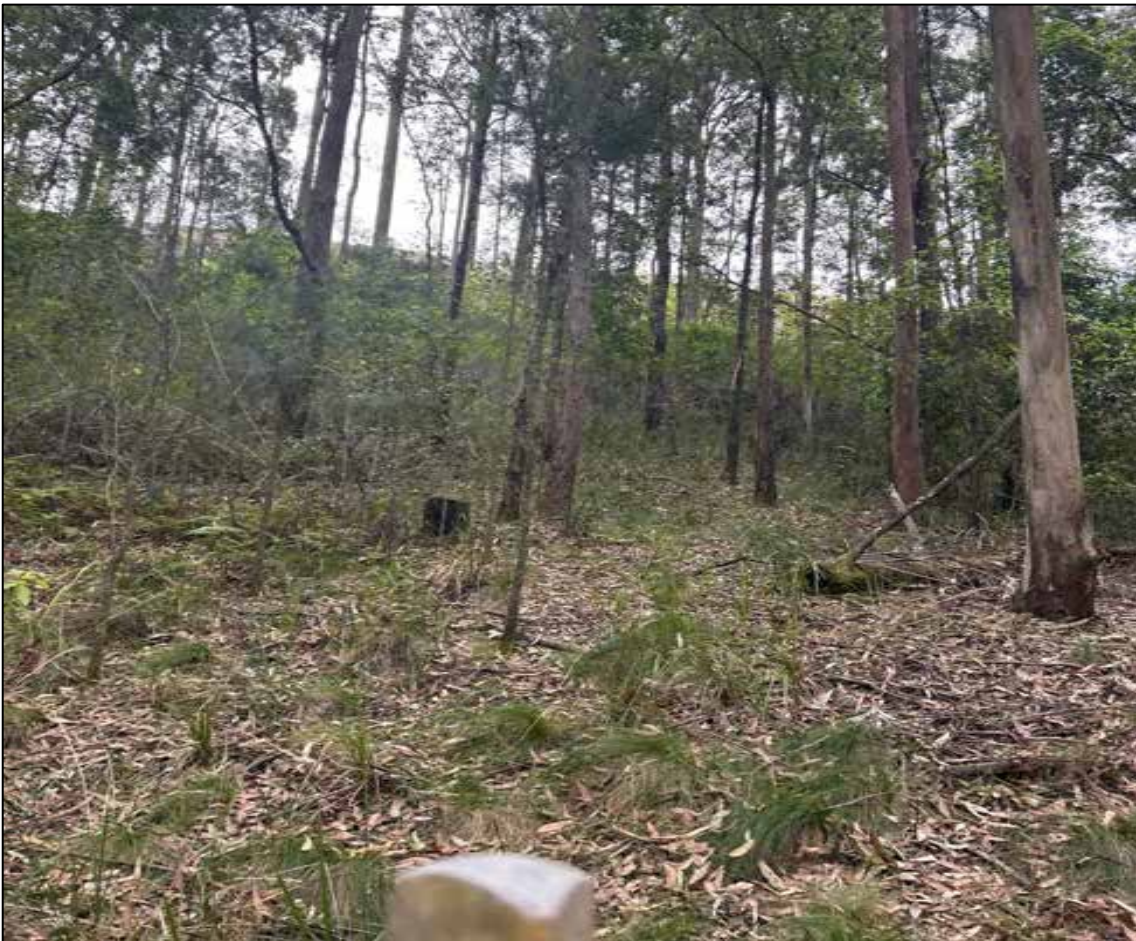
MP 16 2024

Site	Vegetation Community	Vegetation and Habitat Condition	Evidence of Disturbance	Threatened Flora Monitoring
MP16	Spotted Gum – Grey Ironbark open forest	<ul style="list-style-type: none"> Increased ‘grass’ groundcover abundance that has stabilized since previous monitoring. All vegetation strata in healthy condition. Canopy and midstory regeneration present. Moderate fallen timber. Dense leaf litter and moderate ground cover. Minor die back in the canopy Decreased <i>Lantana camera</i> abundance since previous monitoring event. <p>Conclusion: Minor changes, though not significant, in vegetation and habitat condition since the previous survey (2023).</p>	<ul style="list-style-type: none"> No evidence of erosion and sedimentation. No recent evidence of disturbance from grazing, pest animals, rubbish dumping, rock / timber removal. Very high dust cover from edge affects of quarry operations. <p>Conclusion: Very high dust cover that has increased since previous monitoring (2023). No evidence of new disturbance was observed with some reduction in <i>Lantana camera</i>.</p>	<ul style="list-style-type: none"> <i>Asperula asthenes</i> detected within monitoring plot for first time (2021). Six individual plants identified in 2022 and all remain in 2023. An additional two plants were identified during the current monitoring event (2024). Five <i>Asperula asthenes</i> plants were recorded flowering during monitoring. All <i>Asperula asthenes</i> plants within the monitoring site were observed to be in healthy condition <p>Conclusion: Despite increased edge effects from nearby quarry operations, <i>Asperula asthenes</i> is proliferating and healthy.</p>

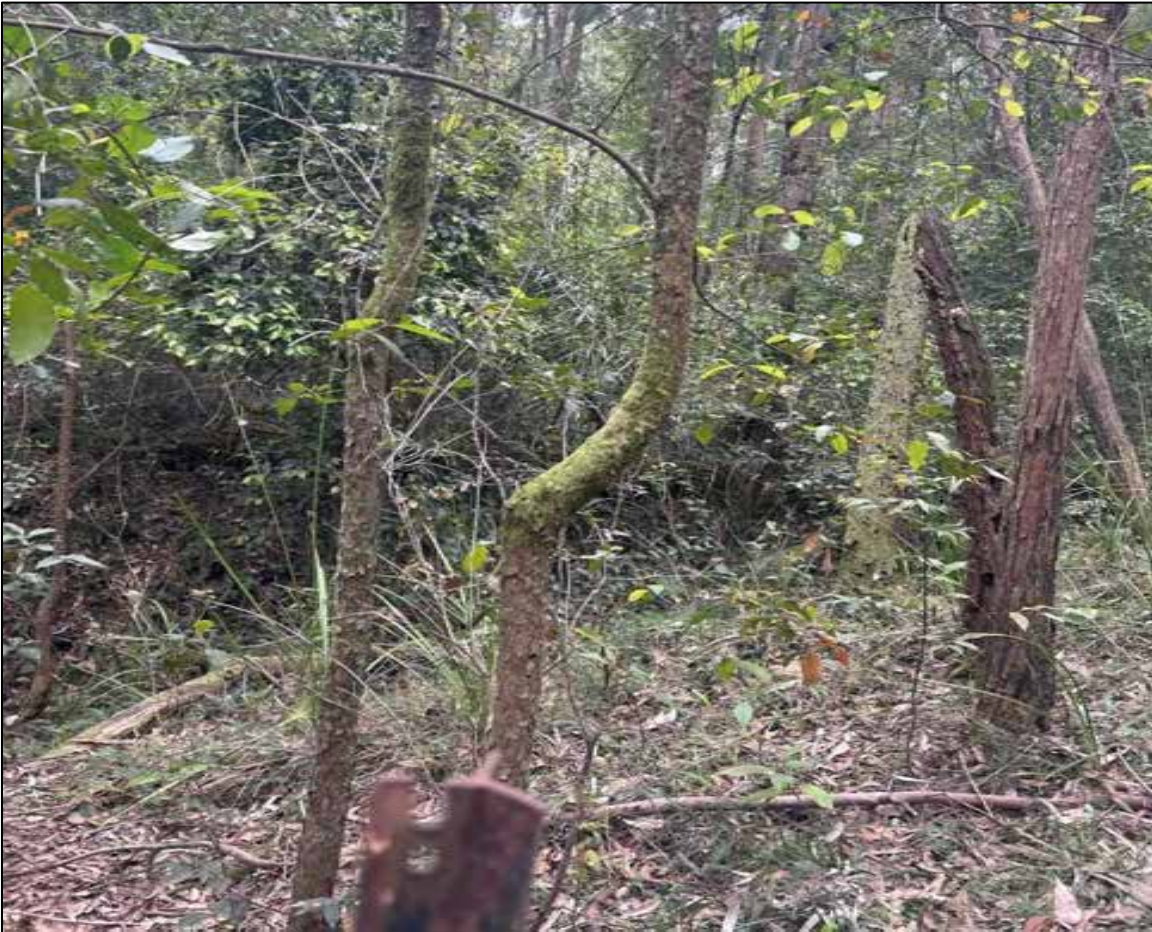
MP 17 2024

Site	Vegetation Community	Vegetation and Habitat Condition	Evidence of Disturbance	Threatened Flora Monitoring
MP17	Brush Box - Turpentine shrubby open forest	<ul style="list-style-type: none"> No evidence of foliage die-back, evidence of midstorey and canopy regeneration. All vegetation strata in healthy condition. Abundance of juvenile <i>Backhousia myrtifolia</i> in midstorey, subsequently increasing mid-storey cover. Increased midstorey has resulted in a decrease in ground cover. <i>Lantana camara</i> abundance remains stable. Moderate fallen timber. Rocky areas along ephemeral creek. Dense leaf litter. <p>Conclusion: No significant changes in vegetation and habitat conditions since the previous survey (2023).</p>	<ul style="list-style-type: none"> Very minor scouring along creek bank. No recent evidence of disturbance from grazing, pest animals, rubbish dumping, rock / timber removal. Moderate dust cover on foliage. Stable exotic plant community (<i>Lantana camara</i>). Dirty water running within the creek. <p>Conclusion: No evidence of new disturbance observed since the previous survey (2023). Creek water remains high in sedimentation.</p>	<ul style="list-style-type: none"> There was a decrease in number of <i>Asperula asthenes</i> individuals within the monitoring site from 10 in 2021 to 6 in 2023 and 6 plants remain in 2024 Some individuals appear to have been removed along the creek bed due to heavy rainfall events, though other individuals were observed that haven't been recorded in recent years. Four <i>Asperula asthenes</i> plants were recorded flowering during monitoring. All <i>Asperula asthenes</i> plants within the monitoring site were observed to be in healthy condition with no yellowing. <p>Conclusion: The population at MP 17 has decreased since 2015 baseline (11 individuals recorded) though it has remained stable in recent years, with new growth occurring.</p>

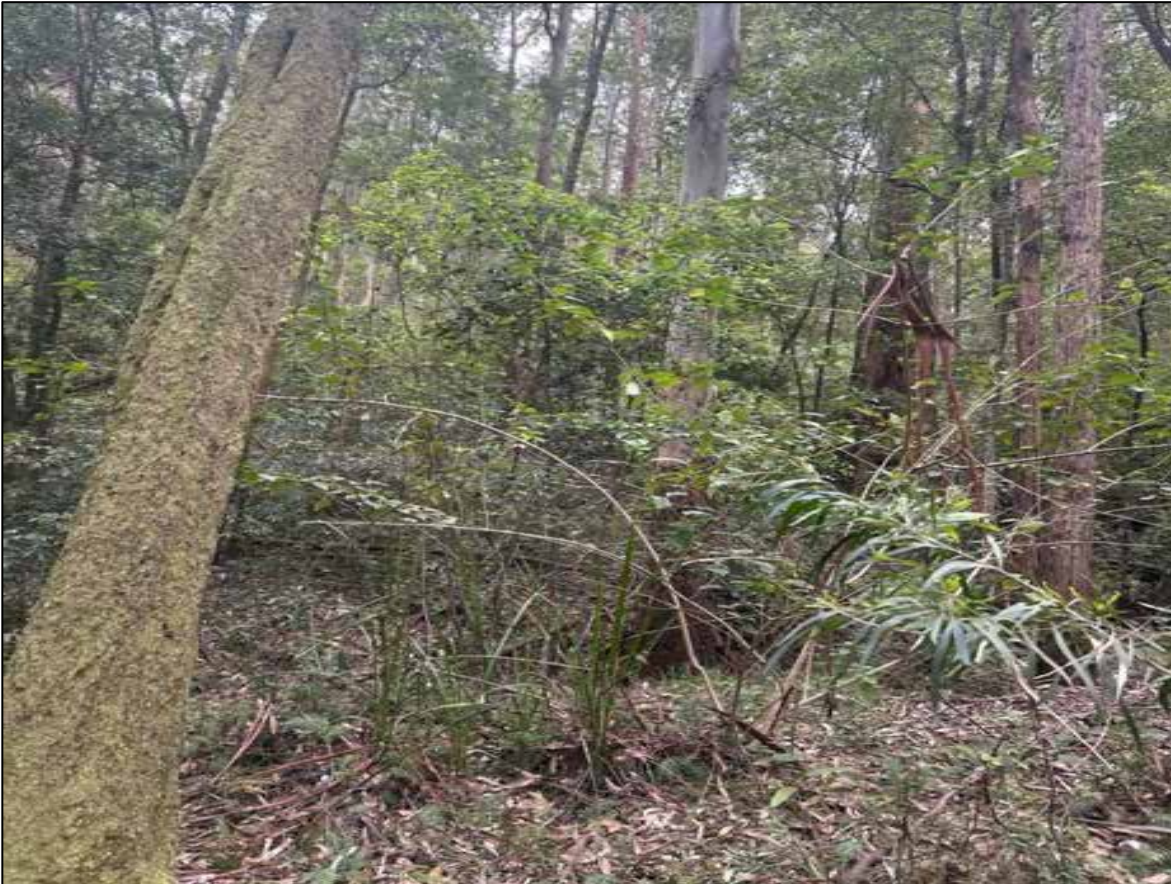
MP 18 2024

Site	Vegetation Community	Vegetation and Habitat Condition	Evidence of Disturbance	Threatened Flora Monitoring
MP18	Brush Box - Turpentine shrubby open forest	<ul style="list-style-type: none"> • All vegetation strata in healthy condition • Canopy and midstorey regeneration present • Low fallen timber • High level of leaf litter present. • High leaf litter and ground cover • Rocky areas along ephemeral creek. <p>Conclusion: No significant or notable changes in vegetation and habitat condition since the previous survey (2023).</p>	<ul style="list-style-type: none"> • Very minor scouring along creek bank. • No recent evidence of disturbance from grazing, pest animals, rubbish dumping, or rock / timber removal. • reduced dust coverage on foliage when compared to previous years. <p>Conclusion: No evidence of new disturbance was observed since the previous survey (2023).</p>	<ul style="list-style-type: none"> • There was a small increase in number of <i>Asperula asthenes</i> individuals within the monitoring site from 11 in 2023 to 12 in 2024. • One new <i>Asperula asthenes</i> plants was recorded in 2024. • Five <i>Asperula asthenes</i> plant was recorded flowering during monitoring. • All <i>Asperula asthenes</i> plants within the monitoring site were observed to be in healthy condition. <p>Conclusion: The population at MP 18 has remained stable since 2015 baseline (13 individuals recorded). Previous years of below average rainfall have likely impacted this population, however there are signs of plants reshooting and flowering, as well as plants sighted outside the monitoring point.</p>
