Appendix 4 – Biodiversity Offset Area Monitoring Report

Karuah East Quarry Biodiversity Offset Area Monitoring Report

Rev 1

Rev. No.	Revision Date	Author/s	Reviewer	Details
Rev 1	10 February 2026	Rachel Neal	Mark Dean	Draft

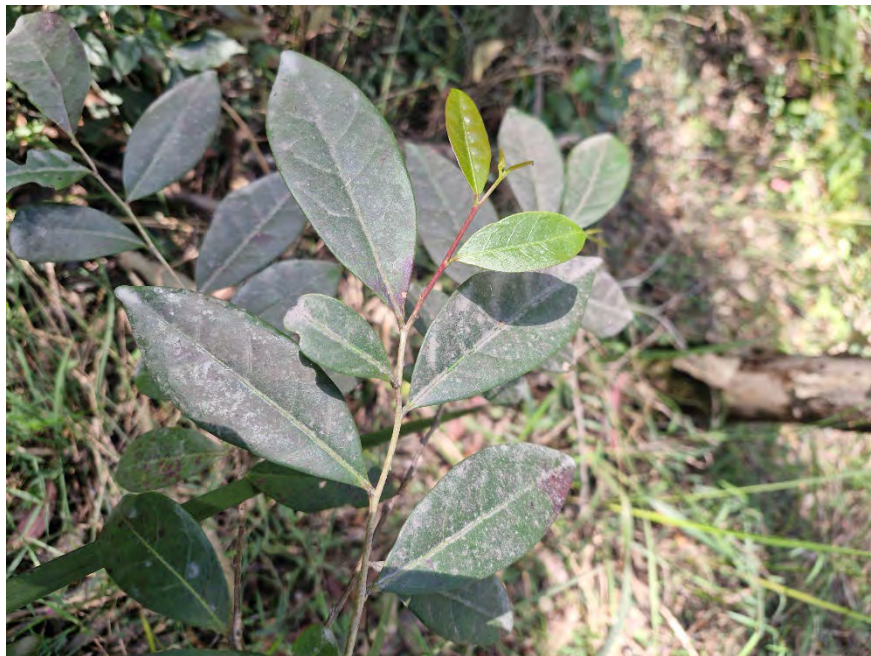
- High levels of dust were observed on foliage (see **Photo 2**) and on the ground at several monitoring sites along the boundaries of quarry operations. Dust levels have increased compared to previous years and remnant vegetation is deteriorating. Monitoring of this disturbance should be continued to assess further impact on remnant vegetation.

Photo 2: Dust Cover on Foliage recorded near MP6 in 2025.

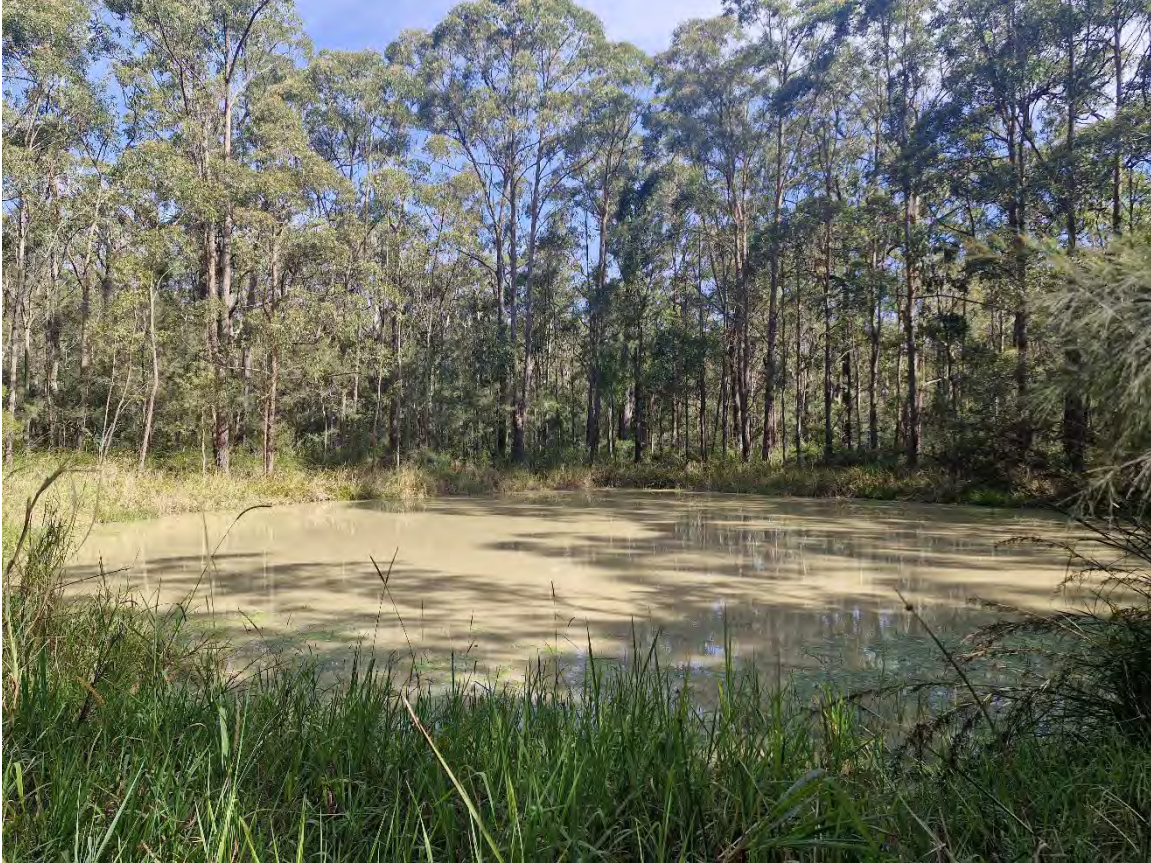
- Evidence of sedimentation and erosion has been observed in a few locations including MP14, and around the extent of the quarry along the south eastern edge of the extraction area and along the western side of the haul road into the Karuah Quarries Conservation Area (**Photo 3** and **Photo 4**).

Photo 3: Sedimentation and Erosion into the Karuah Quarry Conservation Area into Dam (2025) near MP14.

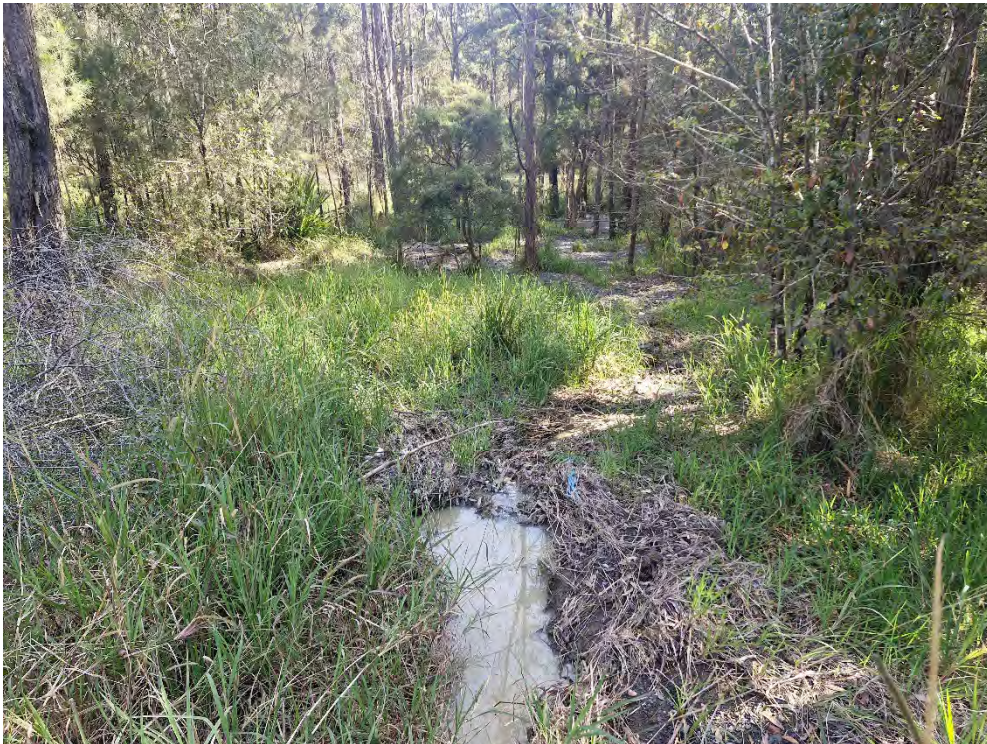
Photo 4: Erosion into the Karuah Quarry Conservation Area Dam and the area overgrown with *Setaria sphacelata* 2025.

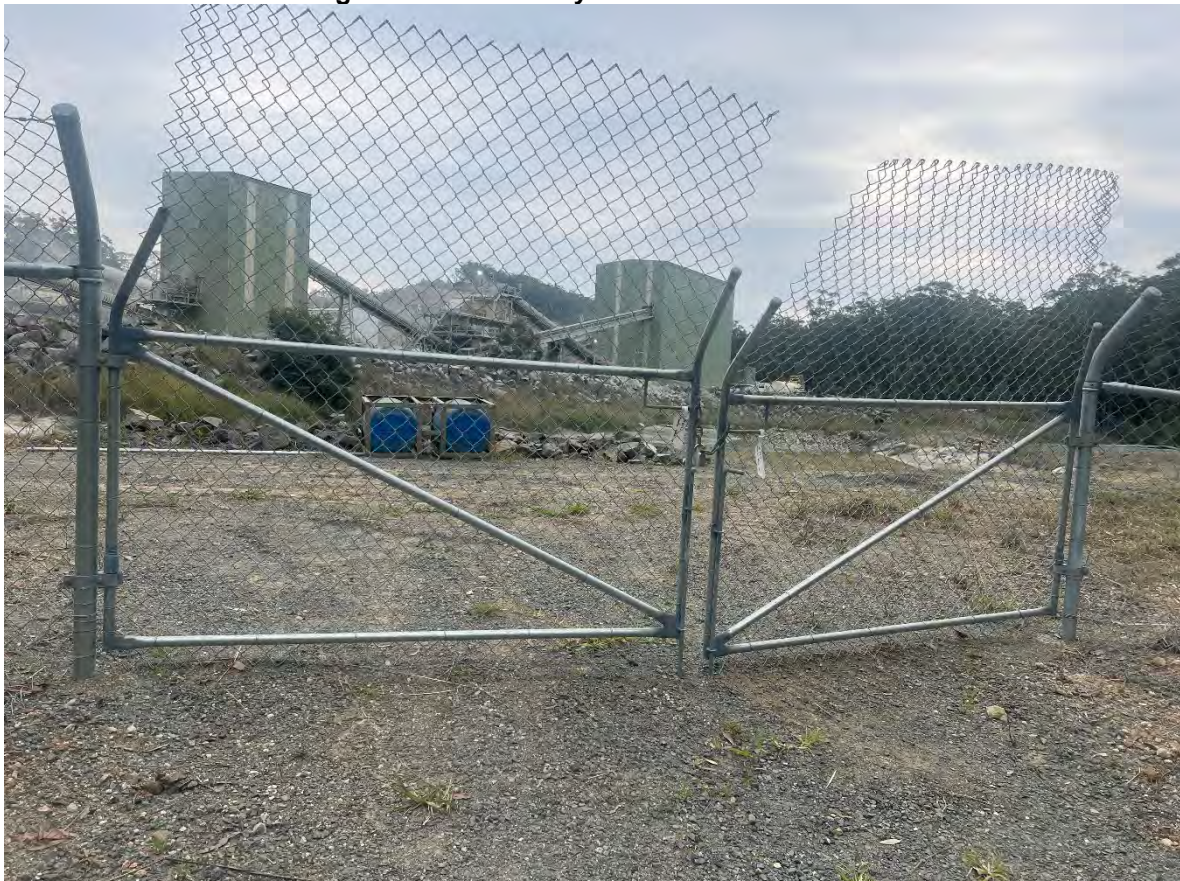
Photo 7: New gate and fencing installed in 2024 along a section of the eastern border of the quarry within Lot 13.

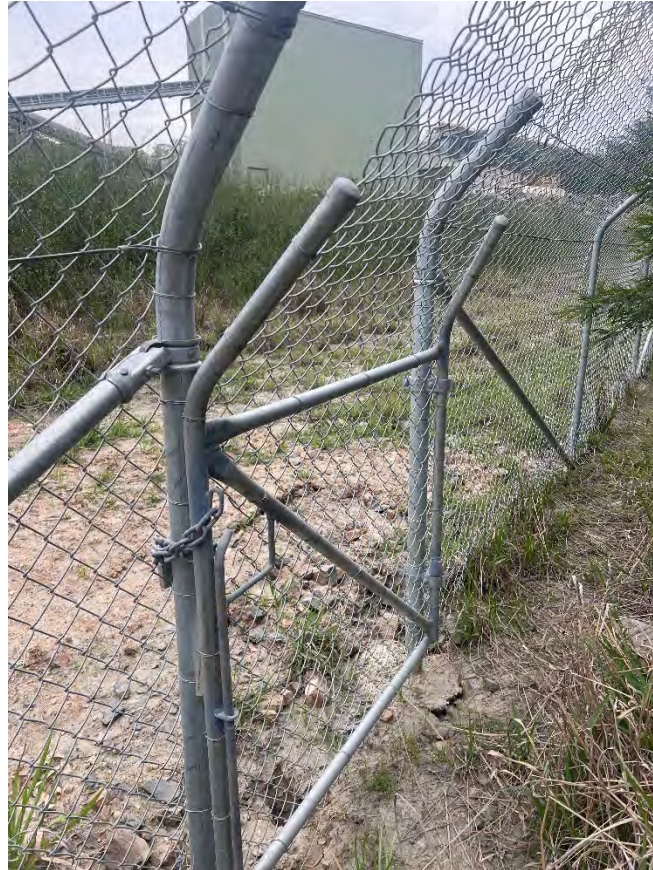
Photo 8: New gate and fencing installed in 2024 along the eastern border of the rock crushing area within Lot 13.

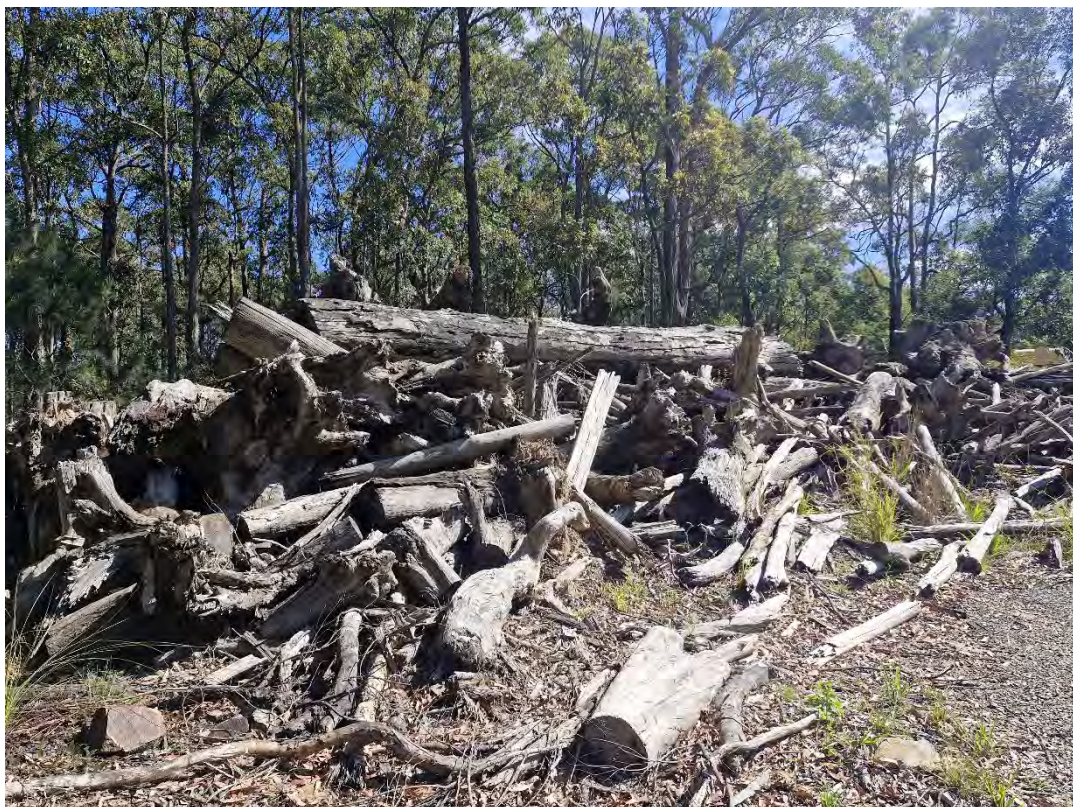
Photo 9: Large timber stockpile outside of the disturbance area towards the southeastern access track from the rock quarry.

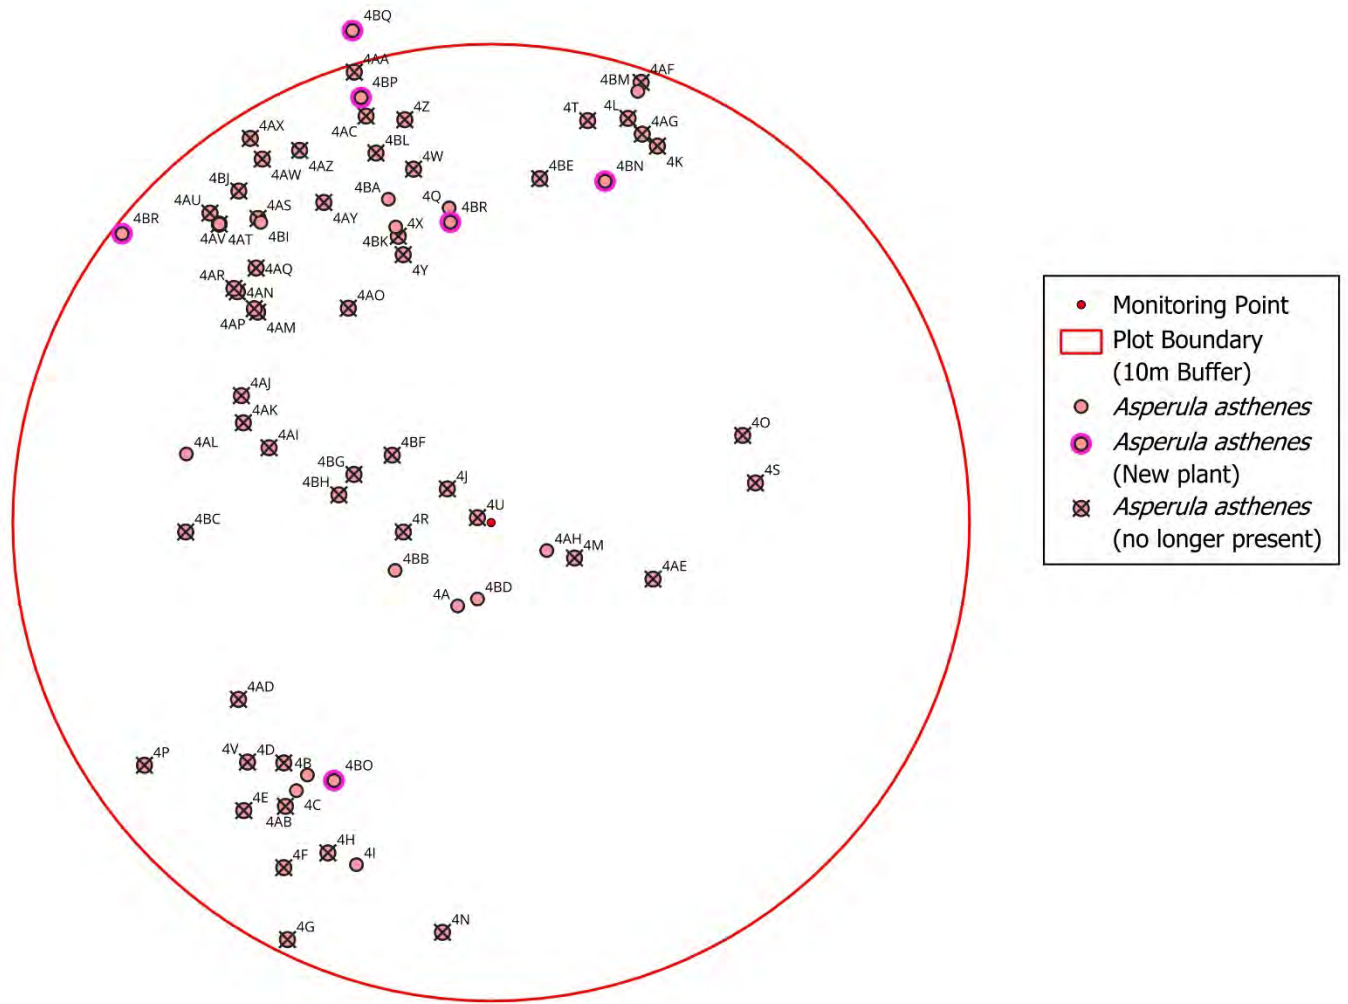
Monitoring Point 4

Unprecedented rainfall occurring from March to May of 2025 has disturbed MP 4. Many markers and, likely many *Asperula asthenes* individuals, have been removed or are unable to be located, despite an overall increase in total individual. Accurate monitoring was therefore difficult. Future monitoring would benefit from a comprehensive review of this plot; recounting and remarking individuals.

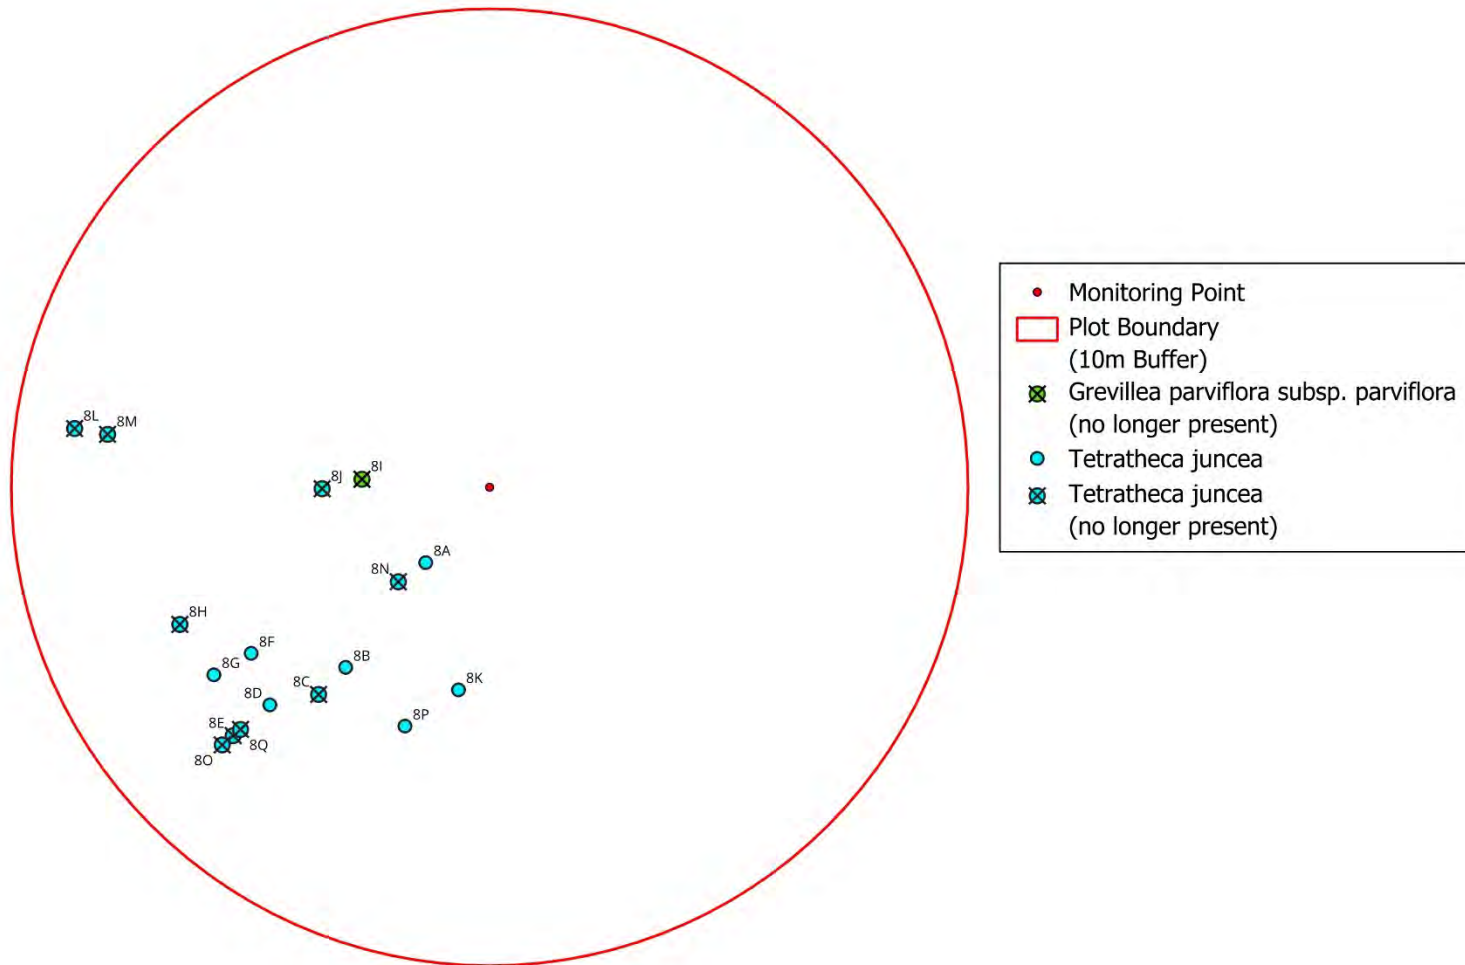
Monitoring Point 8 – *Tetratheca juncea* and *Grevillea parviflora* monitoring results 2025

8H	<i>Tetradlea juncea</i>	730	250	60x50	60x50	100x40	-	90x 30	90x30	-	-	-	-				
8I	<i>Grevillea parviflora</i> subsp. <i>parviflora</i>	310	280	30	30	30	70	60	60x70	-	-	-	-				
8J	<i>Tetradlea juncea</i>	390	275	50x 10	50x 10	65x 10	60x 20	60x20	30x20	25 x 15	30x10	45x5	45x5				
8K	<i>Tetradlea juncea</i>	400	195	60x20	60x20	90x90	170x50	130x60	130x100	75 x 40	105x120	120x80	100x10	100x30	3		New growth
8L	<i>Tetradlea juncea</i>	920	280	-	-	70x 70	70x 80	100x90	100x30	40 x 5	-	-	-

ID	Species	Distance	Bearing	Clump Size (cm)											Flowers/Fruit Present		Comments
				2015	2016	2017	2018	2019	2020	2021	2022	2023	2024	2025	Flowers	Fruits	
8M	<i>Tetraloche juncea</i>	850	280	-	-	-	40x20	-	20x10	20 x 5	-	-	-				
8N	<i>Tetraloche juncea</i>	280	235	-	-	-	-	50x 20	20x10	20 x 5	40x5	-	-				
8O	<i>Tetraloche juncea</i>	780	230	-	-	-	-	-	50x40	25 x 15	-	-	-				
8P	<i>Tetraloche juncea</i>	510	205	-	-	-	-	-	100x40	60 x 40	90x70	90x90	200x30	70x40			
8Q	<i>Tetraloche juncea</i>	730	230	-	-	-	-	-	-	5 x 10	-	-	-

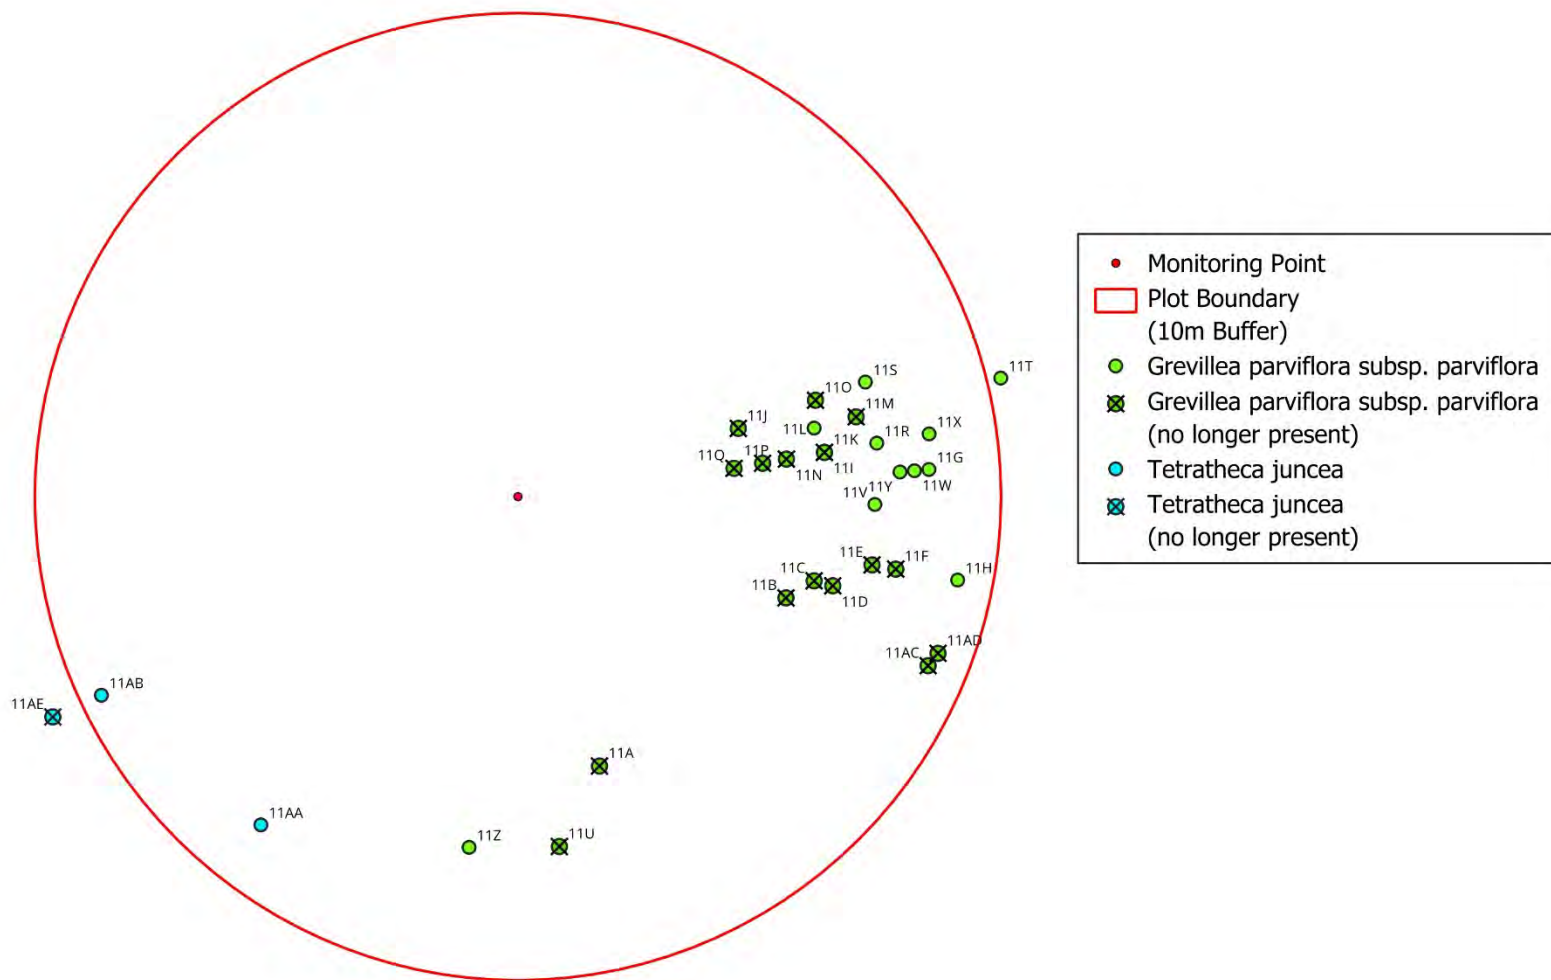
Monitoring Point 11 - *Grevillea parviflora* and *Tetratheca juncea* monitoring results 2025

11W	<i>Grevillea parviflora</i> <i>subsp. parviflora</i>	800	85	-	-	-	-	-	65	60	62	65	70	63			
11X	<i>Grevillea parviflora</i> <i>subsp. parviflora</i>	840	80	-	-	-	-	-	60	85	91	95	85	100	2		
11Y	<i>Grevillea parviflora</i> <i>subsp. parviflora</i>	770	85	-	-	-	-	-	25	55	-	41	44	51			
11Z	<i>Grevillea parviflora</i> <i>subsp. parviflora</i>	720	190	-	-	-	-	-	55	55	65	70	67	74	3		
11AA	<i>Tetradlea juncea</i>	865	220	-	-	-	-	-	75x50	80 x 50	110x80	90x90	90x110	90x120	200

ID	Species	Distance	Bearing	Clump Size (cm)											Flowers/Fruit Present		Comments	
				2015	2016	2017	2018	2019	2020	2021	2022	2023	2024	2025	Flowers	Fruits		
11AB	<i>Tetradlea juncea</i>	970	246	-	-	-	-	-	-	-	-	-	-	60x70	120x45			New clump this year, joining 2 clumps
11AC	<i>Grevillea parviflora subsp. parviflora</i>	890	112	-	-	-	-	-	-	-	-	-	-	-	51			first identified in 2025
11AD	<i>Grevillea parviflora subsp. parviflora</i>	900	110	-	-	-	-	-	-	-	-	-	-	-	39			first identified in 2025
11AE	<i>Tetradlea juncea</i>	1080	246	-	-	-	-	-	-	-	-	-	-	-	90x60	60		first identified in 2025

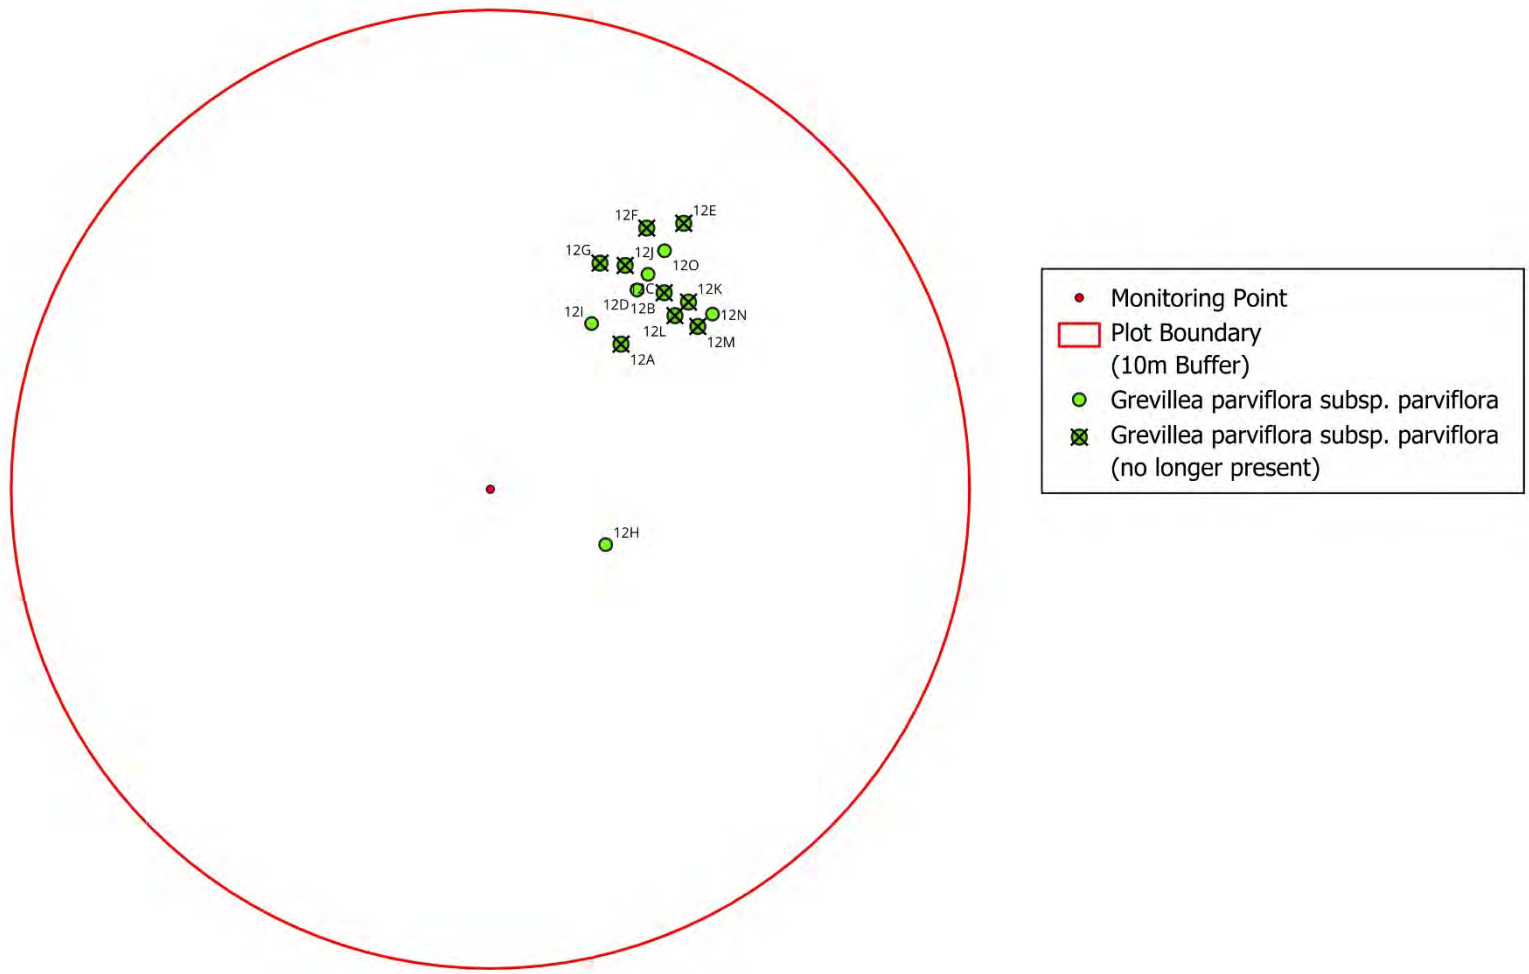
Monitoring Point 12 - *Grevillea parviflora* monitoring results 2025

ID	Distance	Bearing	Clump Size (cm)											Flowers/Fruit Present	Comments	
			2015	2016	2017	2018	2019	2020	2021	2022	2023	2024	2025			
12A	430	40	80	80	80	50	-	-	-	-	-	-	-	-		
12B	570	40	80	90	60	25	50	55	75	93	100	-	-			
12C	580	35	65	70	-	50	45	55	50	50	60	65	60	19 FI		
12D	540	35	20	25	40	30	-	70	100	113	115	120	98	96 FI		
12E	710	35	25	30	-	-	-	-	-	-	-	-	-			
12F	660	30	25	25	-	-	-	-	-	-	-	-	-			
12G	550	25	50	50	40	10	-	-	-	-	-	-	-			
12H	260	110	-	25	55	70	78	78	30	53	61	72	72	13FI		
12I	430	30	-	-	-	50	60	60	70	88	130	140	110	102FI		
12J	570	30	-	-	-	25	-	-	-	-	-	-	-			
12K	590	45	-	-	-	60	50	70	-	-	-	-	-			
12L	550	45	-	-	-	30	50	60	-	-	-	-	-			
12M	570	50	-	-	-	55	65	75	-	-	-	-	-			
12N	610	50	-	-	-	-	40	60	15	42	45	61	82	16FI		
12O	640	35	-	-	-	-	-	-	20	30	29	-	43	5FI

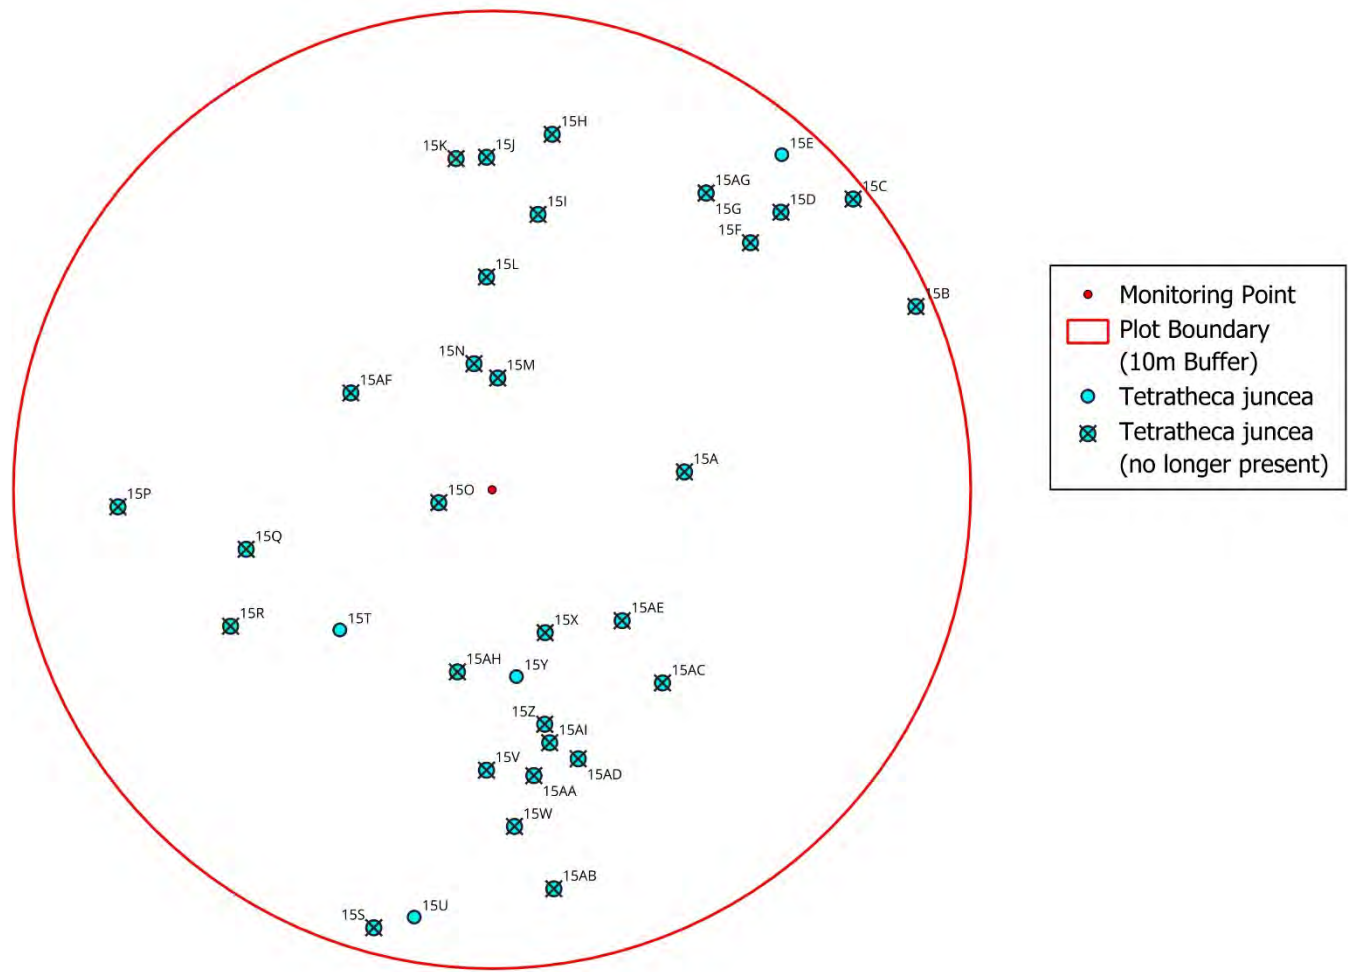
Monitoring Point 15 - *Tetratheca juncea* monitoring results 2025

ID	Distance	Bearing	Clump Size (cm)											Flowers/Fruit Present		Comments	
			2015	2016	2017	2018	2019	2020	2021	2022	2023	2024	2025	Flowers	Fruits		
15V	550	180	30 x 15	40 x 20	40 x 10	-	-	-	-	-	-	-	-	-			
15W	670	175	5 x 5	10 x 5	-	-	-	-	-	-	-	-	-	-			
15X	290	155	40 x 10	40 x 10	30 x 5	-	-	-	-	-	-	-	-	-			
15Y	360	170	5 x 5	30 x 5	-	20x5	-	-	15x5	20x10	55x30	40X30	50x40	5			New shoots
15Z	470	165	30 x 40	50 x 30	60 x 70	60x20	40x20	-	-	-	-	-	-	-			
15AA	570	170	25 x 20	50 x 20	20 x 50	80x20	40x40	-	-	-	-	-	-	-			
15AB	810	170	5 x 5	10 x 5	-	-	-	-	-	-	-	-	-	-			
15AC	520	135	40 x 10	50 x 15	15 x 50	40x30	60x10	50x30	30x20	50x30	-	-	-	-			
15AD	560	160	20 x 30	20 x 30	-	-	40x30	50x30	50x30	-	-	-	-	-			
15AE	370	130	-	20 x 10	-	-	-	-	-	-	-	-	-	-			
15AF	370	310	-	-	-	10x10	50x30	60x40	30x40	-	-	-	-	-			
15AG	800	35	-	-	-	-	-	-	20x20	2010	-	-	-	-			
15AH	350	190	-	-	-	-	-	-	-	50x40	75x80	45x40	-	-			Found tape but no plant

15AI	510	165	-	-	-	-	-	-	-	-	45x10	-	-	-

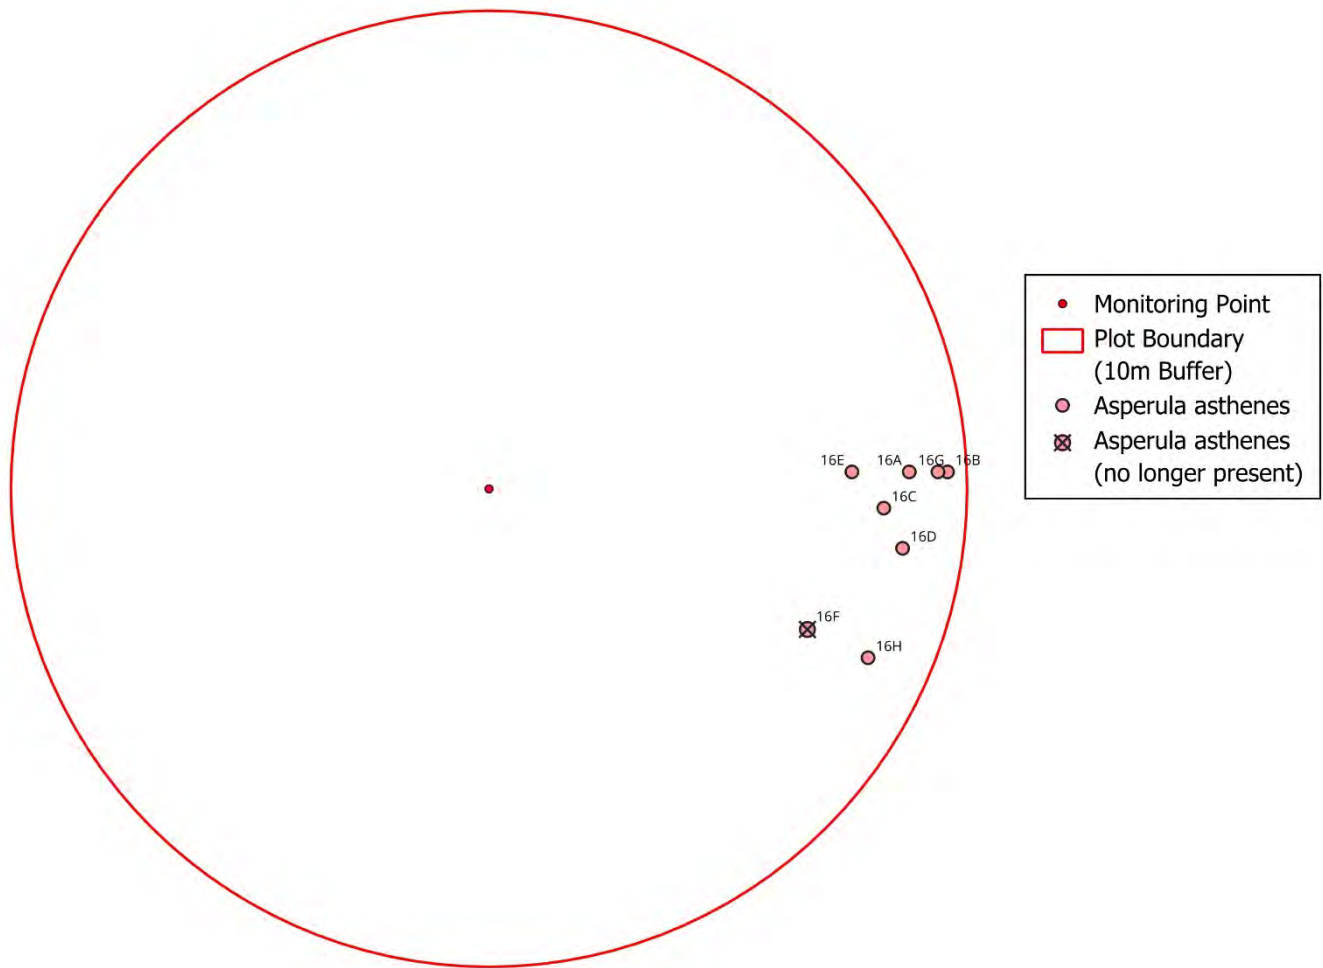
Monitoring Point 16 - *Asperula asthenes* monitoring results 2025

ID	Distance	Bearing	Clump Size (cm)											Flowers/Fruit Present	Comments
			2015	2016	2017	2018	2019	2020	2021	2022	2023	2024	2025		
16A	920	90	-	-	-	-	-	-	50 x 40	40x100	30x10	25X10	100x70	37FI	
16B	1000	90	-	-	-	-	-	-	60 x 50	60x50	15x10	15X10	100x60	42FI	
16C	870	95	-	-	-	-	-	-	30 x 60	40x50	10x5	10X10	10x5		One baby shoot
16D	920	100	-	-	-	-	-	-	40 x 40	30x30	30x5	10X15	40x10		
16E	800	90	-	-	-	-	-	-	20 x 30	50x30	30x20	25X10	40x10	16FI	
16F	780	115	-	-	-	-	-	-	60 x 50	70x60	30x5	20X10	-		Possibly highly trafficked animal track, cant find <i>A.asthenes</i>
16G	980	90	-	-	-	-	-	-	-	-	-	30X10	110x40	45 FI	
16H	920	115	-	-	-	-	-	-	-	-	-	10X10	70x60	10FI	many new shoots

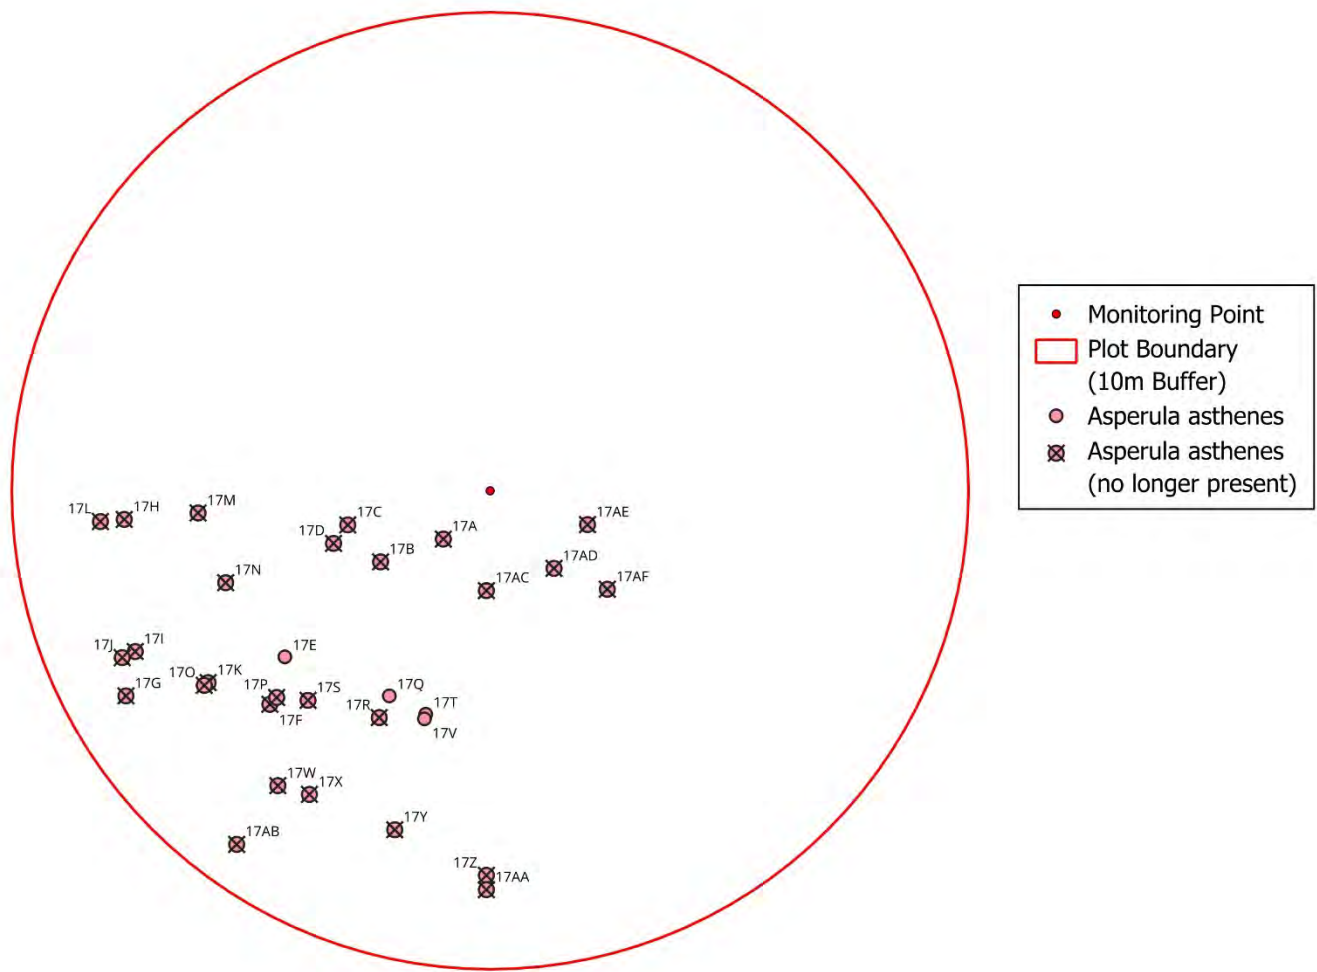
Monitoring Point 17 - *Asperula asthenes* monitoring results 2025

17O	720	235	-	-	-	-	10x5	-	-	-	-	-	-	-		
17P	620	225	-	-	-	-	20x10	-	10 x 10	40x15	30x20	25X10	-	-		No plant or tape found

ID	Distance	Bearing	Clump Size (cm)											Flowers/Fruit Present	Comments
			2015	2016	2017	2018	2019	2020	2021	2022	2023	2024	2025		
17Q	480	205	-	-	-	-	-	35x10	15 x 10	20x20	60x40	65X40	105x90	15 Flowers (combined)	New tape added, joined with 17R
17R	530	205	-	-	-	-	-	30x20	-	-	40x30	60X40	-		New tape added, joined with 17Q, results combined
17S	580	220	-	-	-	-	-	30x10	-	-	-	-	-		
17T	490	195	-	-	-	-	-	40x30	30 x 20	30x20	40x20	30X10	10x10		
17V	500	195	-	-	-	-	-	5x5	-	-	-	5X10	5x10		New tape
17W	760	215	-	-	-	-	-	5x10	-	-	-	-	-		
17X	740	210	-	-	-	-	-	20x20	-	-	-	-	-		
17Y	740	195	-	-	-	-	-	5x5	-	-	-	-	-		
17Z	810	180	-	-	-	-	-	10x10	50 x 40	-	-	-	-		
17AA	840	180	-	-	-	-	-	20x10	20 x 10	80x20	30x70	-	-		
17AB	910	215	-	-	-	-	-	10x5	40 x 30	40x30	15x20	-	-		
17AC	900	215	-	-	-	-	-	5x5	5 x 10	20x10	-	-	-		
17AD	860	220	-	-	-	-	-	10x5	-	-	-	-	-		
17AE	830	225	-	-	-	-	-	10x10	-	-	-	-	-		
17AF	850	330	-	-	-	-	-	10x5	-	-	-	-	-

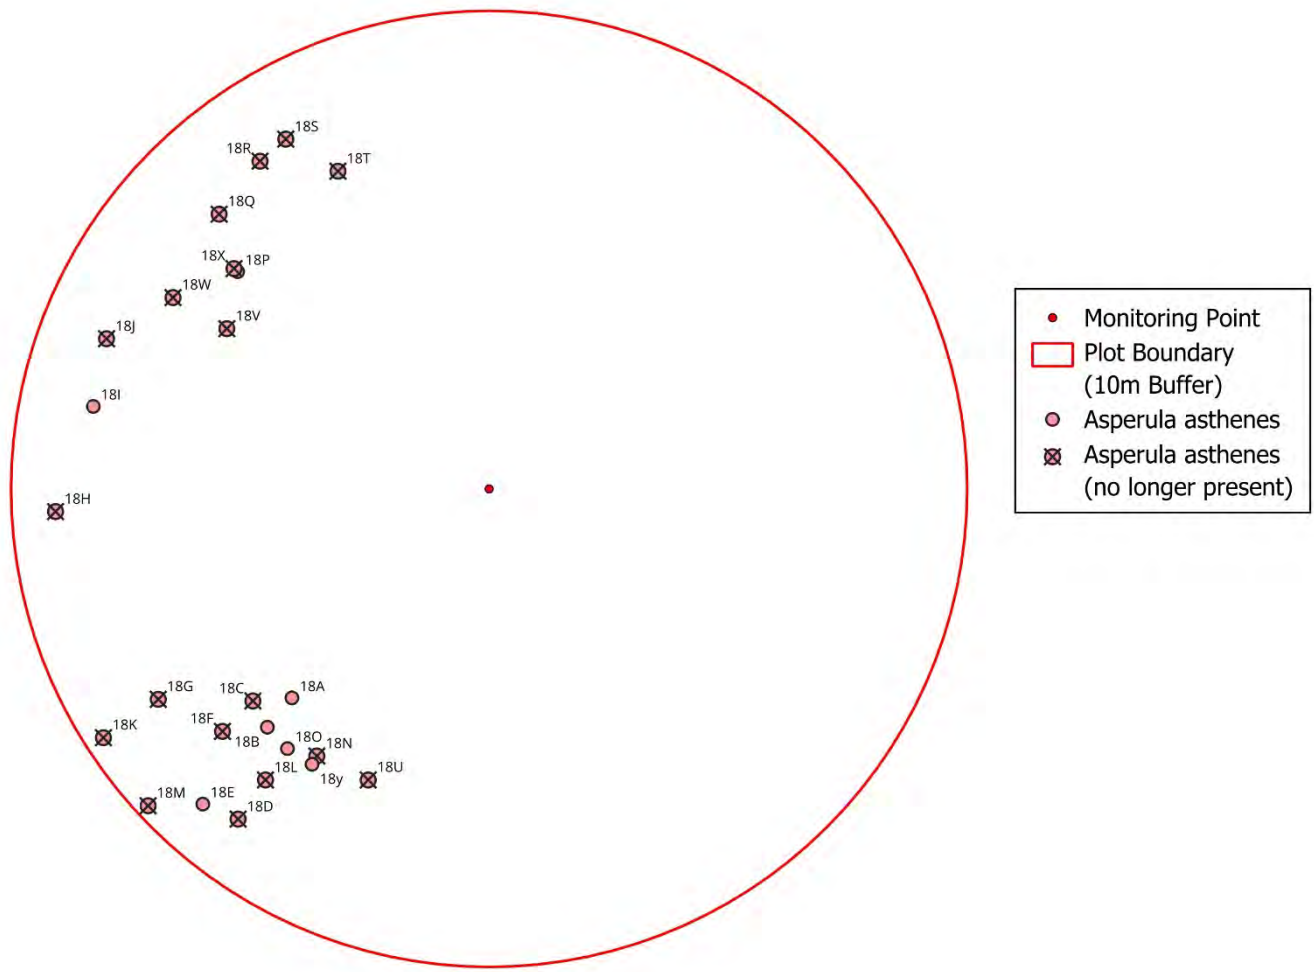
Monitoring point 18 - *Asperula asthenes* monitoring results 2025

ID	Distance	Bearing	Clump Size (cm)											Flowers/Fruit Present	Comments
			2015	2016	2017	2018	2019	2020	2021	2022	2023	2024	2025		
18A	610	220	40 x 30	40 x 30	-	-	-	-	30 x10	40x20	5x5	5x5	20x20	No F/F	Tape present
18B	690	220	100 x 60	100 x 50	-	-	-	-	15 x 15	15x15	40x30	50x30	70x20	No F/F	New shoots
18C	670	225	30 x 20	30 x 20	-	-	-	-	-	-	-	-	-		
18D	880	215	20 x 40	20 x 40	-	-	-	-	-	-	-	-	-		
18E	900	220	100 x 90	90 x 90	10 x 5	-	10 x 5	10 x5	5 x 10	20x20	5x3	15x5	20x10	No F/F	New tape added
18F	760	225	70 x 80	70 x 90	-	-	-	-	-	-	-	-	-		
18G	820	235	70 x 30	70 x 40	10 x 5	-	-	-	-	-	-	-	-		
18H	890	265	5 x 10	20 x 10	-	-	-	-	-	-	-	-	-		
18I	820	280	30 x 40	30 x 30	-	-	-	-	-	45x20	70x40	40x30	75x50	15 fl, buds, no fruit	
18J	830	290	55 x 30	50 x 30	5 x 5	-	5 x 5	1x1	-	-	-	-	-		
18K	960	235	50 x 10	40 x 15	-	-	-	5x5	-	-	-	-	-		
18L	780	215	10 x 10	20 x 20	-	-	-	-	-	-	-	-	-		
18M	980	225	30 x 10	20 x 10	-	-	-	-	-	-	-	-	-

ID	Distance	Bearing	Clump Size (cm)											Flowers/Fruit Present	Comments
			2015	2016	2017	2018	2019	2020	2021	2022	2023	2024	2025		
18N	680	210	-	-	40 x 10	60x10	75x50	70x70	60 x 50	40x40	40x40	30x30	-		Tape found, no plant visible
18O	700	215	-	-	-	70x16	30x20	30x30	25 x 40	40x20	50x30	30x10	40x20	No F/F	
18P	660	310	-	-	-	10x26	45x15	10x10	10 x 10	50x10	15x5	20x5	150x50	No F/F	Merged with 18x, 18v, 18w due to new shoots, along creek line
18Q	770	315	-	-	-	60x21	-	25x10	-	-	-	-	-		
18R	800	325	-	-	-	-	-	10x10	-	-	-	-	-		
18S	810	330	-	-	-	-	-	10x15	-	-	-	-	-		
18T	700	335	-	-	-	-	-	10x10	-	-	-	-	-		
18U	680	200	-	-	-	-	-	-	30 x 30	30x20	60x20	60x20	-		No tape, no asperula found
18V	610	300	-	-	-	-	-	-	10 x 10	60x20	40x10	25x10	-		Merged with 18P
18W	740	300	-	-	-	-	-	-	10 x 15	40x10	42x20	35x25x	-		Merged with 18P
18X	670	310	-	-	-	-	-	-	-	-	20x5	20x5	-		Merged with 18P
18Y	700	210	-	-	-	-	-	-	-	-	-	25x10	20x10	No F/F

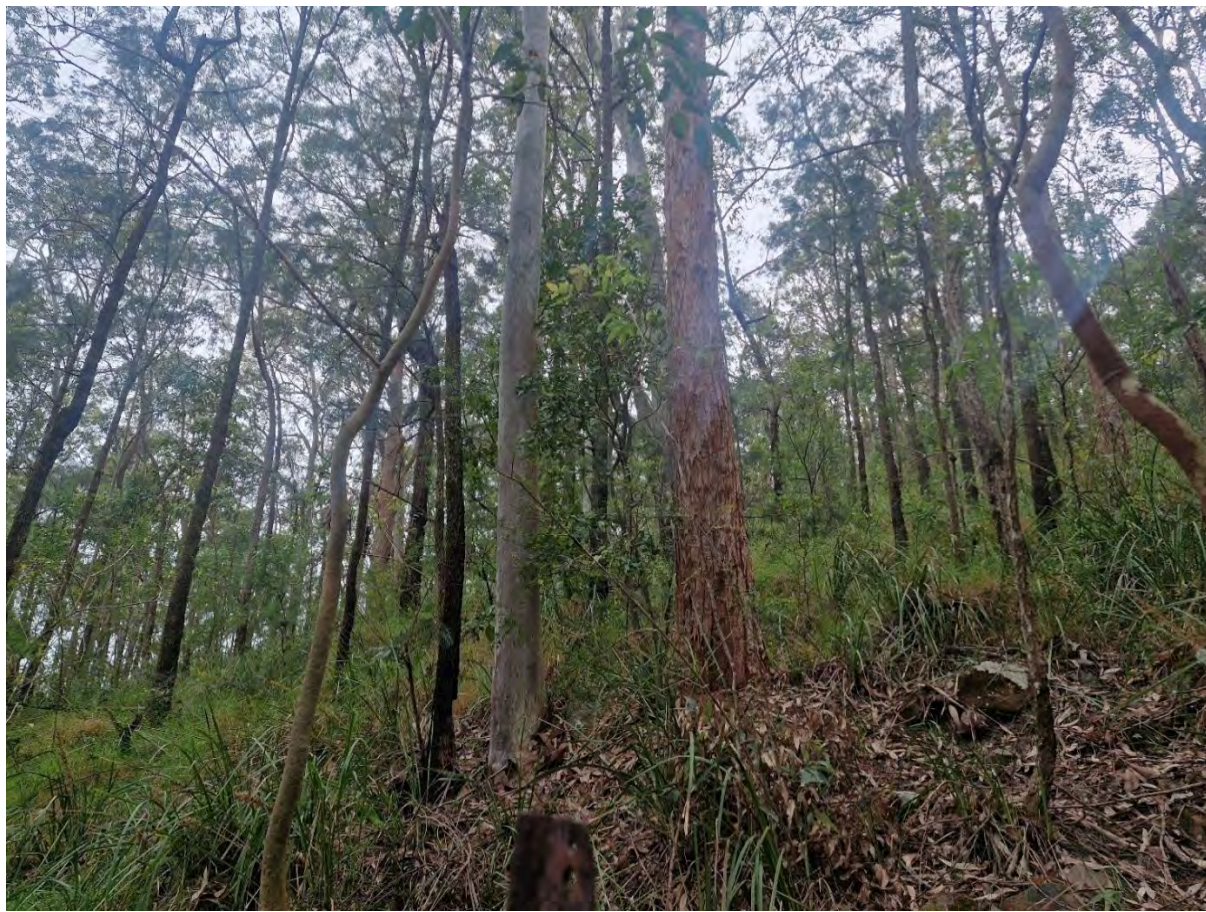
MP 2 2025

Site	Vegetation Community	Vegetation and Habitat Condition	Evidence of Disturbance	Threatened Flora Monitoring
MP2	Spotted Gum – Grey Ironbark open forest	<ul style="list-style-type: none"> • Ground cover in both ‘grass’ and ‘other’ categories have not significantly changed in recent years • Moderate cover of fallen logs / timber. • Rocky areas present. • Hollow-bearing trees and one stag present within vicinity of monitoring site. • Dense leaf litter cover. • Canopy and midstory regeneration present. <p>Conclusion: Dieback evident on the lower limbs of canopy species, notably <i>Allocasuarina spp</i> with the canopy becoming sparse.</p> <p>No other significant changes in vegetation and habitat condition since the previous survey (2024).</p>	<ul style="list-style-type: none"> • No evidence of erosion and sedimentation within the monitoring point, though minimal erosion occurs southwest of the monitoring point due along the steep slopes. • No recent evidence of disturbance from grazing, pest animals, rubbish dumping, rock / timber removal, or dust. • No signs of recent fire. • Weed cover is stable within the monitoring point though Heavy <i>Lantana</i> infestation in the gully southwest of MP2 remains. <p>Conclusion: No new disturbance or changes in existing disturbance severity were observed since the previous survey (2024).</p>	N/A

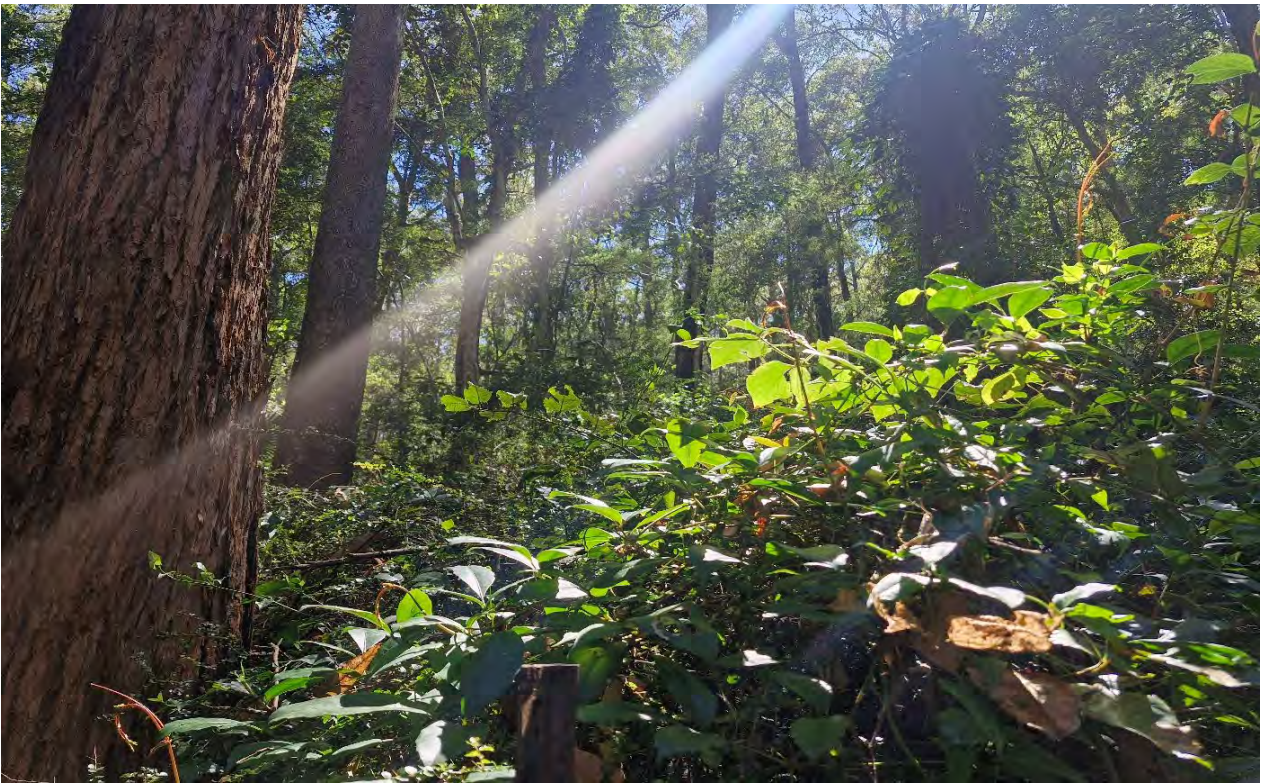
MP3 2025

Site	Vegetation Community	Vegetation and Habitat Condition	Evidence of Disturbance	Threatened Flora Monitoring
MP3	Brush Box – Turpentine shrubby open forest	<ul style="list-style-type: none"> All vegetation strata within the monitoring site in healthy condition. A small increase in canopy cover, though all other vegetation strata remain stable since previous monitoring events. High structural complexity of vegetation. High leaf litter. Light-Moderate cover of fallen timber. Weed cover (<i>Lantana</i>) within the monitoring site has significantly increased. <p>Conclusion: Excluding an increase in the abundance of exotic plants, no significant or notable changes in vegetation and habitat condition since the previous survey (2024).</p>	<ul style="list-style-type: none"> No evidence of erosion and sedimentation. No recent evidence of disturbance from grazing, pest animals, rubbish dumping, or rock / timber removal. No signs of recent fire. <p>Conclusion: No new disturbance or changes in existing disturbance severity were observed since the previous survey (2024).</p>	<ul style="list-style-type: none"> There was an overall decrease in number of <i>Asperula asthenes</i> individuals within the monitoring site from nine (9) in 2024 to ten (10) in 2025. Two new plants were first identified in 2025. Six (6) <i>Asperula asthenes</i> plants were recorded flowering during monitoring though none were observed fruiting. All <i>Asperula asthenes</i> plants within the monitoring site were observed to be in healthy condition. The population at MP 3 has declined significantly since 2021 (18 individuals recorded). <p>Conclusion: <i>Asperula asthenes</i> remains stable with previous monitoring. Though plants continue to be outcompeted by heavy exotic cover and smothering by high leaf litter.</p>
