Appendix 4 – Biodiversity Offset Area Monitoring Report

Karuah East Quarry Biodiversity Offset Area Monitoring Report

Rev 1

Rev. No.	Revision Date	Author/s	Reviewer	Details
Rev 1	10 February 2026	Rachel Neal	Mark Dean	Draft

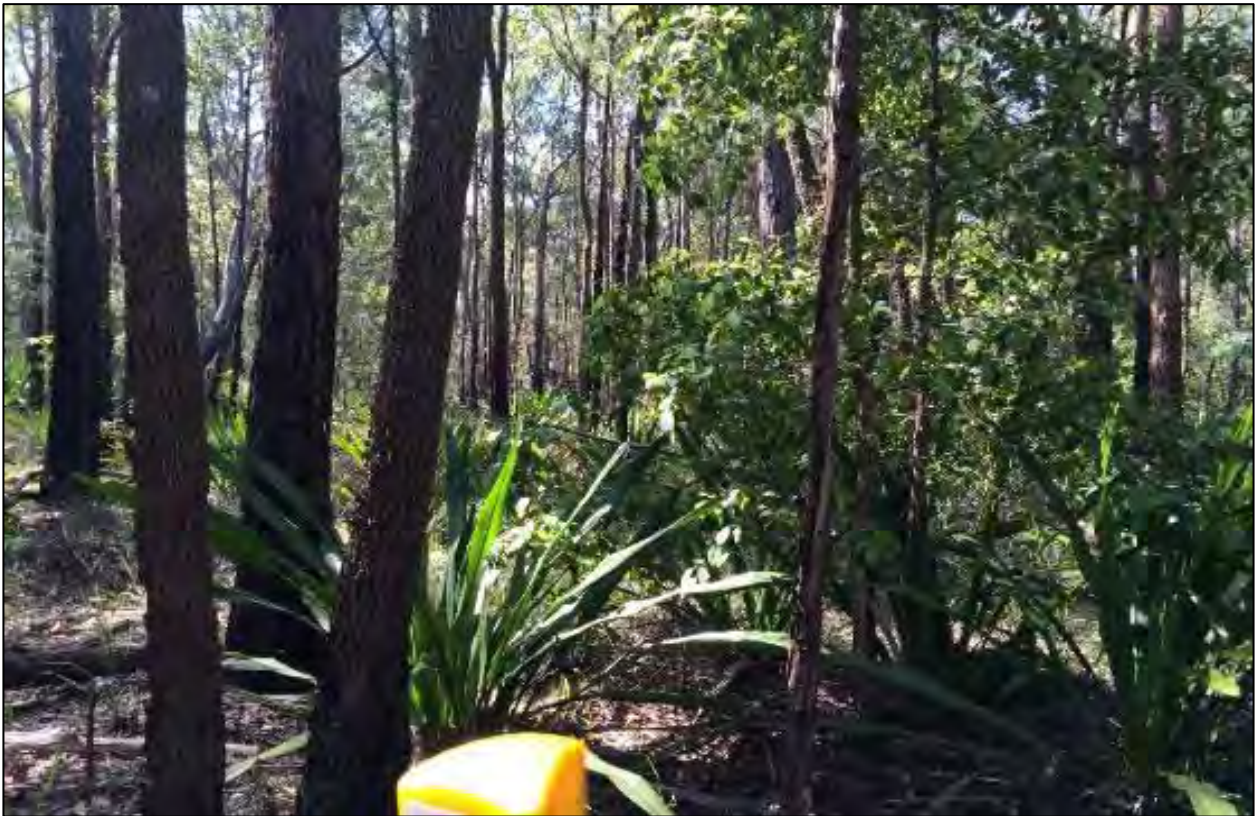
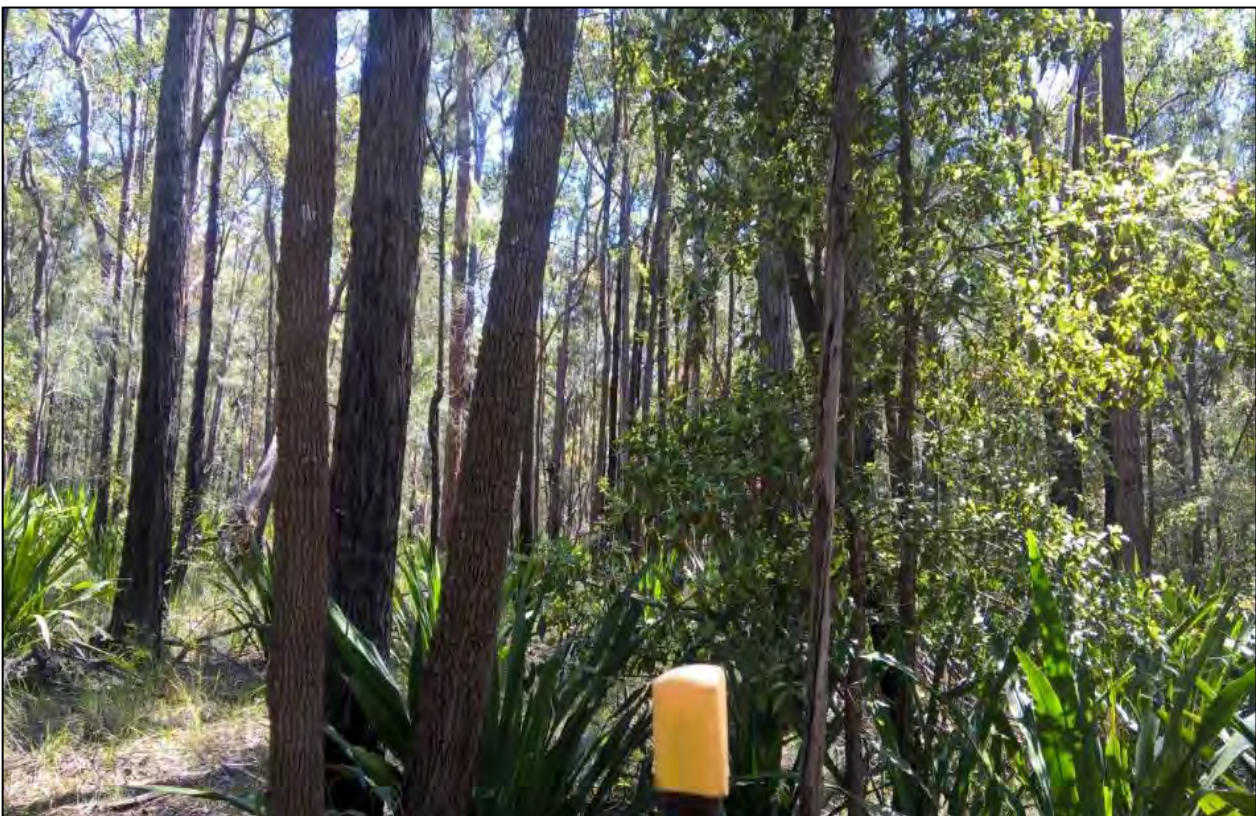
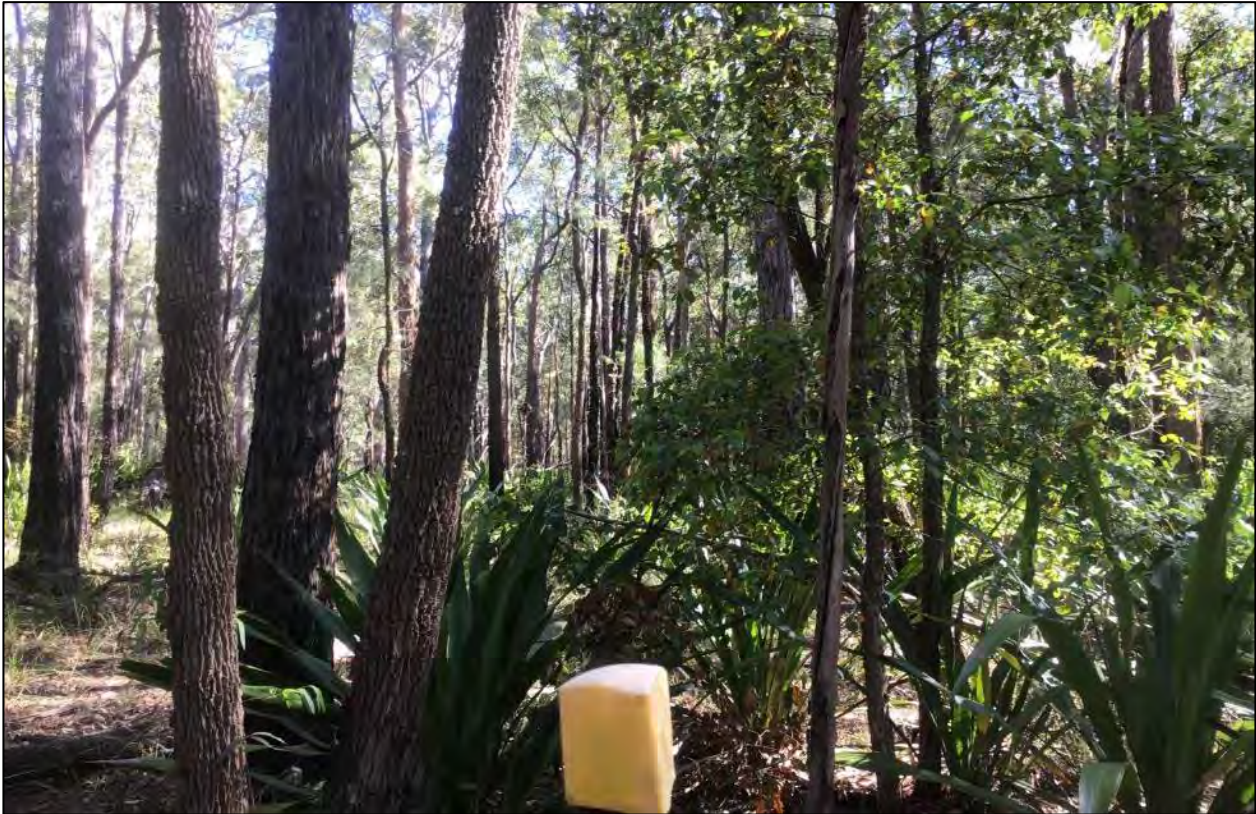
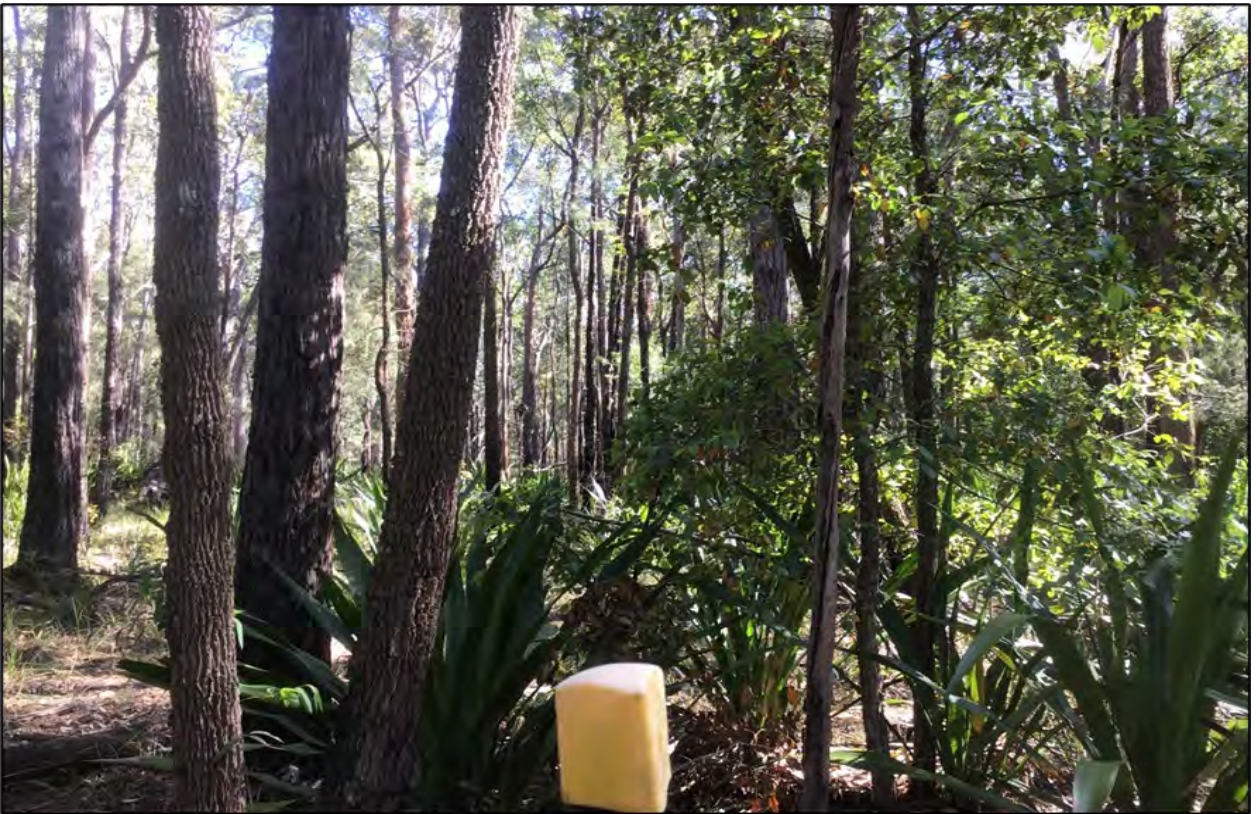
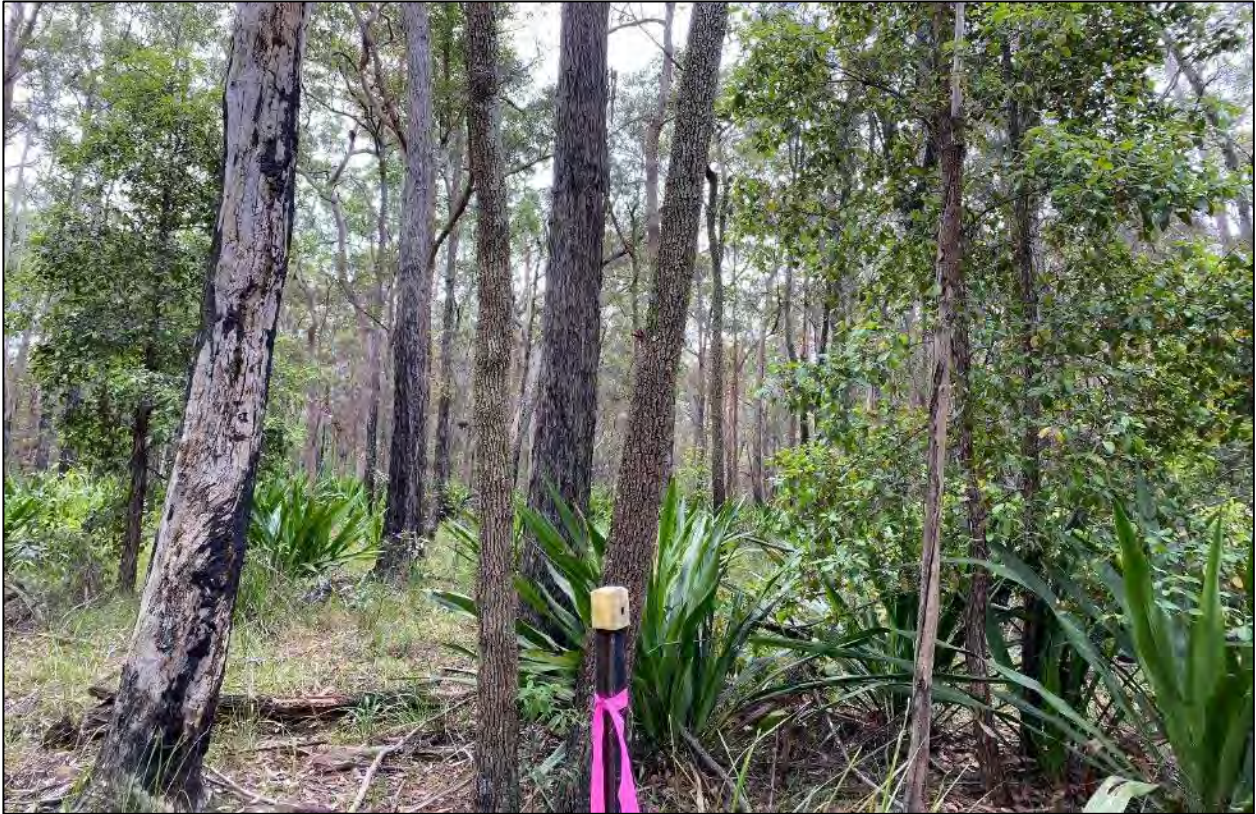
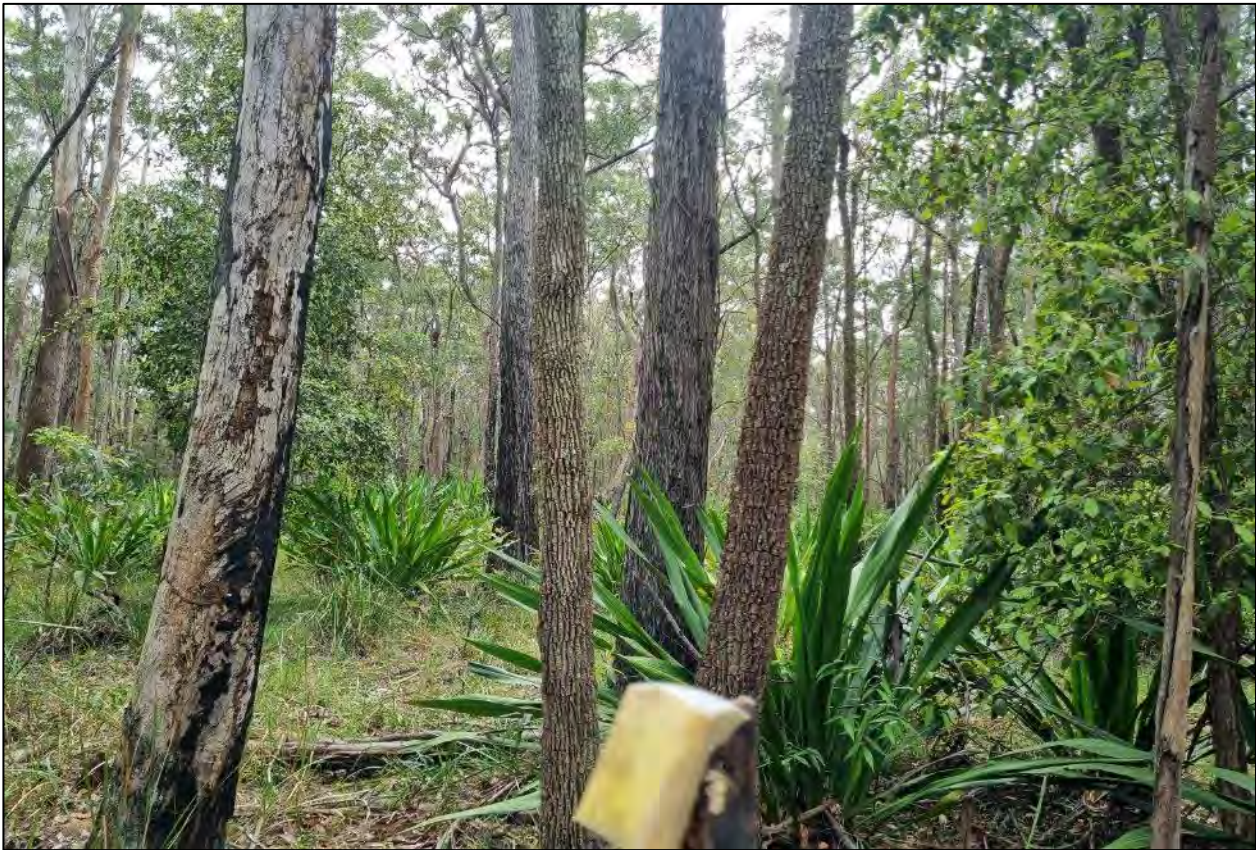
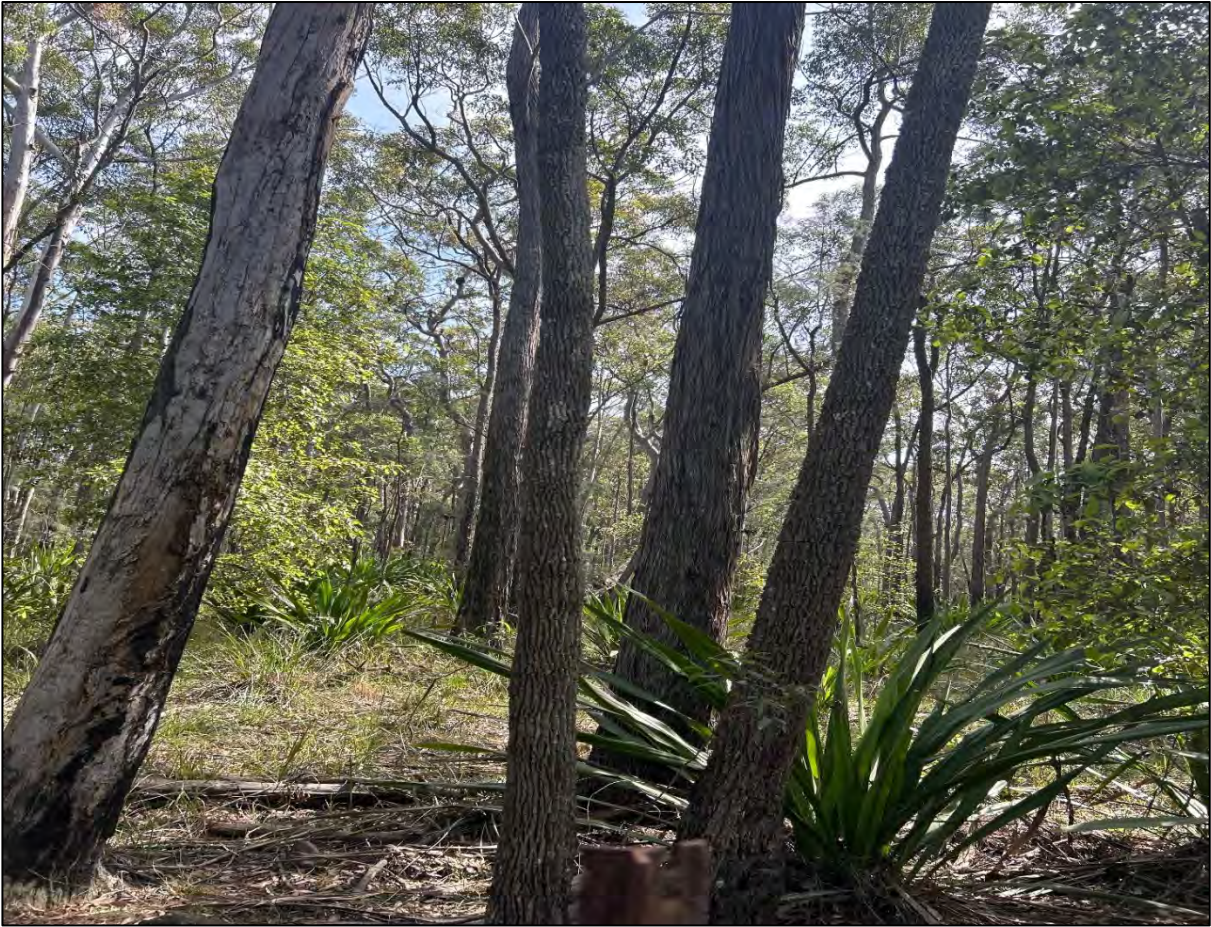
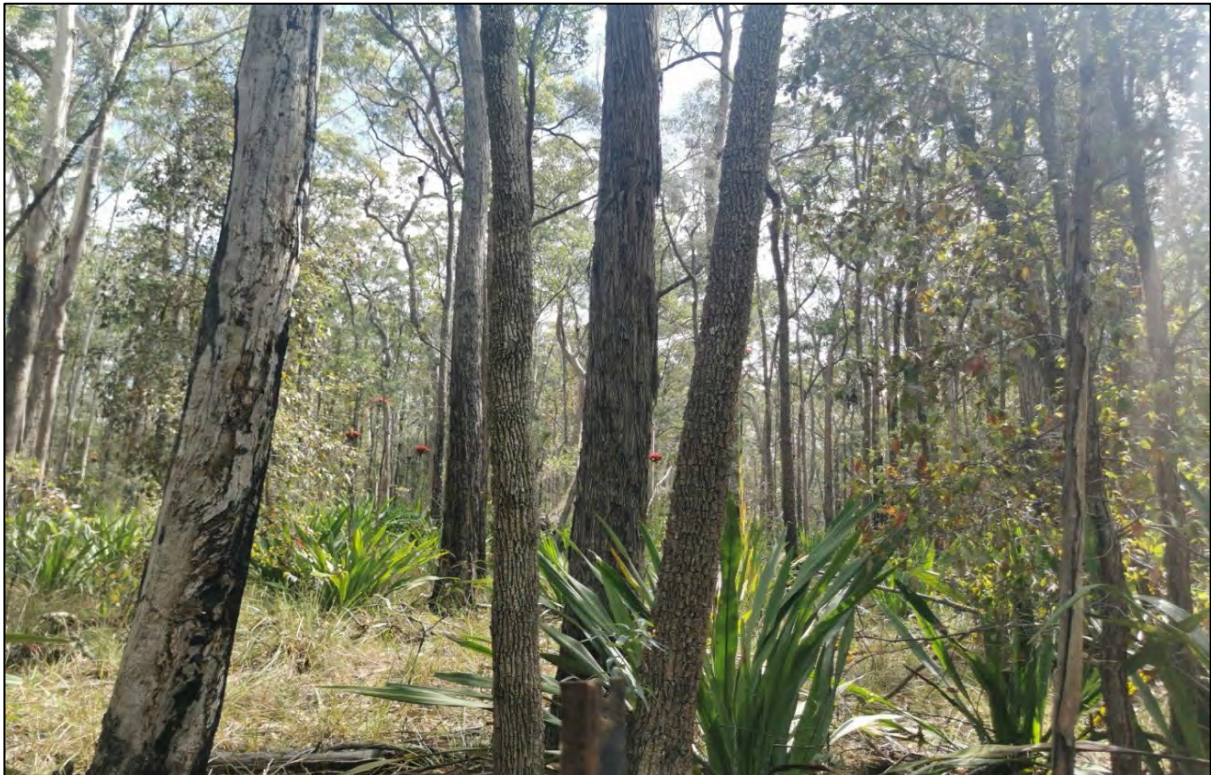
Monitoring Point 13 (MP 13)

Site	Vegetation Community	Vegetation and Habitat Condition	Evidence of Disturbance	Threatened Flora Monitoring
MP13	Spotted Gum – Grey Ironbark open forest	<ul style="list-style-type: none"> Minimal dieback in mature <i>Allocasuarina torulosa</i> individuals although healthy regeneration is observed within the canopy and midstory. Low level of fallen logs / timber. Dense ground cover. Low rock cover. Eucalypt and Midstory seedlings present. <p>Conclusion: Regeneration is occurring within the monitoring point with minimal dieback of <i>Allocasuarina torulosa</i>.</p>	<ul style="list-style-type: none"> No evidence of erosion and sedimentation. No recent evidence of disturbance from grazing, pest animals, rubbish dumping, rock / timber removal, or dust. Significant dust settlement recorded here in 2023, though this appears to have reduced at the current monitoring event with no obvious dust present in 2025 <p>Conclusion: No evidence of new disturbance was observed since the previous survey (2024).</p>	N/A

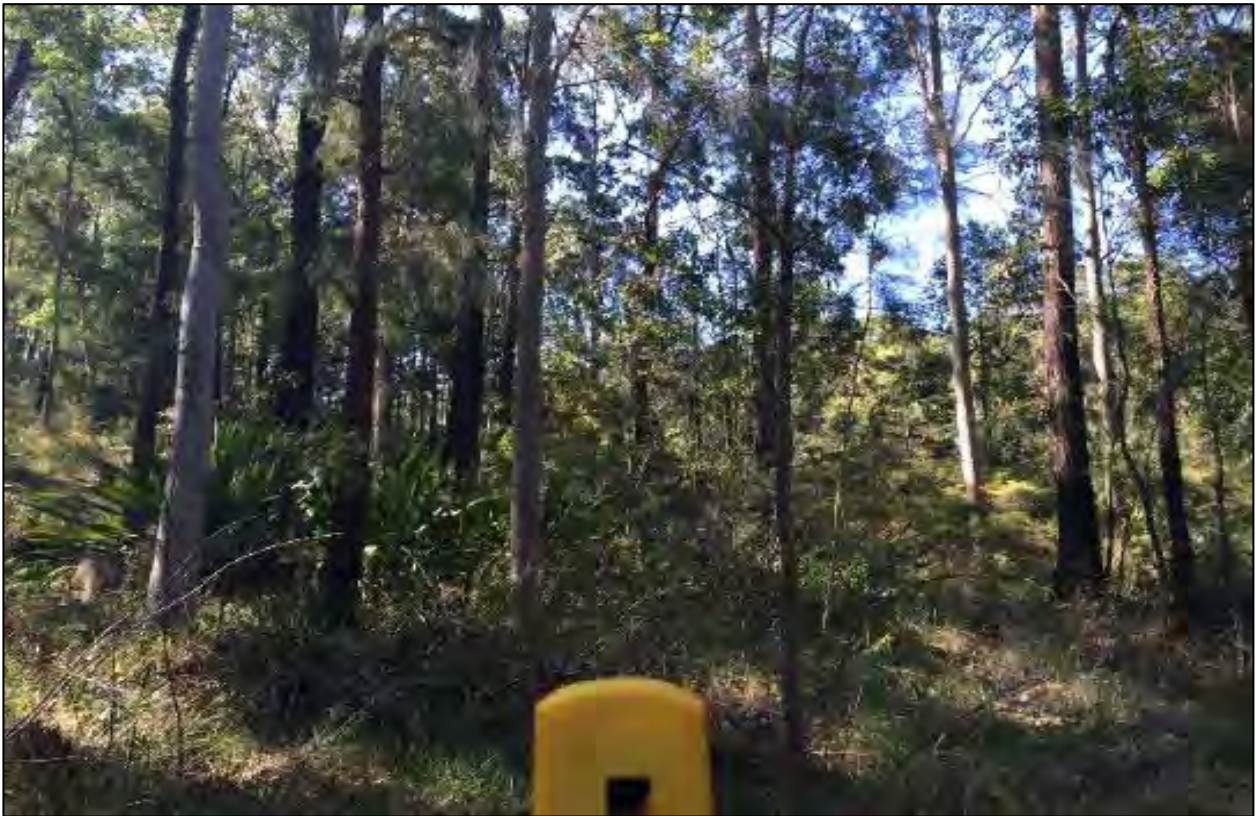
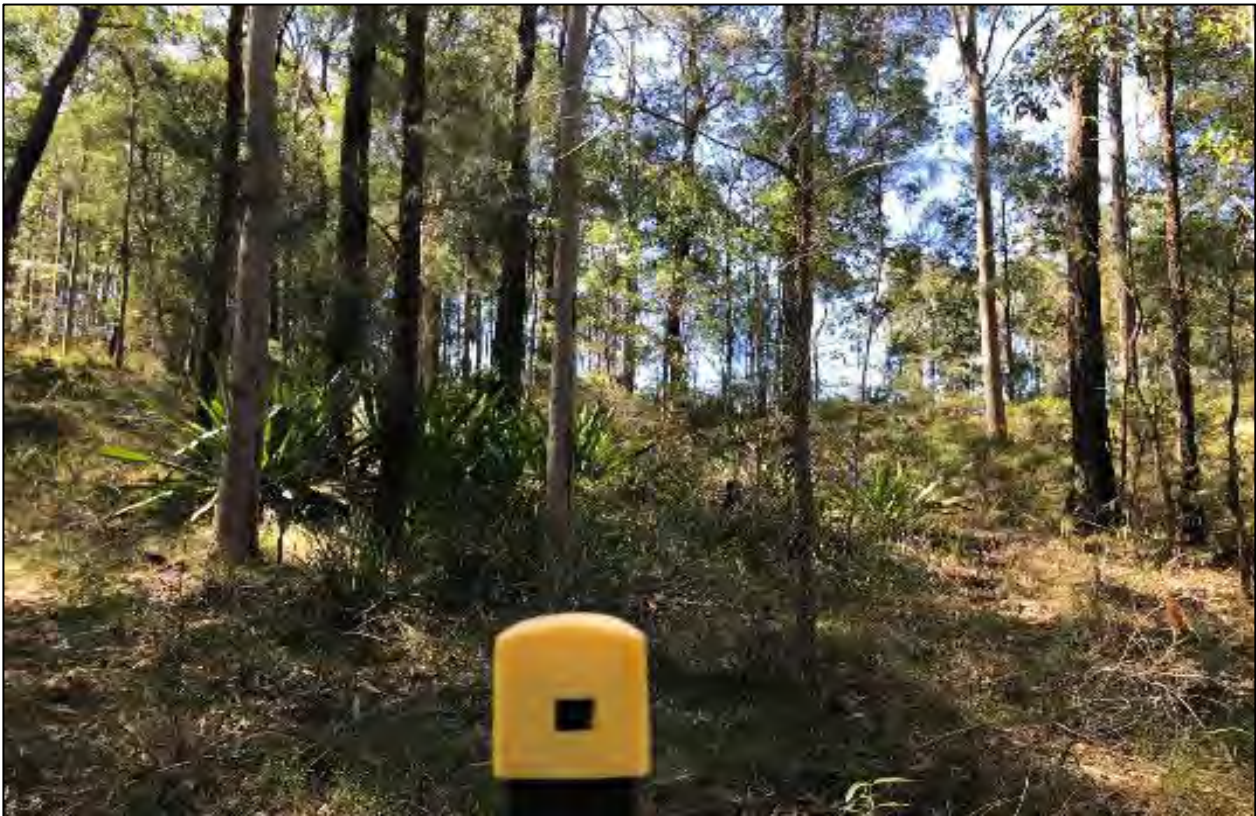
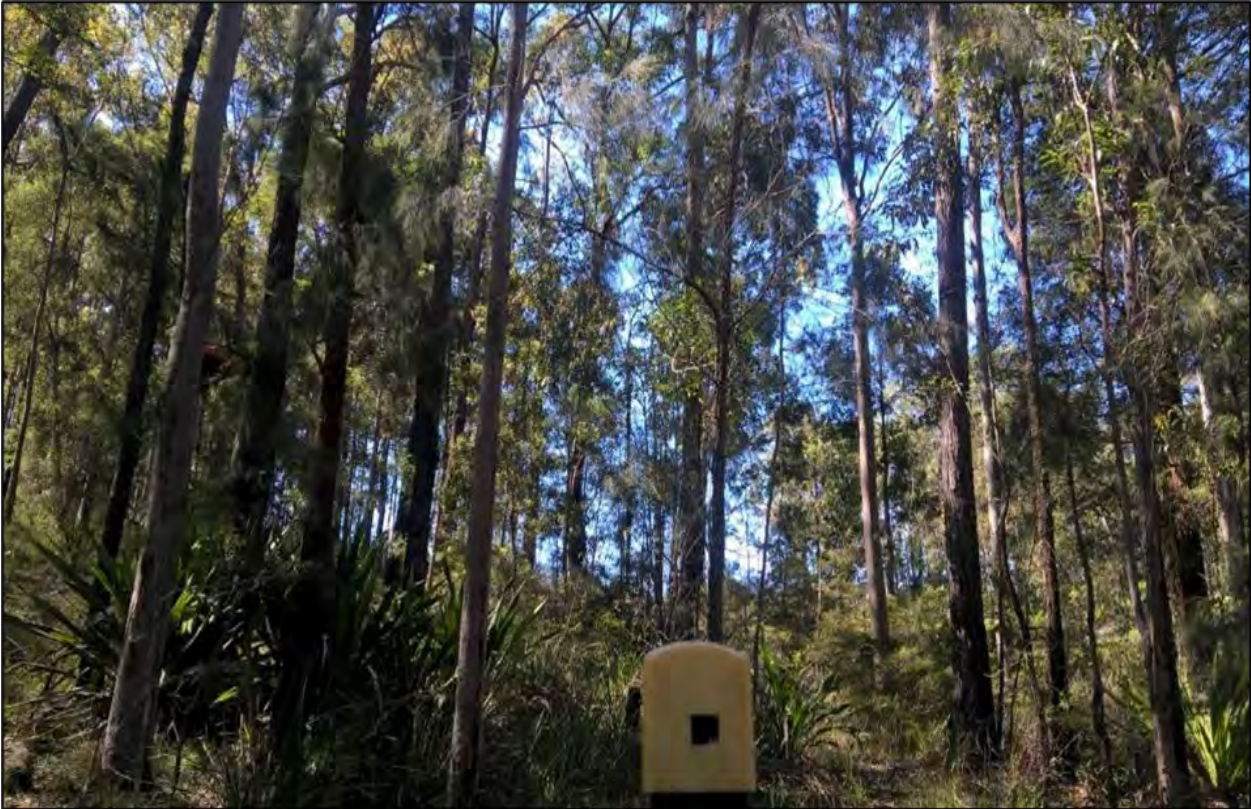
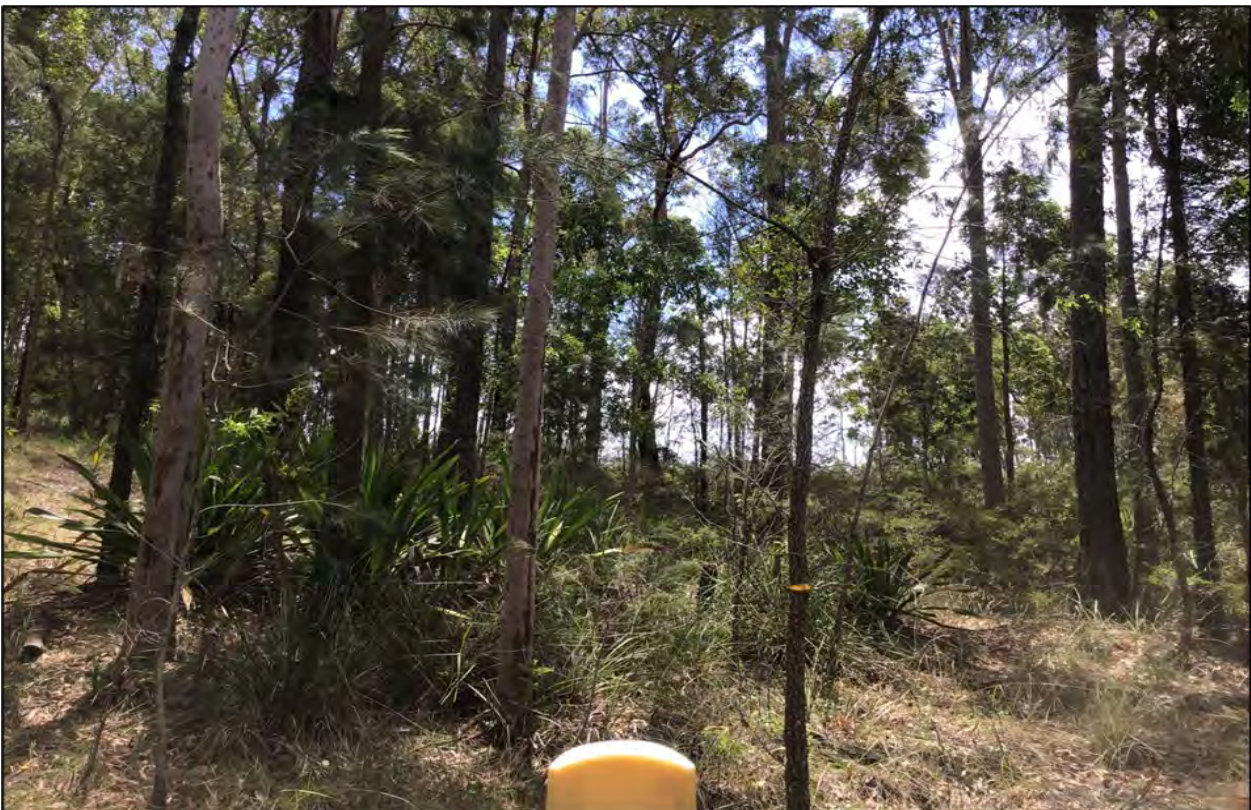
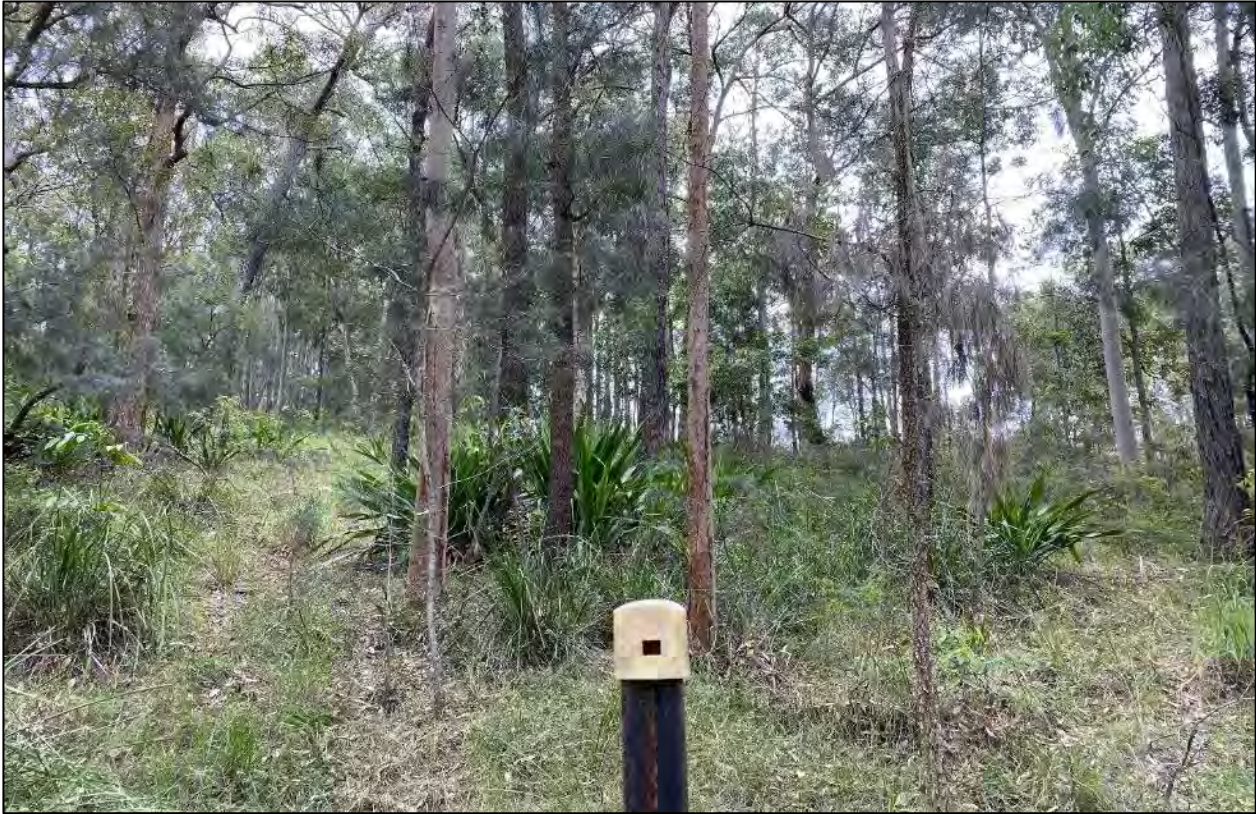
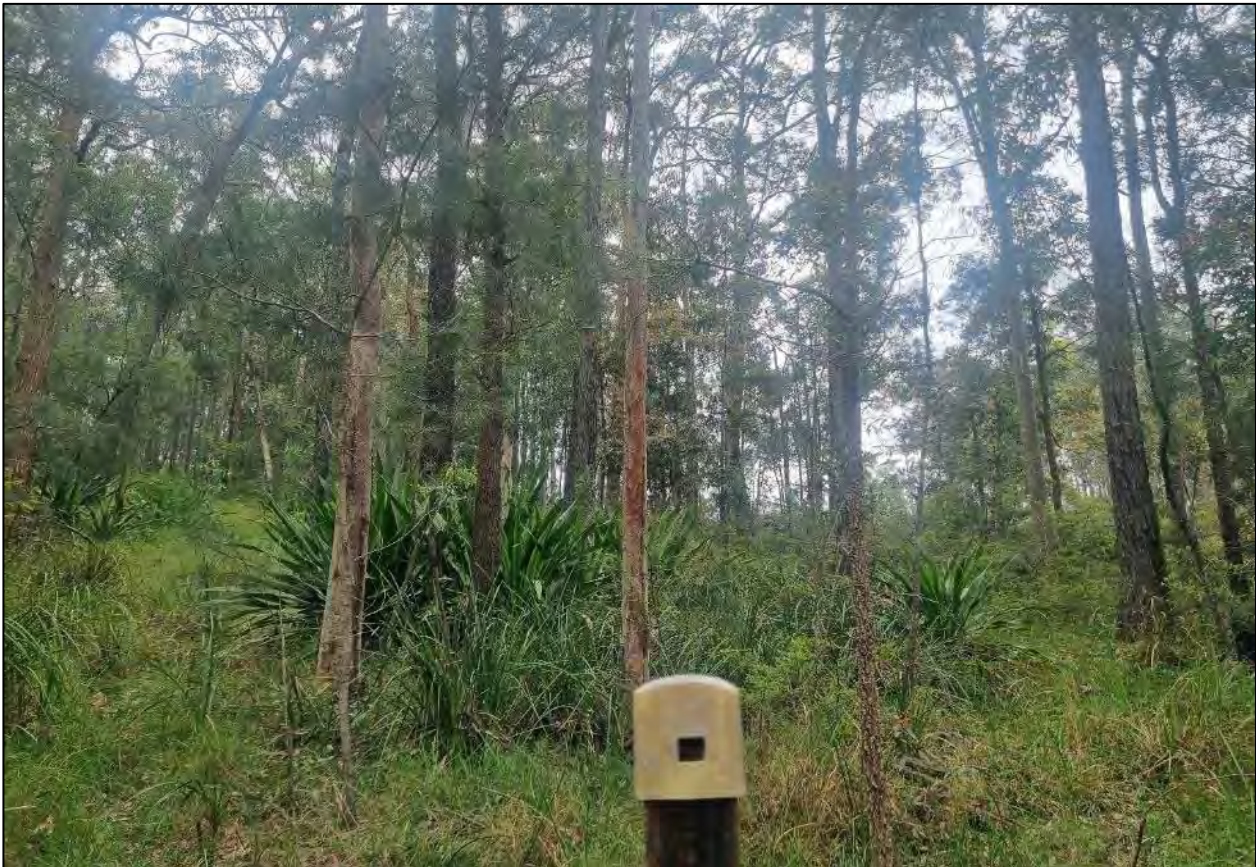
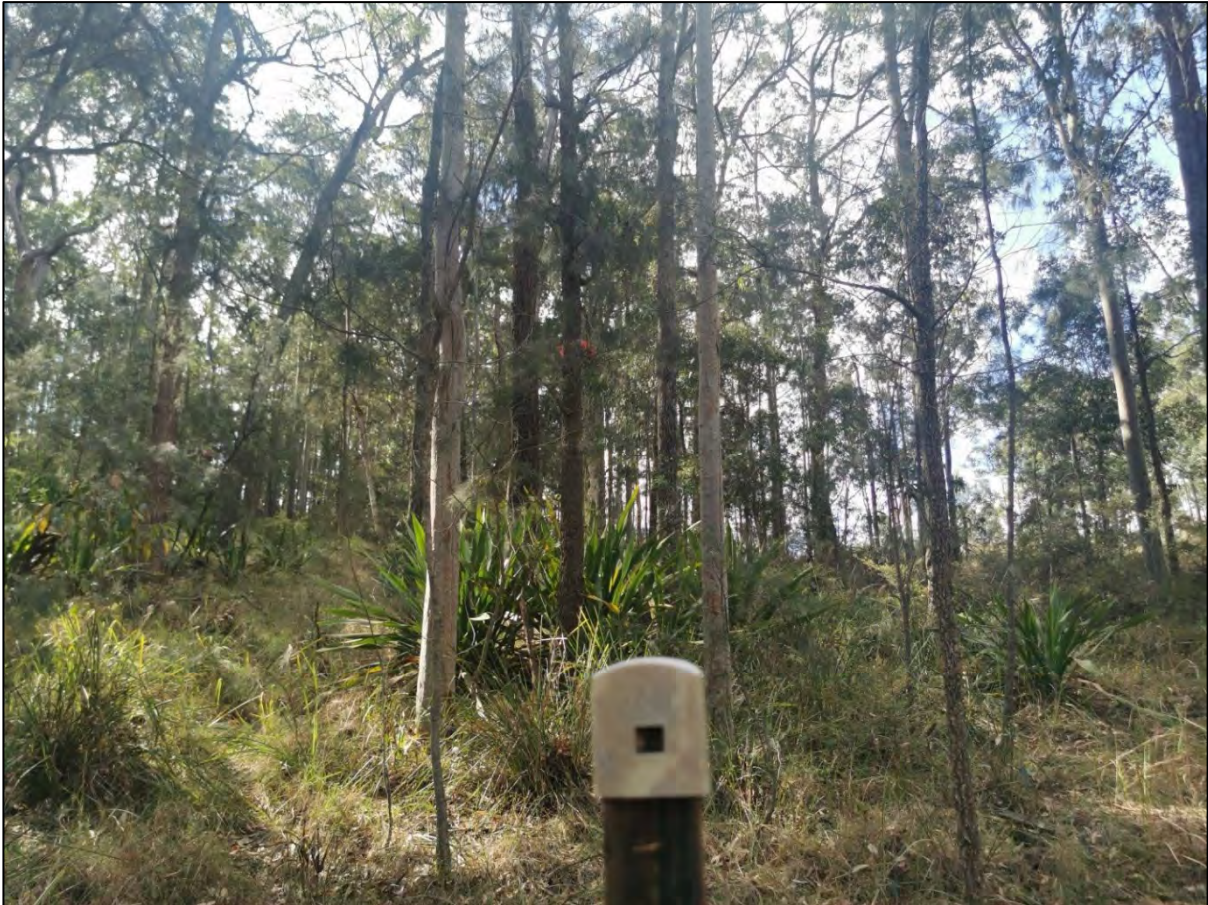
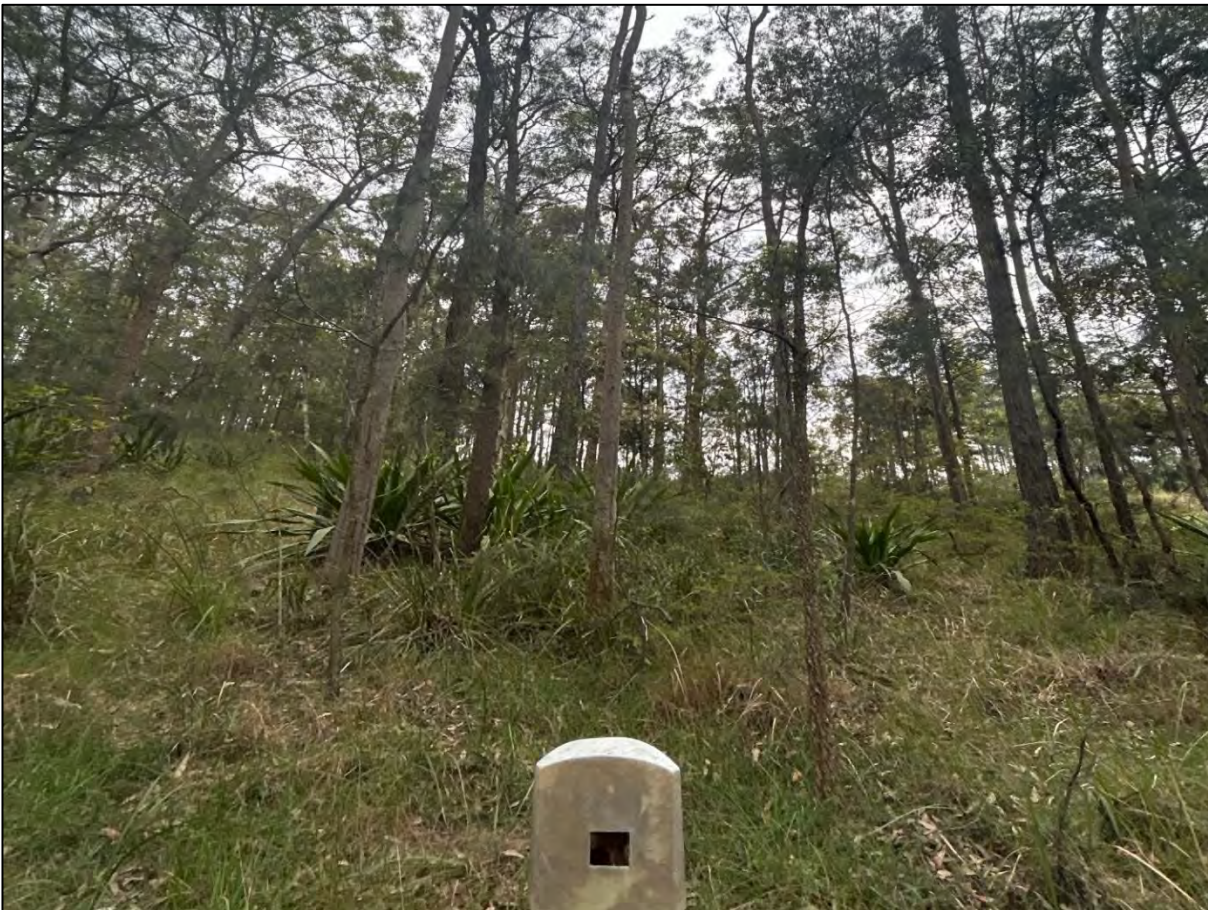
Monitoring Point 14 (MP 14)

Site	Vegetation Community	Vegetation and Habitat Condition	Evidence of Disturbance	Threatened Flora Monitoring
MP14	Smooth-barked Apple - Red Bloodwood open forest	<ul style="list-style-type: none"> • Most vegetation strata in healthy condition. • Canopy and midstory regeneration present. • Low fallen/ timber. • Dense ground and leaf litter cover. • Flourish of new growth evident in the midstory and shrub layer due to recent rainfall. <p>Conclusion: No significant or notable changes in vegetation and habitat condition since the previous survey (2024).</p>	<ul style="list-style-type: none"> • Evidence of sedimentation of quarry rock material adjacent to monitoring plot from haul road into the nearby dam. • High occurrence of <i>Setaria sphacelata</i> occurring south of the monitoring point. • Dust accumulation on foliage from Quarry. • Sediment runoff occurring south of the monitoring point contaminating the dam. • Moderate cover of exotic grasses around dam to south and along access track. <p>Conclusion: Prevailing evidence of sedimentation was observed and high weed coverage still persist within the area since the previous survey (2024).</p>	N/A
