Appendix 4 – Biodiversity Offset Area Monitoring Report

Karuah East Quarry Biodiversity Offset Area Monitoring Report

Rev 1

Rev. No.	Revision Date	Author/s	Reviewer	Details
Rev 1	10 February 2026	Rachel Neal	Mark Dean	Draft

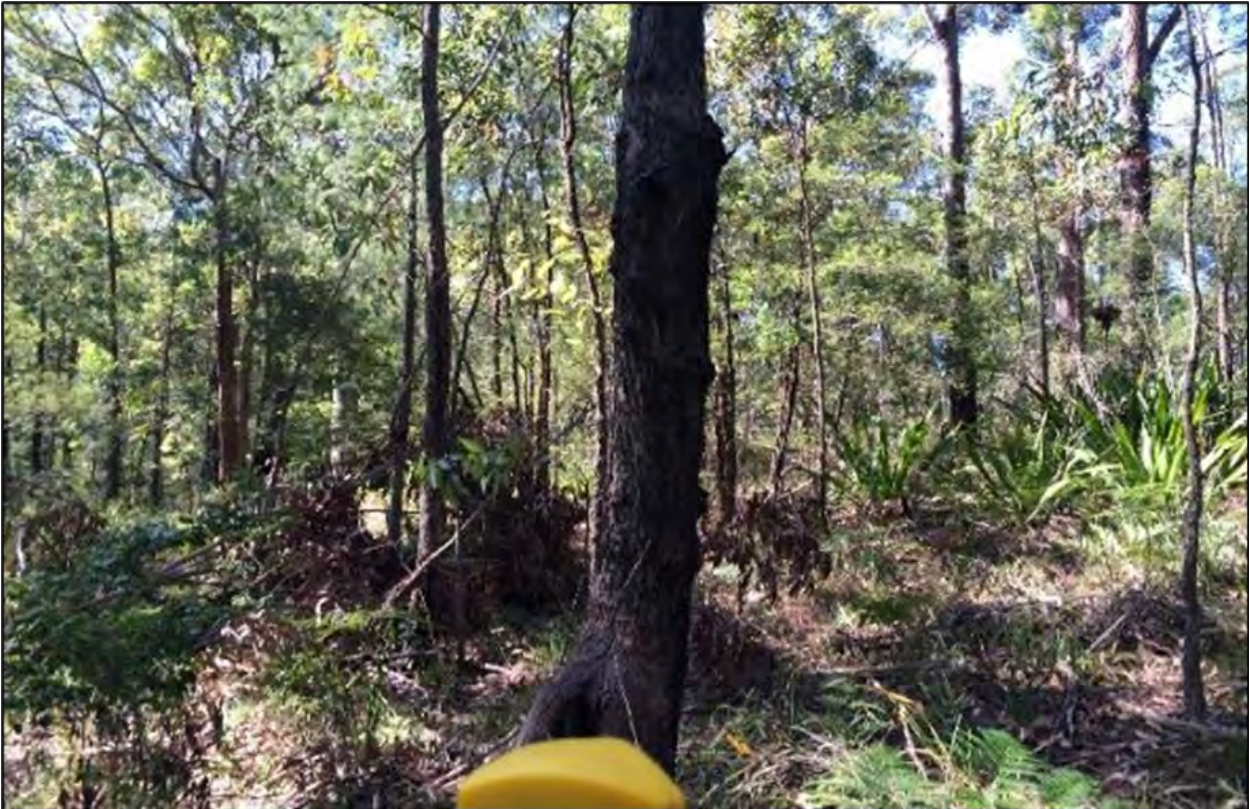
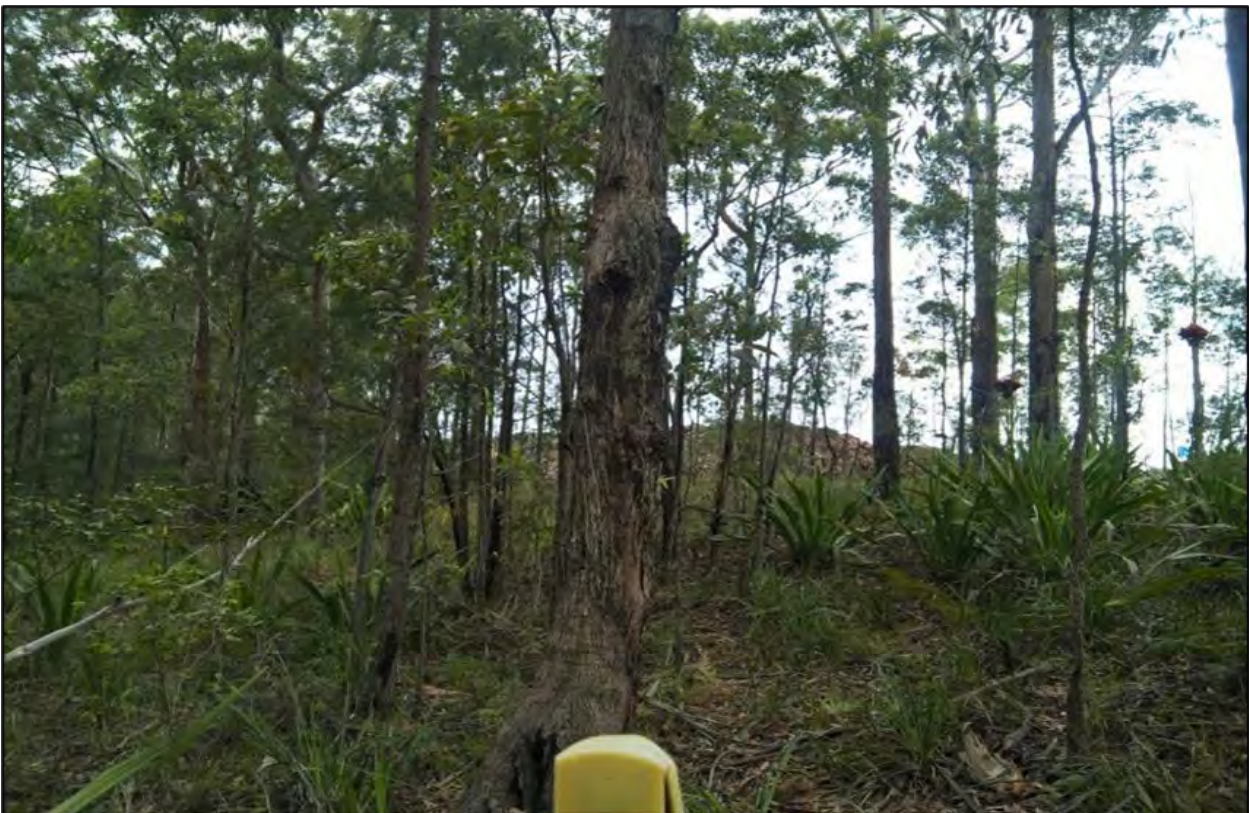
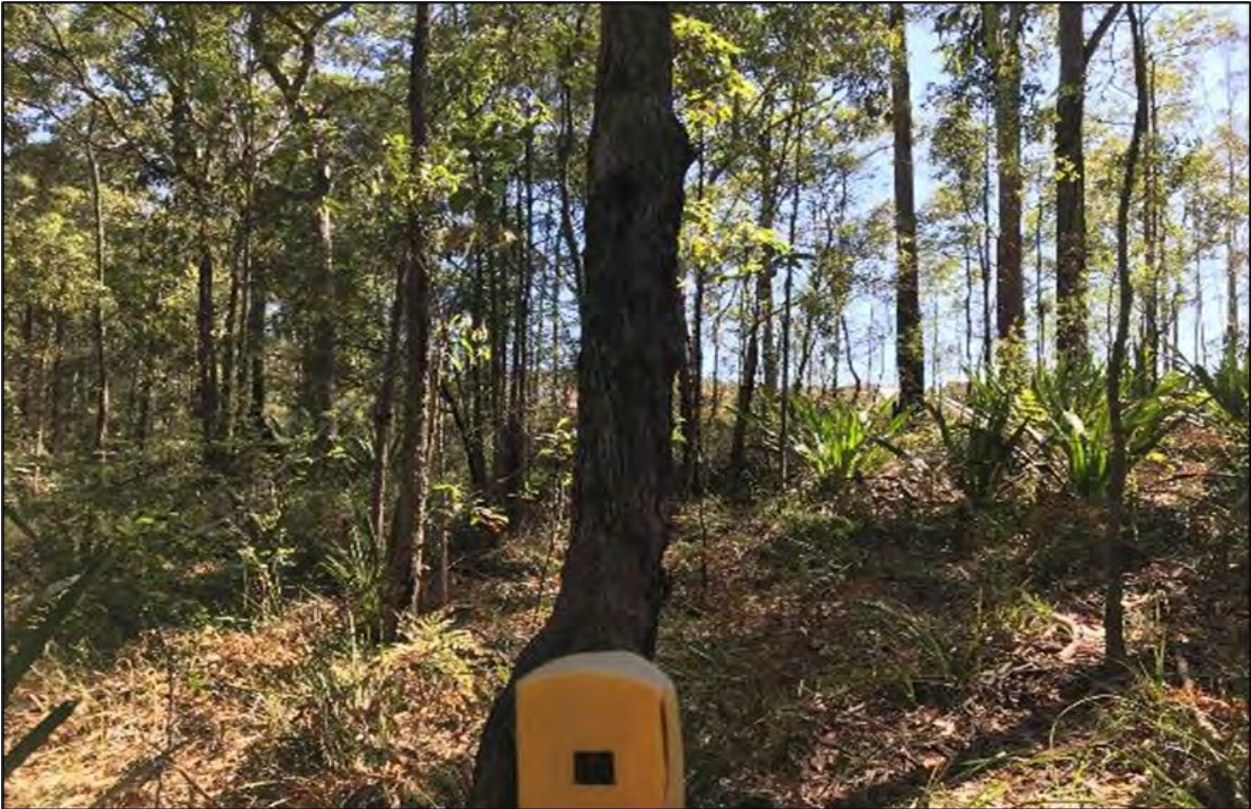
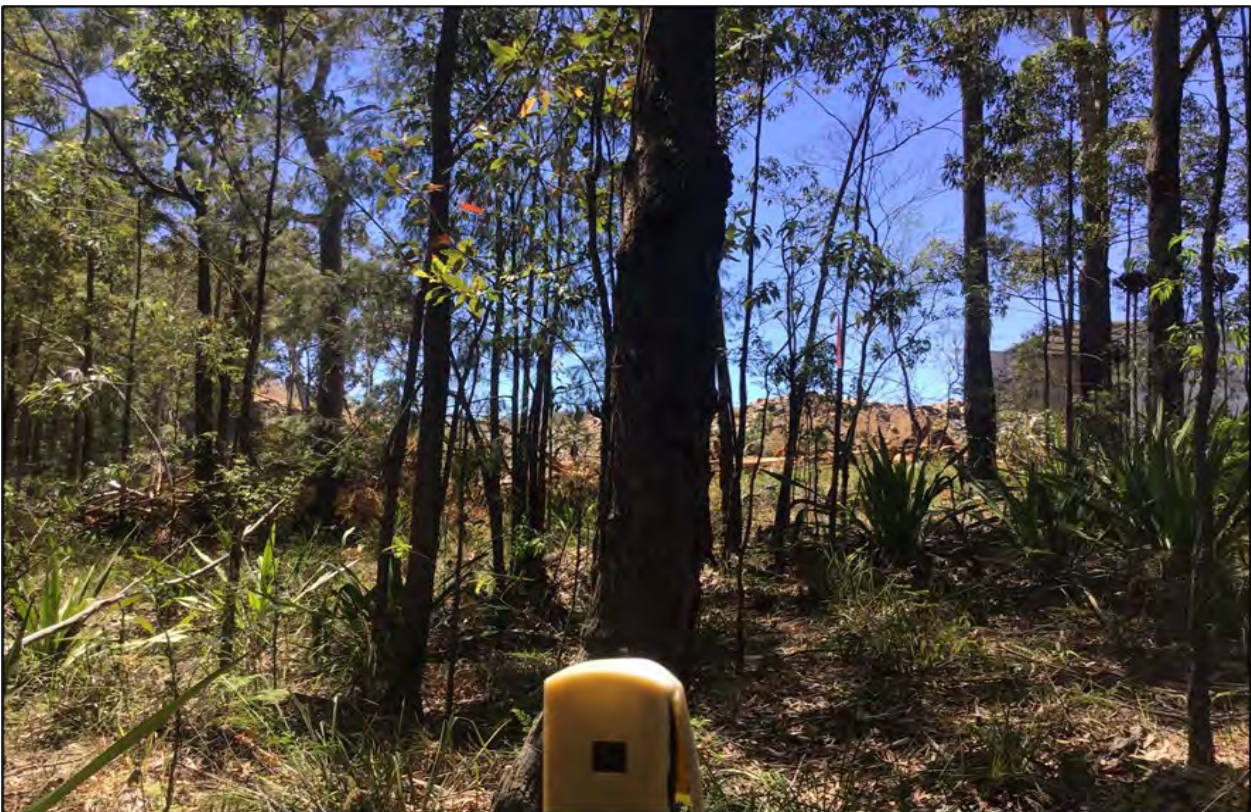
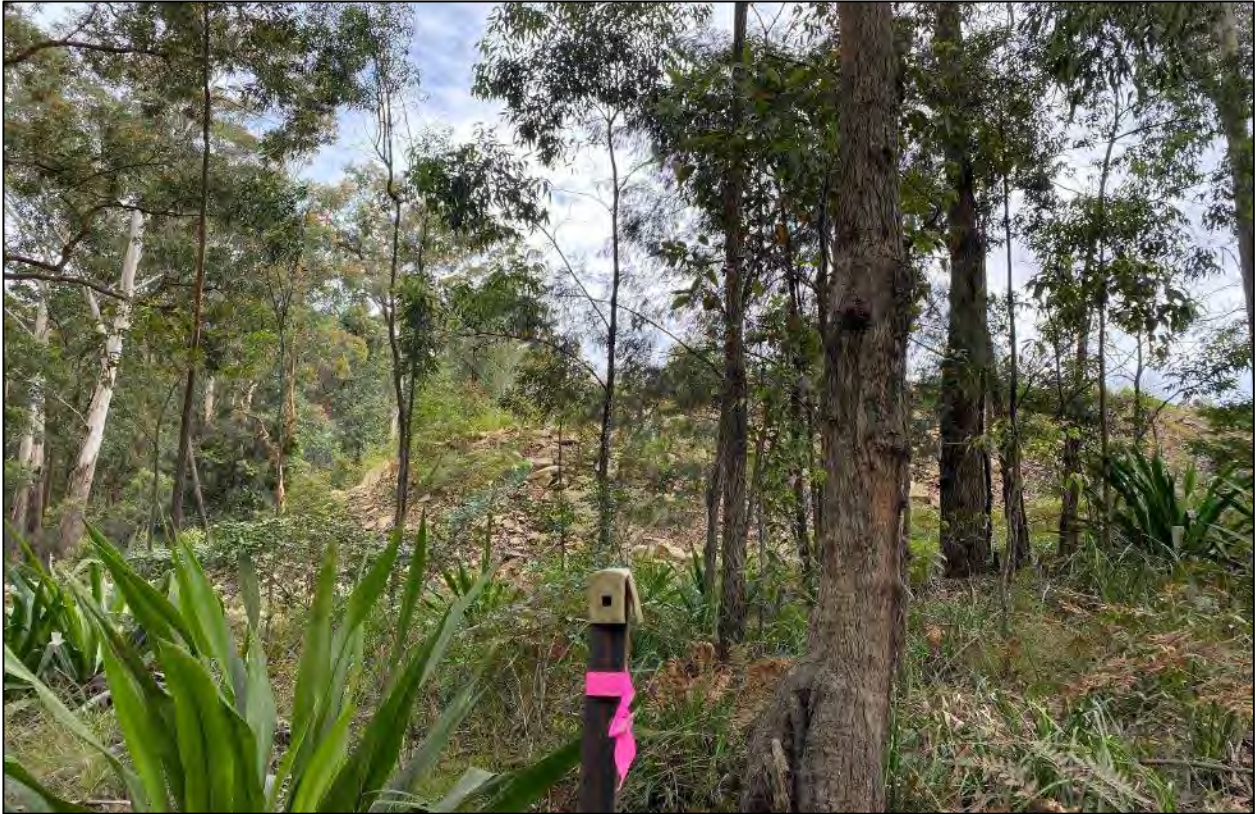
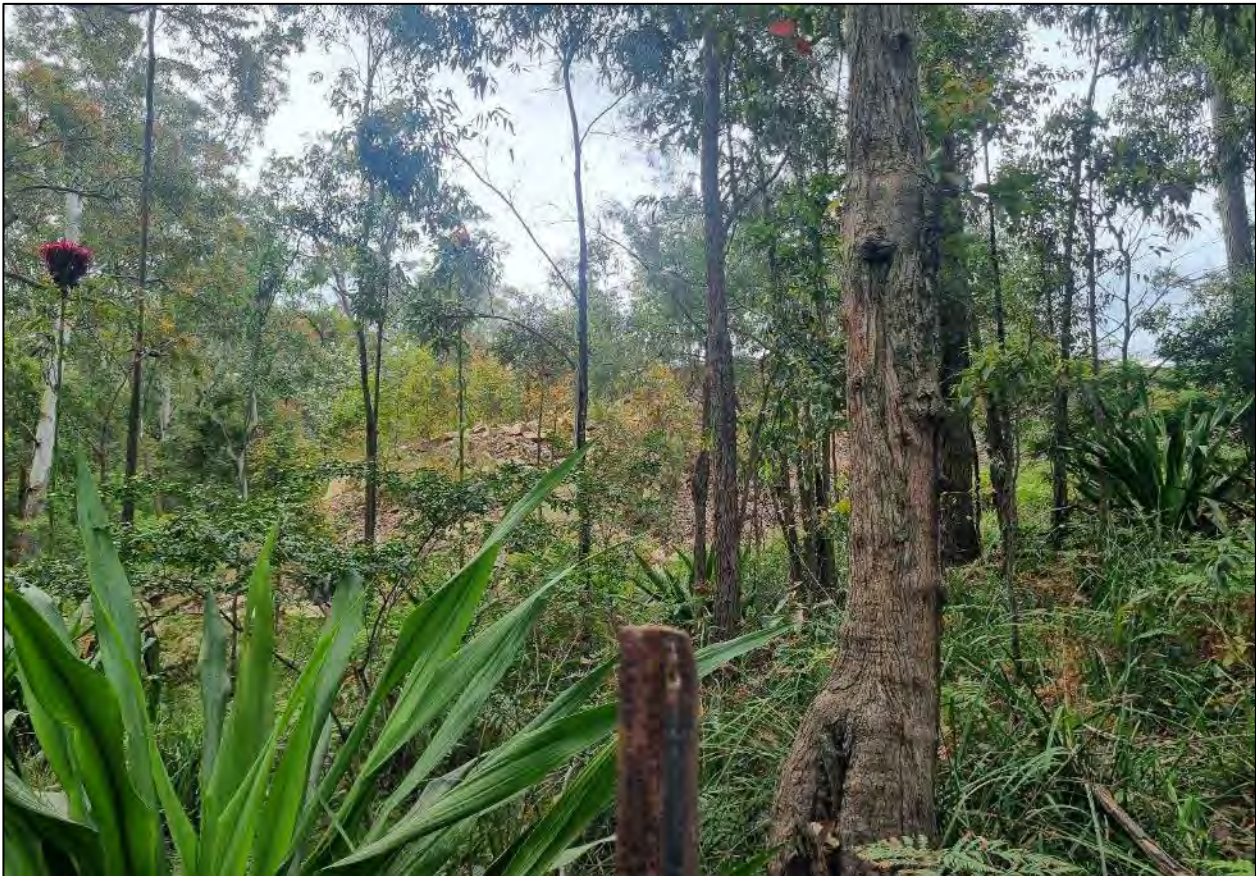
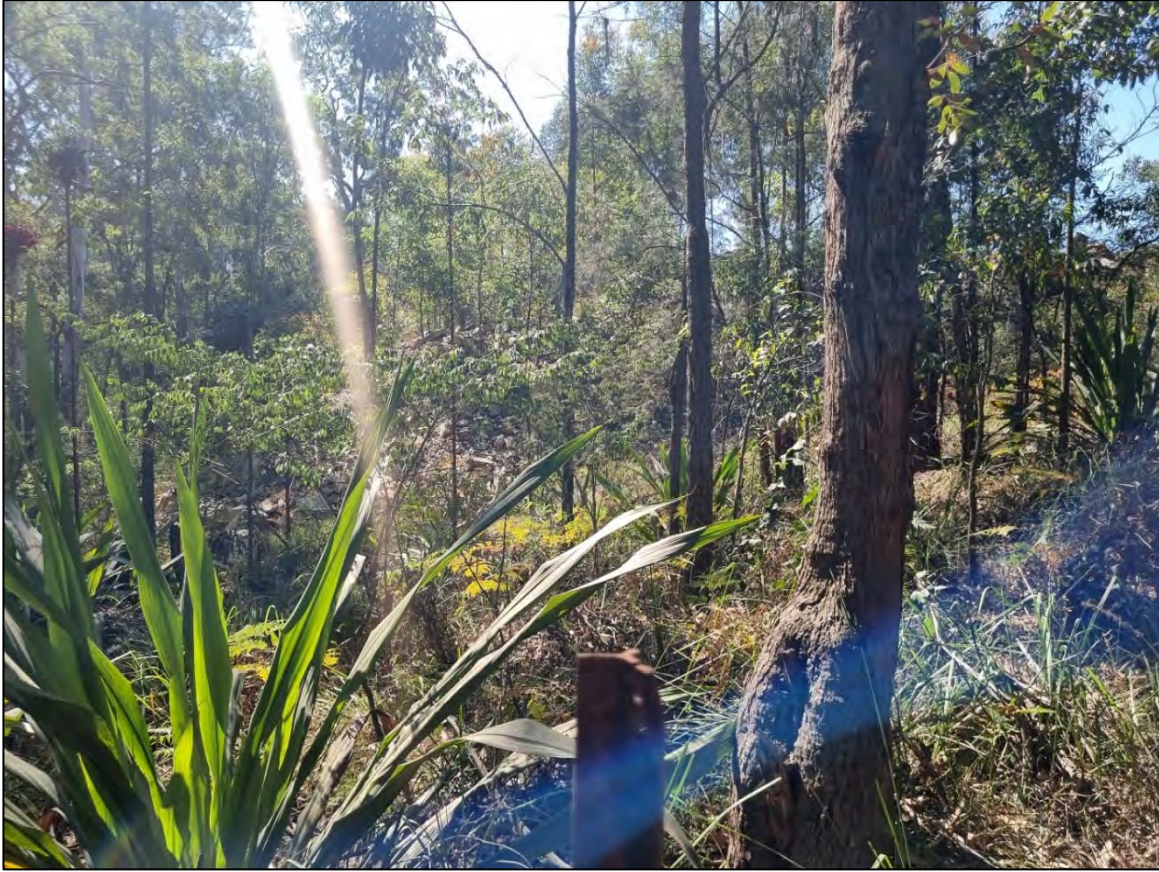
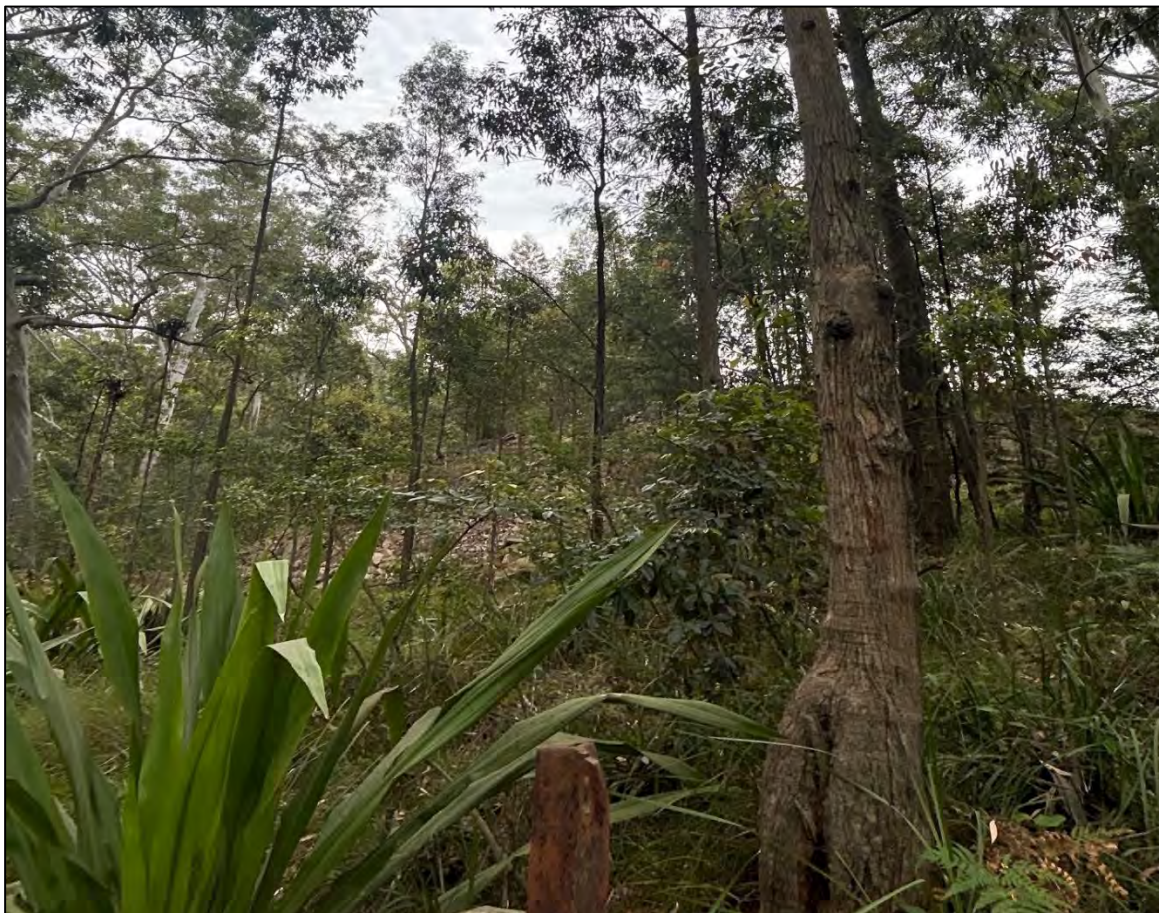
Monitoring Point 15 (MP 15)

Site	Vegetation Community	Vegetation and Habitat Condition	Evidence of Disturbance	Threatened Flora Monitoring
MP15	Blackbutt - Turpentine - Tallowood shrubby open forest	<ul style="list-style-type: none"> • Dieback on the lower limbs of the canopy and midstory species. • All vegetation strata in moderately healthy condition. • Moderate fallen timber. • Dense ground cover and leaf litter. • Rocky areas in low abundance. • Large hollow present. <p>Conclusion: No significant changes in vegetation and habitat condition since the previous survey despite proximity to quarry (2024).</p>	<ul style="list-style-type: none"> • No evidence of erosion and sedimentation. • There are some edge effects from adjacent clearing. • Thick dust coating on foliage. <p>Conclusion: Dust cover on foliage was observed within the monitoring site in 2024 though appears less at the current event due to recent rainfall.</p>	<ul style="list-style-type: none"> • Four <i>Tetratheca juncea</i> clumps persist. • One new <i>Tetratheca juncea</i> that has not been detected in more recent years was observed reshooting. • All 4 <i>Tetratheca juncea</i> plants were recorded flowering during monitoring. • All <i>Tetratheca juncea</i> plants within the monitoring site were observed to be in healthy condition. <p>Conclusion: The <i>Tetratheca juncea</i> population at MP 15 has declined since 2015 baseline (30 individuals recorded). This decline in the <i>T. juncea</i> at MP 15 is most likely due to the lower than average rainfall during 2019, exacerbated by the location of the monitoring point; upper slopes of exposed hill side and thick dust cover.</p>

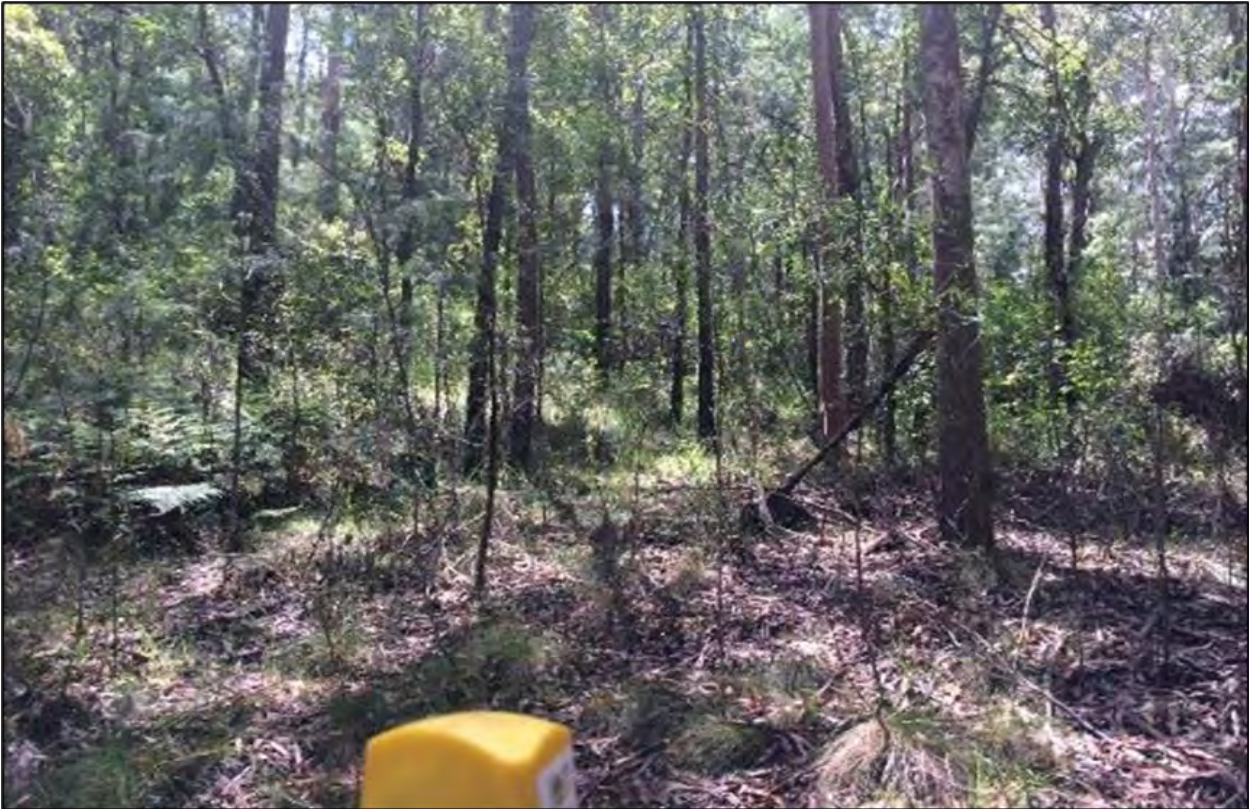
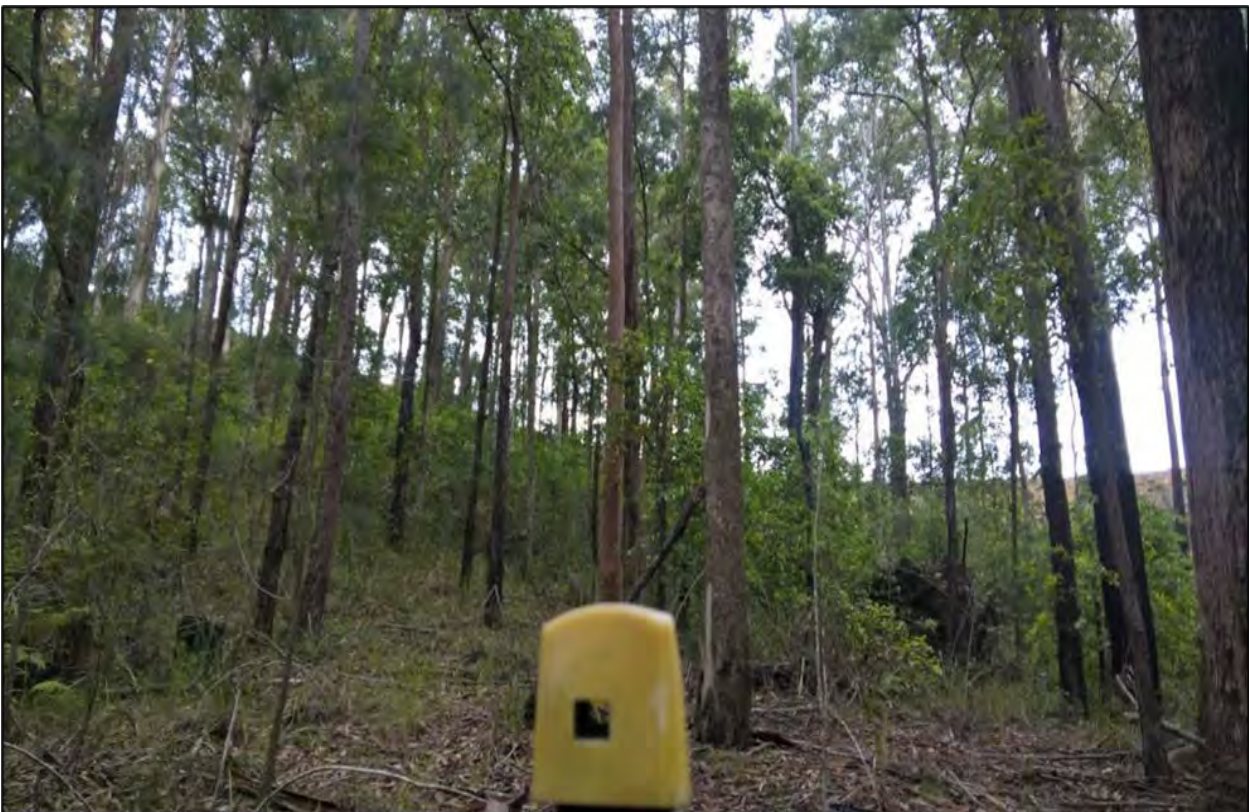
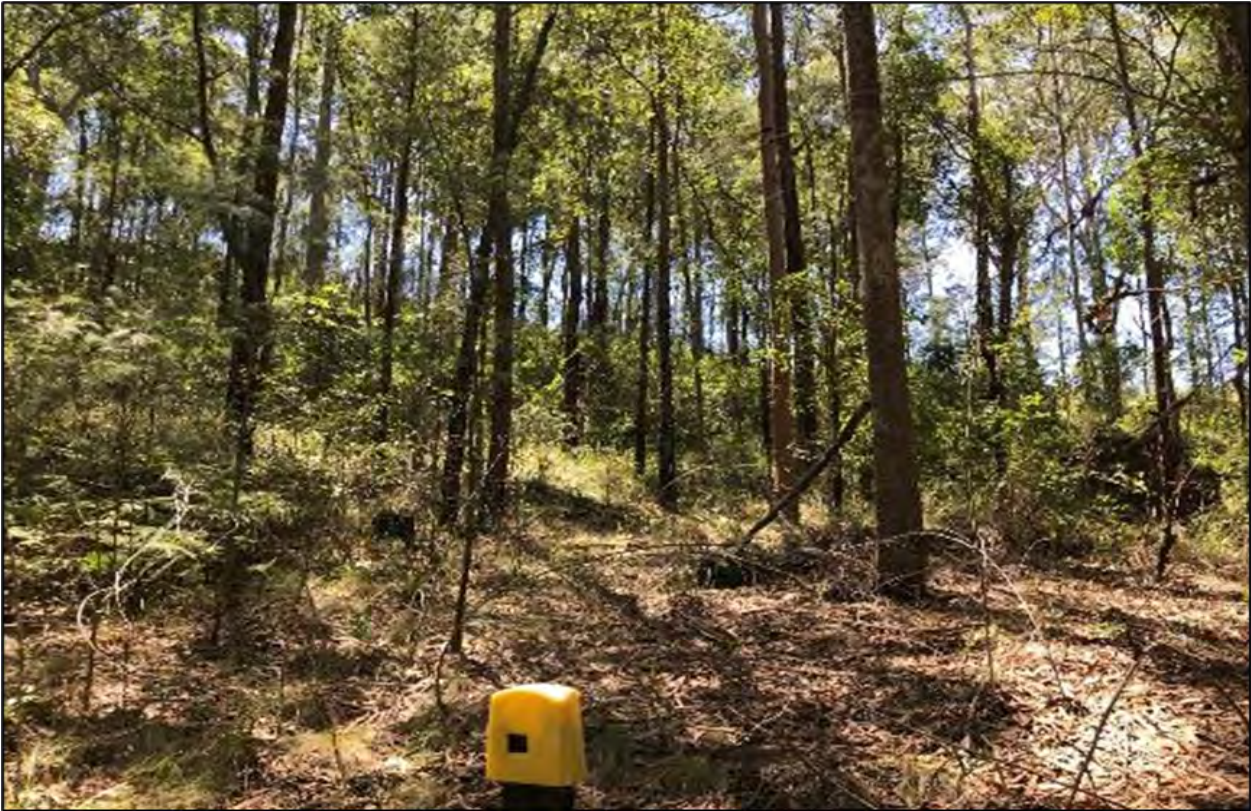
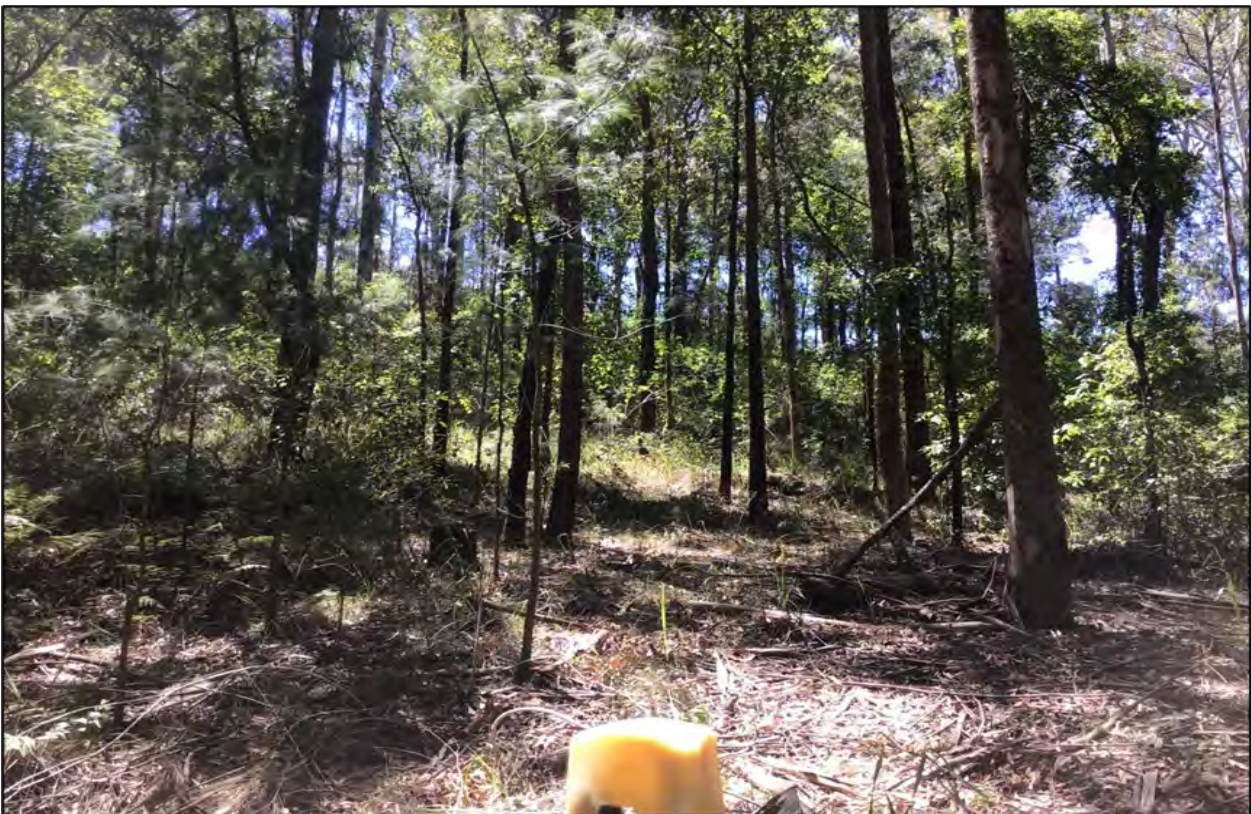
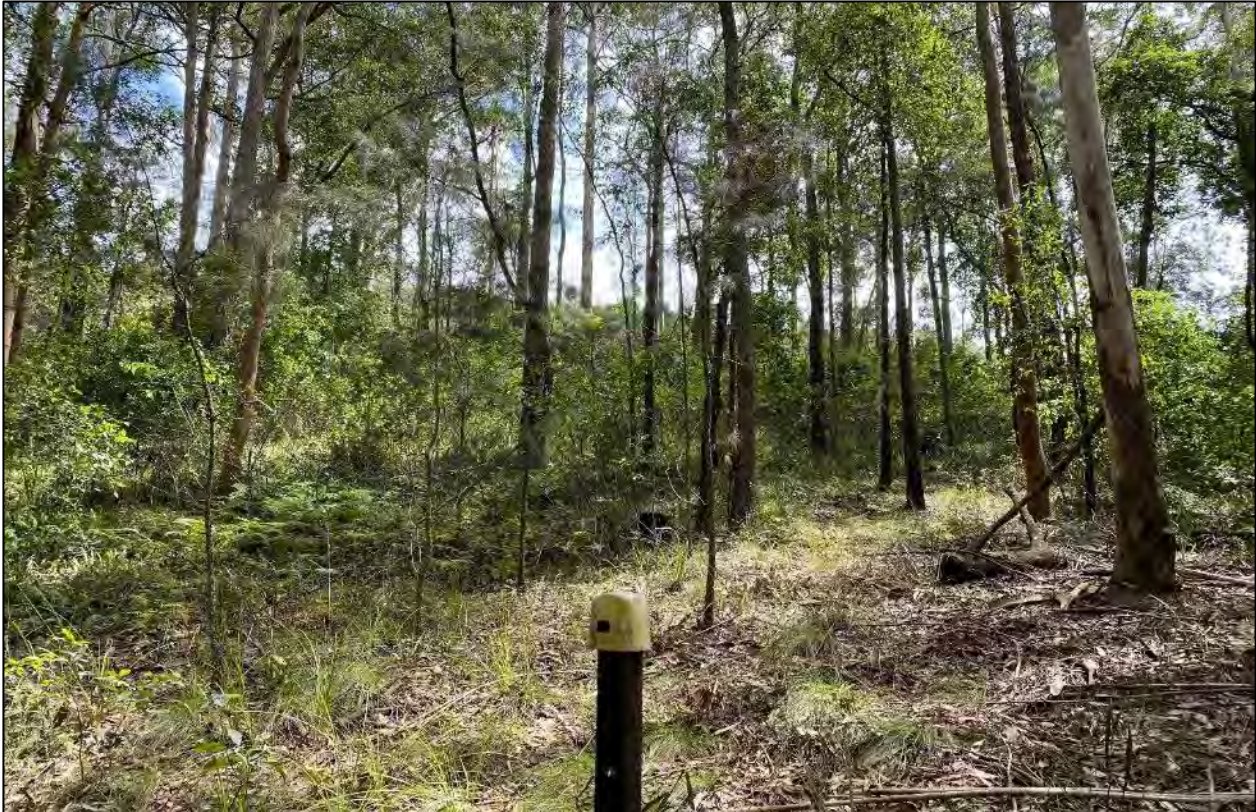
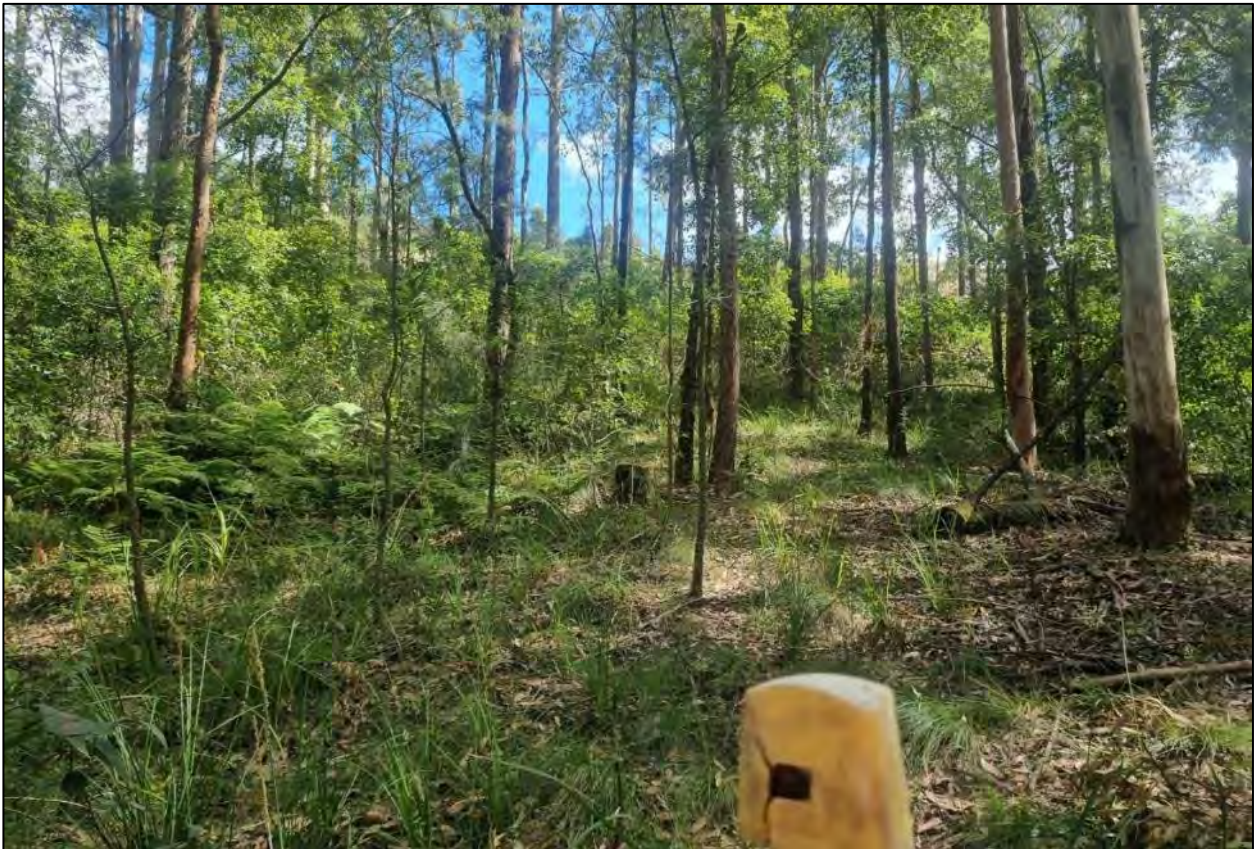
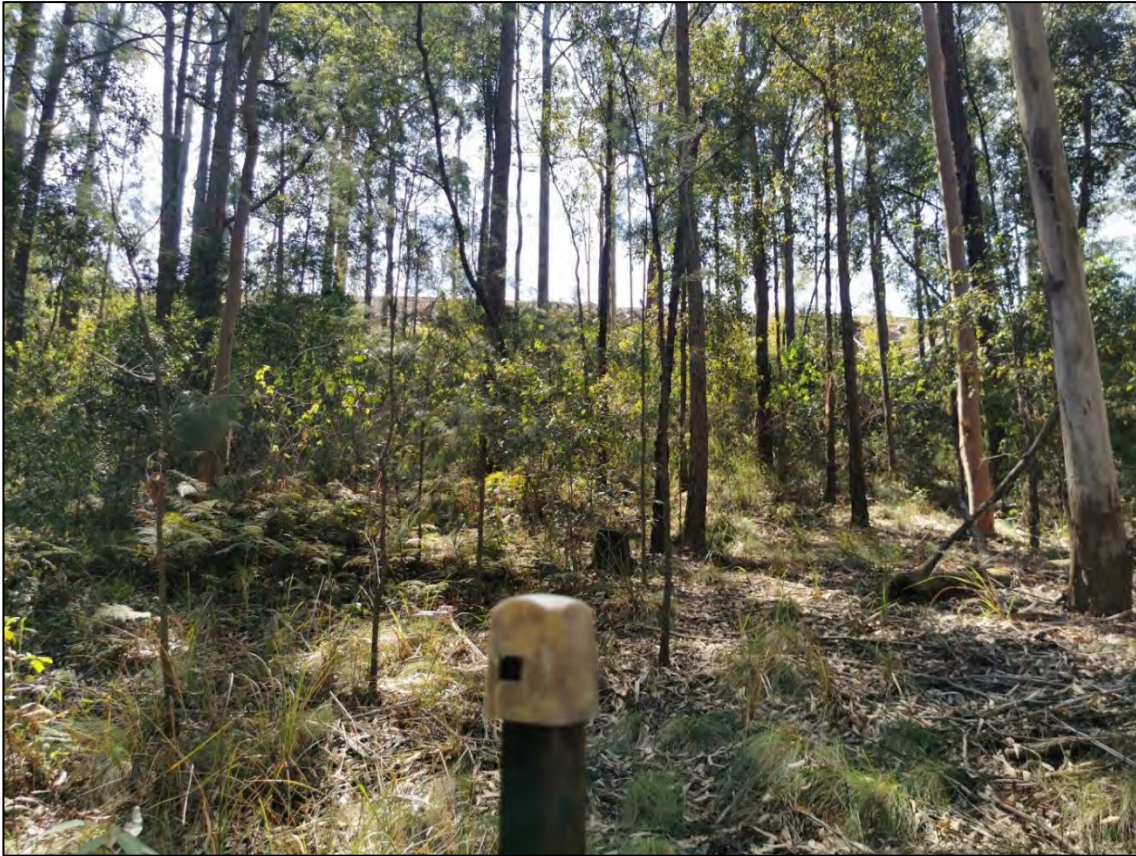
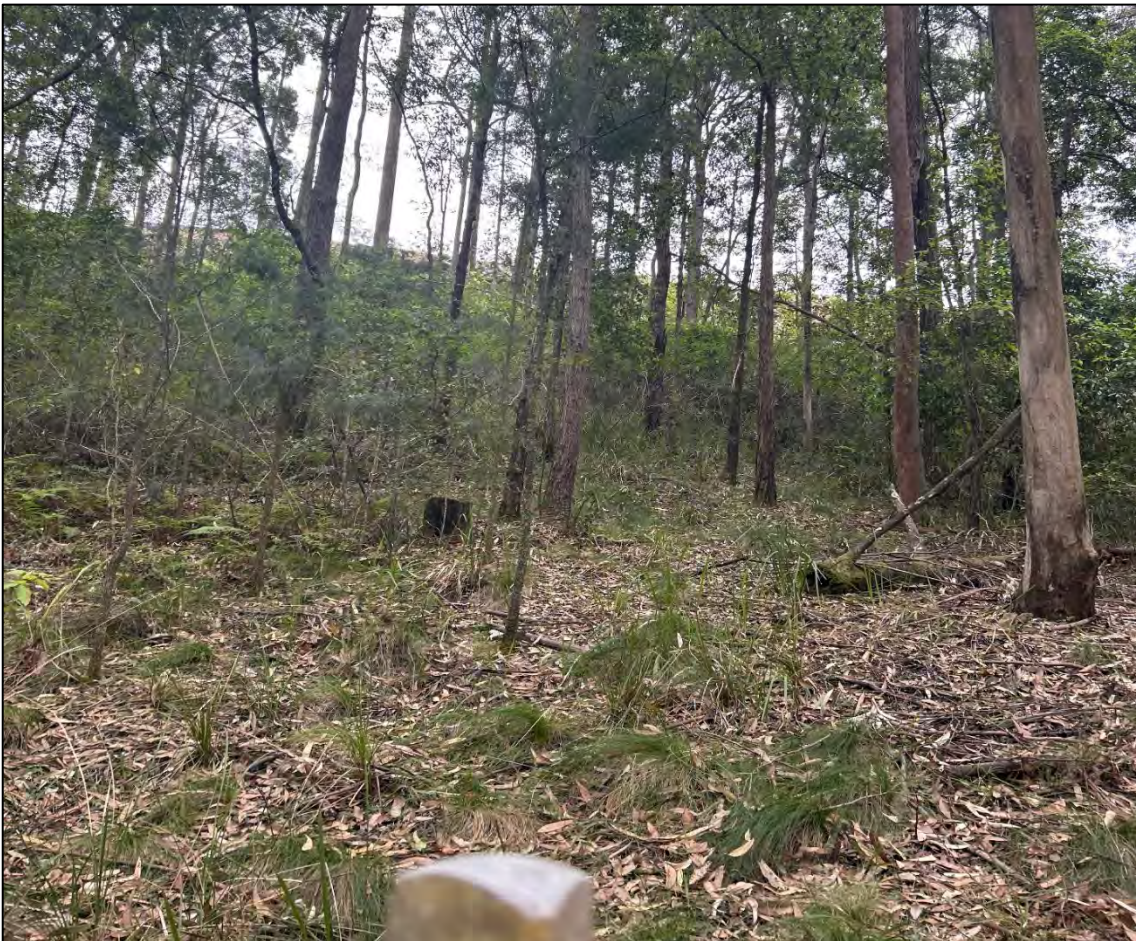
Monitoring Point 16 (MP 16)

Site	Vegetation Community	Vegetation and Habitat Condition	Evidence of Disturbance	Threatened Flora Monitoring
MP16	Spotted Gum – Grey Ironbark open forest	<ul style="list-style-type: none"> Increased ‘grass’ groundcover abundance that has stabilized since previous monitoring. All vegetation strata in healthy condition. Canopy and midstory regeneration are present though dieback observed on lower limbs. Moderate fallen timber. Dense leaf litter and moderate ground cover. Decreased <i>Lantana camera</i> abundance since previous monitoring event. <p>Conclusion: Minor changes, though not significant, in vegetation and habitat condition since the previous survey (2024).</p>	<ul style="list-style-type: none"> No evidence of erosion and sedimentation. No recent evidence of disturbance from grazing, pest animals, rubbish dumping, rock / timber removal. Very high dust cover from edge affects of quarry operations. <p>Conclusion: Very high dust cover that has increased since previous monitoring (2024). No evidence of new disturbance was observed with some reduction in <i>Lantana camera</i>.</p>	<ul style="list-style-type: none"> <i>Asperula asthenes</i> detected within monitoring plot for first time (2021). Seven plants identified in 2025, reduced from eight in 2024. Five <i>Asperula asthenes</i> plants were recorded flowering during monitoring. All <i>Asperula asthenes</i> plants within the monitoring site were observed to be in healthy condition <p>Conclusion: Despite increased edge effects from nearby quarry operations, <i>Asperula asthenes</i> is proliferating and healthy.</p>

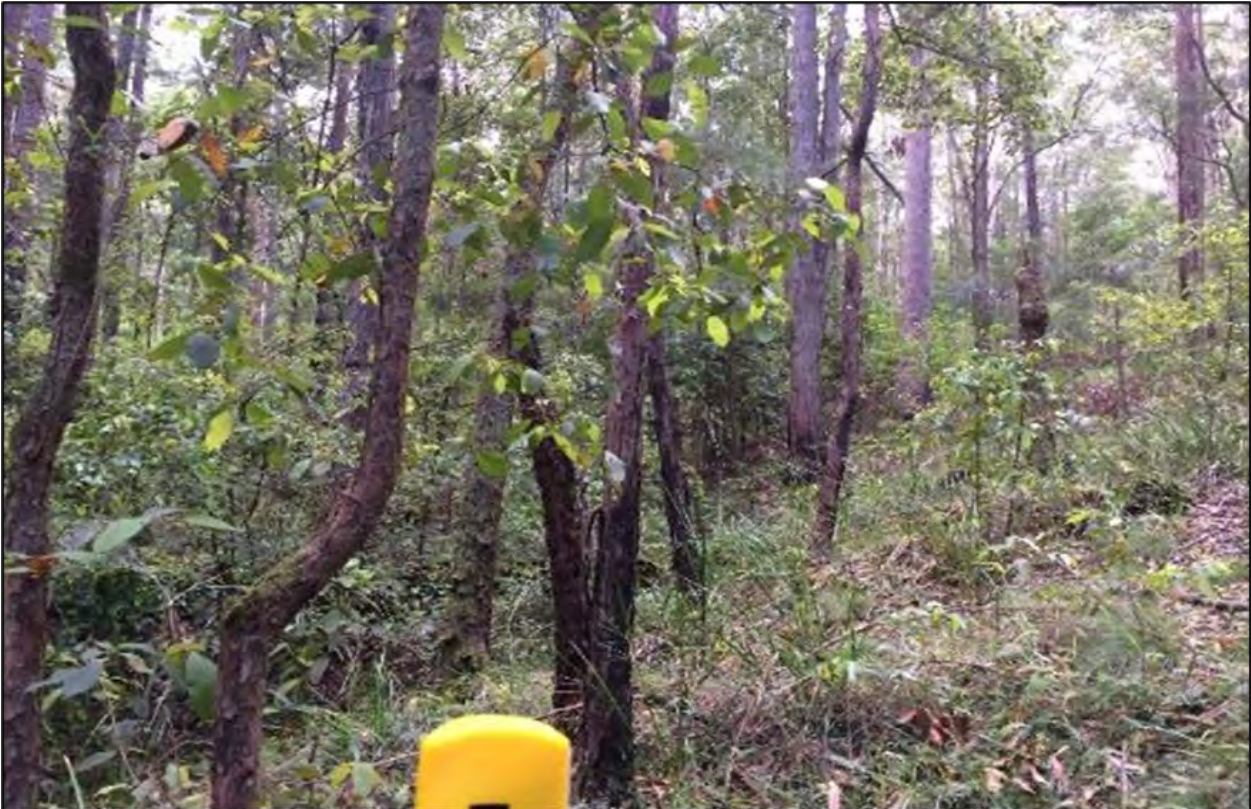
MP 17 2015

Site	Vegetation Community	Vegetation and Habitat Condition	Evidence of Disturbance	Threatened Flora Monitoring
MP17	Brush Box - Turpentine shrubby open forest	<ul style="list-style-type: none"> No evidence of foliage die-back, All vegetation strata in healthy condition. Abundance of juvenile <i>Backhousia myrtifolia</i> in midstorey, subsequently increasing mid-storey cover. Increased midstorey has resulted in a decrease in ground cover. <i>Lantana camara</i> abundance remains stable. Moderate fallen timber. Rocky areas along ephemeral creek. Dense leaf litter. <p>Conclusion: No significant changes in vegetation and habitat conditions since the previous survey (2024).</p>	<ul style="list-style-type: none"> Very minor scouring along creek bank. No recent evidence of disturbance from grazing, pest animals, rubbish dumping, rock / timber removal. Moderate dust cover on foliage. Stable exotic plant community (<i>Lantana camara</i>). Dirty water running within the creek. <p>Conclusion: No evidence of new disturbance observed since the previous survey (2024). Creek water remains high in sedimentation.</p>	<ul style="list-style-type: none"> There was a decrease in number of <i>Asperula asthenes</i> individuals within the monitoring site from six plants in 2024 to five in 2025. Some individuals appear to have been removed along the creek bed due to heavy rainfall events, though other individuals were observed that haven't been recorded in recent years. Two <i>Asperula asthenes</i> plants were recorded flowering during monitoring. All <i>Asperula asthenes</i> plants within the monitoring site were observed to be in healthy condition with no yellowing. <p>Conclusion: The population at MP 17 has decreased since 2015 baseline (11 individuals recorded) though it has remained stable in recent years, with new growth occurring.</p>

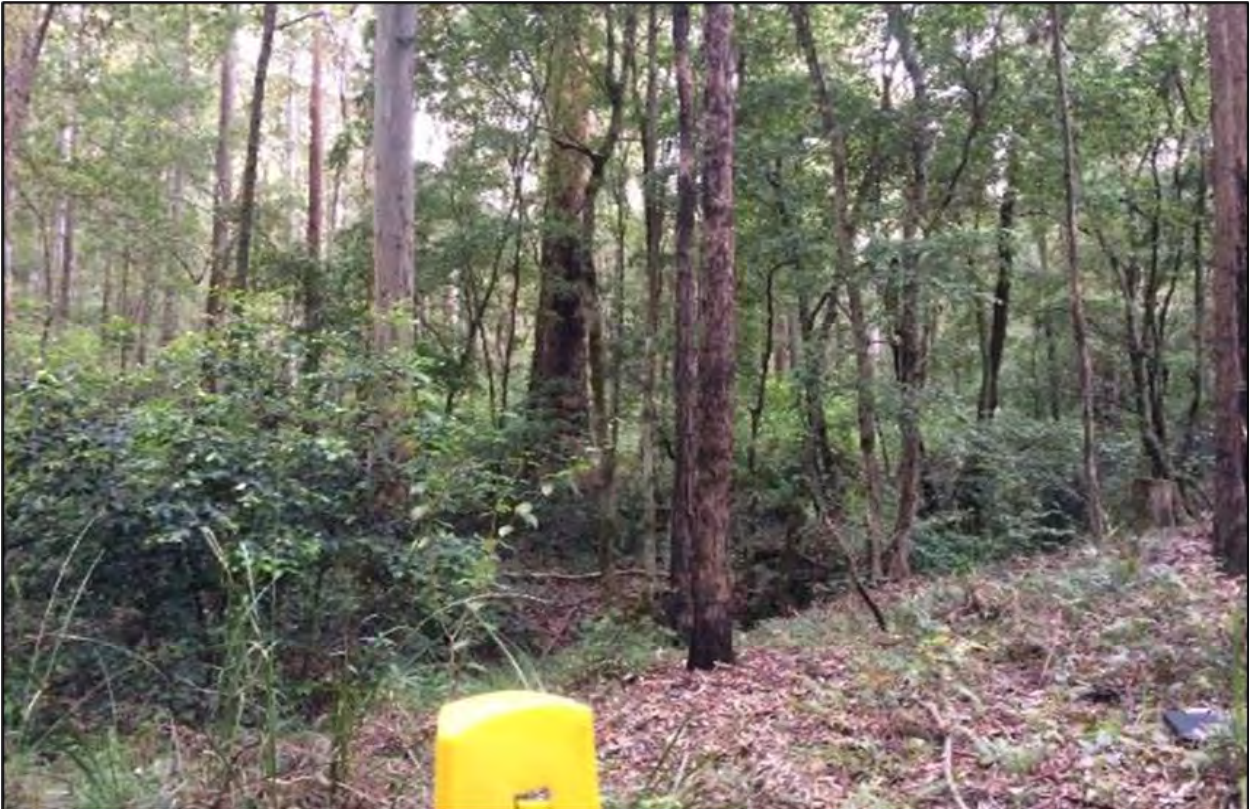
MP 18 2015

Site	Vegetation Community	Vegetation and Habitat Condition	Evidence of Disturbance	Threatened Flora Monitoring
MP18	Brush Box - Turpentine shrubby open forest	<ul style="list-style-type: none"> • All vegetation strata in healthy condition with a flourish of new growth following recent rainfall. • Canopy and midstorey regeneration present • Low fallen timber • High level of leaf litter present. • High leaf litter and ground cover • Rocky areas along ephemeral creek. <p>Conclusion: No significant or notable changes in vegetation and habitat condition since the previous survey (2024).</p>	<ul style="list-style-type: none"> • Very minor scouring along creek bank. • No recent evidence of disturbance from grazing, pest animals, rubbish dumping, or rock / timber removal. • reduced dust coverage on foliage when compared to previous years. • Scattered Lantana present. <p>Conclusion: No evidence of new disturbance was observed since the previous survey (2024).</p>	<ul style="list-style-type: none"> • There was a decline in total number of <i>Asperula asthenes</i> from twelve plants in 2024 to seven in 2025, however this is due to significant proliferation of new growth merging clumps together. Four previous clumps have combined to represent a single mass. • One <i>Asperula asthenes</i> plant was recorded flowering during monitoring. • All <i>Asperula asthenes</i> plants within the monitoring site were observed to be in healthy condition. <p>Conclusion: The population at MP 18 has remained stable since 2015 baseline (13 individuals recorded). Previous years of below average rainfall have likely impacted this population, however there are signs of plants reshooting and flowering, as well as plants sighted outside the monitoring point.</p>
