# 2020 Annual Monitoring Report

## Karuah East Quarry Biodiversity Offset Area and Lot 12

15 December 2020

Kleinfelder Document: NCA20R119674

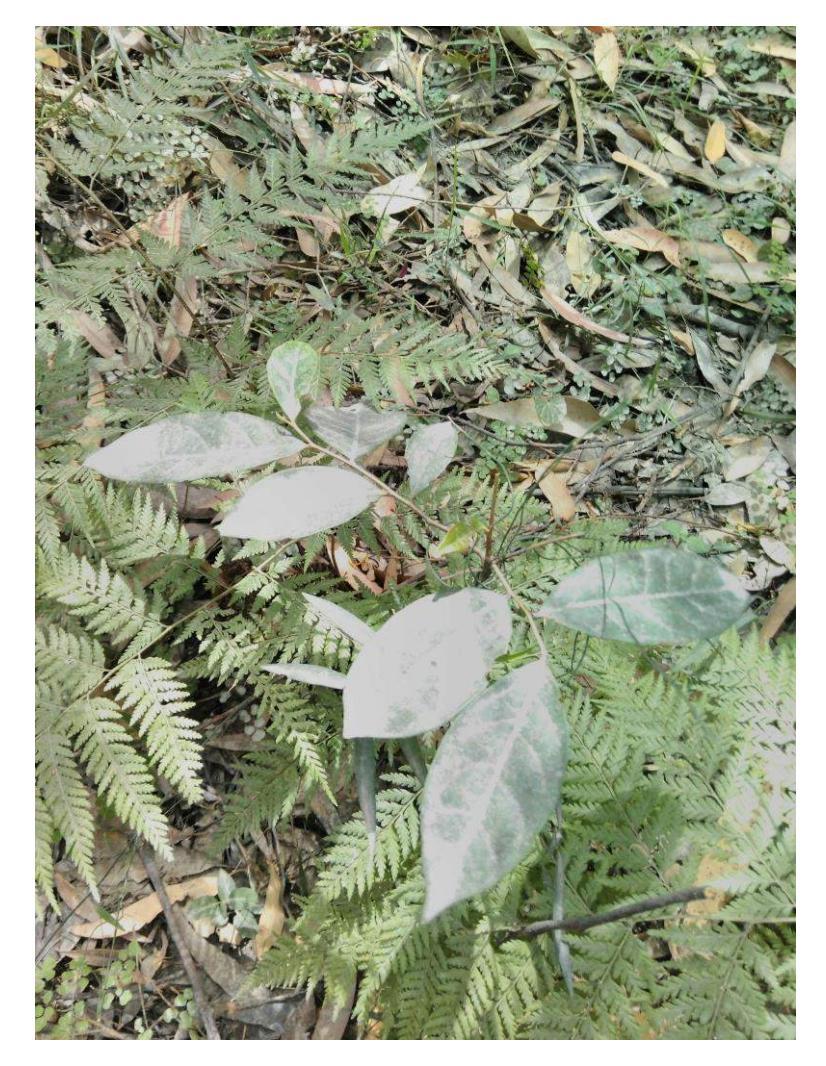
- Past clearing at MP 12 is beginning to show signs of regeneration.
- High levels of dust were observed on foliage (see Photo 1) and on the ground at monitoring sites MP 6 and MP 7 along the eastern boundary of quarry operations. Minor dust cover was recorded at MP 18 and MP 15 along the quarry's western boundary. Whilst rainfall events following the 2020 monitoring event have likely reduced dust levels, monitoring of this disturbance should be continued in future years to assess any potential impacts to remnant vegetation.

Photo 1 Dust cover on foliage recorded at MP 4

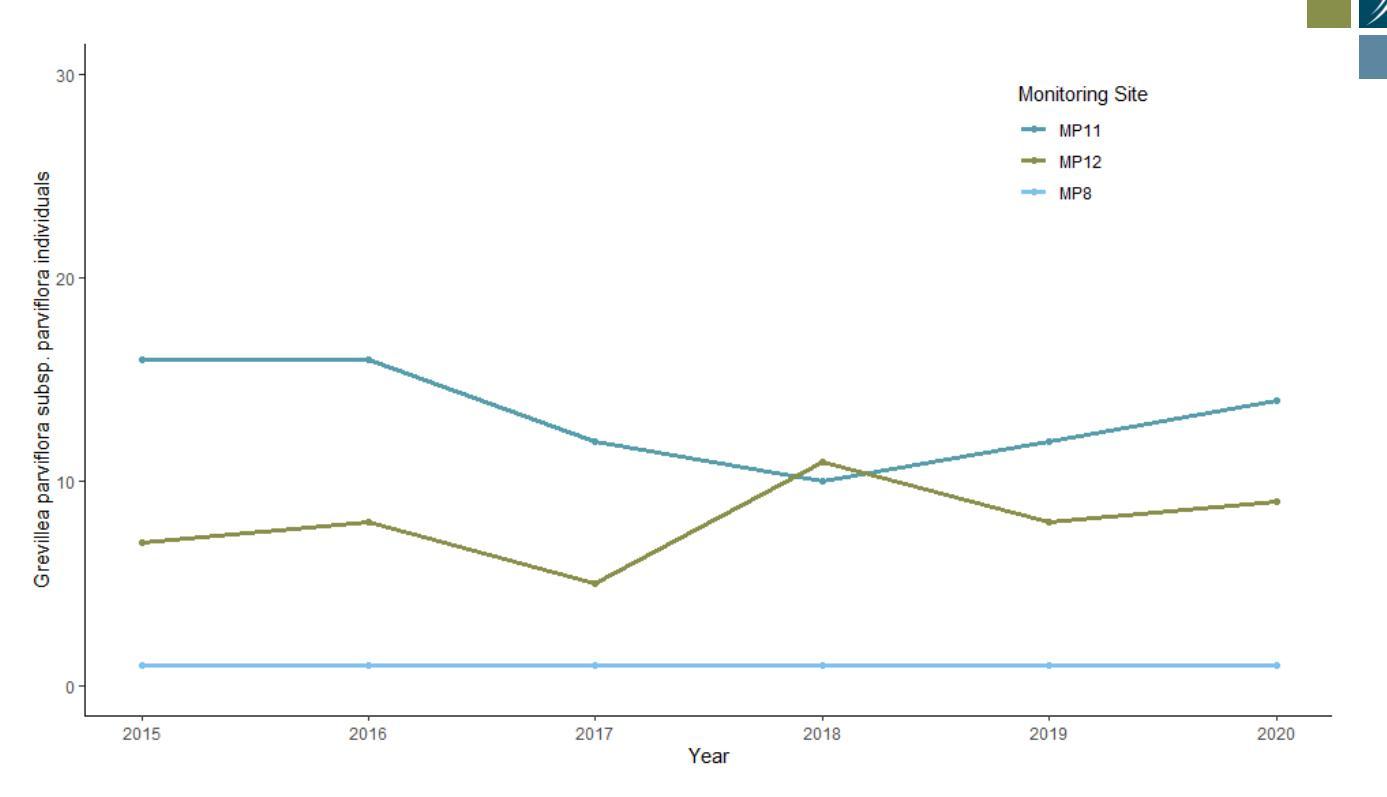
Monitoring for *G.parviflora* subsp. *parviflora* was completed at three monitoring sites; MP 8, MP 11 and MP 12. The population remains stable with a small increase in abundance recorded between 2019 and 2020 at MP 11 (12 to 14 plants) and at MP 12 (8 to 9 plants) (see **Plate 10**). However, despite the increase in abundance at MP 11 four plants were found to have died since 2019 with minor dieback recorded on three others. Overall, there is little change in abundance for the species since the 2015 baseline indicating minimal impact from quarry operations.

Plate 10 Grevillea parviflora subsp. parviflora abundance at monitoring sites (2015-2020)

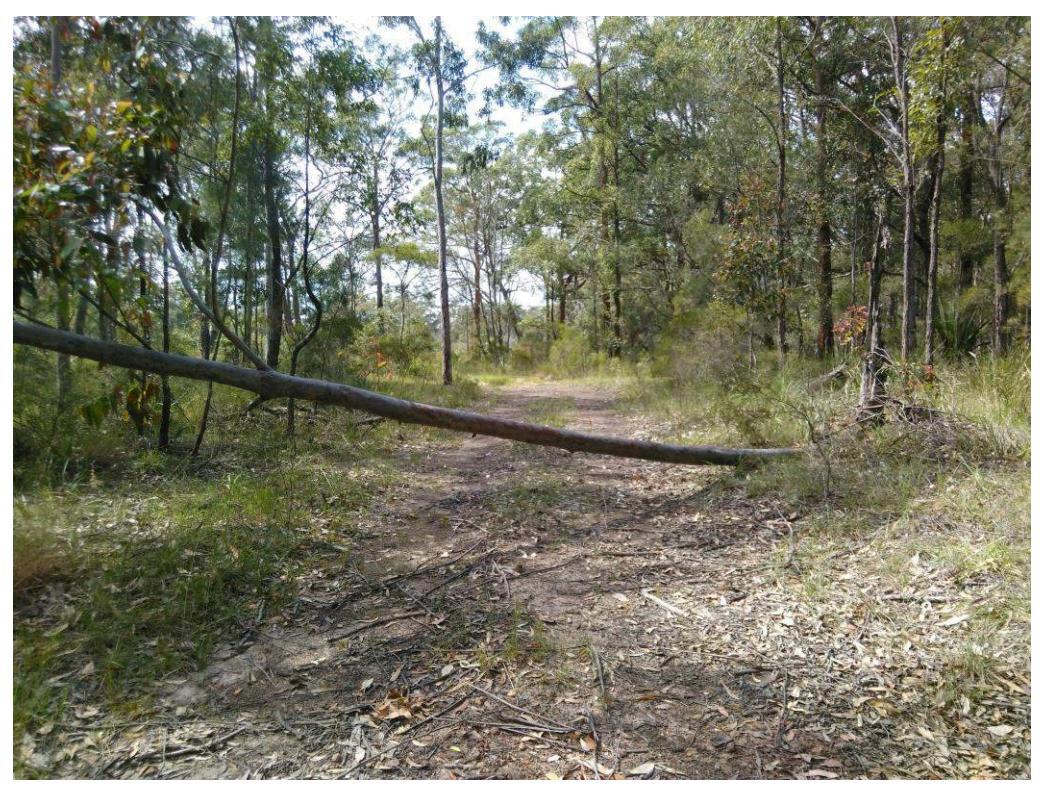
Maintenance is recommended at the access track along the south-western boundary of Lot 14 to remove a small tree that has recently fallen over (see **Photo 2** and **Figure 6**). Works along the powerline easement track have improved accessibility and should continue to be maintained.

Photo 2 Fallen Tree along access track in Lot 14

- Maintenance required to repair sediment fencing and remove fallen tree currently blocking access to a track in the south eastern corner of the site (Lot 13/Lot 14).

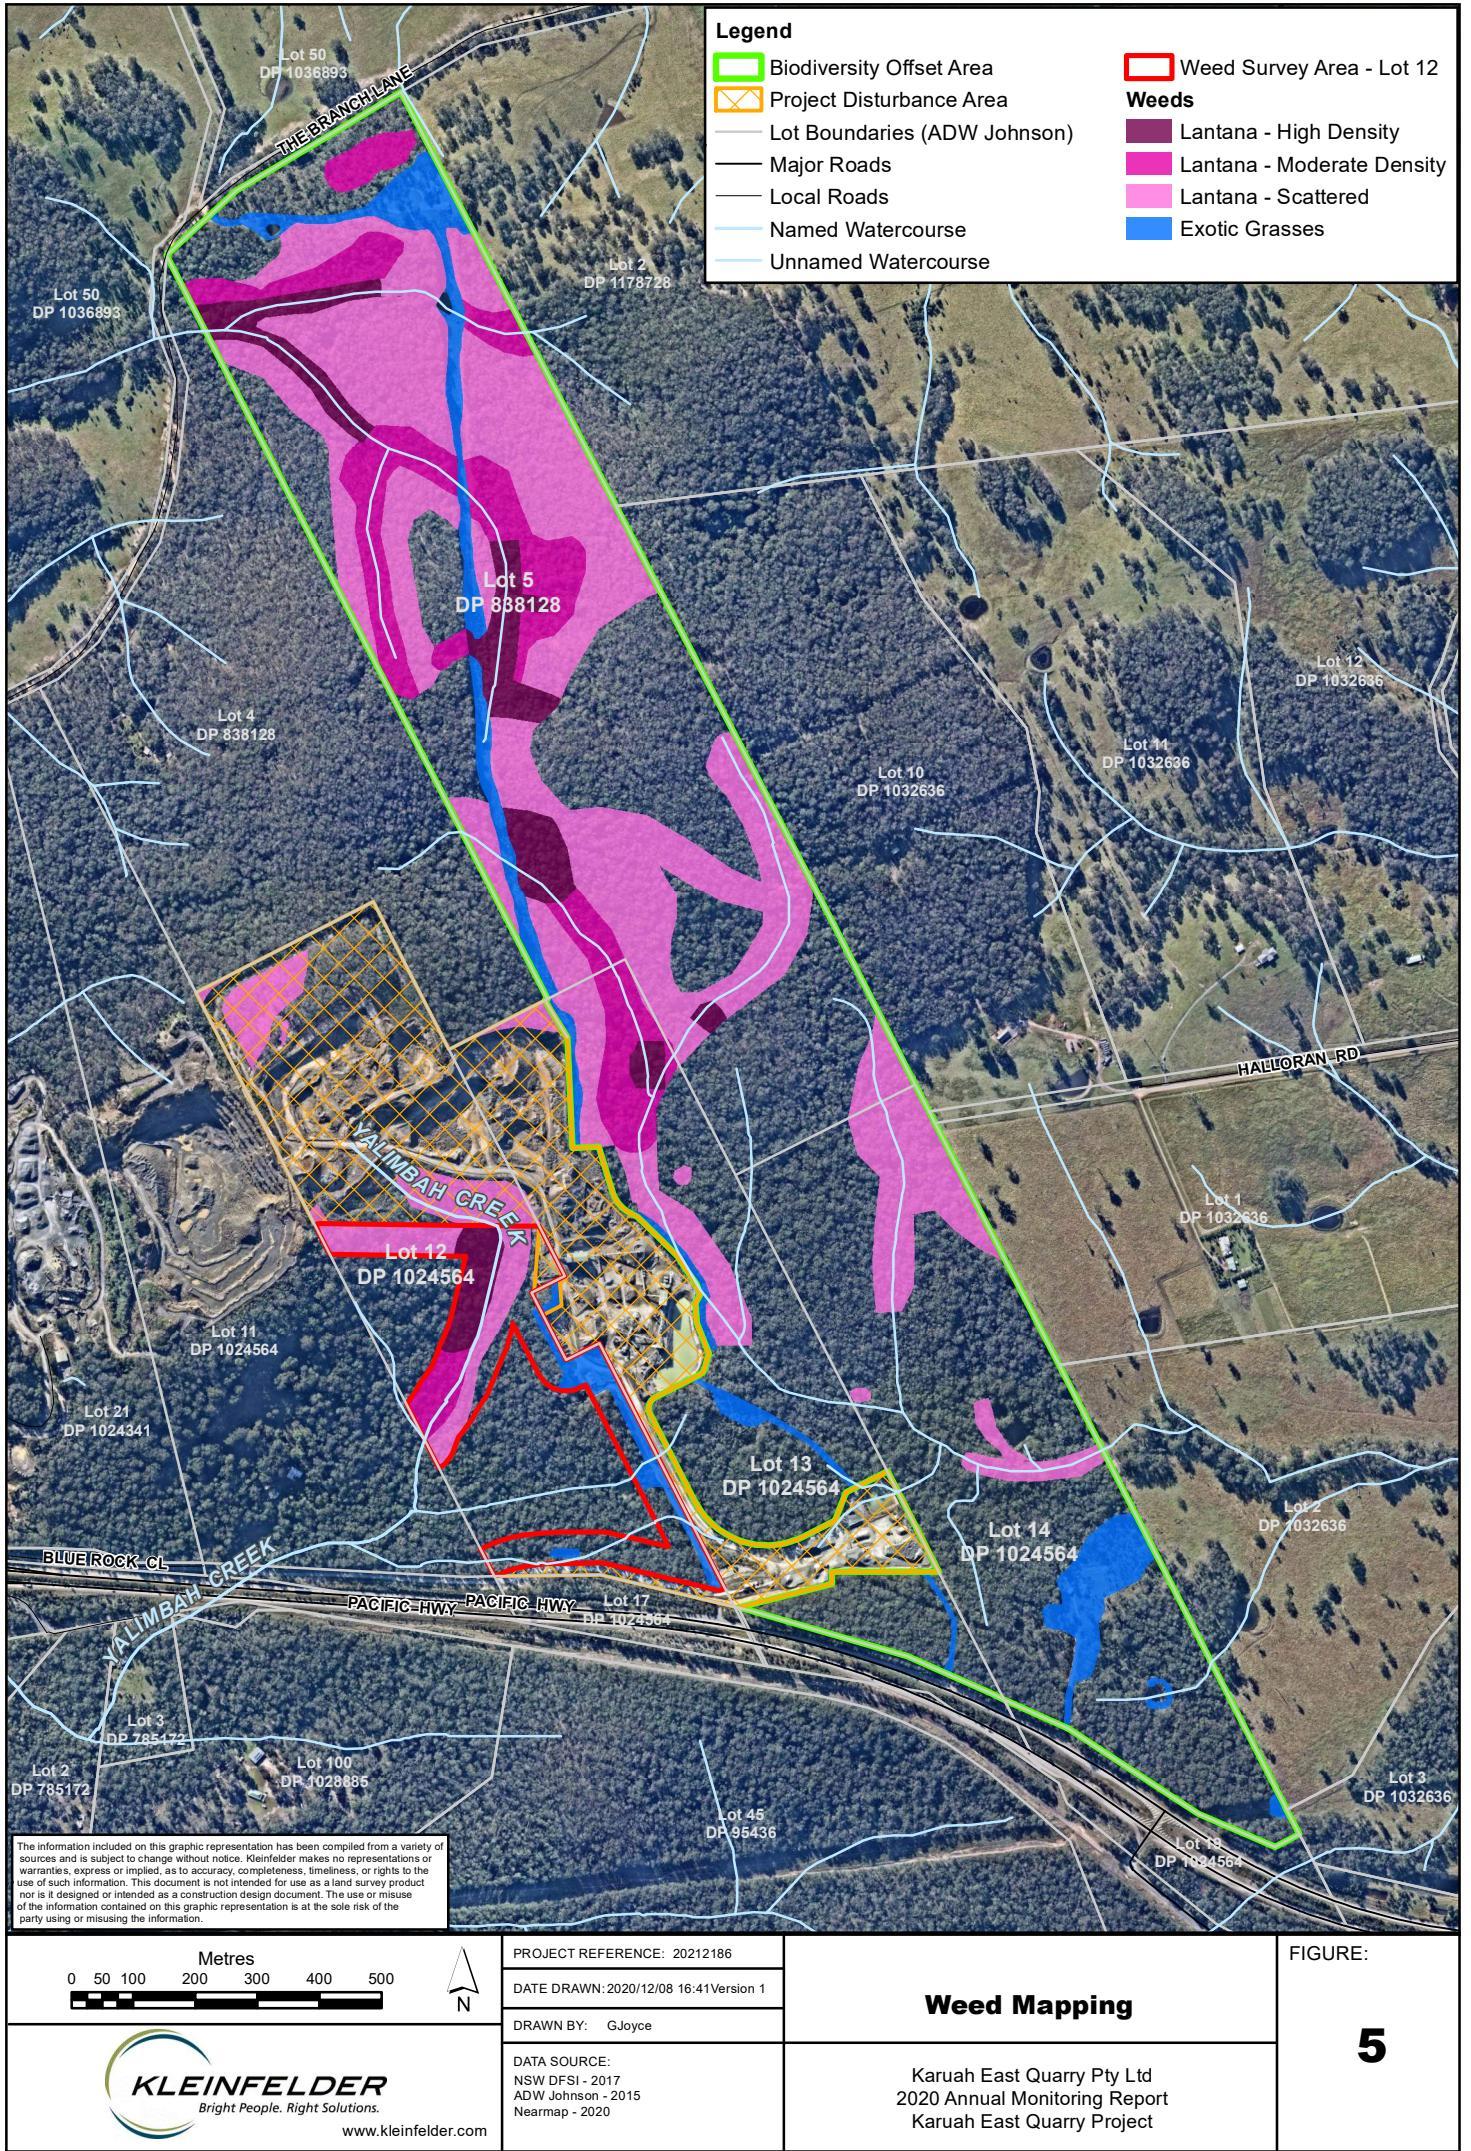
L:\GIS FOLDER\00 CLIENT FILES\125004\_GWH\_Build\_KaruahEastQuarry\AnnualMonitoring\_KaruahEast\_BOA\20212186\_2020Monitoring\Mapping\20212186\_Fig5\_WeedMapping.mxd

It is recommended weed control works for the next 12 months should focus on the Lantana infestations in the south-west portion of Lot 5 and north-east part of Lot 13, especially within the vicinity of MP 3 and MP 4 to protect *Asperula asthenes* individuals. These weed control activities must be undertaken in spring in accordance with the procedures detailed in Section 3.10 of the BOAMP due to the presence of threatened flora (*Asperula asthenes*) in these areas.

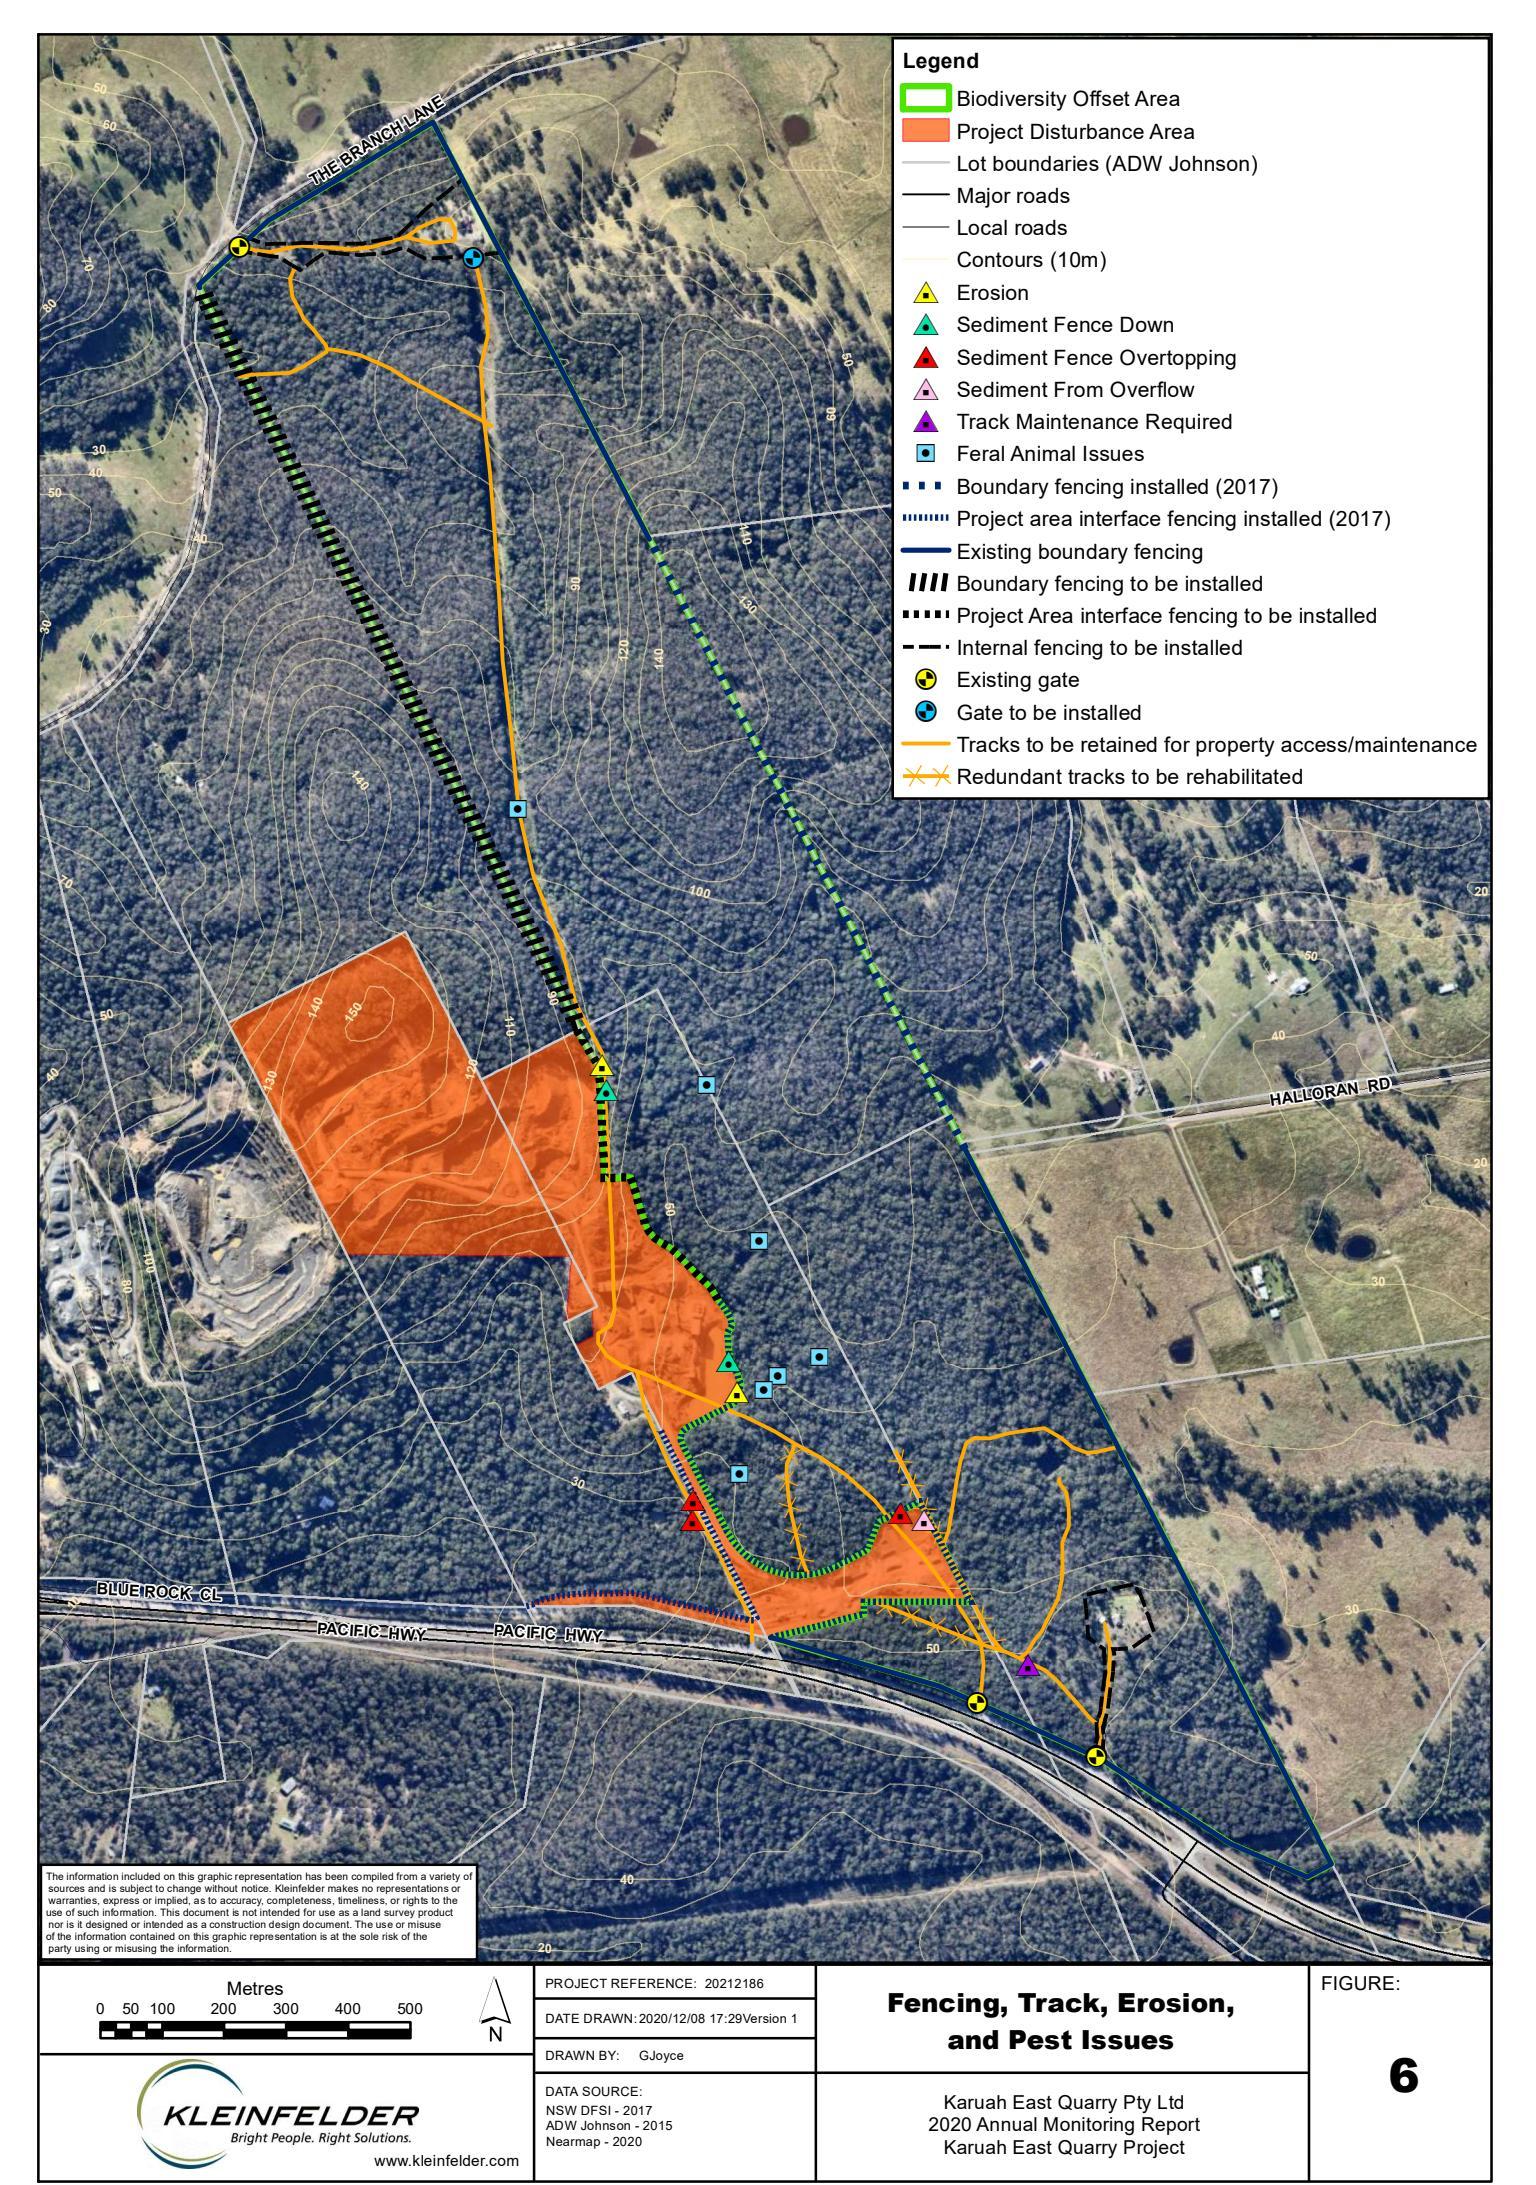
L:\GIS FOLDER\00 CLIENT FILES\125004\_GWH\_Build\_KaruahEastQuarry\AnnualMonitoring\_KaruahEast\_BOA\20212186\_2020Monitoring\Mapping\20212186\_Fig6\_FencingAndTracks.mxd

The layout of existing and required fencing, gates and tracks across the BOA is shown in **Figure 6**. Boundary fencing is required around the entire KEQ project area. Fencing of KEQ project area / BOA boundary has commenced (approximately 70% completed in 2017). A new fence was installed along the eastern boundary of the BOA adjoining Lot 10 in 2017. Fencing along the remaining 30% of project area / BOA boundary, and Lot 5 / Lot 14 boundary is required. Internal fencing is also required around the existing dwellings on Lot 5 and Lot 14. It is noted that that the dwelling in Lot 5 is not currently occupied. This internal fencing must be installed prior to this dwelling being occupied. All fencing works shall be undertaken in accordance with Section 3.2 of the BOAMP.

- In three locations the installed sediment fencing was overtopping (observed in 2018, 2019 and 2020) and, therefore, no longer provided active sediment control (**Figure 6**). It was observed in these locations that some sediment had been deposited within the surrounding environment. The overtopping sediment fencing along the western boundary of the quarry, within Lot 12, and adjacent to monitoring site MP 14 shows evidence of resulting sedimentation of the drainage channel and dam located to the immediate west of the fencing (see **Photo 3**).

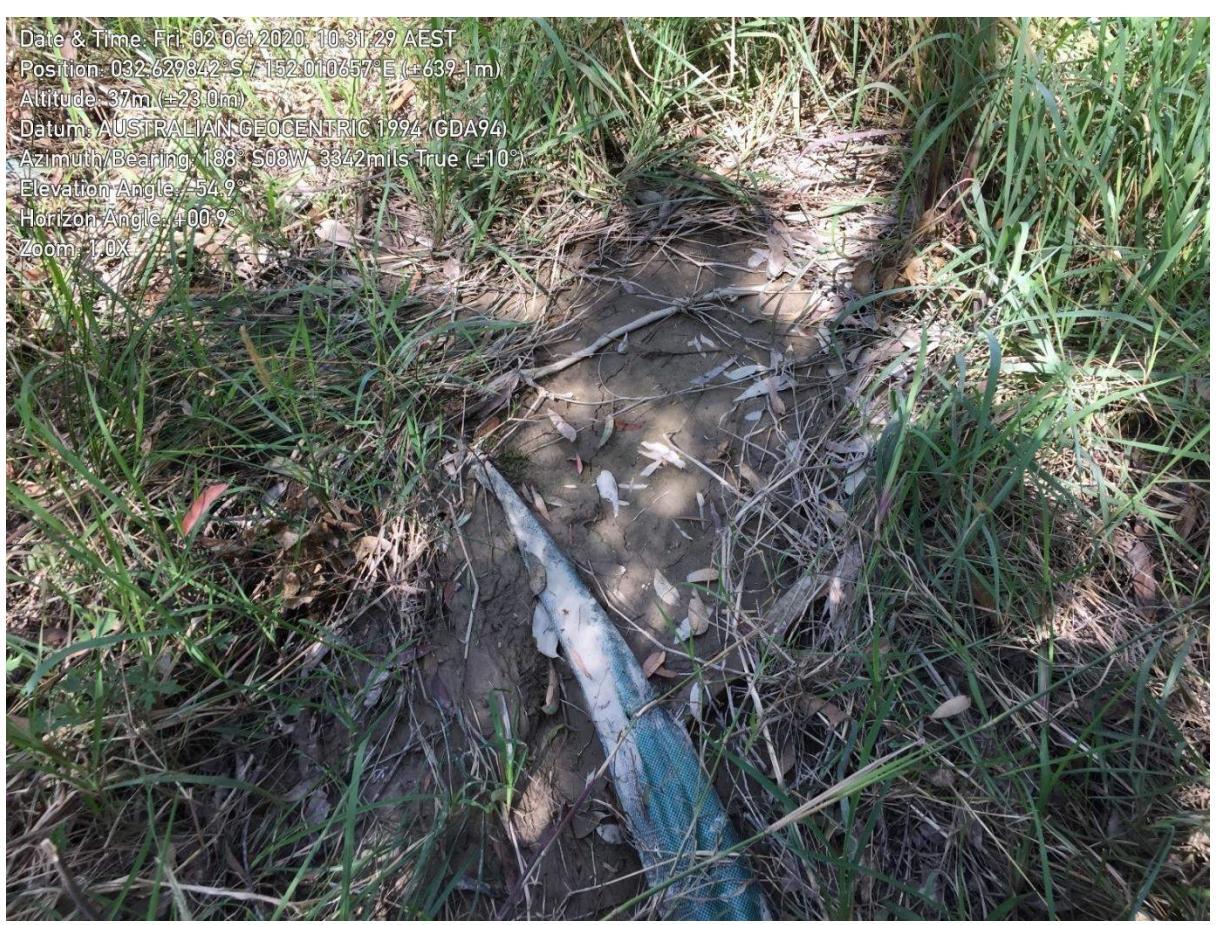
Photo 3 Sediment fencing down and overtopping within Lot 12

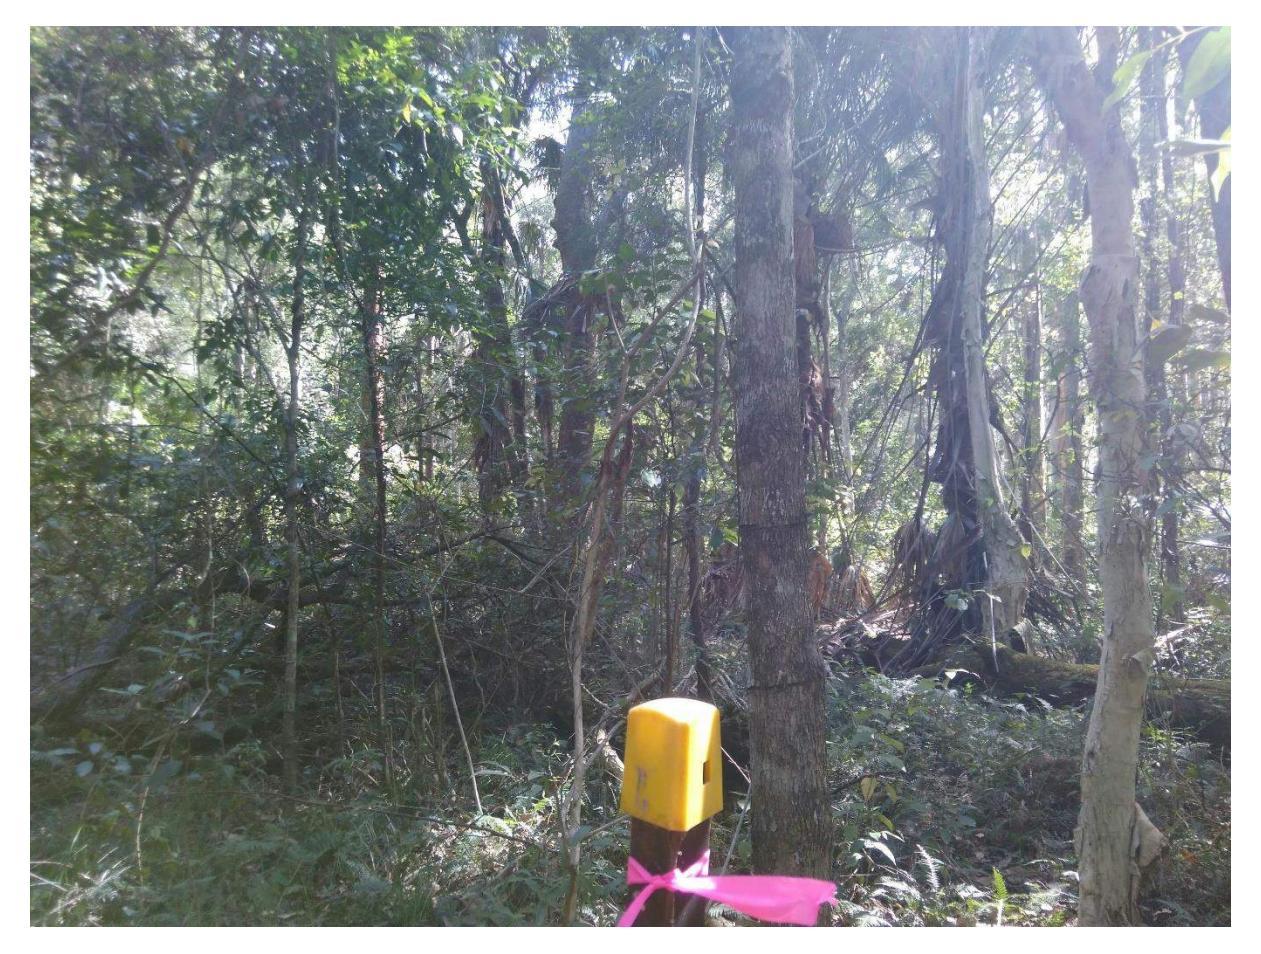
MP 4 2020

- Wild pigs were observed within the vicinity of monitoring site MP 4. Recent erosion and disturbance to the groundcover within this area is likely the result of the pest species Impacts of vertebrate pests are further discussed in **Section 3.3.4**.
