## **Karuah Hard Rock Quarry**

### **Summary of Environmental Monitoring Data**

**For the Period: February 2013**

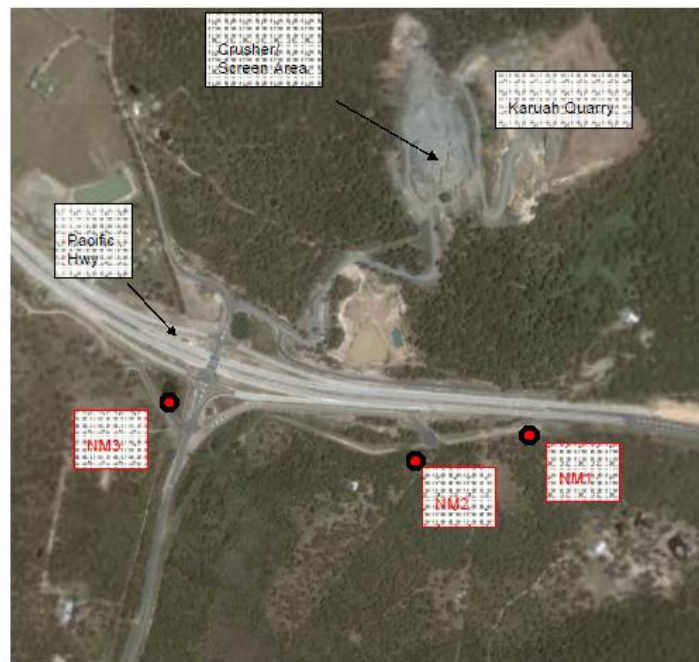
**Figure 2 - Noise Monitoring Locations**

**Figure 2** below illustrates the noise monitoring locations at Karuah Quarry.
