## **Karuah Hard Rock Quarry**

### **Summary of Environmental Monitoring Data**

**For the Period: February 2014**

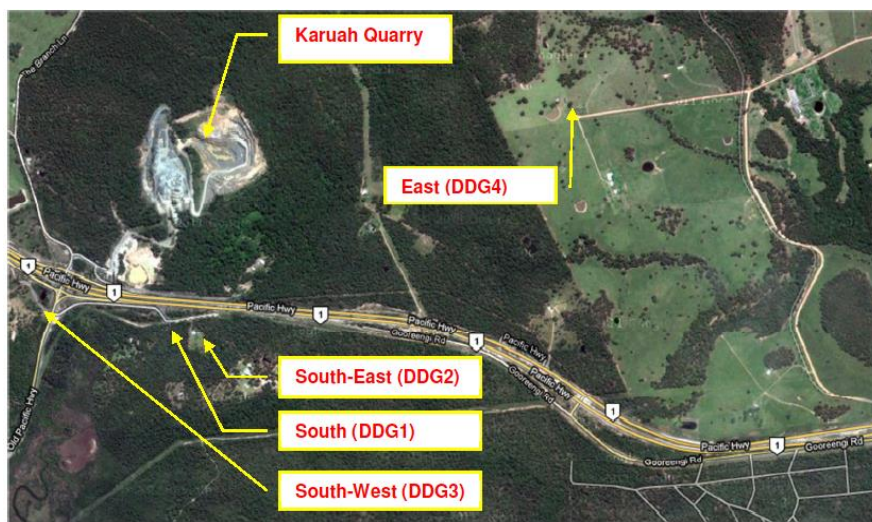
Figure 1 - Air Quality Monitoring Locations

Figure 1 illustrates the air quality monitoring locations at Karuah Quarry.

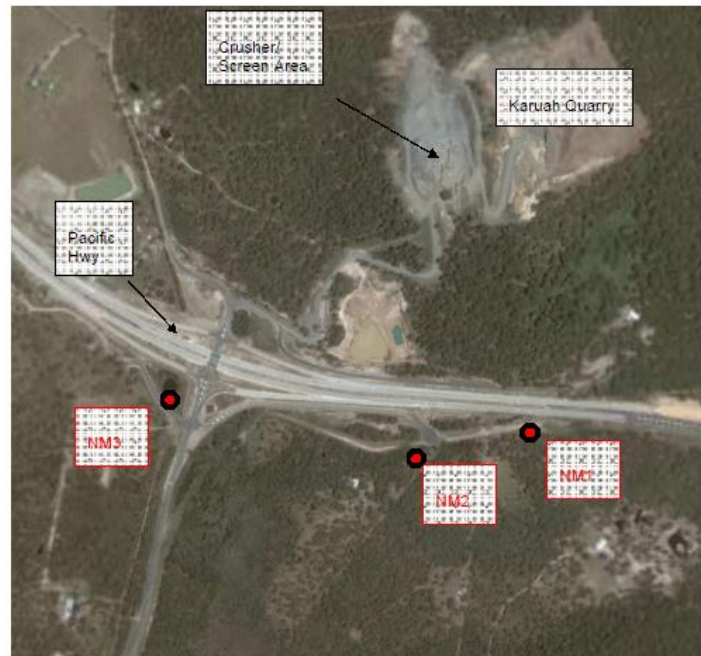
**Figure 2 - Noise Monitoring Locations**

**Figure 2** below illustrates the noise monitoring locations at Karuah Quarry.
