# Environmental Monitoring Report June 2021

Hunter Quarries Pty Ltd Monthly Environmental Monitoring Report

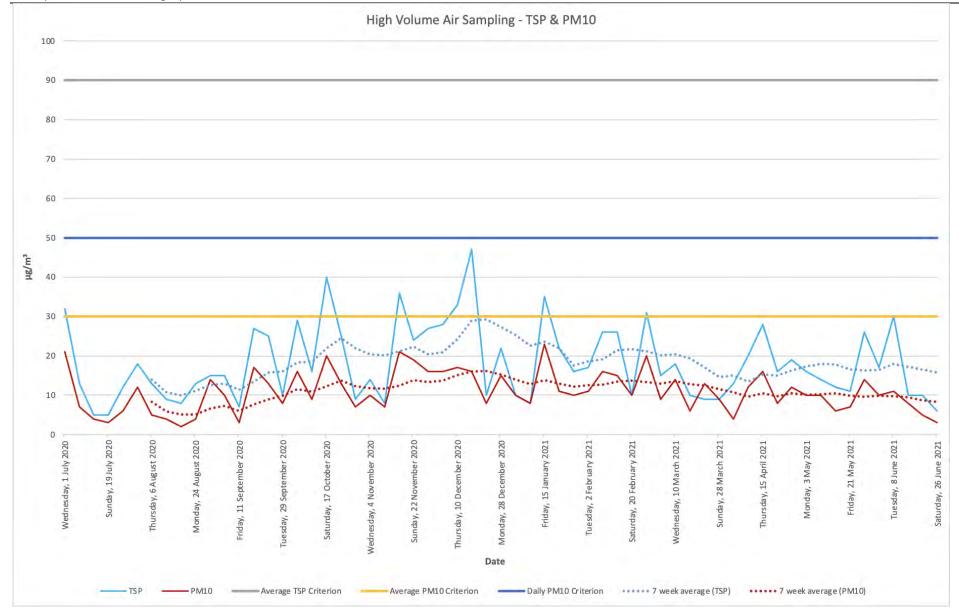
Figure 1 High Volume Air Sampling: Year-to-date results

The TSP and PM<sub>10</sub> results for June 2021, the report average and a rolling annual average are shown in are shown in Table 8. Figure 1 illustrates the year-to-date results for HVAS monitoring.

All HVAS monitoring results for the period to and including June 2021 were compliant with the long term and short term impact assessment criteria outlined in *Schedule 3 Condition 13* of the Consent (see Table 3, Table 4 and Table 5).

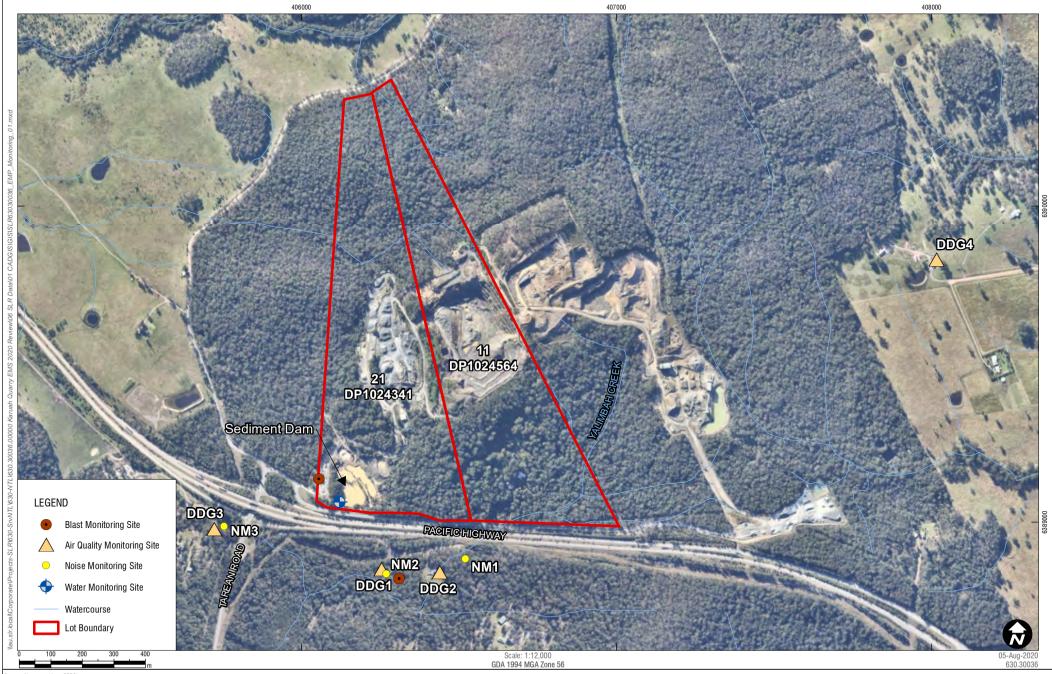
Karuah Hard Rock Quarry Environmental Monitoring Locations

# Appendix 1 – Monitoring Locations

Monitoring locations are identified in Appendix 1.
