Karuah East Quarry

Environmental Monitoring Report:

September 2021

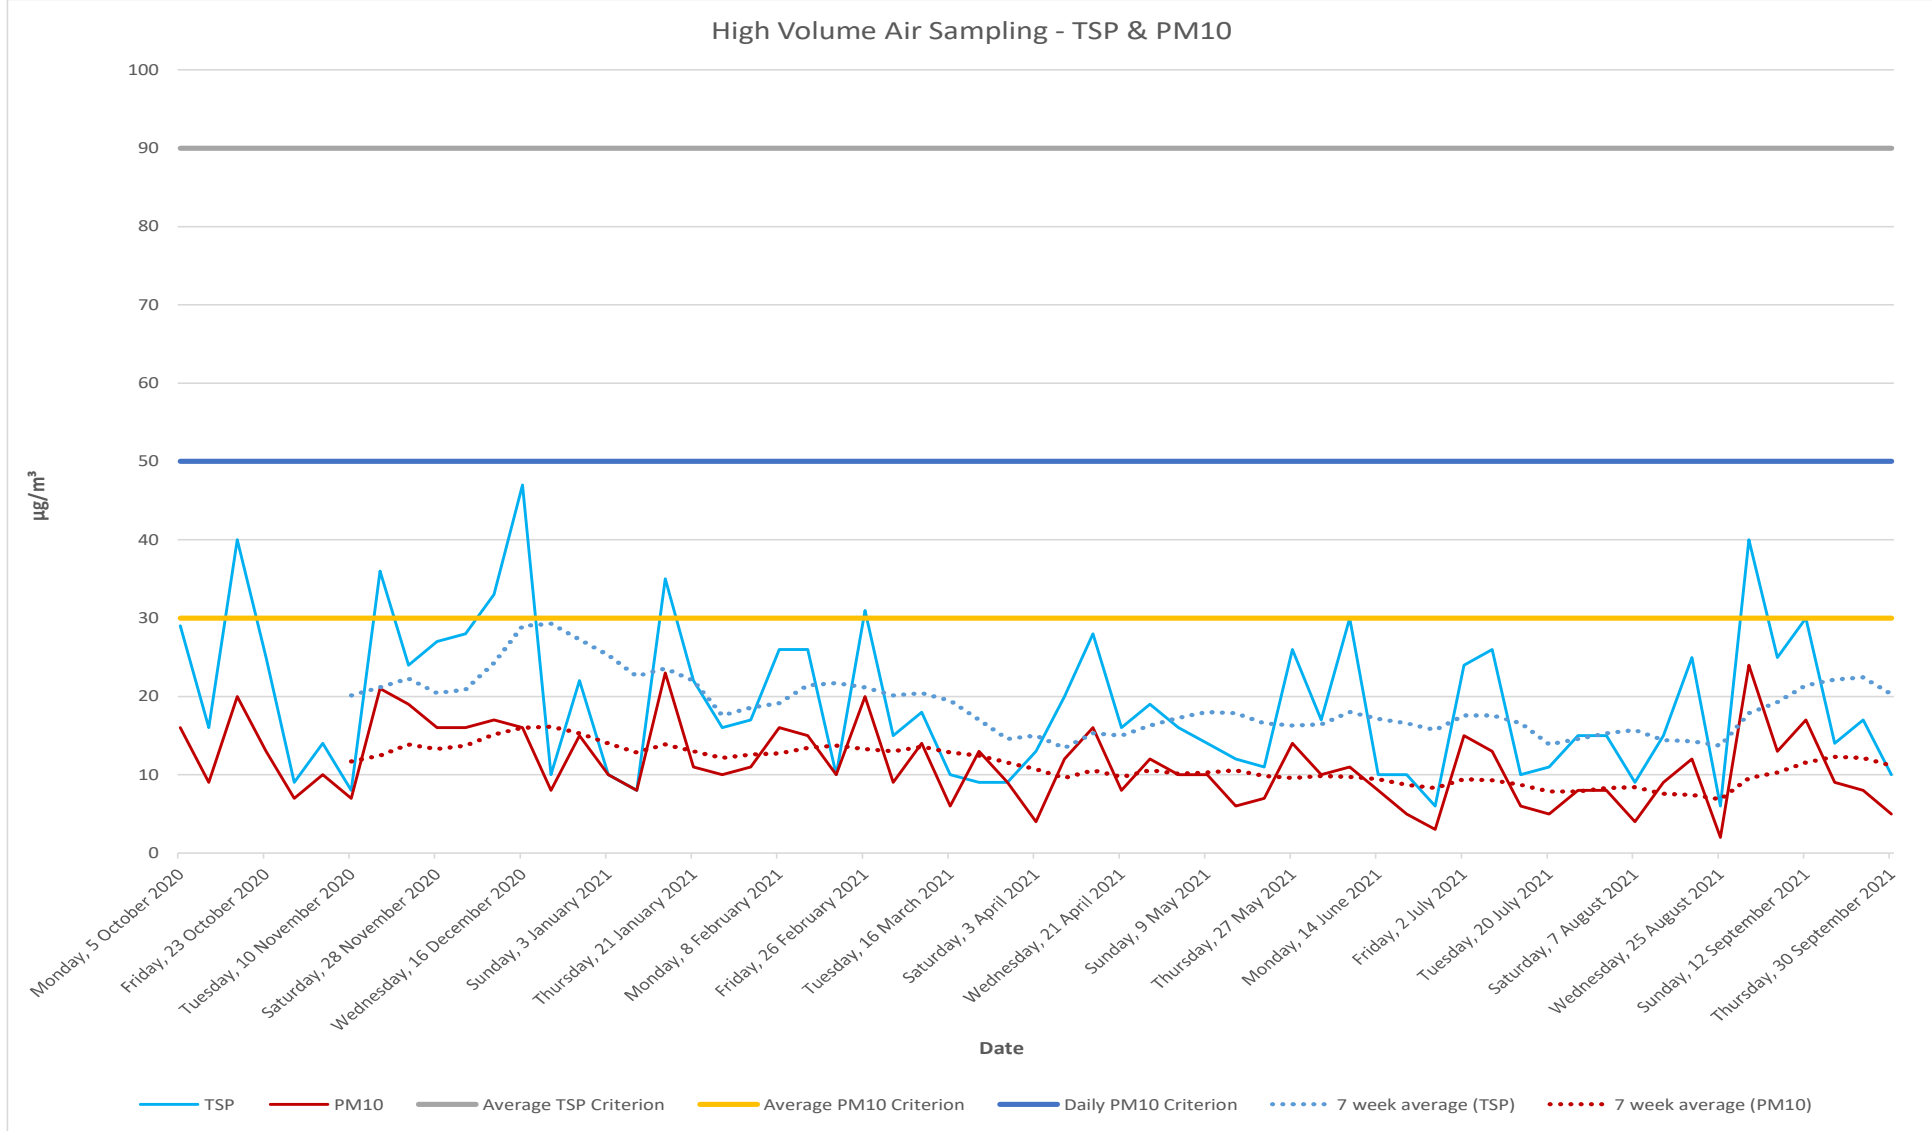
Figure 1 High Volume Air Sampling: Year-to-date results

The TSP and PM₁₀ results for September 2021, the report average and a rolling annual average are shown in are shown in Table 8. Figure 1 illustrates the year-to-date results for HVAS monitoring.

All HVAS monitoring results for the period to and including September 2021 were compliant with the long term and short term assessment criteria (see Table 4 and Table 5).

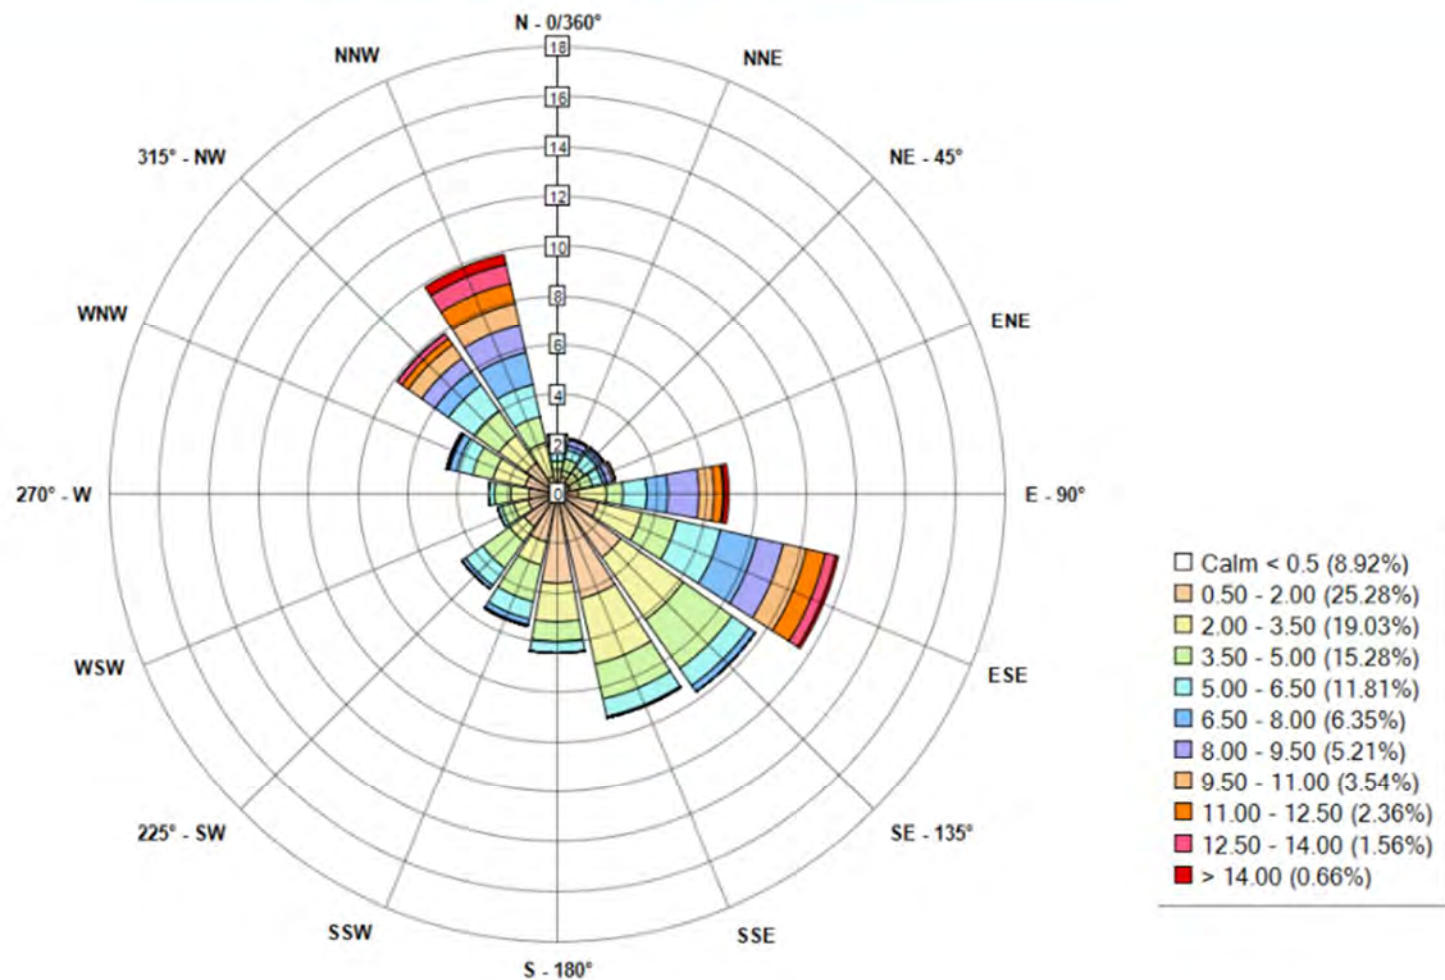
Figure 3 Wind rose September 2021

A wind rose is a graphic tool used to depict the average direction and speed of the wind over a recorded period. Figure 3 shows the wind rose generated from data gathered during September 2021.

Wind Rose Report for: Karuah East - 15 Min Data

WDIR Vector Wind Dir and VWSP Vector Wind Spd in km/h

Period: 2021-09-01 00:00 to 2021-09-30 23:59

Direction the Wind is Blowing To
