## **Karuah Hard Rock Quarry**

### **Summary of Environmental Monitoring Data**

**For the Period: March 2020**

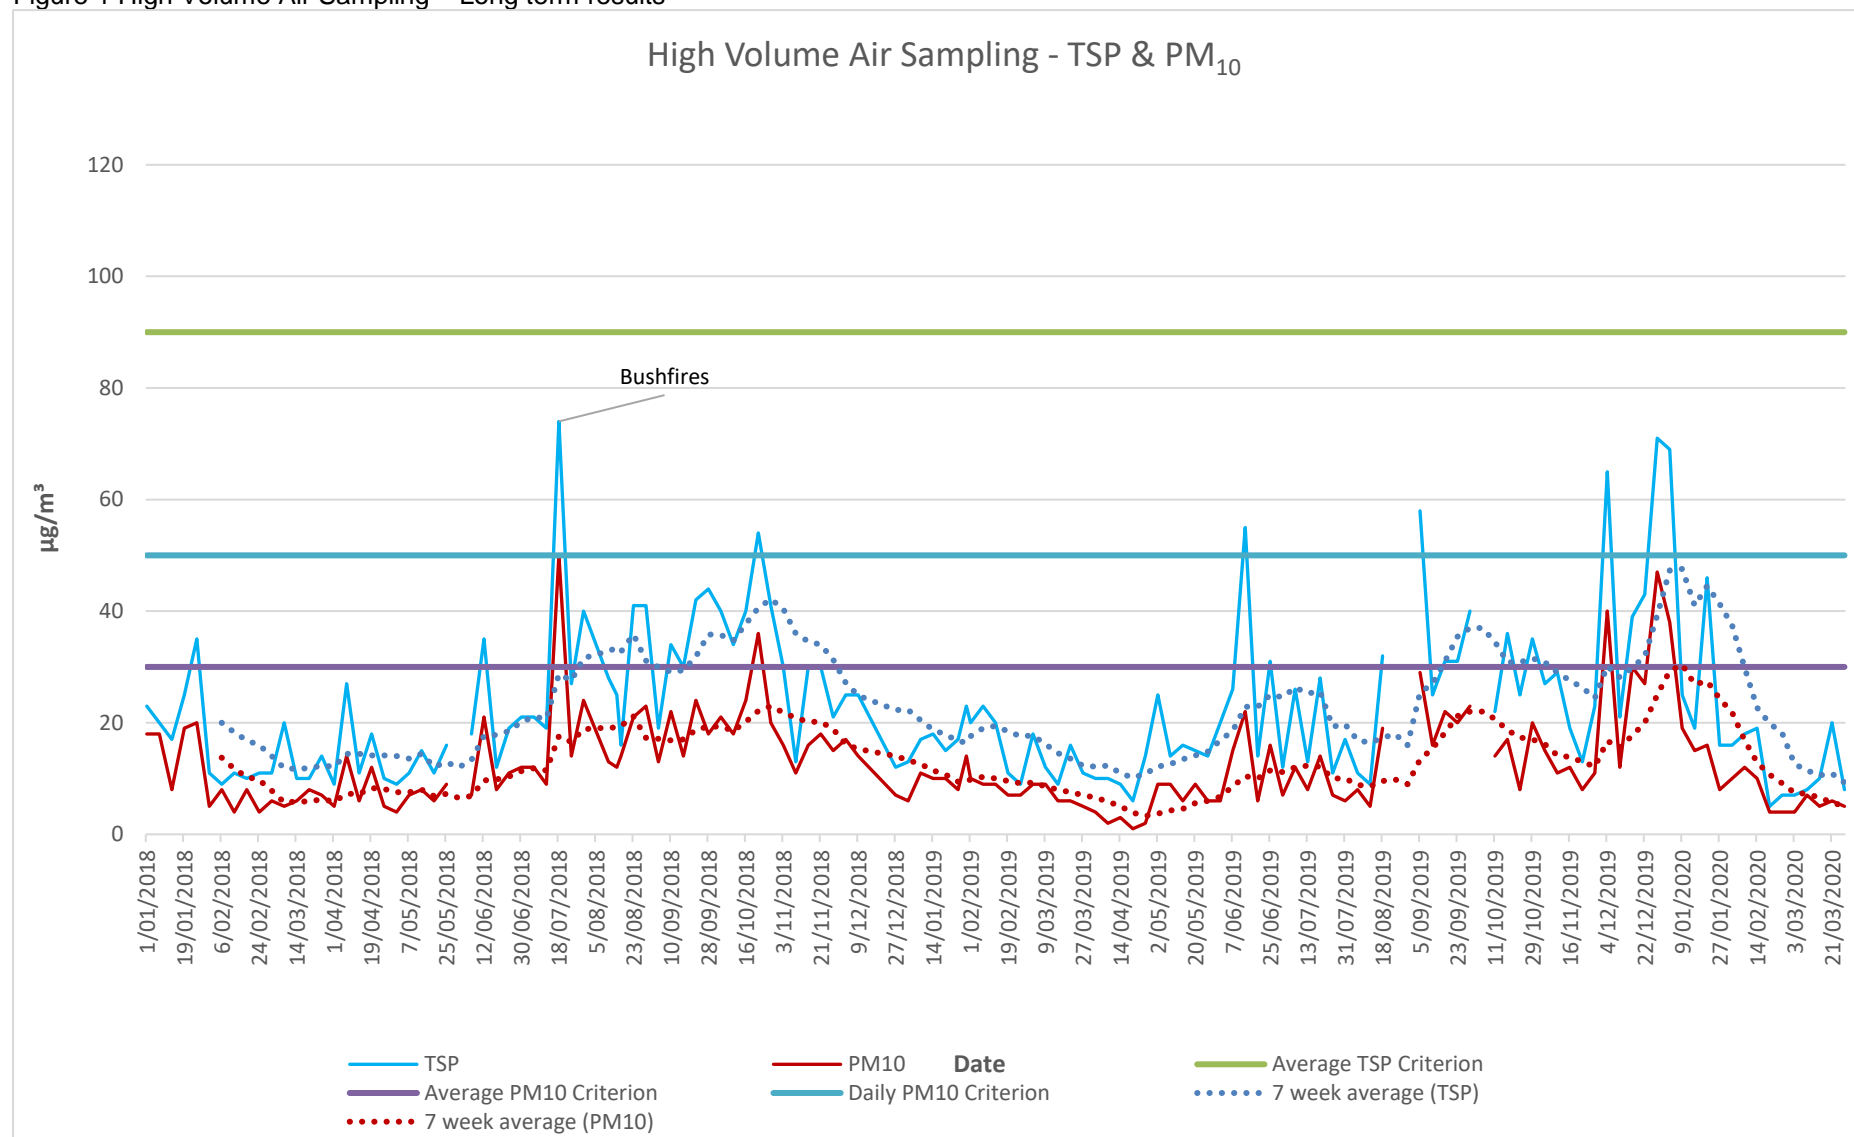
Figure 1 High Volume Air Sampling – Long term results

The TSP and  $\text{PM}_{10}$  results for March 2020 are shown in Table 5 with the long-term monitoring results displayed in **Figure 1**.

All monitoring results to the end of March 2020 indicate that the TSP and PM<sub>10</sub> levels recorded were below the project criterion.

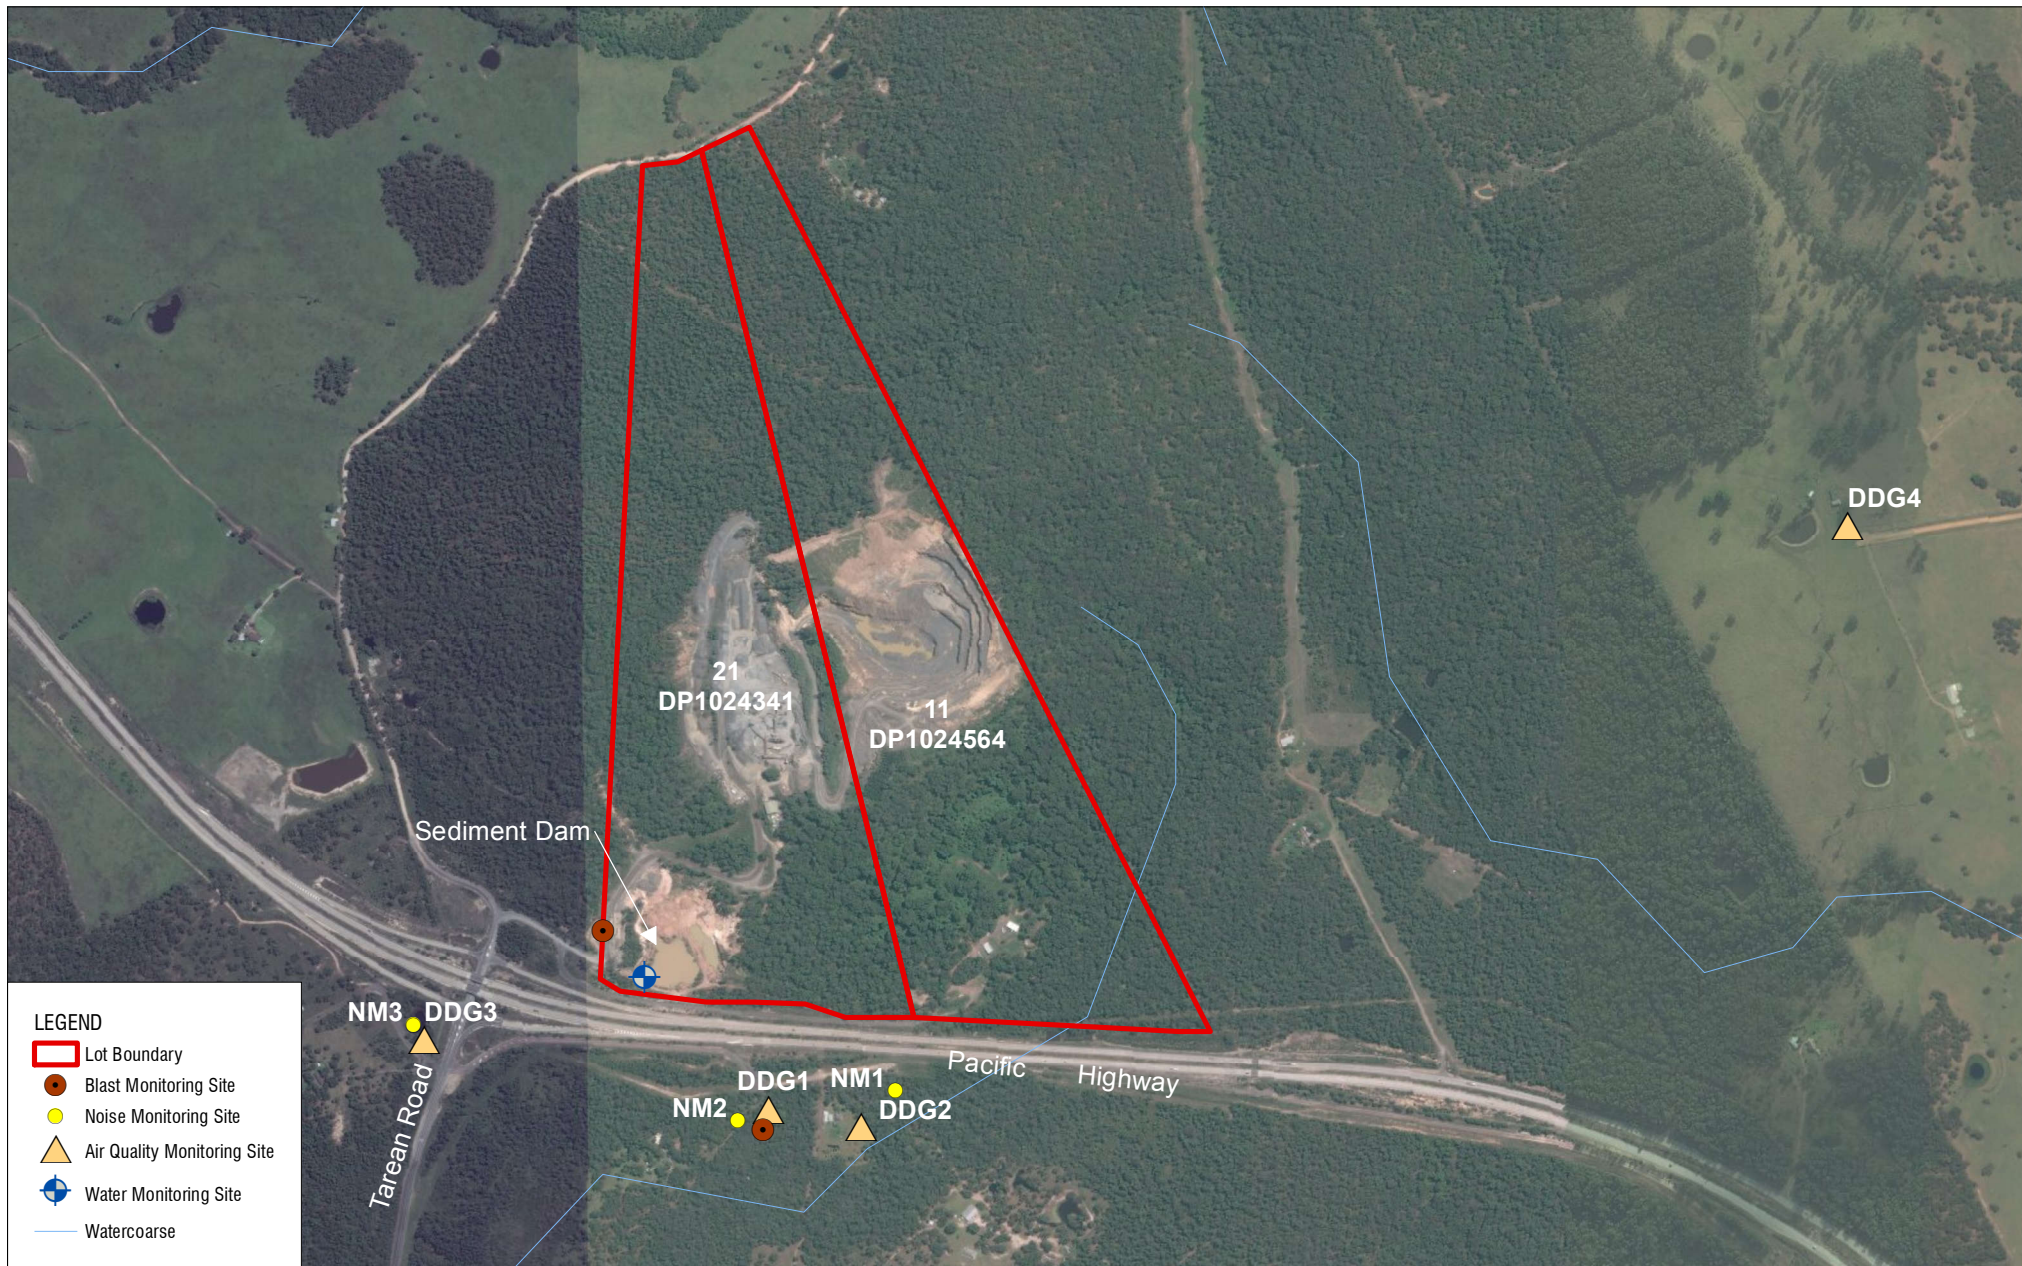
**Karuah Hard Rock Quarry  
Environmental Monitoring Locations**

**Appendix 1** Illustrates the air quality monitoring locations at Karuah Quarry.
