Karuah Hard Rock Quarry

Summary of Environmental Monitoring Data

For the Period: April 2018

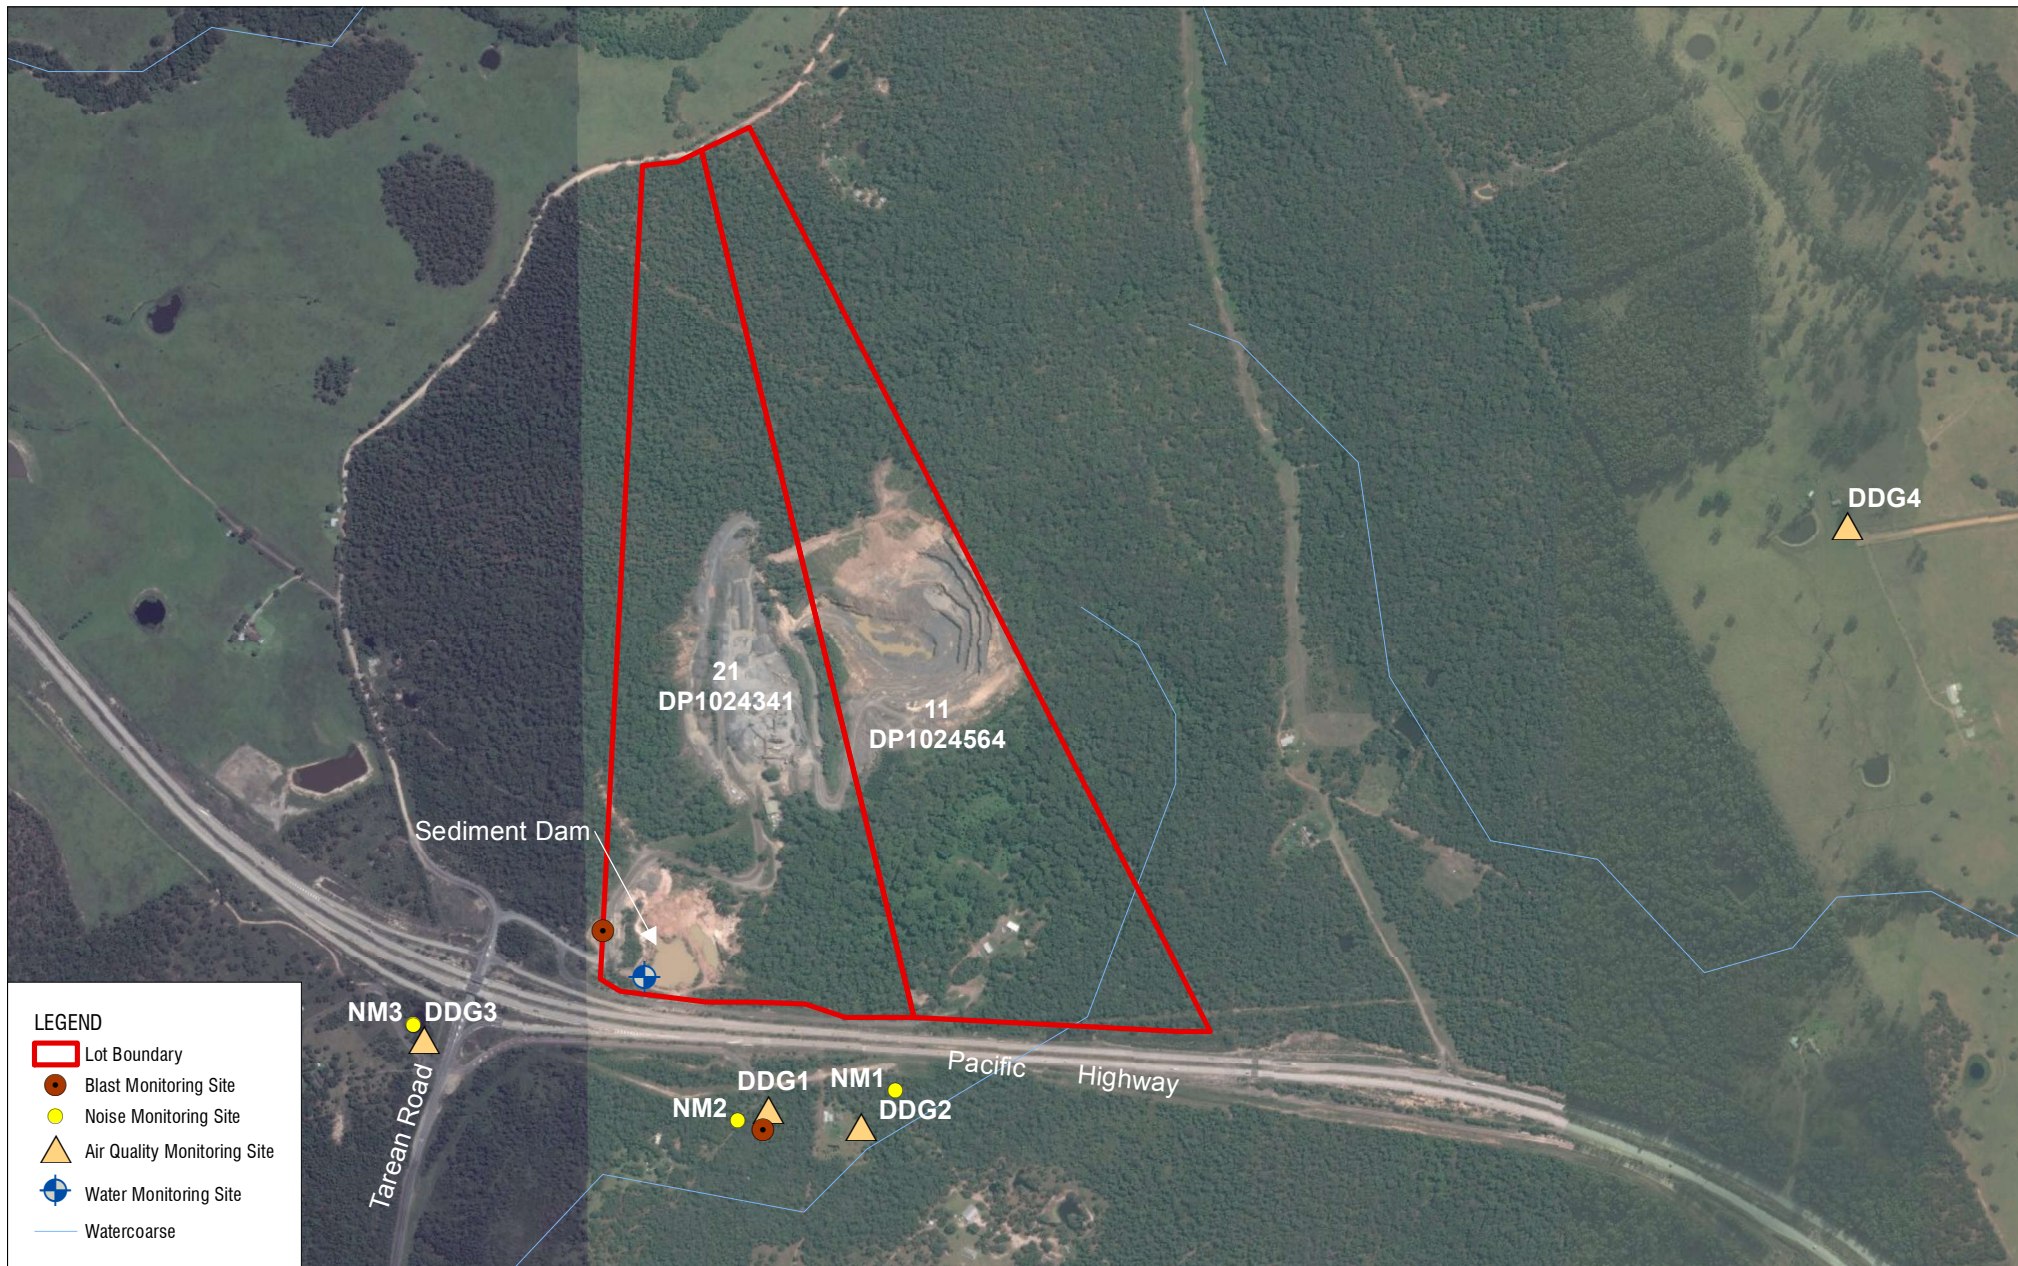
FIGURE 1

Appendix 1 Illustrates the air quality monitoring locations at Karuah Quarry.

**Karuah Hard Rock Quarry
Environmental Monitoring Locations**
