### Karuah Hard Rock Quarry

### Summary of Environmental Monitoring Data

For the Period: April 2019

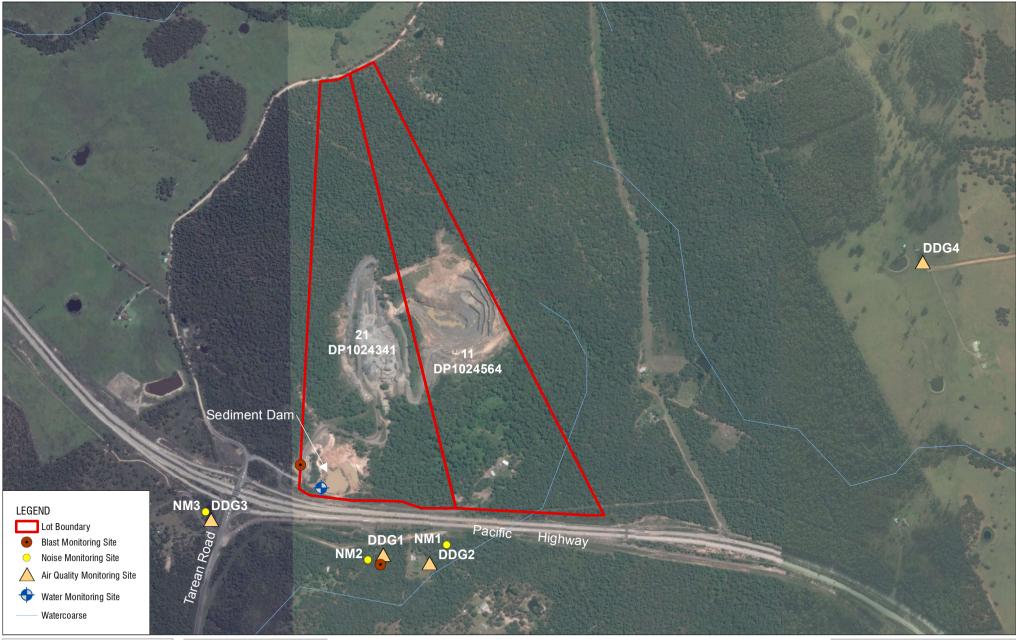
# **APPENDIX 1**

**Appendix 1** Illustrates the air quality monitoring locations at Karuah Quarry.

Karuah Hard Rock Quarry **Environmental Monitoring Locations**
