Karuah Hard Rock Quarry

Summary of Environmental Monitoring Data

For the Period: May 2017

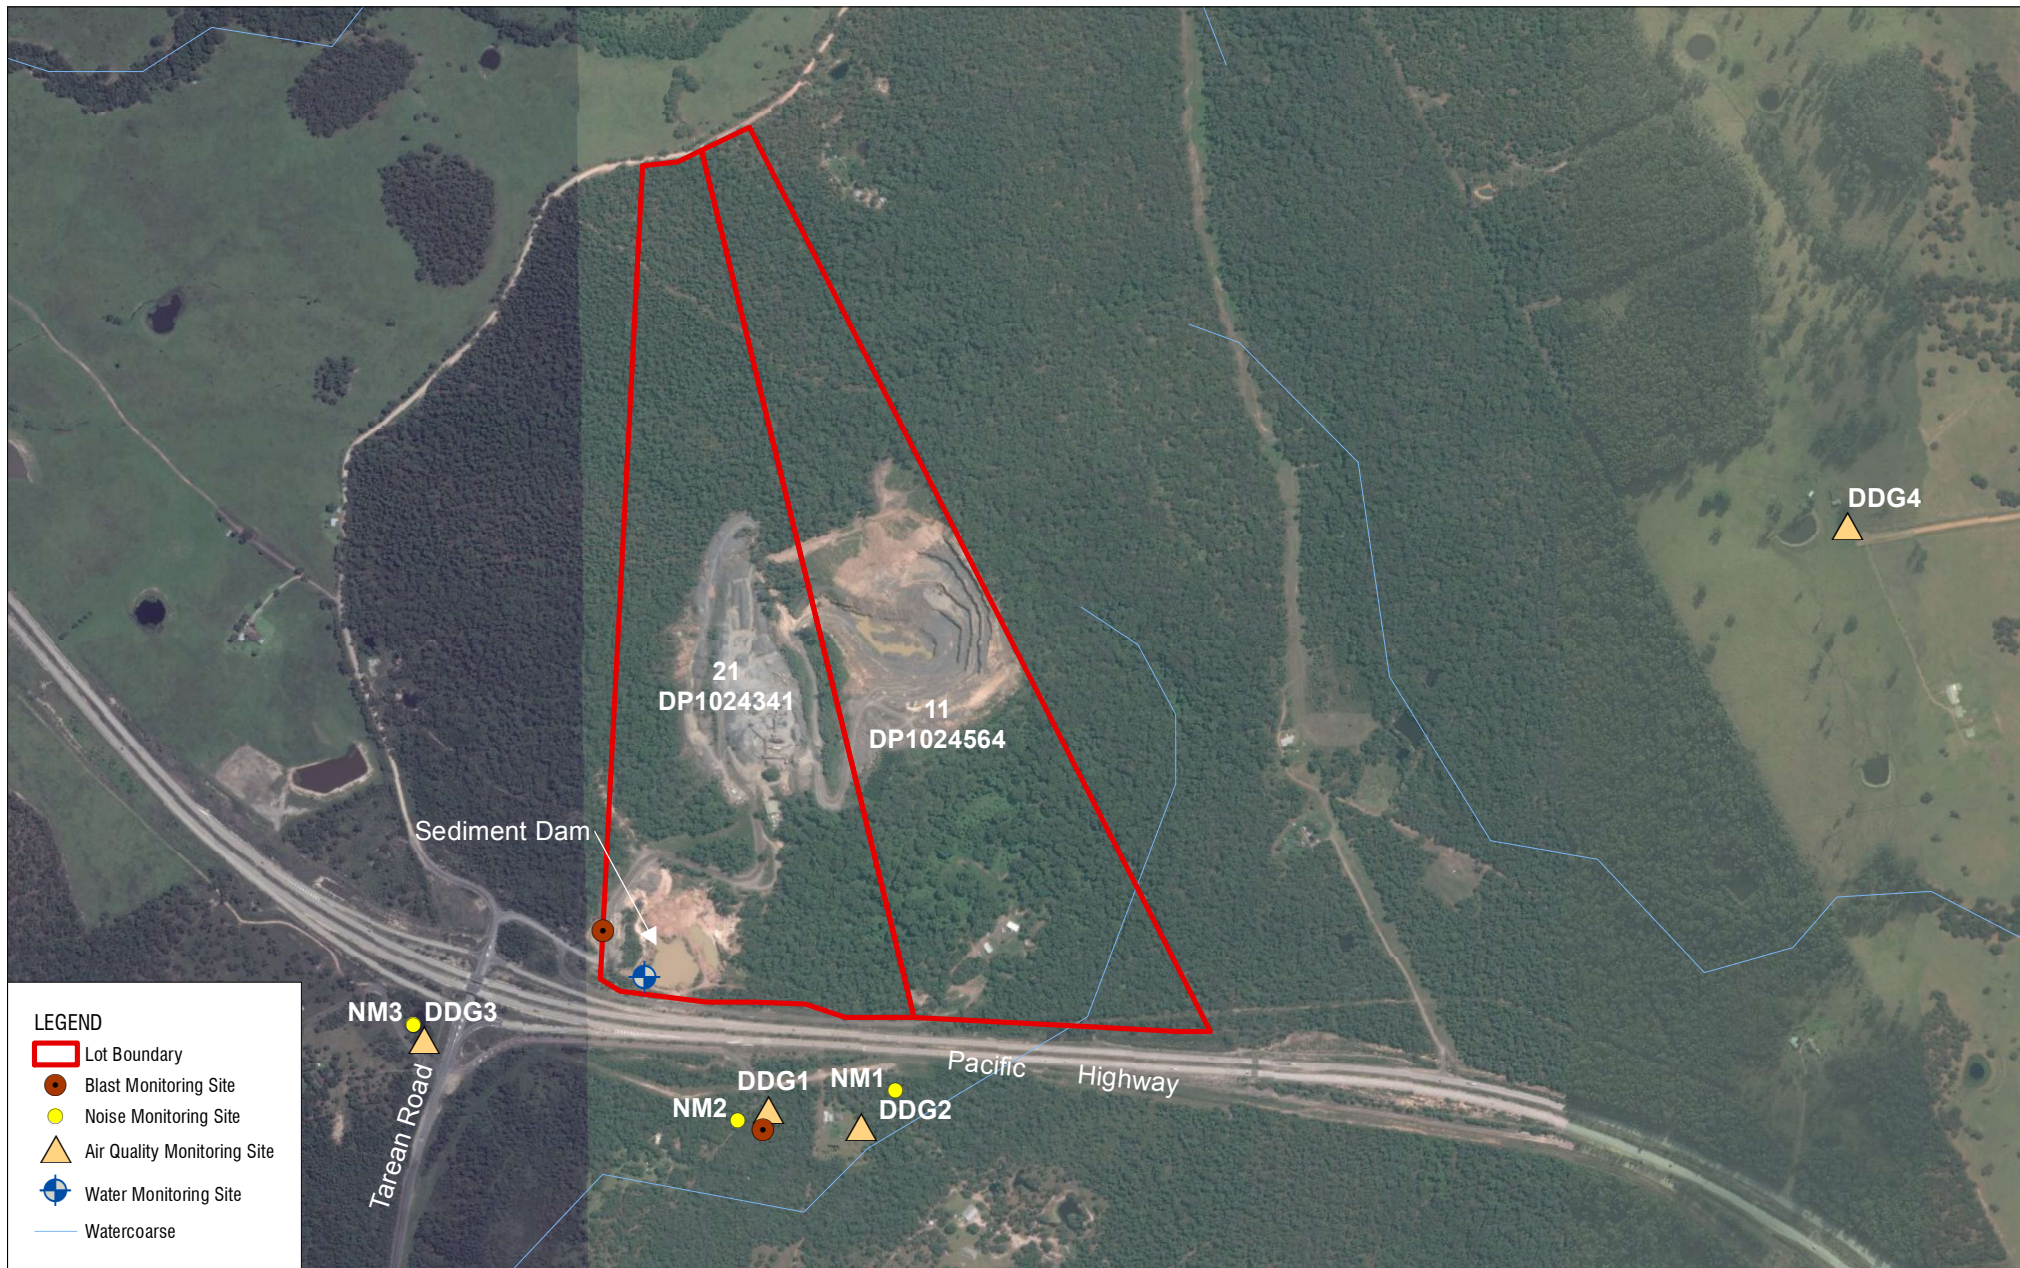
FIGURE 1

Appendix 1 Illustrates the air quality monitoring locations at Karuah Quarry.

**Karuah Hard Rock Quarry
Environmental Monitoring Locations**
