Karuah Hard Rock Quarry

Summary of Environmental Monitoring Data

For the Period: June 2018

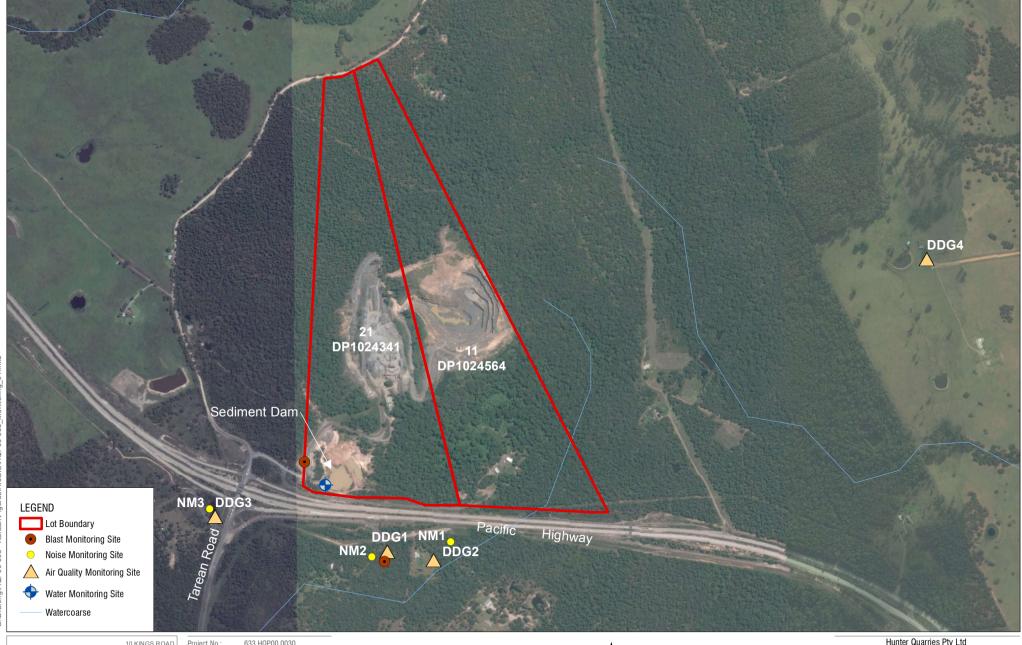
FIGURE 1

Appendix 1 Illustrates the air quality monitoring locations at Karuah Quarry.

Karuah Hard Rock Quarry **Environmental Monitoring Locations**
