## **Karuah Hard Rock Quarry**

### **Summary of Environmental Monitoring Data**

**For the Period: June 2016**

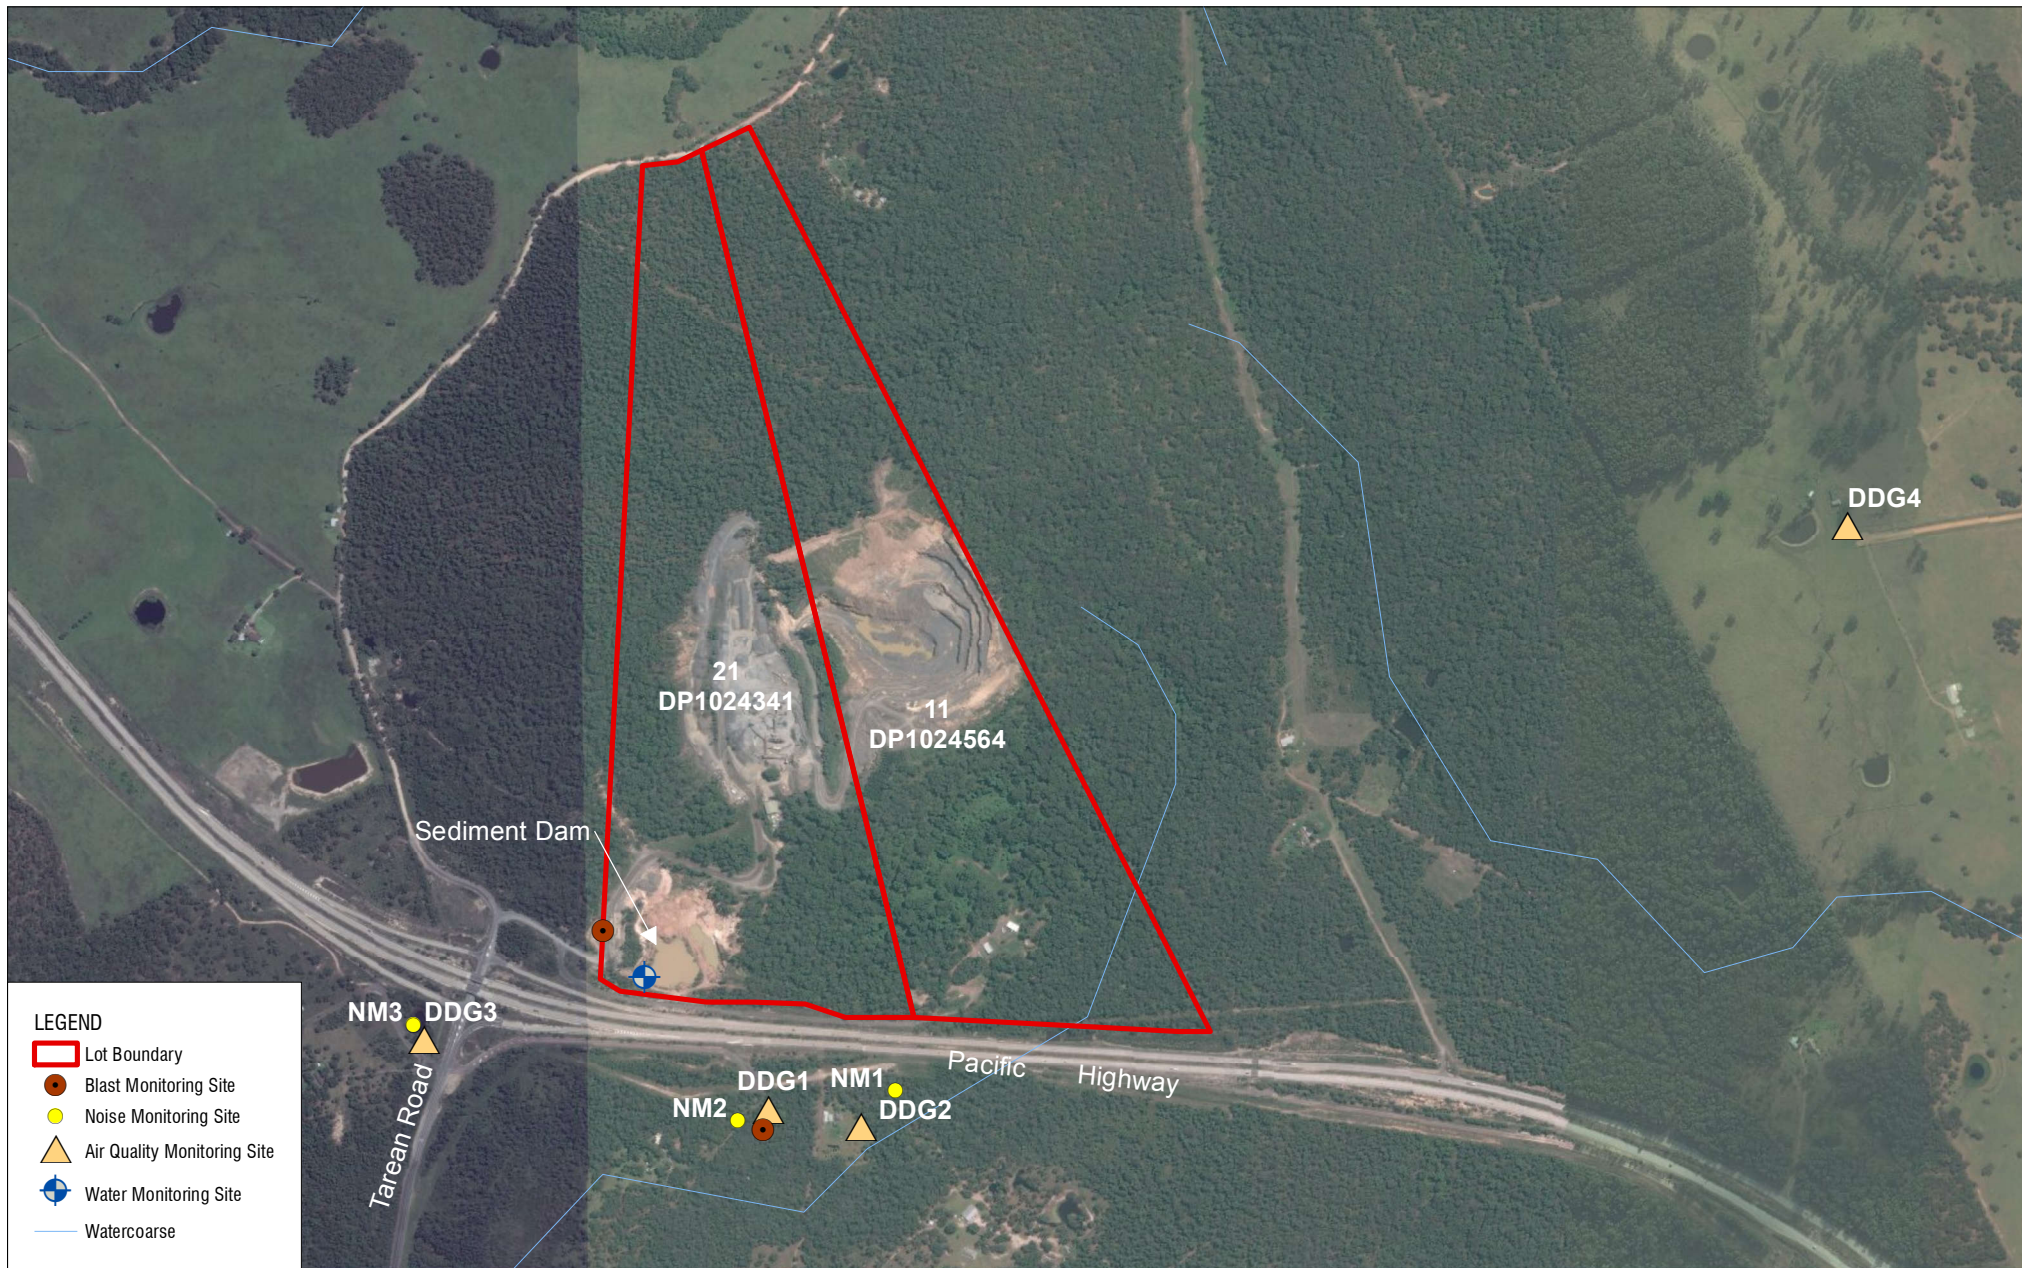
FIGURE 1

## **Appendix 1 – Monitoring Locations**

**Karuah Hard Rock Quarry  
Environmental Monitoring Locations**

**Appendix 1** Illustrates the air quality monitoring locations at Karuah Quarry.
