Karuah Hard Rock Quarry

Summary of Environmental Monitoring Data

For the Period: June 2017

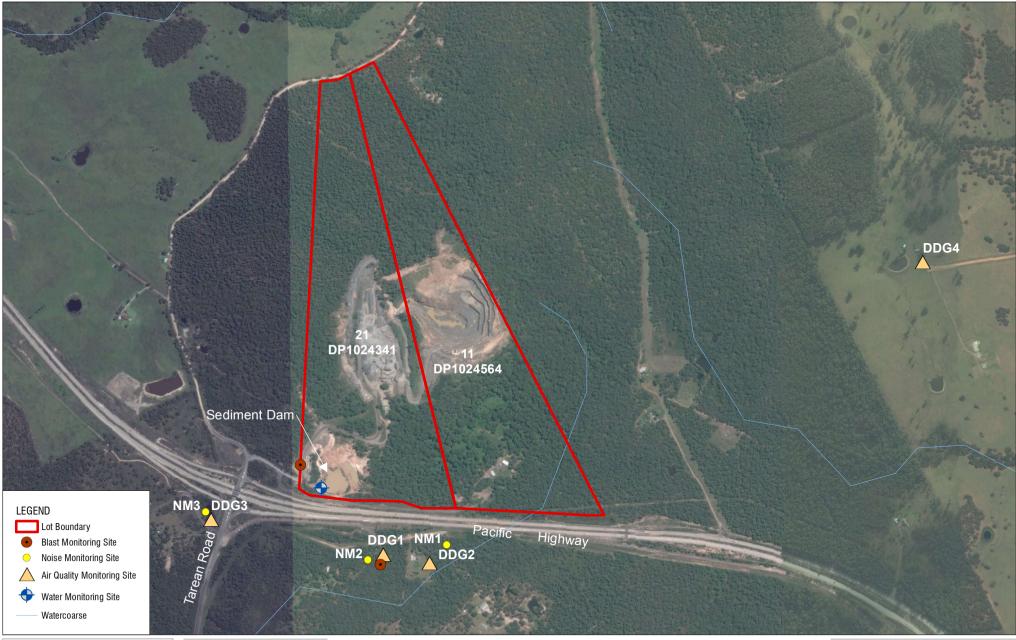
FIGURE 1

Appendix 1 Illustrates the air quality monitoring locations at Karuah Quarry.

Karuah Hard Rock Quarry **Environmental Monitoring Locations**
