## **Karuah Hard Rock Quarry**

### **Summary of Environmental Monitoring Data**

**For the Period: August 2016**

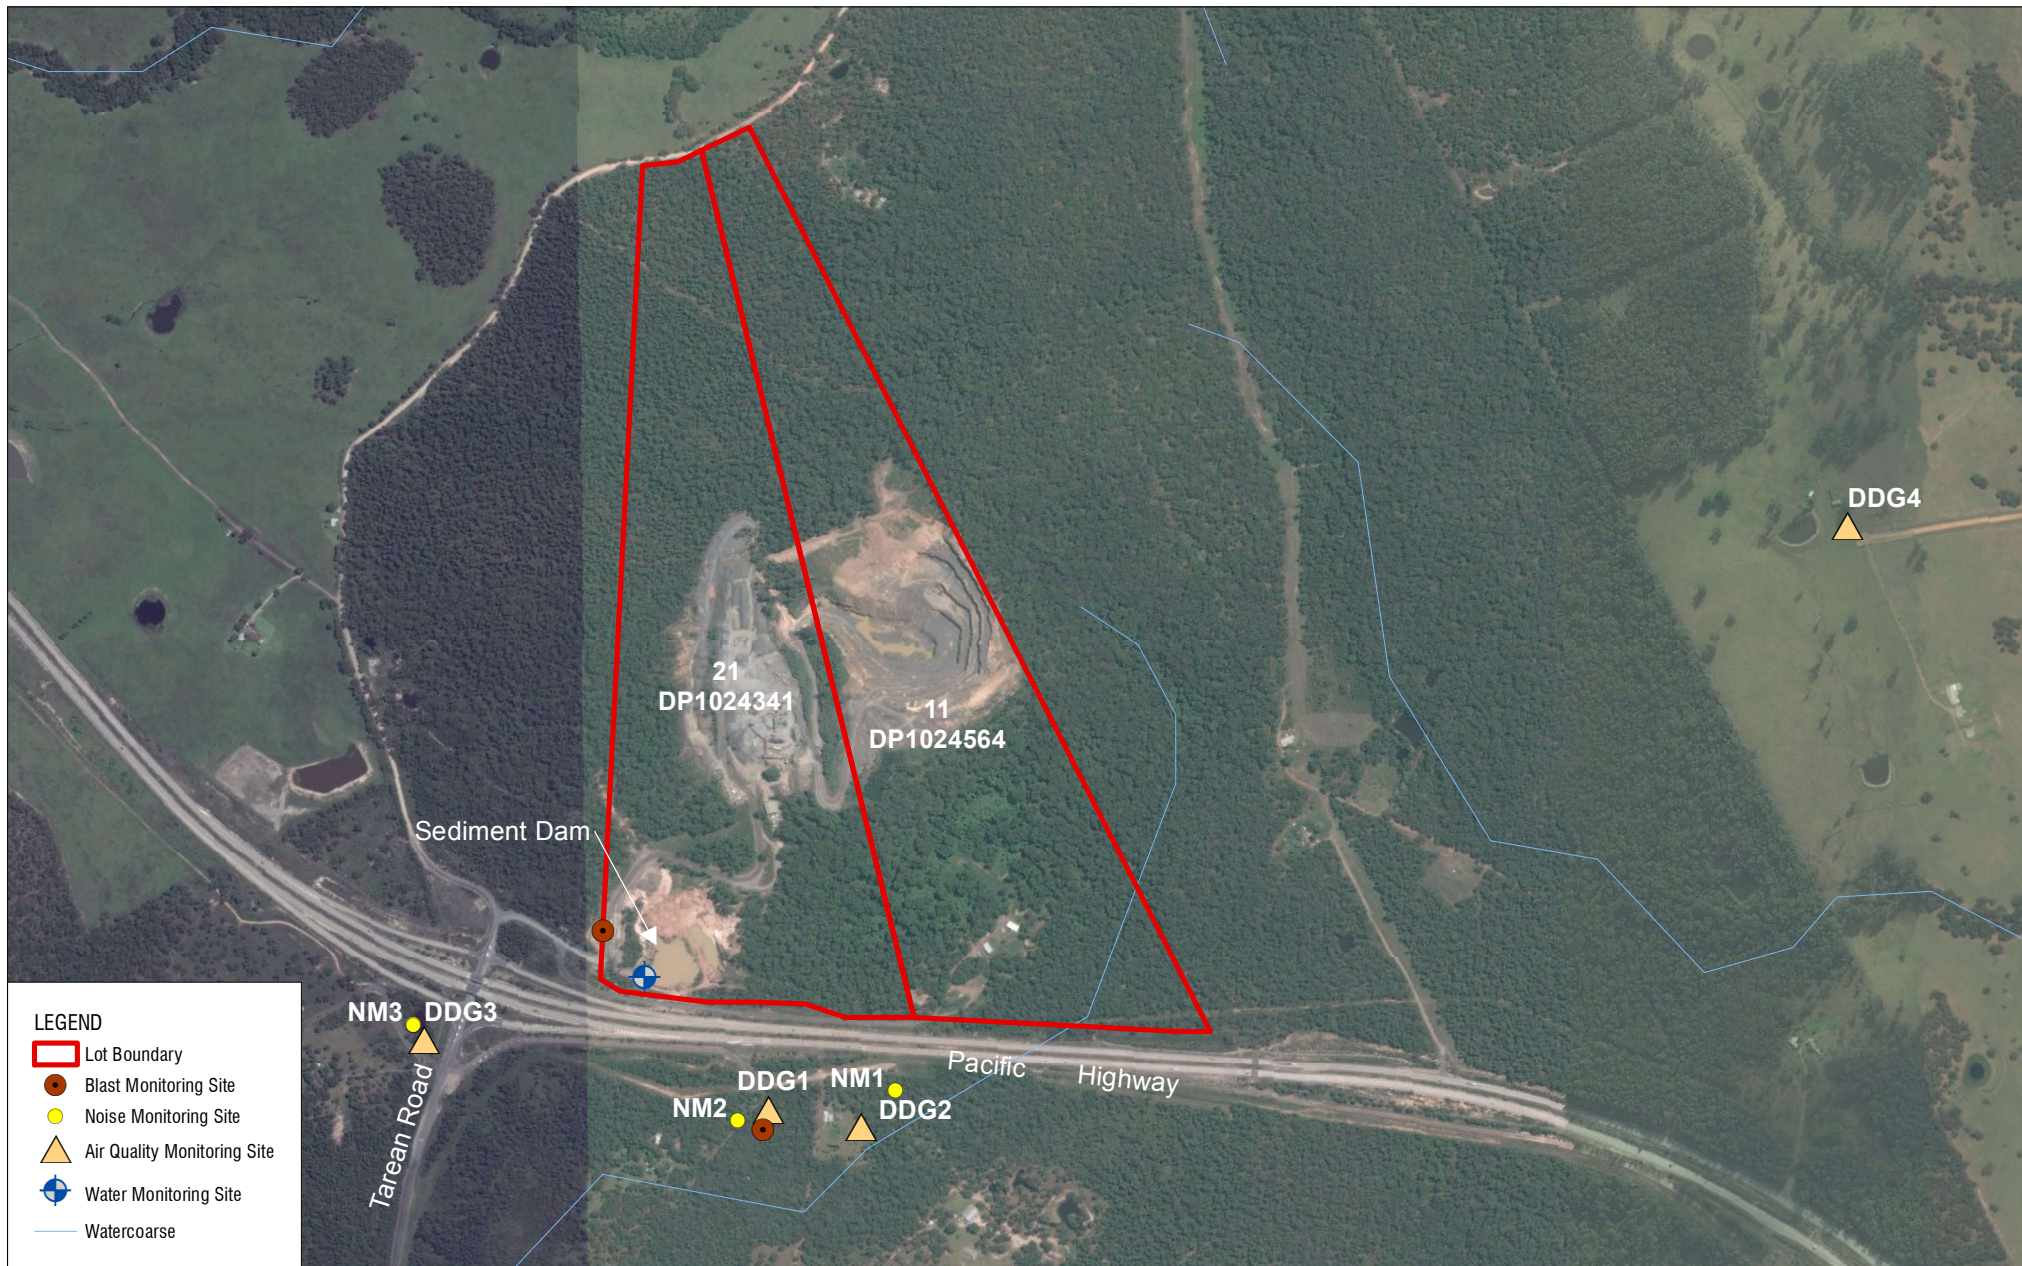
FIGURE 1

**Appendix 1** Illustrates the air quality monitoring locations at Karuah Quarry.

**Karuah Hard Rock Quarry  
Environmental Monitoring Locations**
