Karuah East Quarry

Monthly Environmental Monitoring Report

September 2017

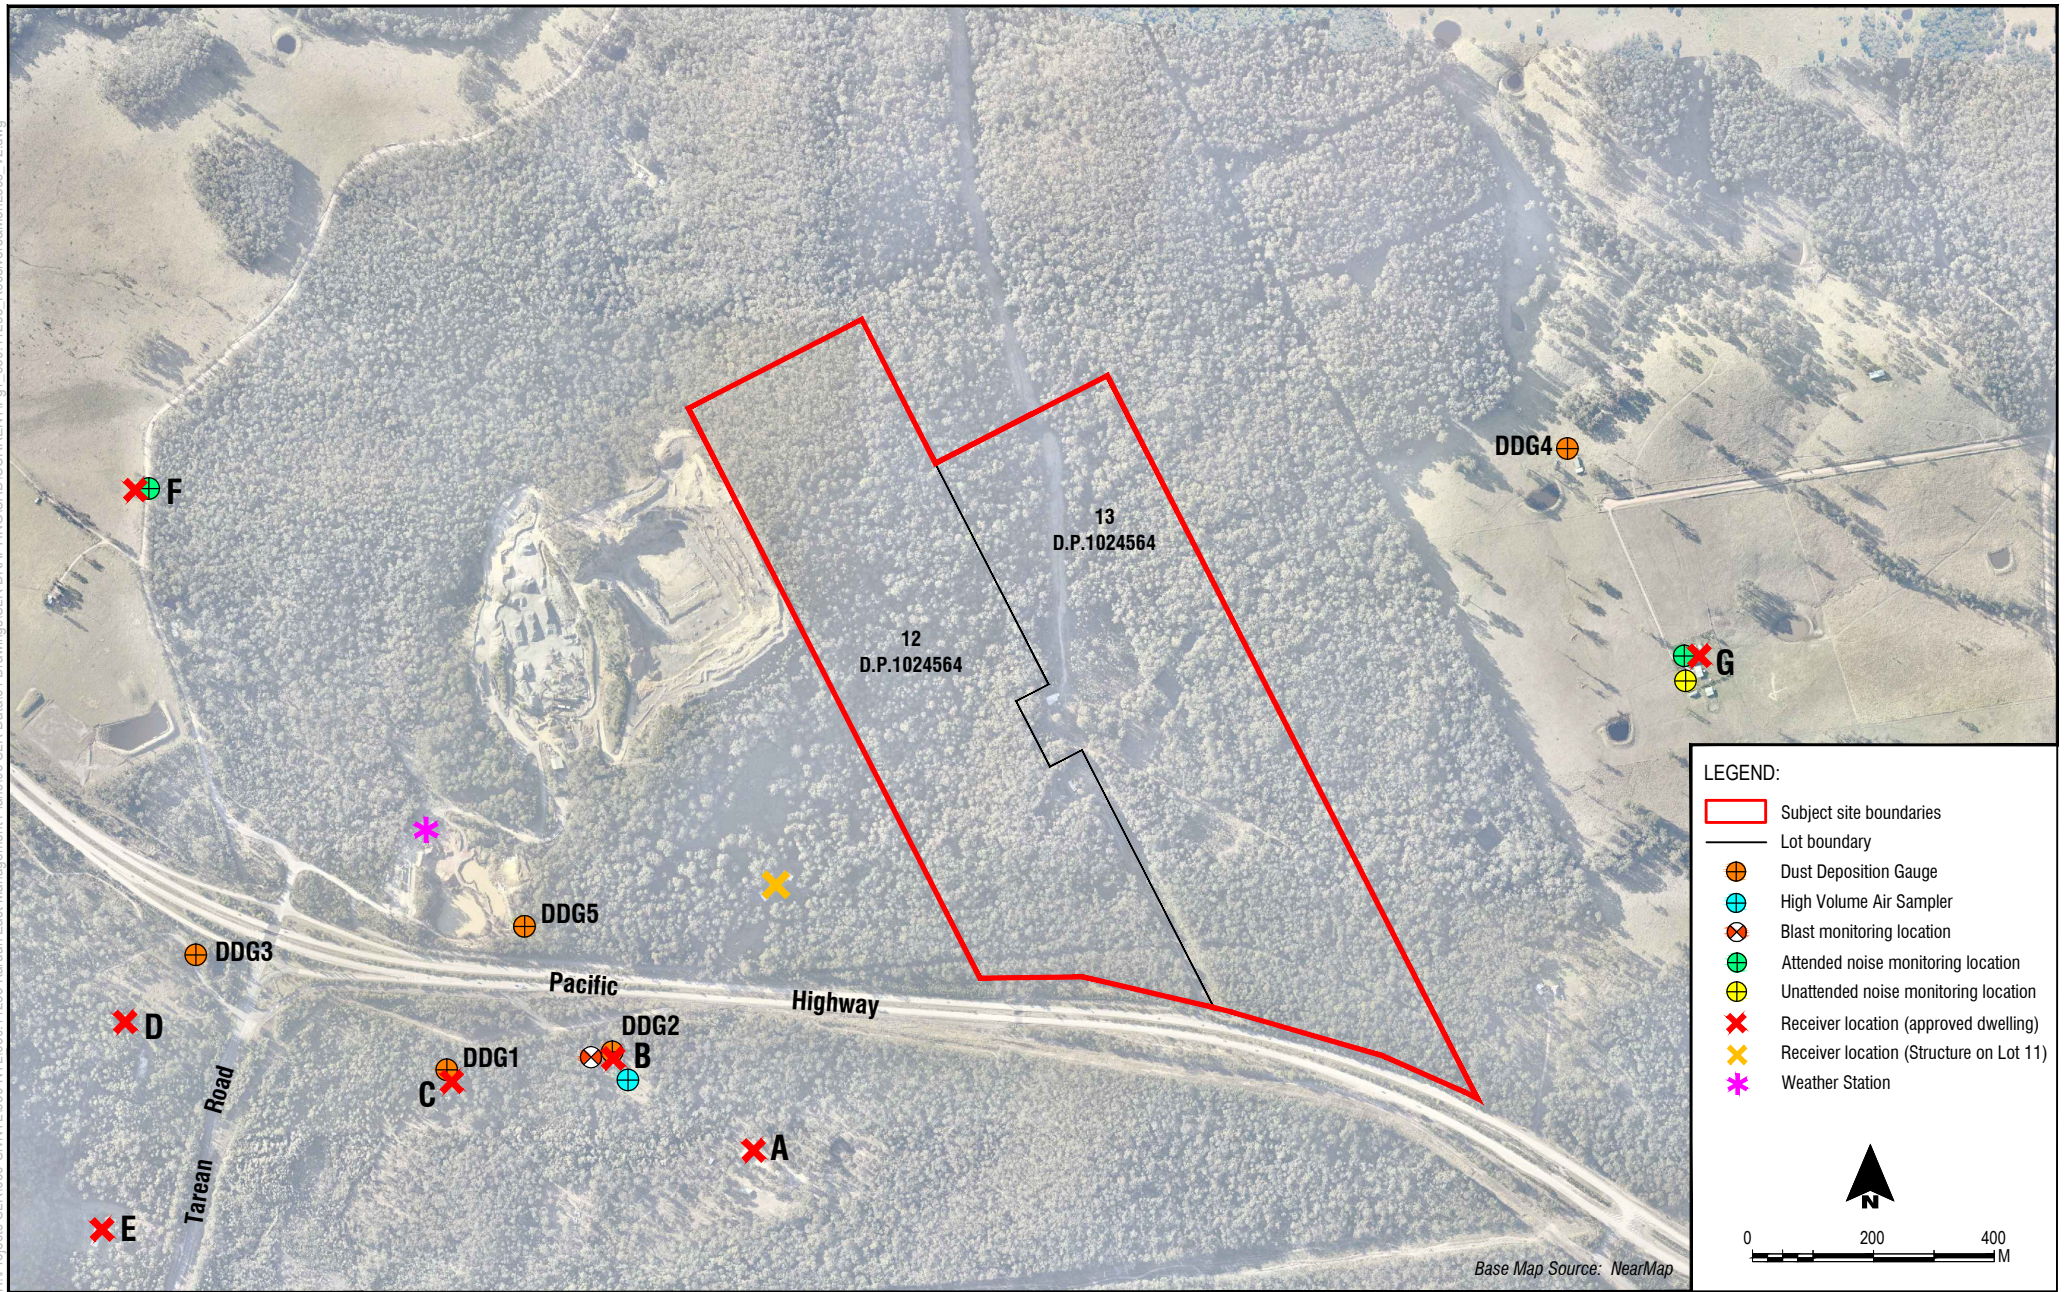
Monitoring Locations

- Appendix 1 illustrates the monitoring locations.
- Criteria is for daytime limits. Daytime is defined as the period from 7am to 6pm Monday to Saturday and 8am to 6pm Sunday and Public Holidays.

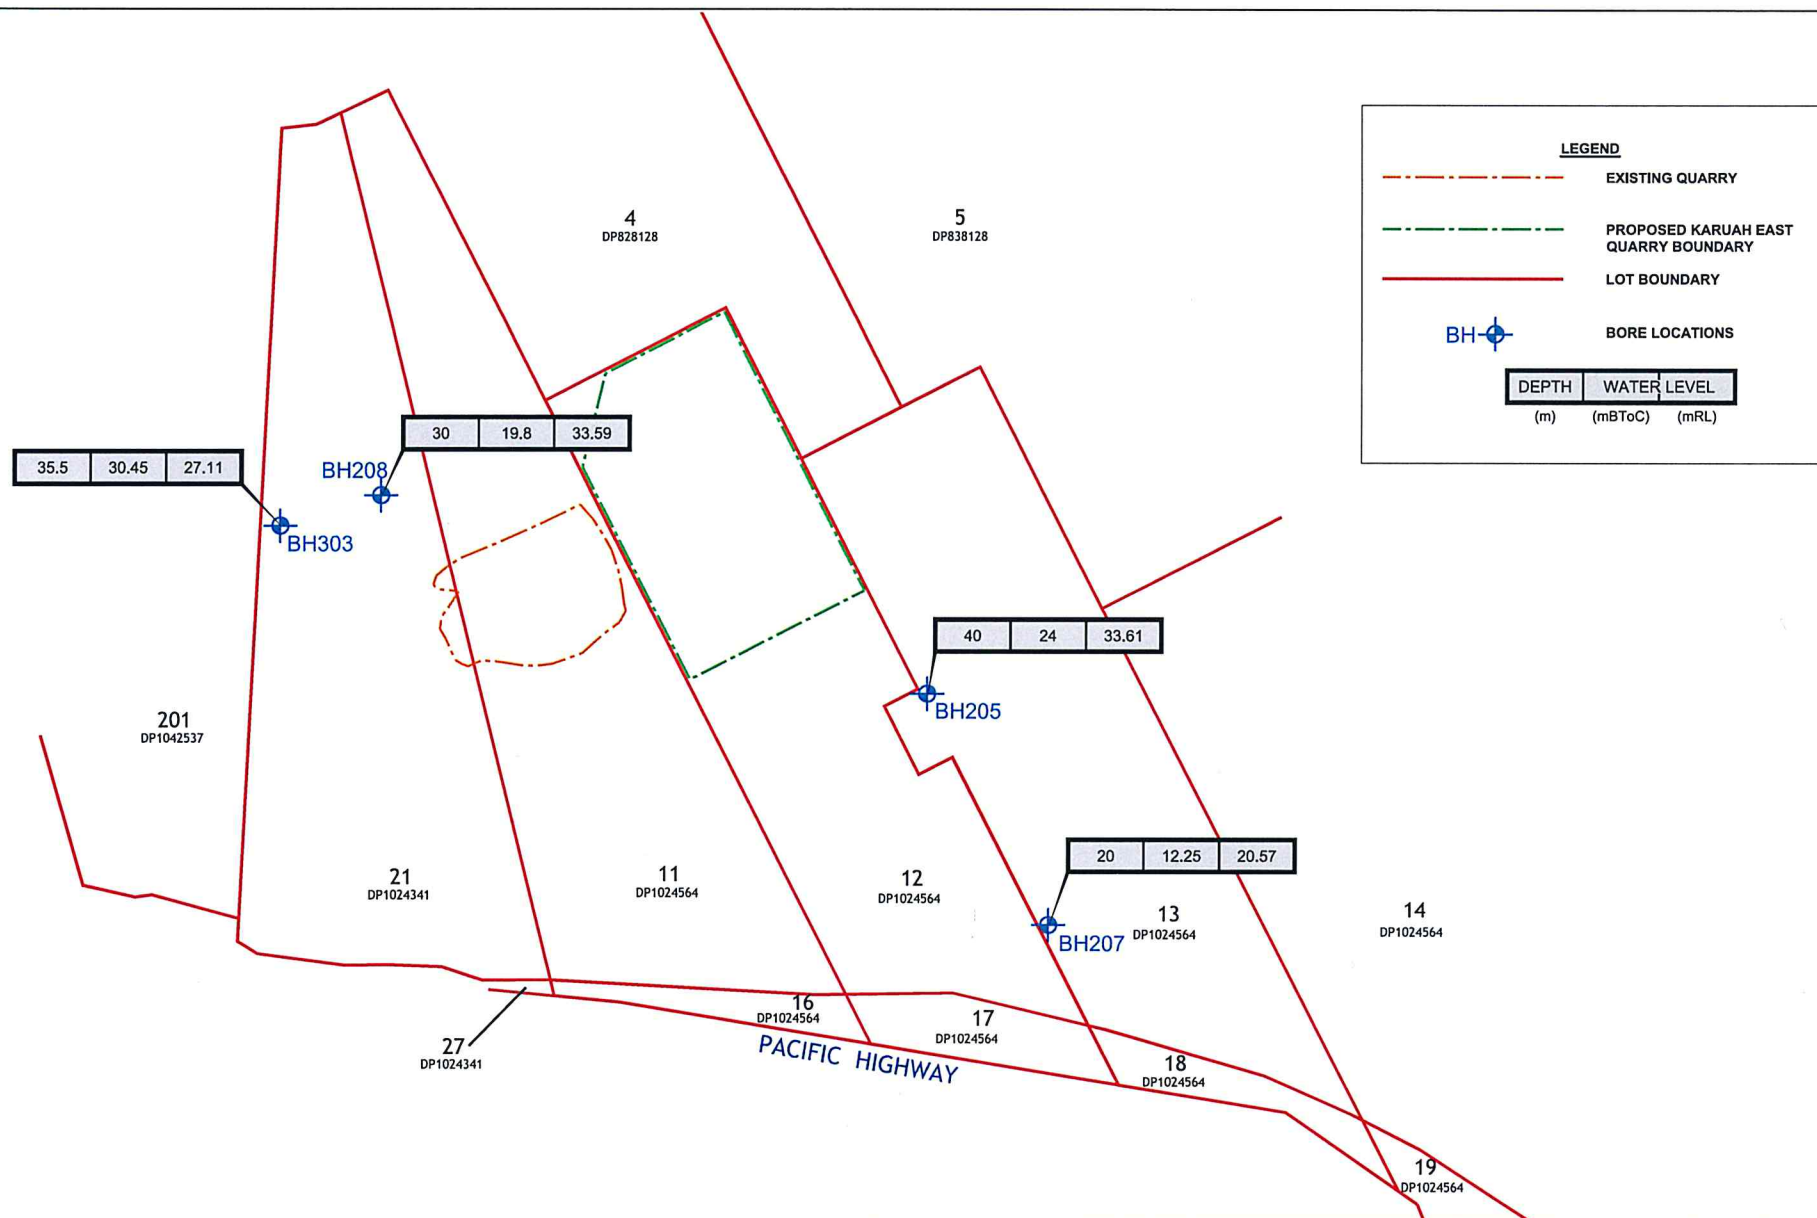
coffey geotechnics SPECIALISTS MANAGING THE EARTH	client:	KARUAH EAST QUARRY PTY LTD	
approved	MB		project:	PROPOSED KARUAH EAST HARD ROCK QUARRY GROUNDWATER STUDY	
date	18.08.11		title:	GROUNDWATER BORE LOCATIONS AND MONITORING DATA	
scale	1:12,000		project no:	GEOTWARA21232AA-AG	figure no: FIGURE 3.1
original size	A4

Groundwater monitoring is undertaken to meet the *EA Statement of Commitments* (Appendix 6, PA 09_0175) and Section 8.2 [Water Management Plan \(SLR, 2015\)](#). Groundwater levels are monitored quarterly and water quality biannually at four groundwater monitoring bores (piezometers). Details of this monitoring program is shown in **Table 18**. Refer to Appendix 1 for piezometer locations.
