Karuah Hard Rock Quarry

Environmental Monitoring Report:

May 2021

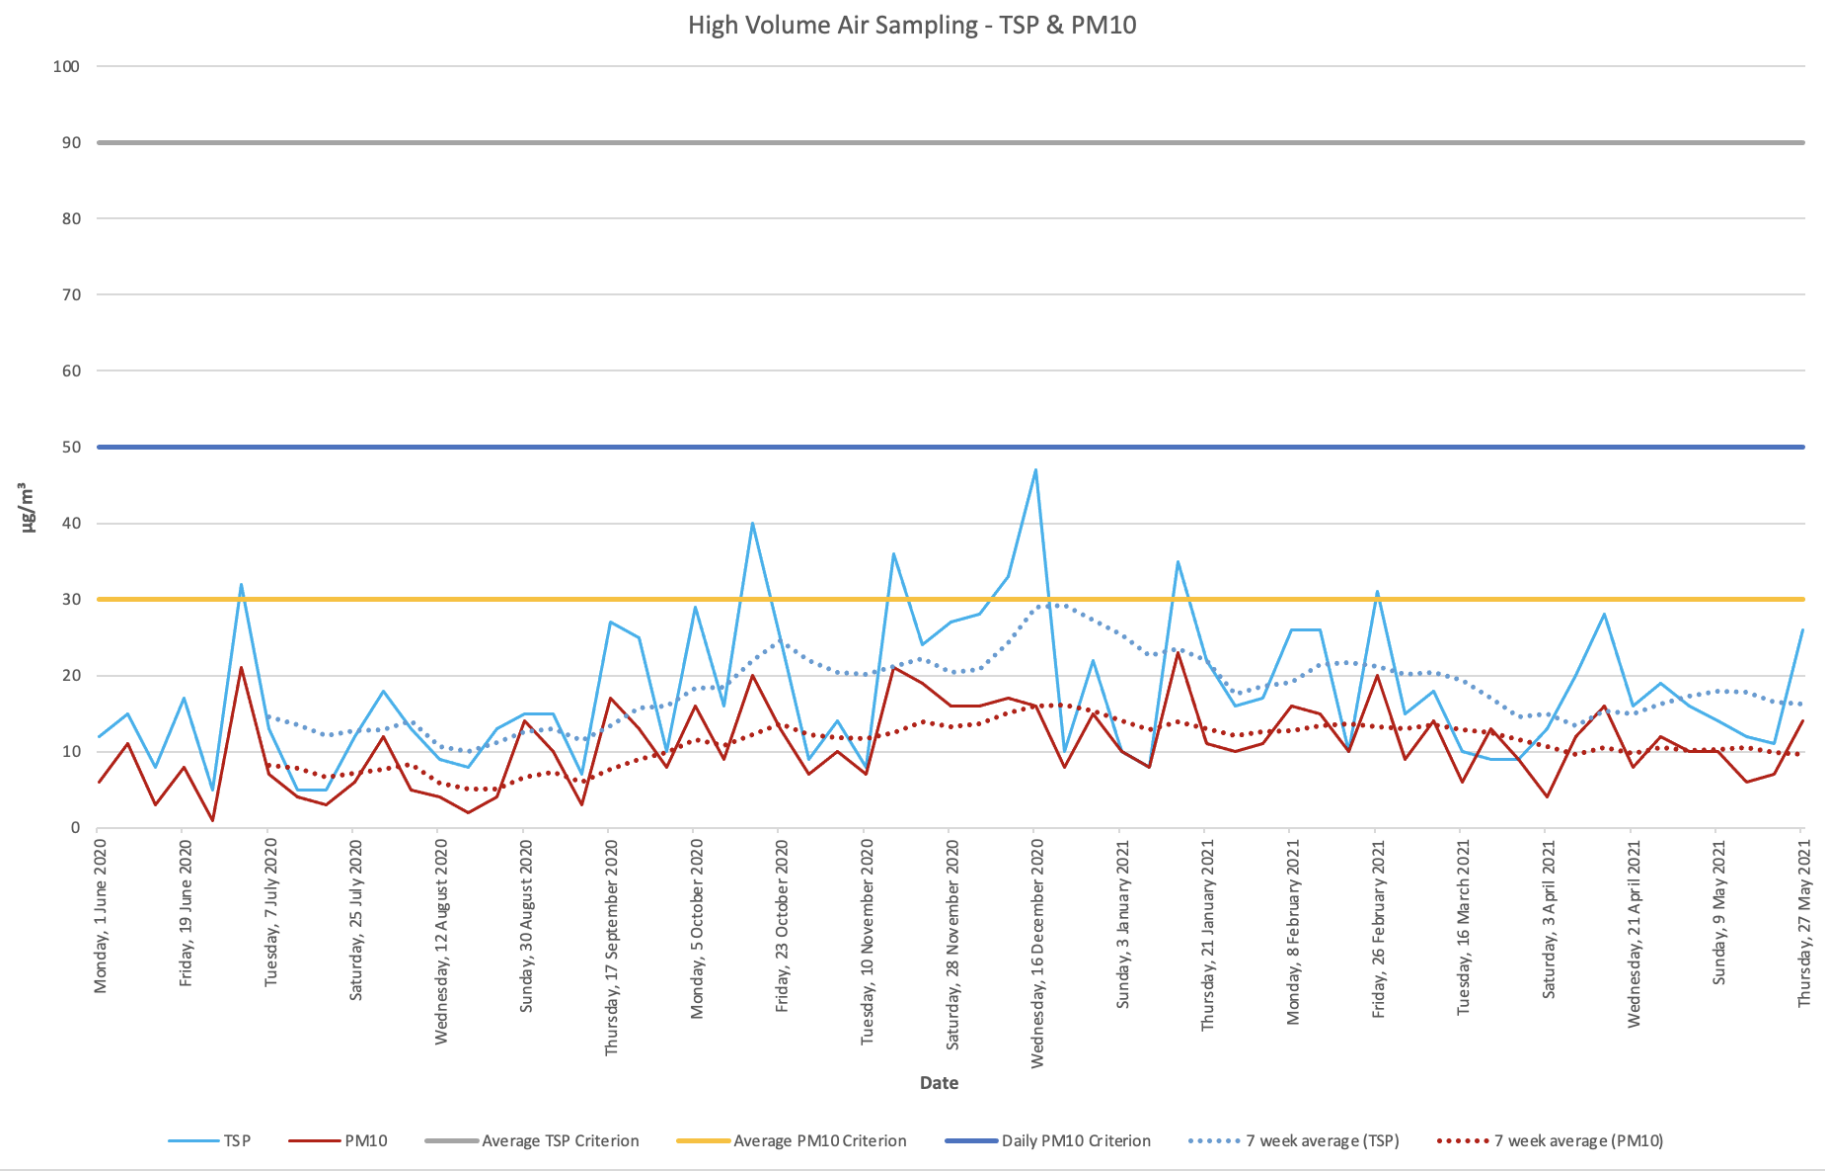
Figure 1 High Volume Air Sampling: Year-to-date results

Figure 1 illustrates the year-to-date results for HVAS monitoring.

All HVAS monitoring results, to the end of May 2021 were compliant with the long term and short term impact assessment criteria outlined in *Schedule 3 Condition 13* of the Consent (see Table 3, Table 4 and Table 5).

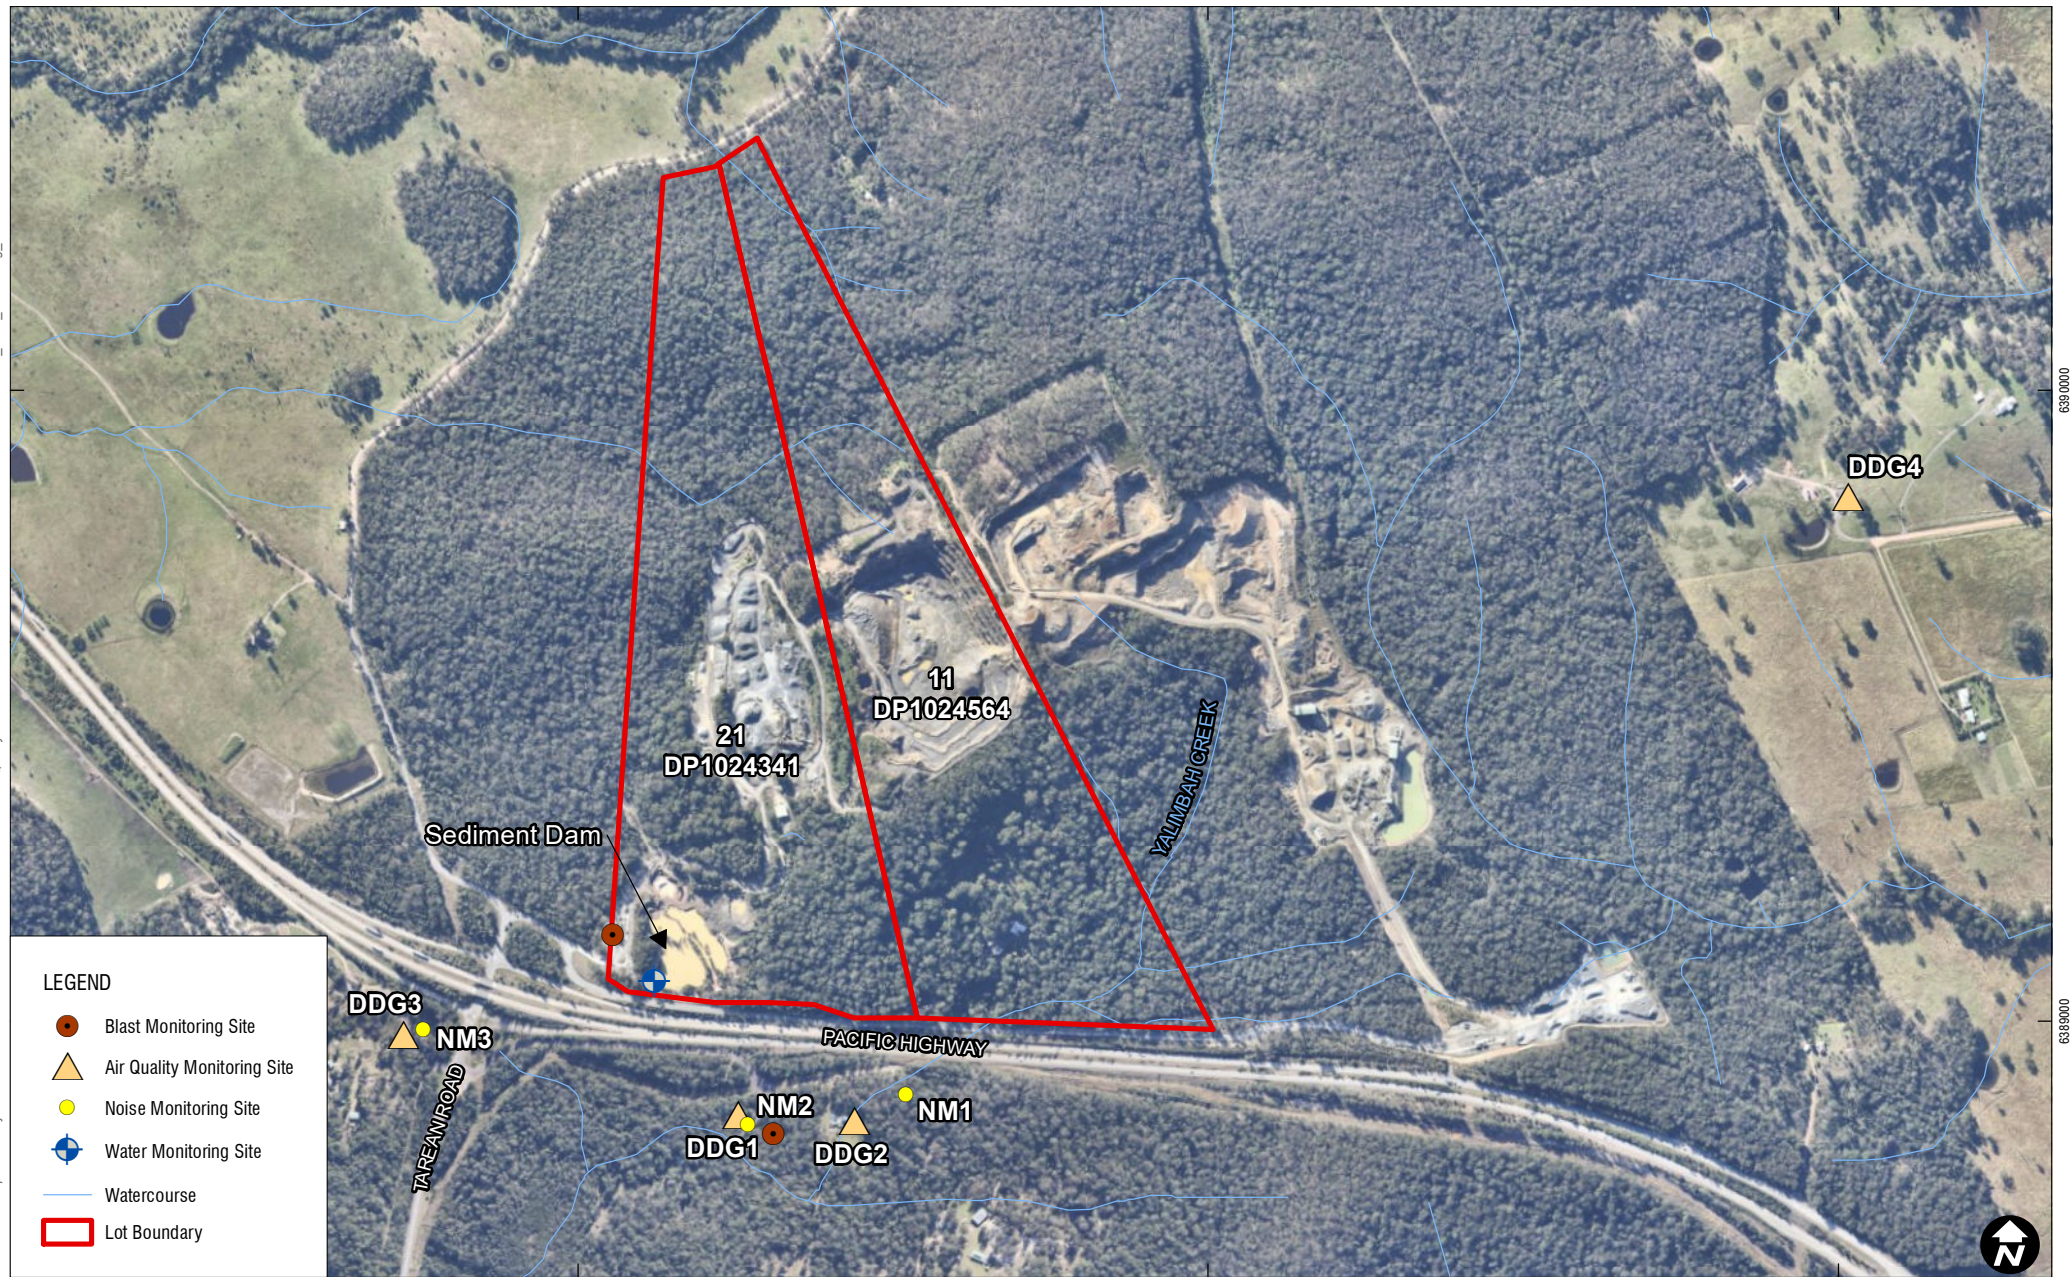
Appendix 1 – Monitoring Locations

Monitoring locations are identified in in Appendix 1.
